**CONDITION OF "ELASTIZELL"
LIGHTWEIGHT CONCRETE BACKFILLS
AFTER ONE YEAR IN PLACE**

(First Progress Report)

Research Laboratory Section
Testing and Research Division
Research Project 75 E-54
Research Report No. R-1096

Michigan State Highway Commission
Peter B. Fletcher, Chairman; Carl V. Pellonpaa,
Vice-Chairman; Hannes Meyers, Jr., Weston E. Vivian
John P. Woodford, Director
Lansing, September 1978

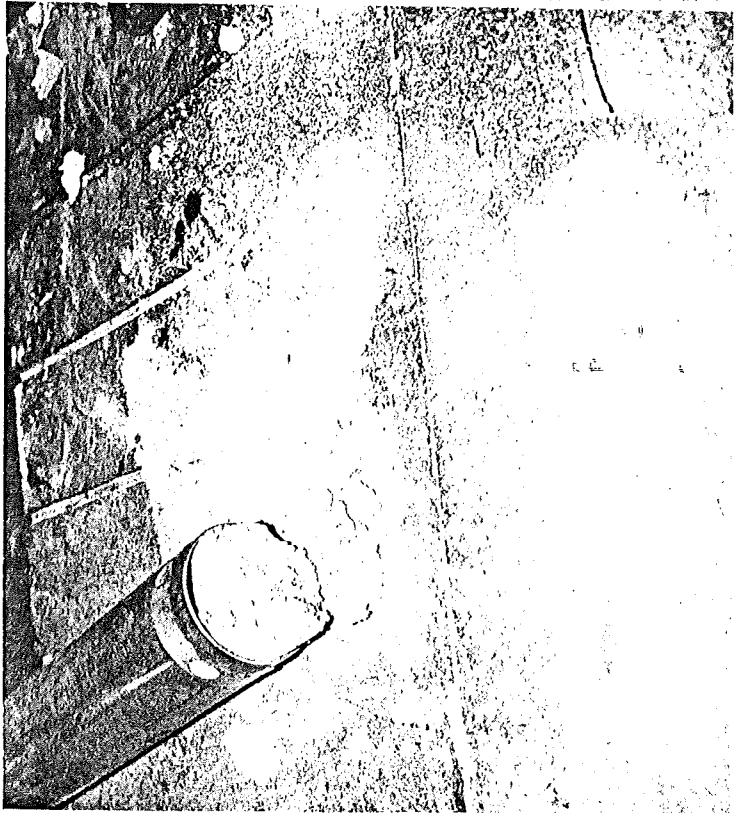
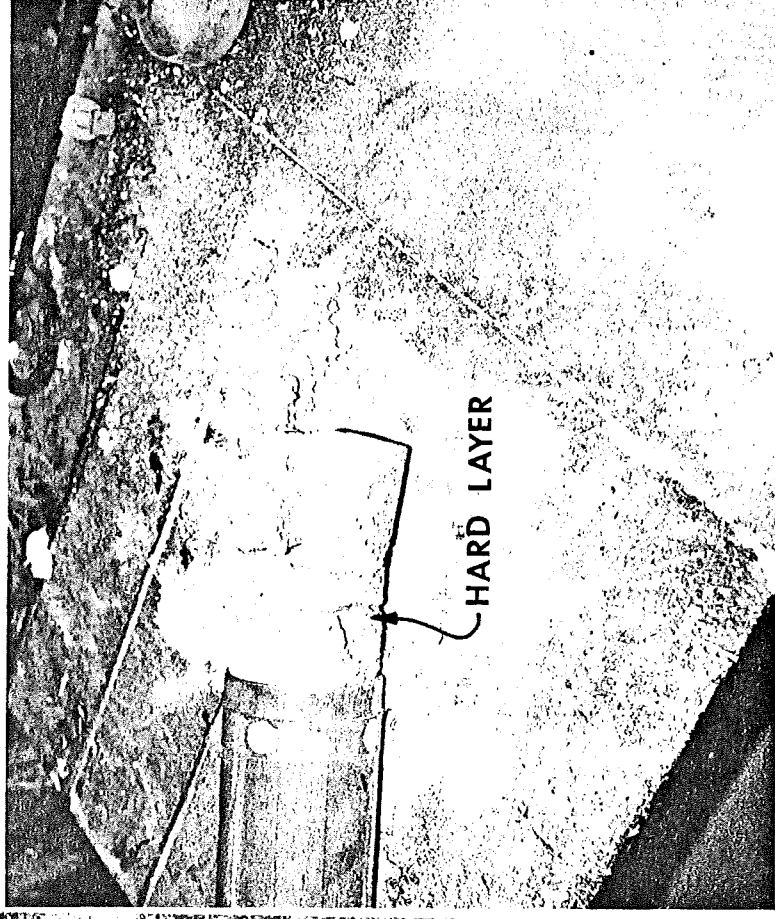
Figure 1. Shelby tube samples showing a soft Elastizell layer and the associated hard layer.

Various properties of the Elastizell fill were determined by testing the in-place material. Samples were obtained by driving 3-in. diameter Shelby tubes into the Elastizell at four test sites with a 140-lb hammer. Each tube contained about a 3-ft length of sample. Figure 1 shows an Elastizell sample in a section of tubing.

A large number of the sample cores were either cracked, so that compression strengths could not be determined, or were so weak and powdery that proper test samples could not be obtained. Generally, the soft material was associated with a thin, hard, dense layer of portland cement paste, as shown in Figure 1. The material above the hard layer was so weak it could not be handled without crumbling to a powder. This condition indicates that the portland cement had, in some cases, settled to the bottom of a pour leaving cell walls of the layer extremely thin and weak. Why this occurs in some cases and not in others is not known. Inadequate control of the quality and mixing of individual batches of Elastizell could be responsible for the lack of uniformity. Because of the overall structural integrity of the fill, it is assumed that the weak layers are localized and probably represent only a small percentage of the total pour.

Compressive strengths of 32 samples which were firm enough to be tested, are all well above the minimum allowable 20 psi. In spite of the presence of locally weak areas, the overall strengths of the Elastizell fills appear to be satisfactory. It is felt that most of such weaker areas could be eliminated in future work by closer control by the contractor of the batch mixing.

Hard white layer of portland cement paste with no foam cells as normally found below soft crumbled layers.

Soft crumbled layer of lightweight concrete apparently caused by too much foam in the mix.

2) Although structurally sound, the Elastizell fills contain a large number of soft, powdery areas having little or no support value. To date, these have not appeared to be damaging, but they should certainly be eliminated, or minimized, by closer batch mixing control on future jobs.

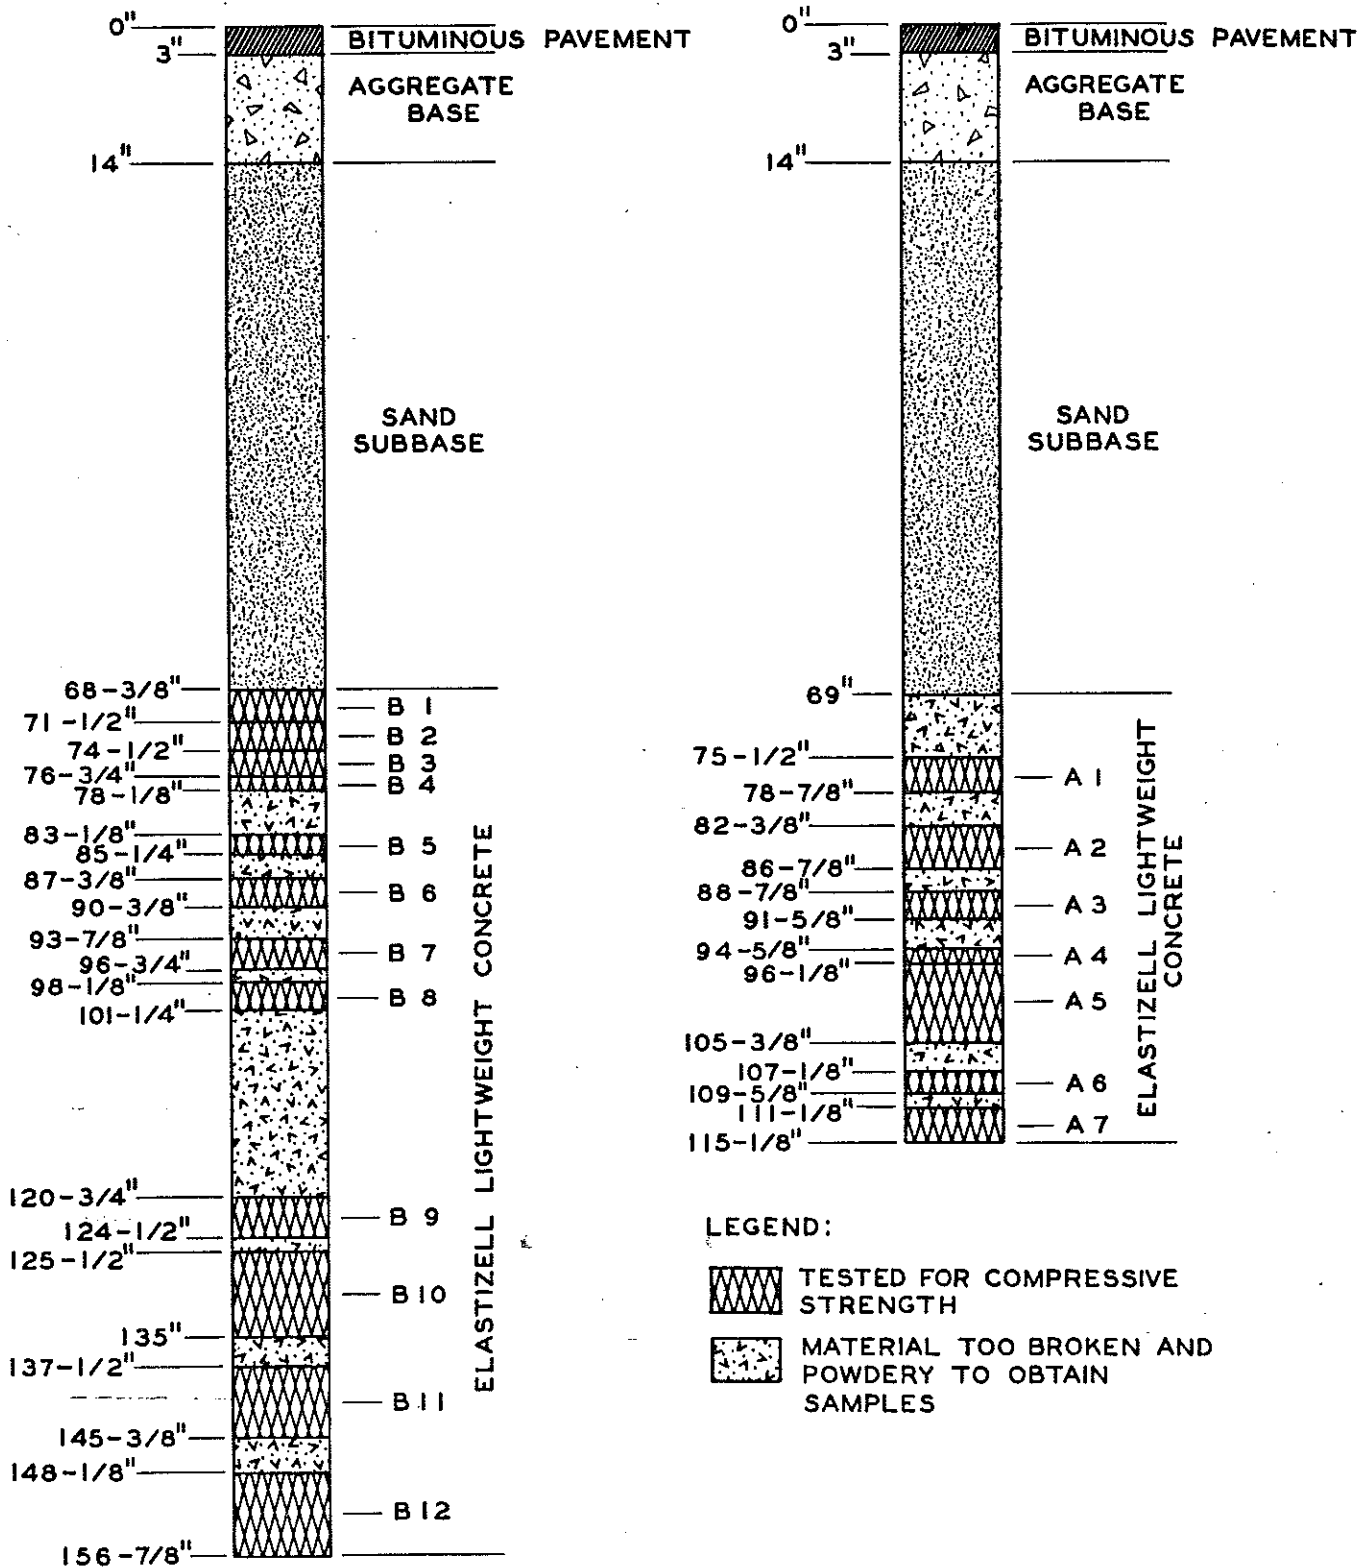
Figure 2. Profile of the east approach fill of the M 28 Waiska River bridge (not to scale).

Figures 2 and 3 show profiles of the Elastizell fills at both the Waiska River and the Pine River jobs as obtained from the sampling tubes. Moisture content, density, and compressive strength data for individual samples cut from the profile, are summarized in Tables 2 and 3. These data indicate that the in-place density of the Elastizell fill, as a whole, is below the 35 lb/cu ft design density. Neither the densities nor the moisture content values show that moisture is being absorbed by the fill. This important characteristic will be followed closely, however. In general, the moisture contents are fairly uniform throughout the fills with no consistent differential between the tops and bottoms. The Waiska River fill has a moisture content higher than that of the Pine River fill, the reason for which is unknown.
