EVALUATION OF GLARE SCREEN

**EVALUATION OF GLARE SCREEN**

**Research Laboratory Section  
Testing and Research Division  
Research Project 73 F-135  
Research Report No. R-1249**

**Michigan Transportation Commission  
William C. Marshall, Chairman;  
Lawrence C. Patrick, Jr., Vice-Chairman;  
Hannes Meyers, Jr., Carl V. Pellonpaa,  
Weston E. Vivian, Rodger D. Young  
James P. Pitz, Director  
Lansing, August 1984**

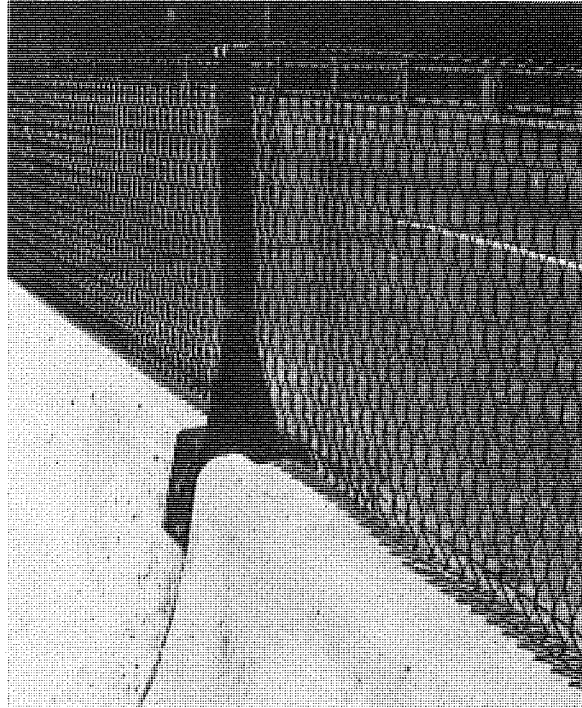
Glare screen is placed between opposing streams of traffic to shield drivers' eyes from the headlights of oncoming cars. Traditional metal mesh type screens constructed of either steel or aluminum (Fig. 1) have proven to be quite expensive to install and subject to damage from plow-thrown snow, vehicle-induced wind-blast vibrations, and vehicle impact. The results have been poor appearance, impaired functioning, and considerable maintenance expense.

Figure 1. Traditional wire mesh glare screen.

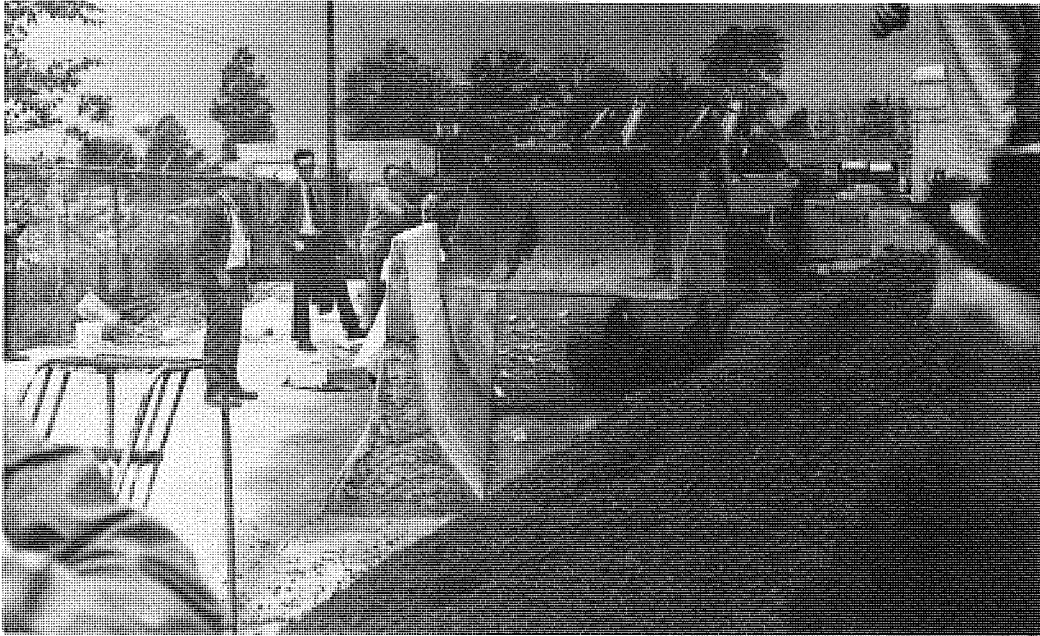
It was predicted that most traffic would probably strike the lower portion of the screen. It was decided to locate the point of impact near the top, however, subjecting the screen to its most severe impact condition. A wrecking ball, estimated to weigh 2,000 lb, was used to break the glare screen. It was swung by a crane and was not controllable to hit a precise location. The magnitude of impact was increased by swinging the ball through a greater arc. An additional test involved ramming a section of the screen with an end-loader. The result of this test, indicating the nature of the resulting fracture, is shown in Figure 4.

Figure 4. Glare screen being struck by a front-end loader.

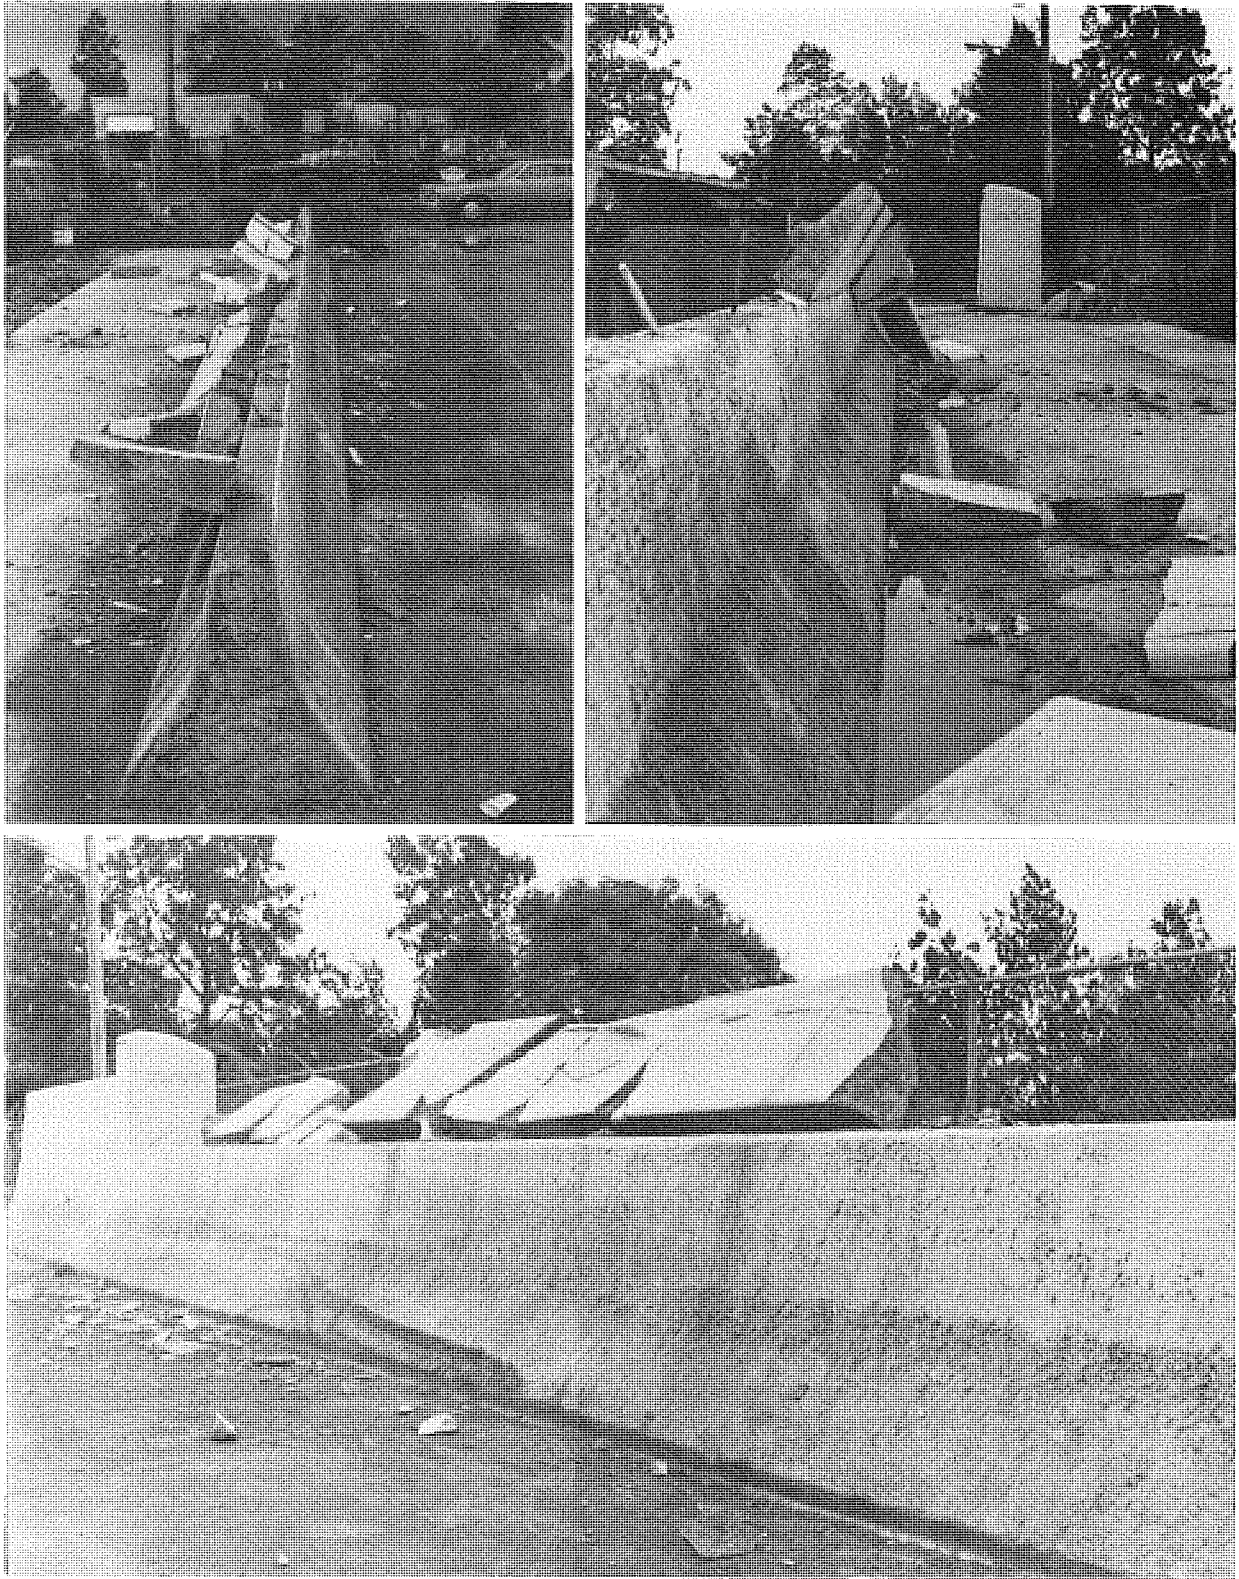
1) Section with Longitudinal Reinforcement. Swing of approximately 10 ft, striking 6 in. from the bottom of the screen resulted in no damage. Swing of about 15 ft developed a vertical crack through the screen. After six 15-ft swings, one large piece was broken from the end with other large pieces of concrete flying no more than 3 to 4 ft. A hit near the top with a 25-ft swing knocked 6 to 8-in. pieces about 10 ft. The same impact

at a lower point only caused a vertical crack. Figure 5 shows the type of failures which occurred in the concrete glare screen after being struck with the wrecking ball.

Figure 5. Damage to the glare screen after being struck by the wrecking ball.

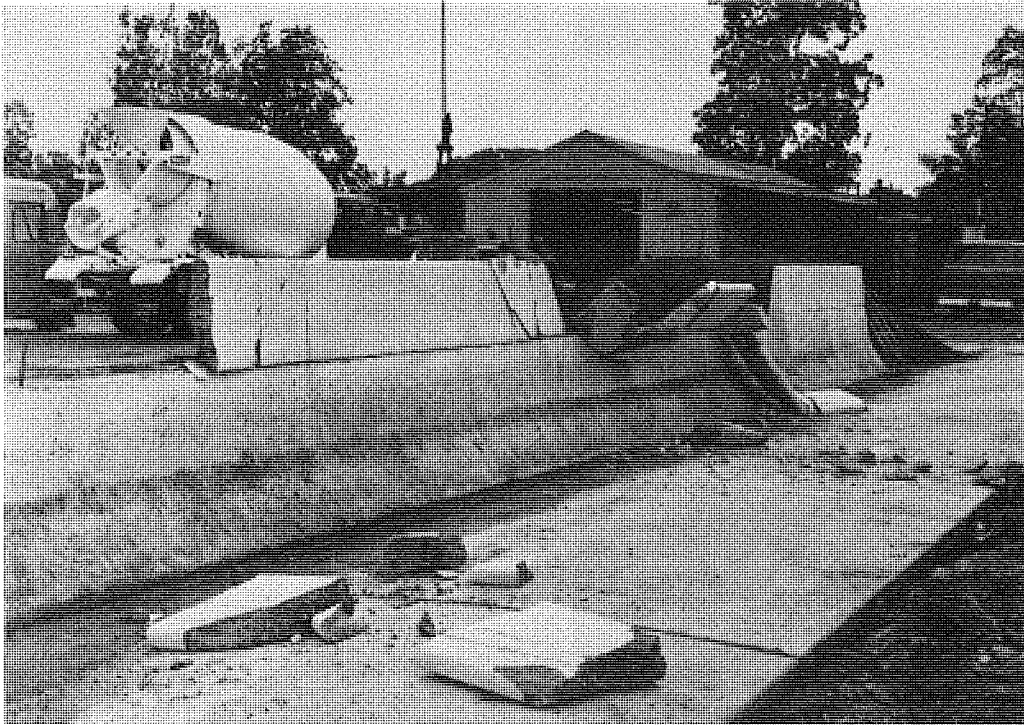
2) Section With No Longitudinal Reinforcement. A 20-ft swing approximately half-way down the screen caused only cracking. The third 20-ft swing fractured the screen off the wall in pieces approximately 2 ft in length. Figure 6 shows the types of failure encountered in concrete glare screen cast with and without the lower longitudinal rebar indicating the effectiveness of the rebar in holding larger fragments of concrete together.

Figure 6. Damage to glare screen after impact with wrecking ball showing the difference between the portions with (right) and without (left) reinforcing steel.

The limited evaluation of Phase I showed that slip-form construction of concrete glare screen on top of an existing concrete median barrier was feasible. Such an installation could be expected to provide long life, lower maintenance costs, and enhance safety. Based on the performance of the concrete glare screen under impact, the design details were modified to include only the bottom longitudinal rebar.

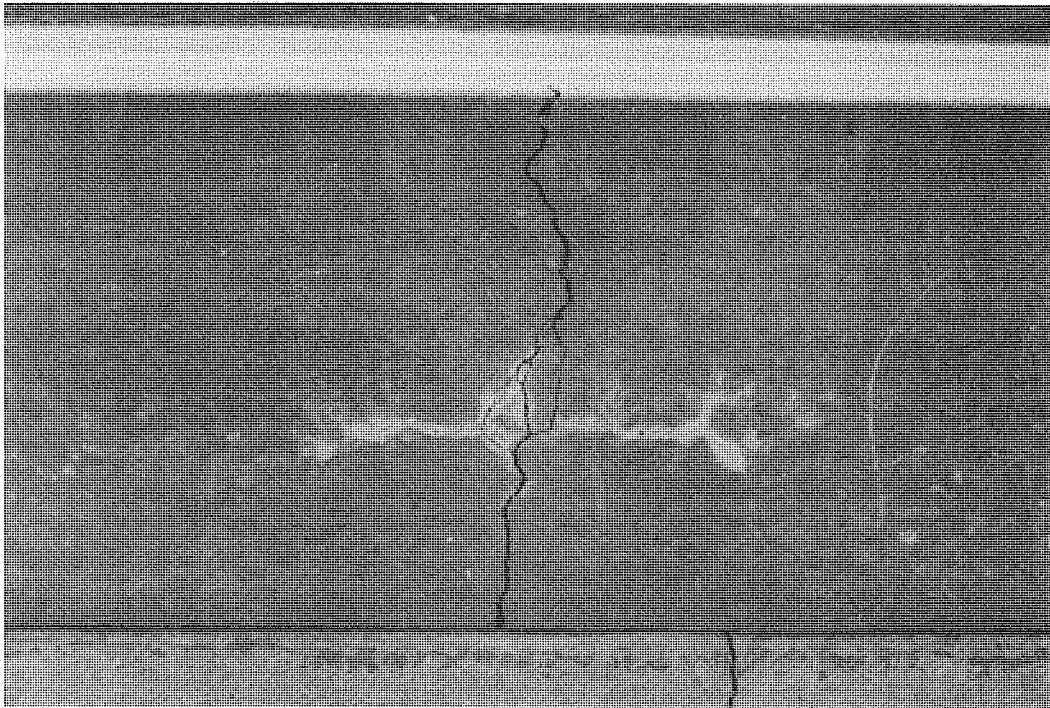
1) Several vertical cracks were found in the concrete base, barrier walls, and glare screen. The amount of additional cracking that has taken place since the 1976 survey was significantly greater than that found at the Woodward Ave Location. Figure 7 shows some of the cracking found in the 1983 survey.

Figure 7. Cracking in concrete glare screen and median barrier, I 696, spring 1983.

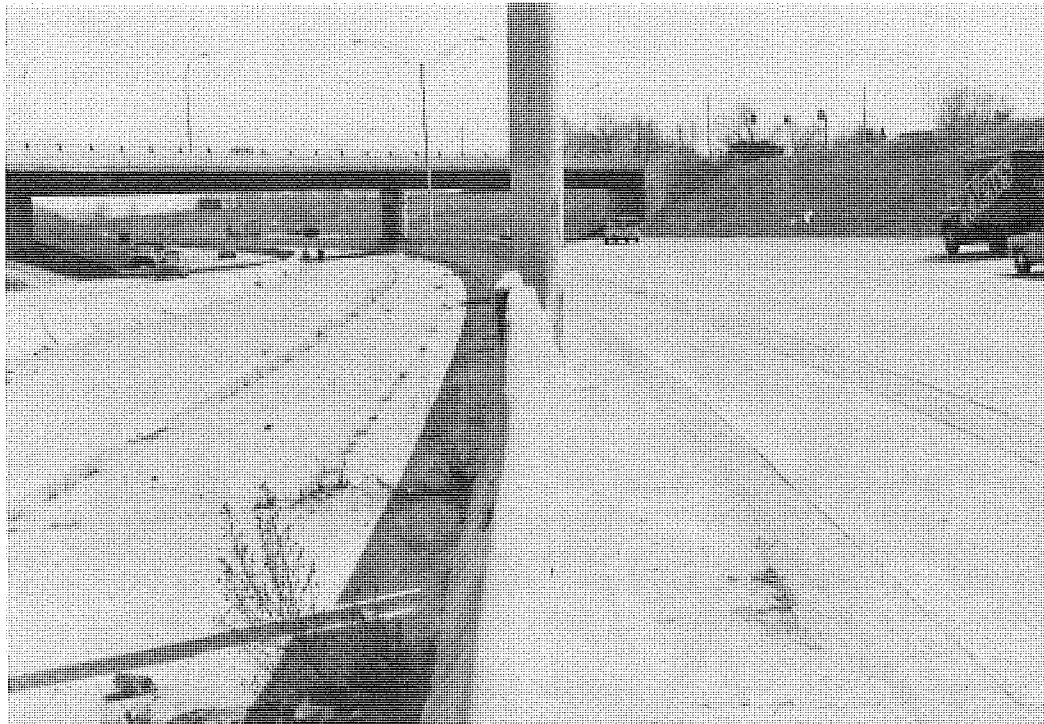
2) A section of concrete glare screen in the vicinity of Sta. 102+75 appeared to have been hit. The glare screen was moved out of alignment, but did not separate from the barrier (Fig. 8).

Figure 8. Section of glare screen out of alignment on I 696, spring 1983.

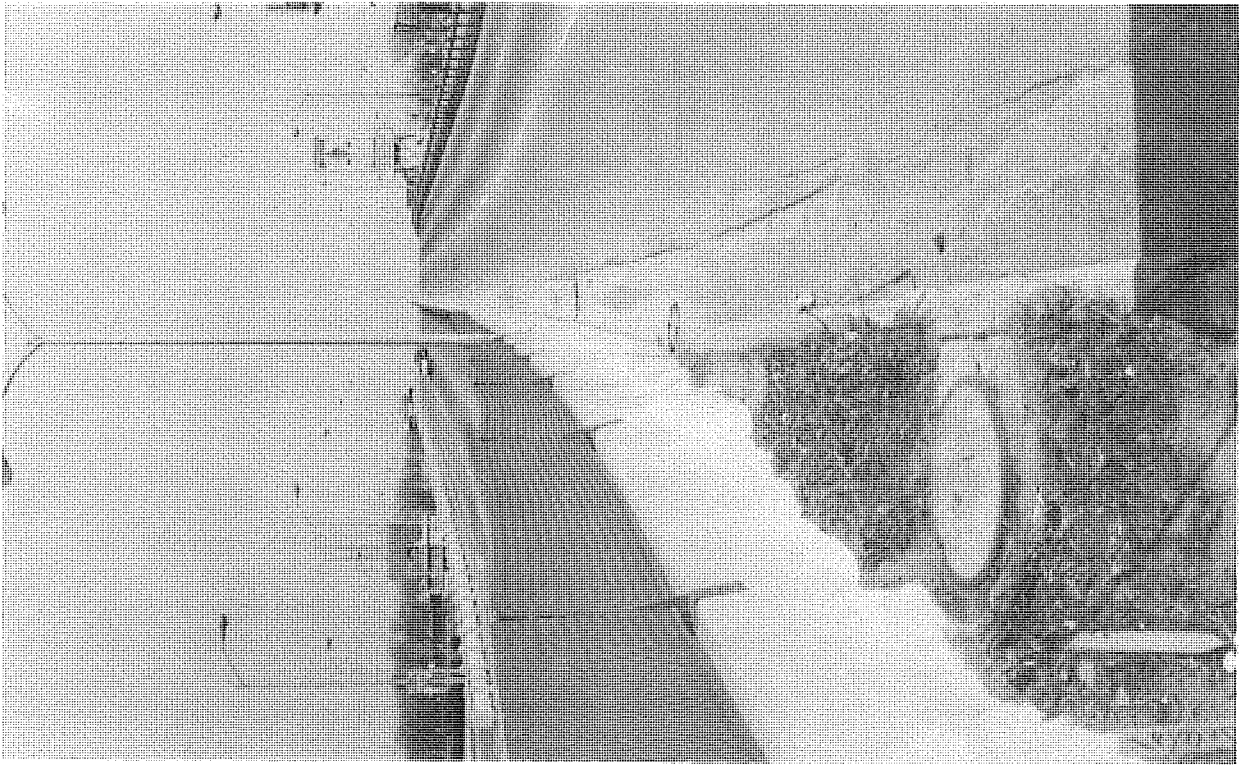
1) All the original steel mesh glare screen which remains is in relatively good condition (Fig. 9).

Figure 9. Steel mesh glare screen on Woodward Ave at Eight Mile Rd, spring 1983.

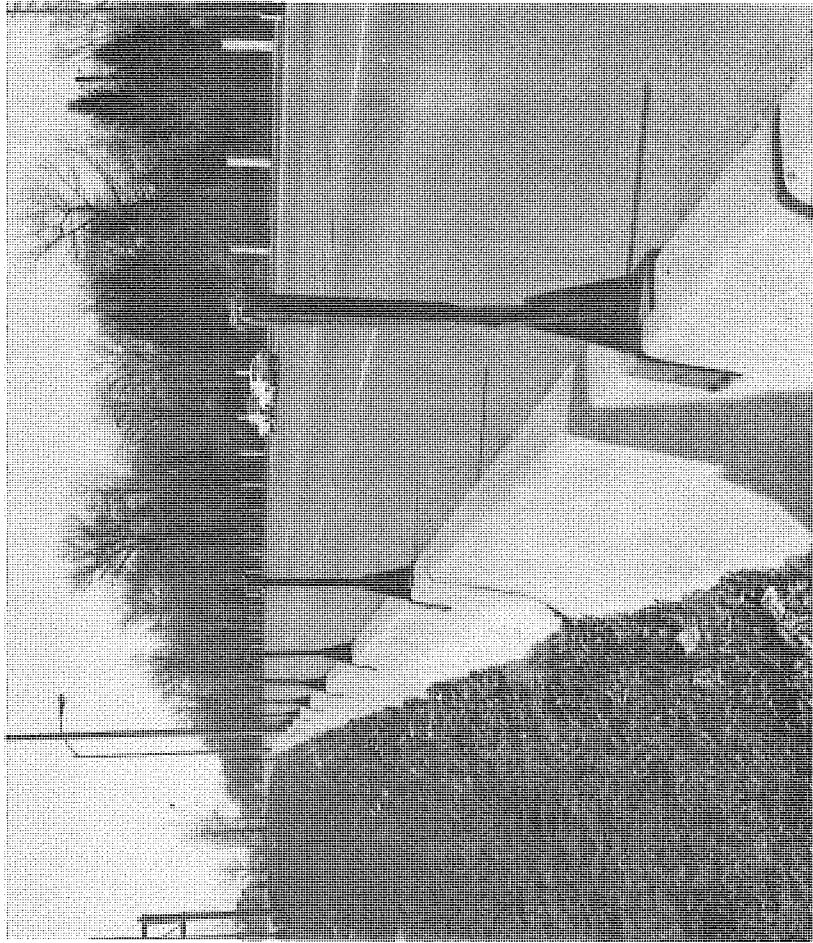
2) The seven sections of steel mesh at the beginning of the project which were missing when the 1976 condition survey was conducted have not been replaced (Fig. 10). These apparently have not been hit by vehicles because the vertical supports are still in place. Figure 10 shows some evidence of buckling on the first post, but the rest do not seem to be damaged.

Figure 10. Missing section of steel mesh glare screen on Woodward at Eight Mile Rd, spring 1983.

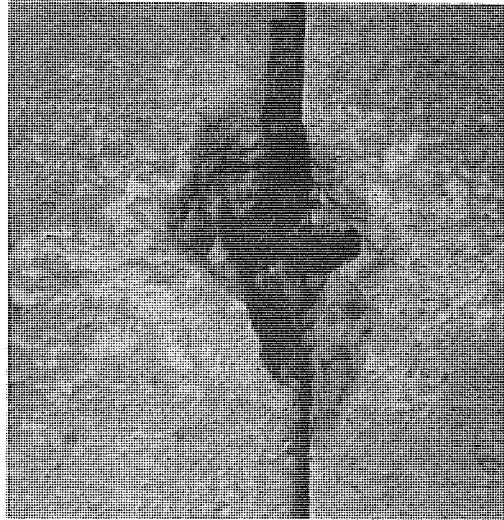
6) Spalling of the concrete glare screen occurred near the contraction joints where the longitudinal rebar was not terminated but carried through the joint, thus exposing the steel. This appeared to be a problem at most of the contraction joints, but particularly those where the longitudinal reinforcing steel was spliced at or near the contraction joint (Fig. 11).

Figure 11. Spalling of glare screen where longitudinal steel was carried through a contraction joint on Woodward Ave at Eight Mile Rd, spring 1983.

If glare screen is desired where concrete barriers exist, it is recommended that the Department use concrete glare screen rather than steel mesh glare screen. Field evaluations have shown that most deterioration problems occur when the longitudinal steel used in the glare screen is carried through the joints or begins to rust and expand causing spalling and staining. The use of epoxy coated steel in the glare screen should be considered as a means of preventing the type of deterioration caused by rebar corrosion. This will protect the reinforcing steel from corrosion and delay spalling of the concrete. Another alternative to remedy the problem of deterioration near the longitudinal reinforcing steel would be to delete the longitudinal bar option from Standard Plan III-76E and use the inverted u-shaped bar detail only. In any case reinforcing steel should not extend through the expansion or contraction joints, as shown in Standard Plan III-76E.

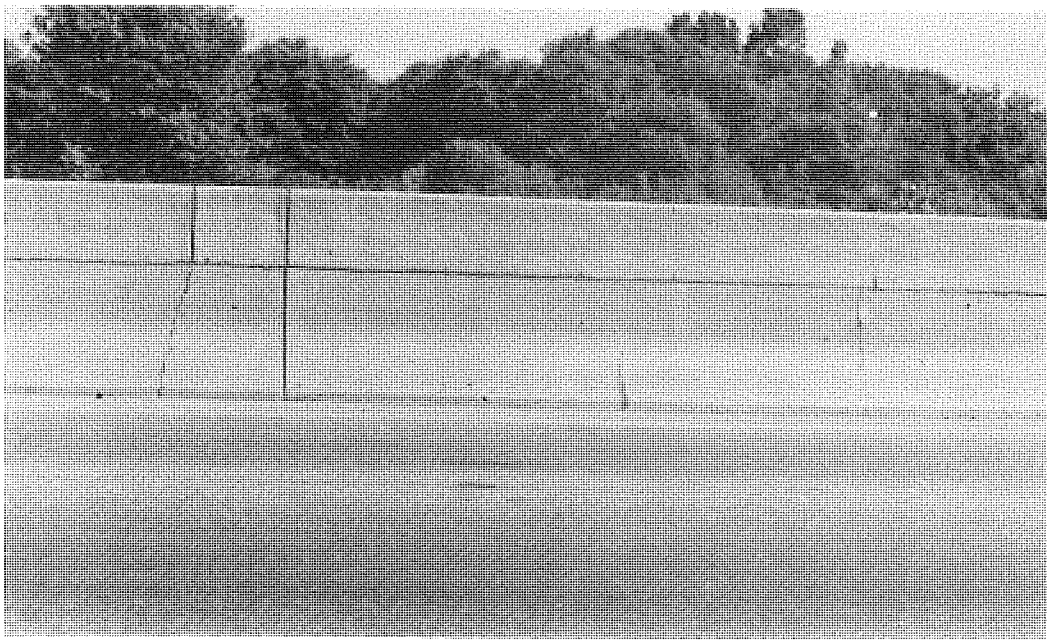
2) There is considerably more cracking in both the glare screen and the median barrier from Sta. 783+90 to 948+00. A note added to the Standard Plans in 1975 states that contraction joints are to be put in the concrete glare screen to match cracks in the existing concrete barrier which appear to be functioning as joints. Several of these contraction joints were found in the concrete glare screen over existing cracks in the median barrier; however, many of these existing cracks did not appear to be acting as joints (Fig. 12).

Figure 12. Cracking in concrete median barrier below contraction joints on I 94 near Jackson, summer 1983.

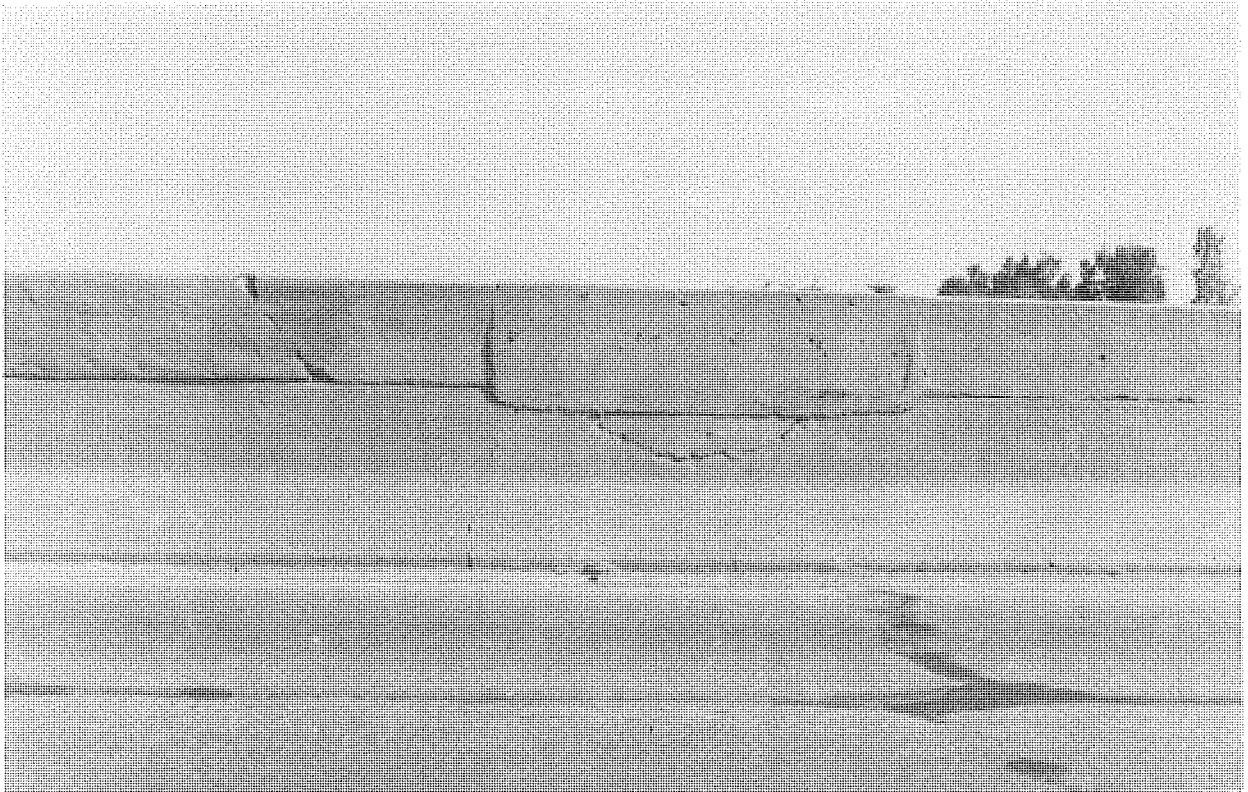
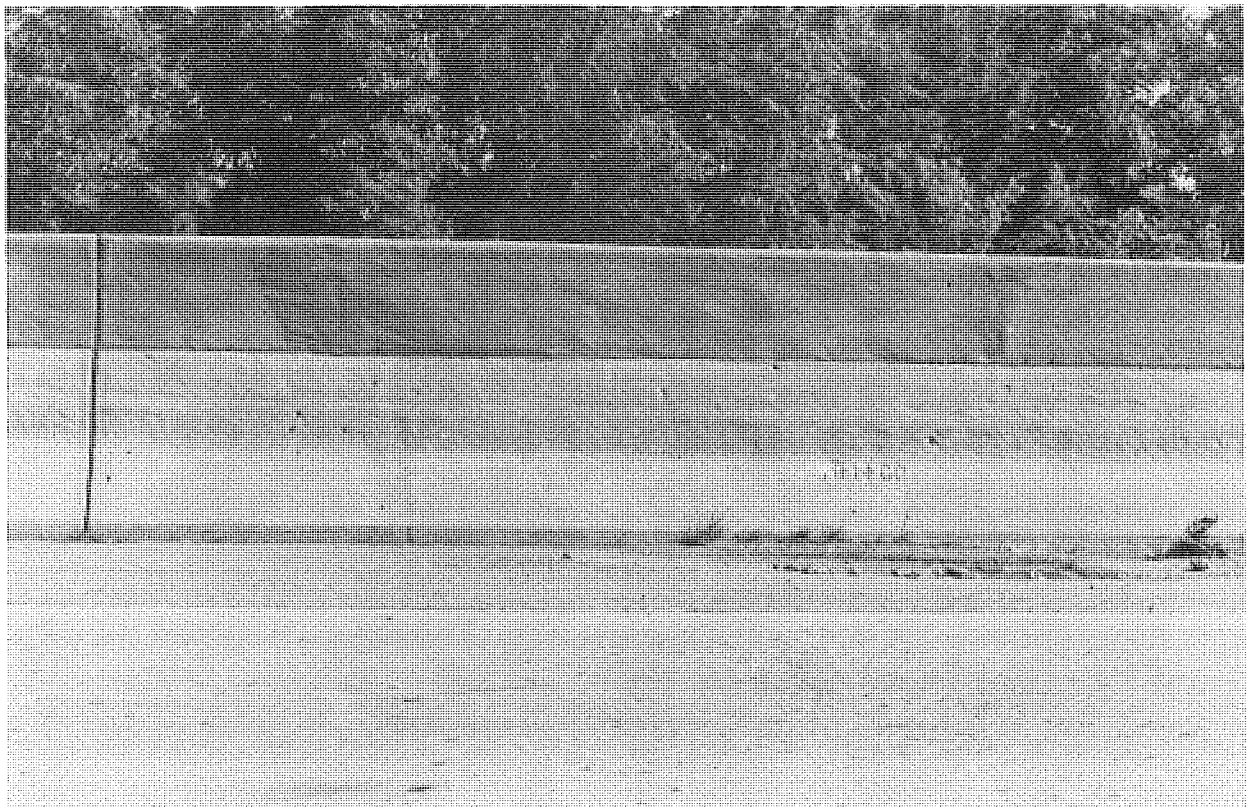
Figure 13. Repairs of concrete glare screen on I 94 near Jackson, summer 1983.

3) Several glare screen repairs were located throughout the section (Fig. 13). According to District 8 Maintenance personnel, these repairs averaged just under \$1,000 per repair during the 1983-84 fiscal year.

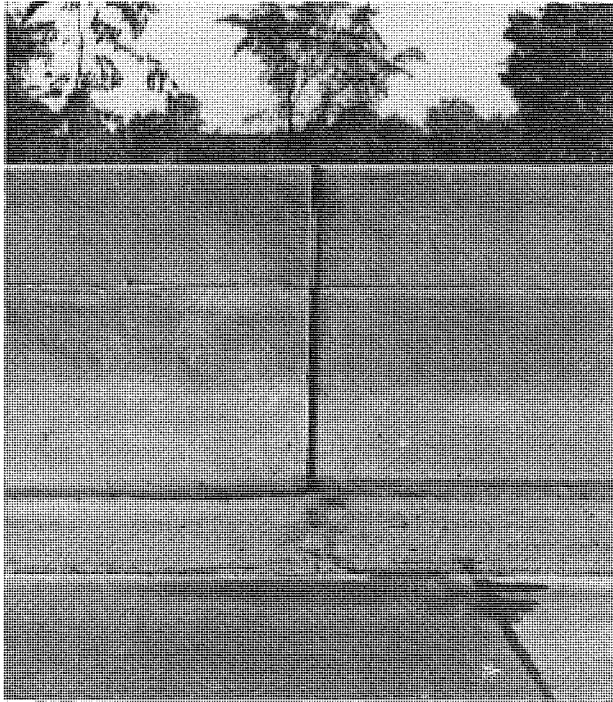
4) Many of the expansion joint fillers are missing (Fig. 14). As with the glare screens evaluated at previously described locations, this is not causing any performance problems.

Figure 14. Missing expansion joint filler in glare screen on I 94 near Jackson, summer 1983.

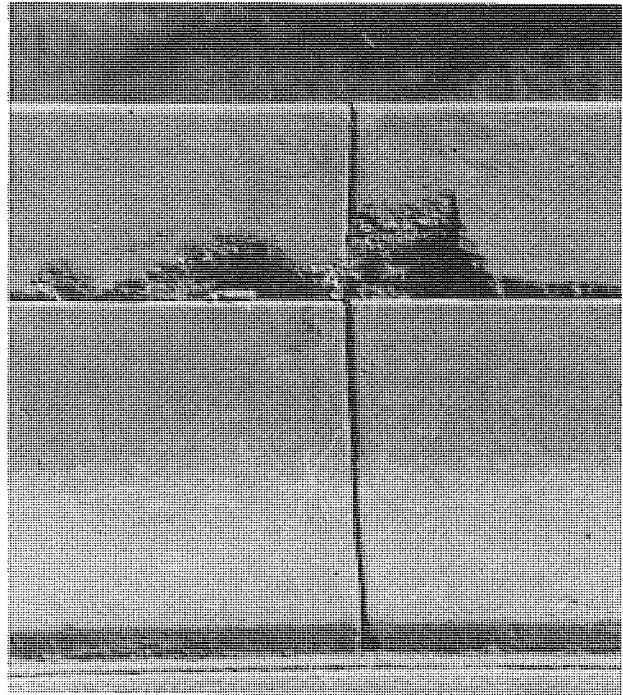
5) Considerable spalling, with reinforcing steel exposed, was found approximately one mile west of Elm Rd (Fig. 15).

Figure 15. Spalling of glare screen on I 94 near Jackson, summer 1983.

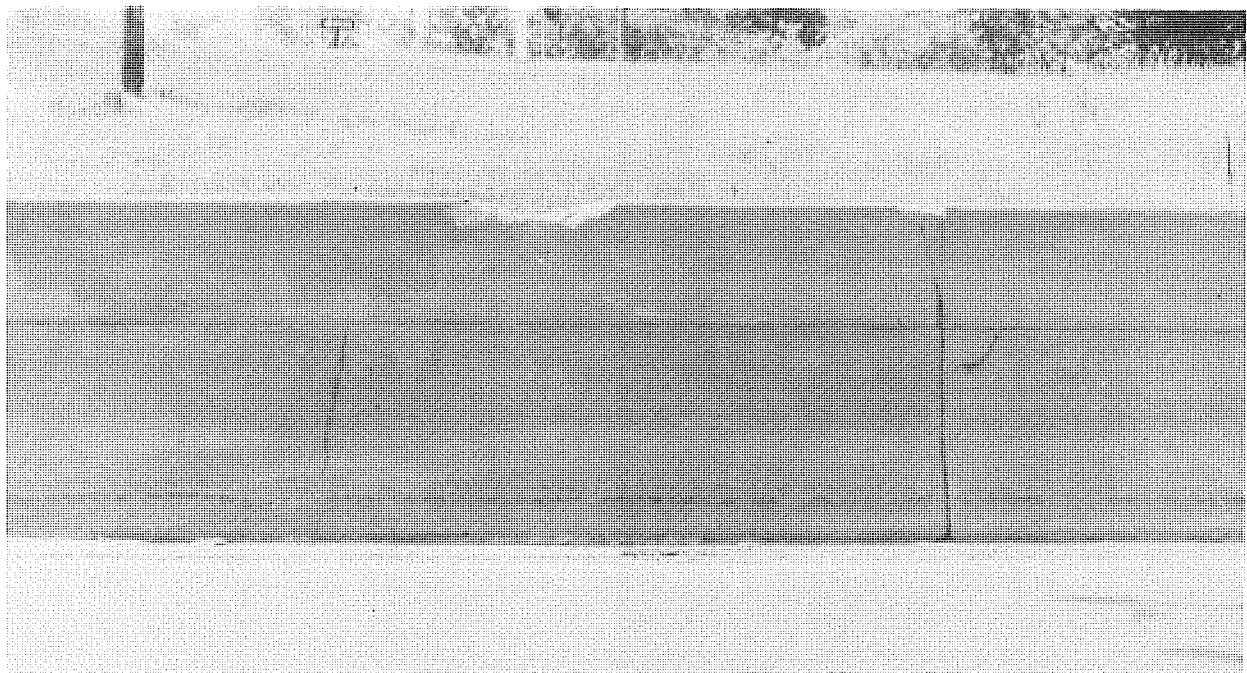
6) A section of glare screen near Elm Rd is missing, but there is no visible evidence of it having been hit by a vehicle (Fig. 16).

Figure 16. Piece of glare screen broken out, with no additional evidence of vehicular impact on I 94 near Jackson, summer 1983.
