**INSULATION BETWEEN STEEL AND ALUMINUM
FOR EXTRUDED TRAFFIC SIGN MOUNTINGS**

Research Laboratory Division
Office of Testing and Research
Research Project R-61 G-105
Research Report No. R-426

Michigan State Highway Department
John C. Mackie, Commissioner
Lansing, June 1963

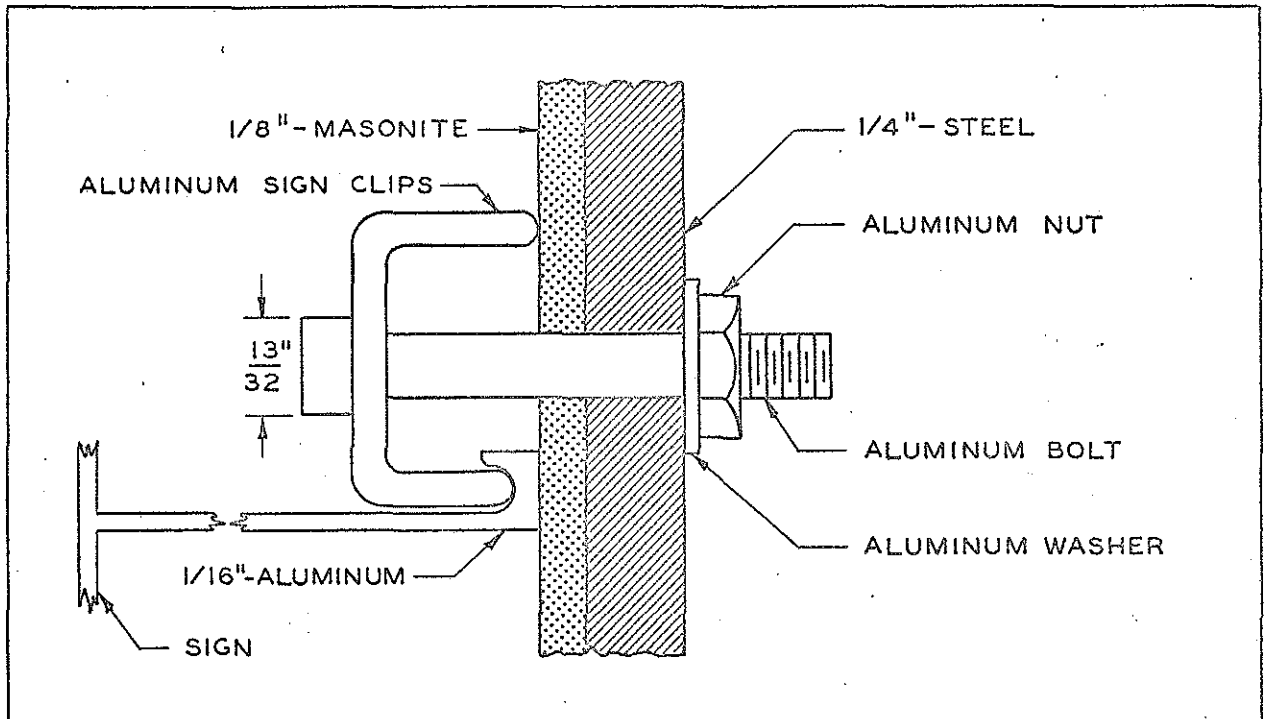
Current Departmental design practice is illustrated in Fig. 1, which shows that electrical contact is made between the steel plate and the aluminum bolt and washer. In this design, the steel surface is protected with paint, so that until the paint film is perforated or worn, the aluminum may not be seriously affected. However, as time passes, the galvanic action may become quite intense, resulting in pitting of the aluminum and eventual perforation failure.

Figure 1. Current Departmental sign fastening practice.

On the other hand, the current method of installing Masonite strips, shown in Fig. 1, permits eventual conduction of electric current between the aluminum sign and the steel framework through the aluminum bolt. Since these spots are potential sites where galvanic corrosion may be expected to develop over the years, it is recommended that this electrical circuit be broken by the use of an insulating material as illustrated in Fig. 2. Otherwise the advantages of using the Masonite strip currently inserted will be largely negated.

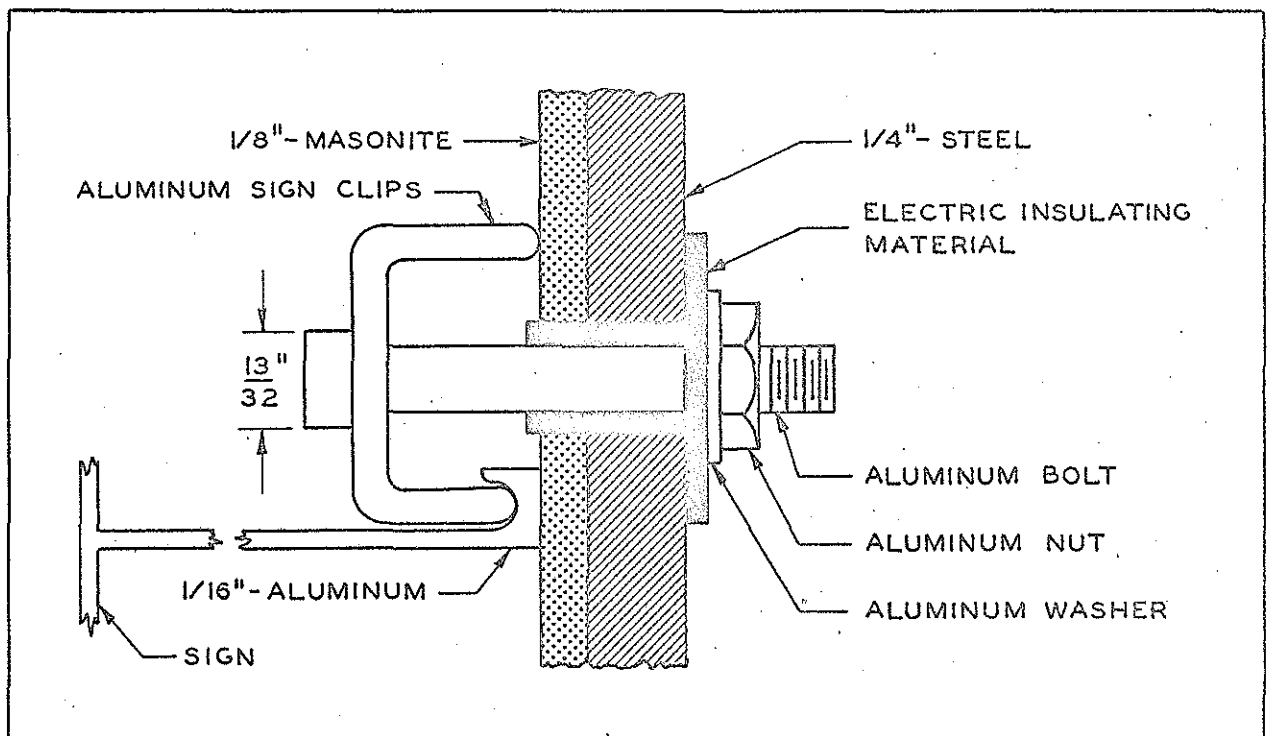
In Fig. 2, a possible improvement in design is shown, which would prevent or minimize galvanic action by the use of plastic sleeves or washers.

Figure 2. Suggested improved practice using a plastic sleeve and washer.

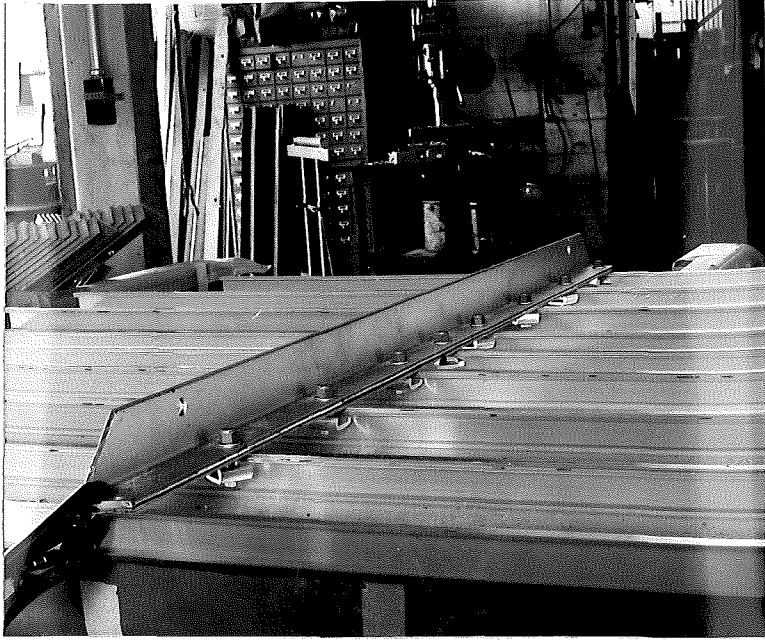
Figure 3. Steel angle assembly clamped in position prior to being bolted in place. Note Masonite strip held in place by clamps.

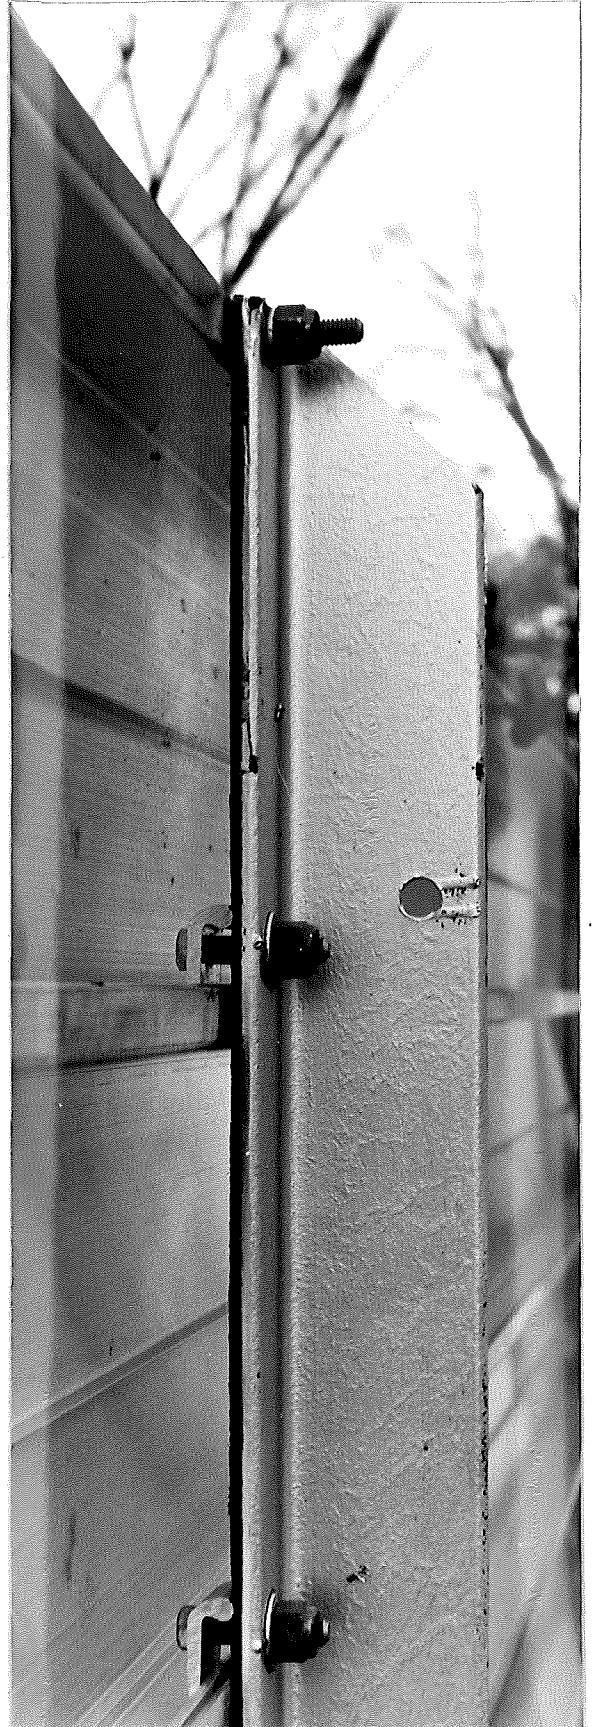
Figure 4. Finished sign ready for installation. Note how steel angle is separated from interlocking aluminum panels by strip of Masonite, but electrical contact is still maintained between steel and aluminum through bolt and washer. Aluminum paint and primer have not covered steel angle completely.

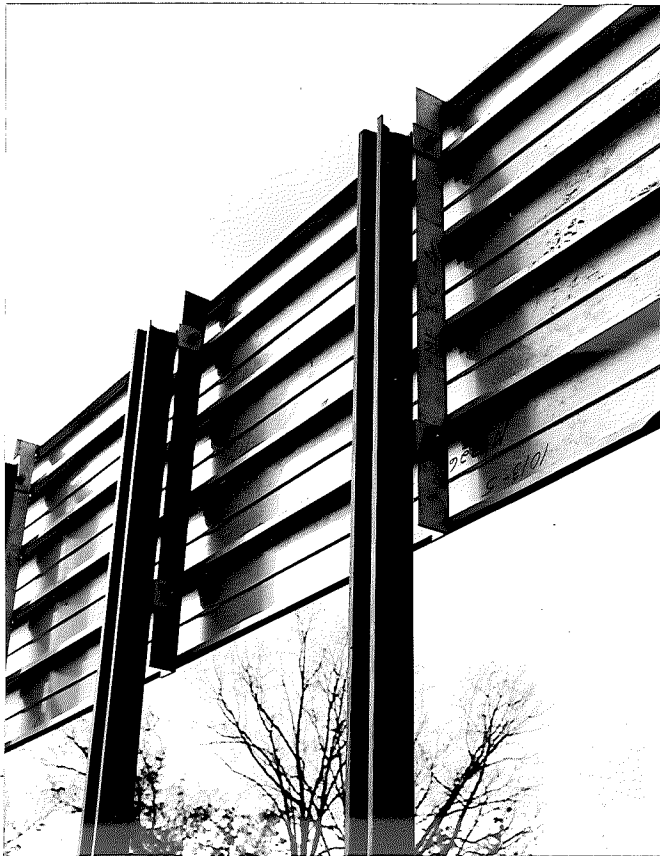
Figure 5. Three-post sign support assembly on eastbound I 96 (legend: "Detroit 39"). Steel members are in direct contact with aluminum, and corrosion has begun. Age: 3 months.

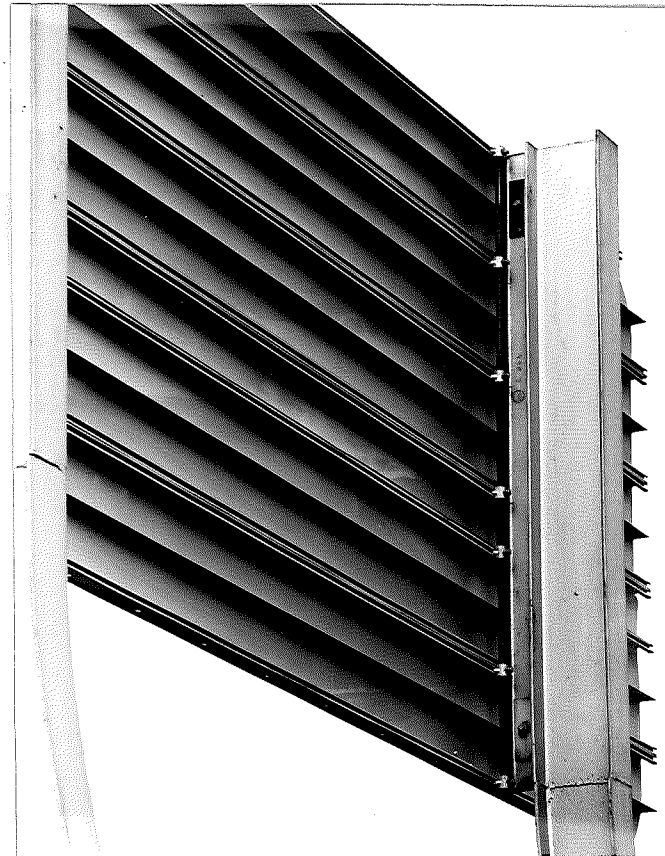
Figure 6. Roadside sign support assembly on eastbound I 96 (legend: "Farmington 5, Detroit 24"). Vertical steel angle is separated from aluminum panels by Masonite strip, but some corrosion is evident. Age: 2 1/2 years.

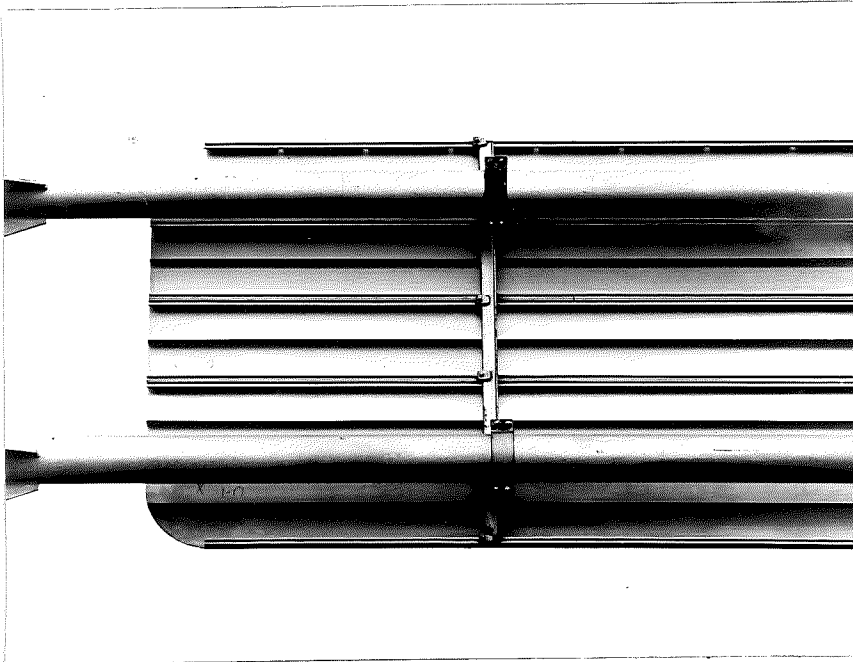
Figure 7. Corrosion of vertical angle and straps on cantilever type sign structure on eastbound I 96 (legend: "Farmington" with arrow). Age: 2 1/2 years.

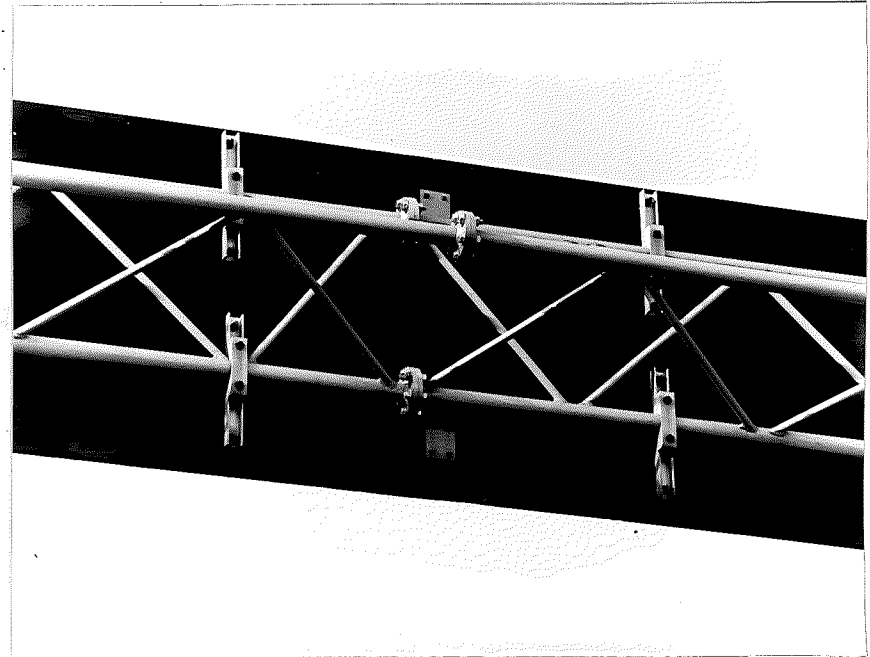
Figure 8. Bolt heads and nuts are corroded on overhead truss support structure on southbound US 127 (legend: "Mason" and "Jackson" with arrows). This is one of two such experimental installations in Michigan. Age: 5 1/2 years.

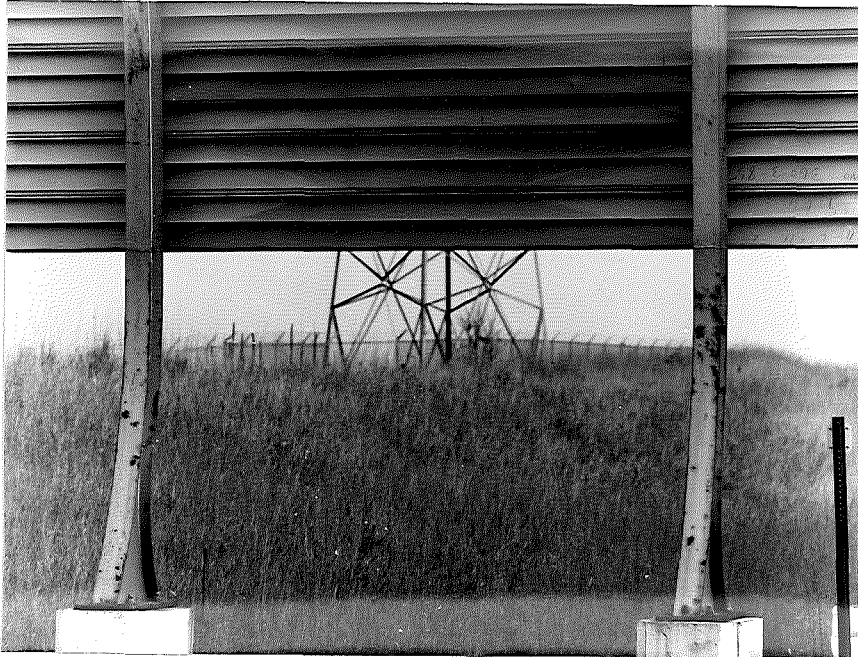
Figure 9. Relatively pronounced oxidation corrosion of steel supports of roadside signs support assembly on eastbound I 96 (legend: "New Hudson 4, Lansing 56"). Age: 2 1/2 years.

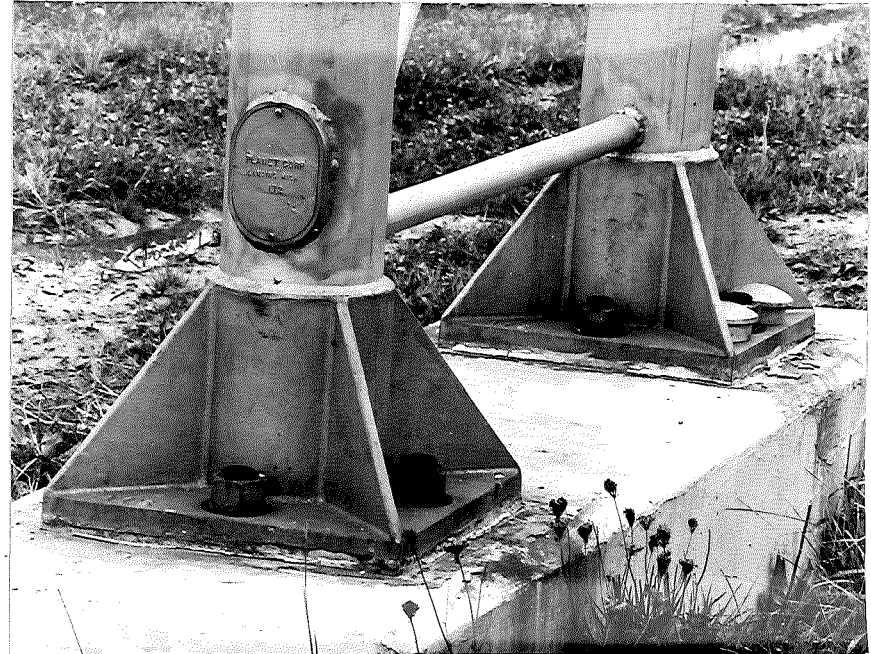
Figure 10. Extensive oxidation corrosion of steel nuts and bolt heads (and base plate staining) on an experimental overhead assembly on Farm Lane, MSU. Tubing, stiffener elements, and base plate are aluminum alloy, and bolts are cadmium-plated (0.2-mil) steel. Age: 5 years.
