**Pavement Demonstration Program Project Finalization
Low Volume (Thin) Concrete Reconstruction Projects –
M-13 & M-99
(MDOT Job Numbers 53356 & 75184)**

Final Technical Report

Report No. OR23-304, B

April 2024

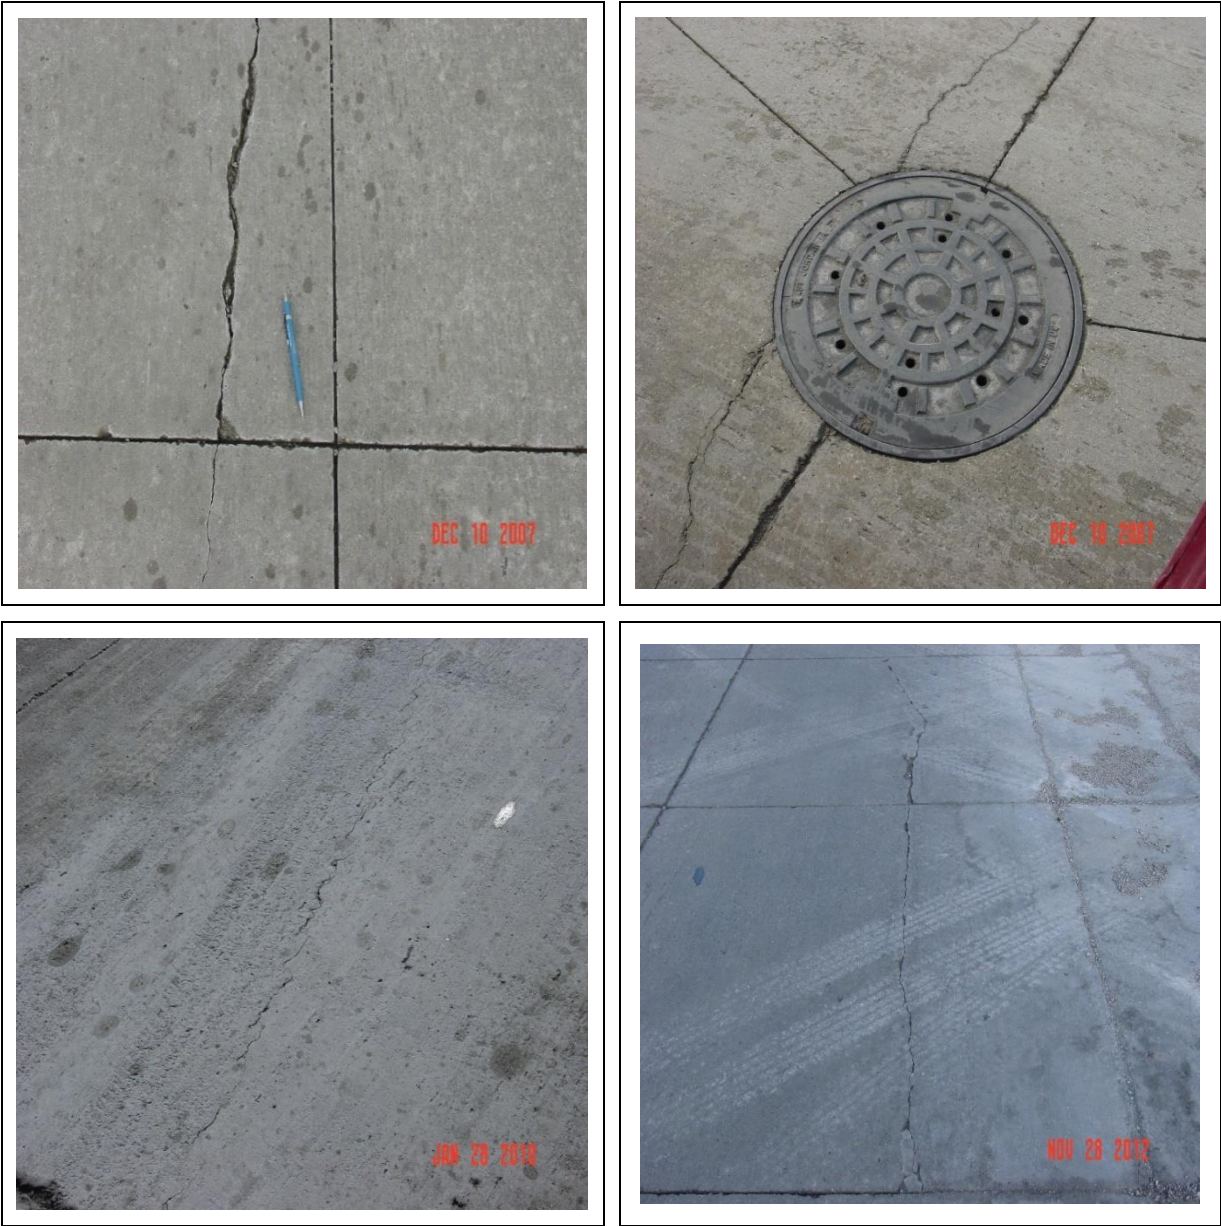
Annual surveys noted that within the first 5 years of service, the M-13 project experienced minimal overall distress. Still, field surveys observed 9 cracked panels, some faulting along the longitudinal middle joint of the northbound outside lane, and minor intermittent joint spalling/raveling (less than 1" wide and 12" long). Notably, some of the cracked panels were at or near drainage structures. Additionally, the Pinconning Bridge had construction work conducted in 2010, for which heavy equipment (large crane, etc.) was parked on the travel lanes approximately 100 feet south of the bridge. Accordingly, the following year, 16 slabs were found to be cracked in all lanes and both directions of that area. As previously noted, the slab thickness decreases below the design thickness within 200-feet of the bridge. This may have also been a contributing factor along with the construction equipment. Examples of the observed pavement distresses are shown in Figures 5 and 6.

Figure 5. Field Survey Pictures of M-13

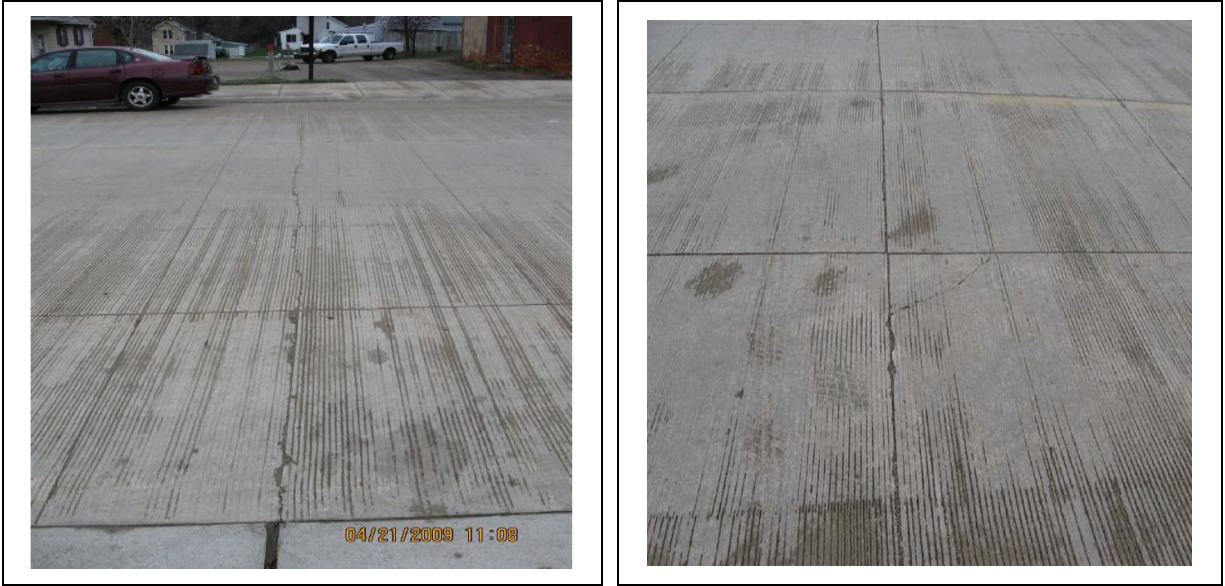
Figure 8. Transverse and Corner Cracks on M-99 from MDOT Warranty Report SWAD 2870 (2009)

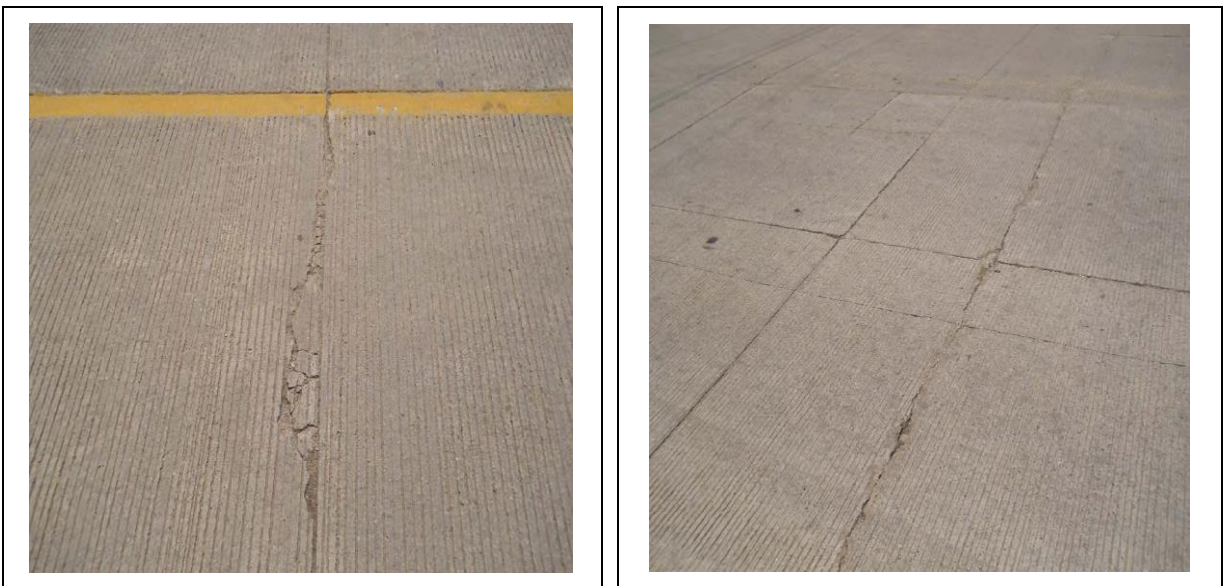
Figure 9. Joint Spalling and Transverse Cracks on M-99 from MDOT Warranty Report SWAD 2870 (2011)

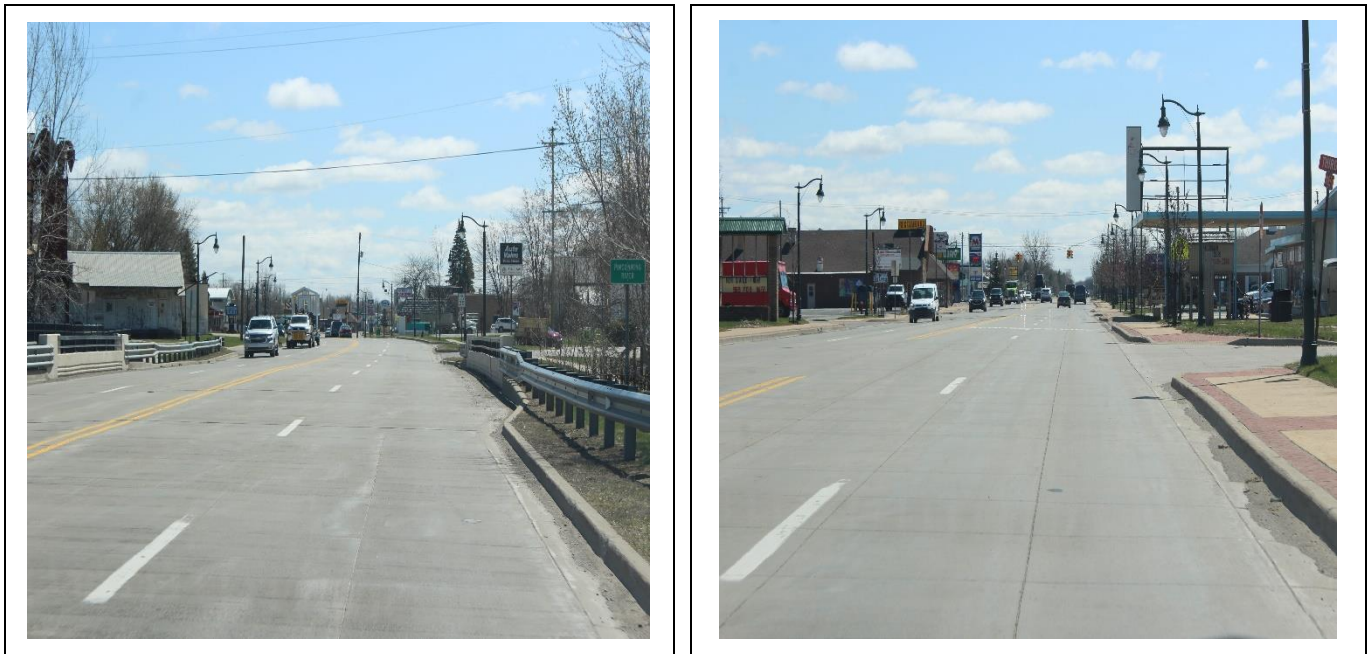
According to the April 2022 field survey of M-13, after 17 years of service, approximately 2.4 percent of all concrete panels are cracked or repaired. This percentage is relatively minimal over this timespan. Excluding the cracked and repaired slabs at the south side of the Pinconning River Bridge, this percentage decreases to 1.9 percent. Figure 10 shows the overall trend of crack and repair through the pavement's design life. Otherwise, some intermittent scaling and joint spalling

were observed. This primarily occurred within the first 550 feet of the project's south end within the northbound lanes. To address this, these have been filled with a spray-on asphalt emulsion patching material (commonly referred to by its commercial name AMZ). This joint deterioration is commonly related to the timing of the sawing operation. In both directions, the mid-lane longitudinal joint of the rightmost lane is exhibiting some widening and low levels of faulting at various locations. Accordingly, the field survey described the pavement's overall performance as good*. The April 2022 field survey notes are shown in Appendix Figure A34. Pictures of the current pavement condition on M-13 are shown in Appendix Figure A35.

Figure A 35. April 2022 Field Evaluation Pictures for M-13

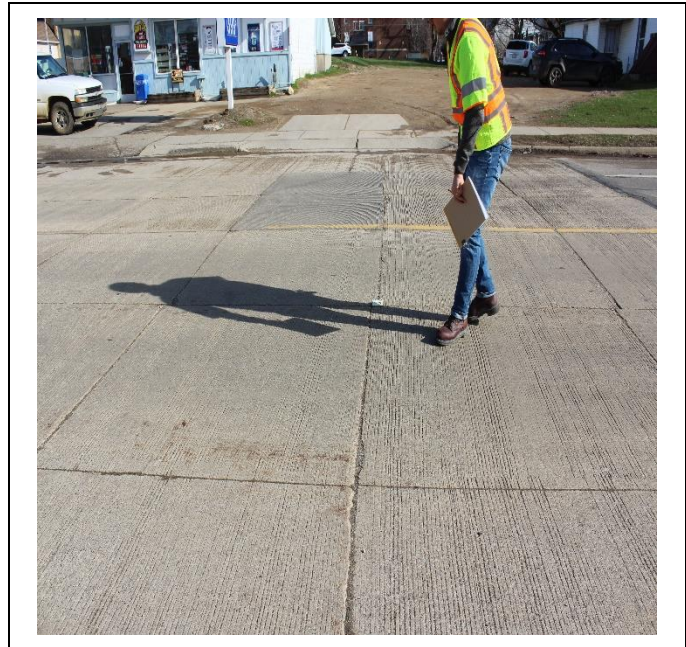
According to the April 2022 field survey of M-99, after 16 years of service, approximately 7.9 percent of all concrete panels are either cracked or repaired. While this percentage is higher than that of M-13, construction-related issues are at least partly contributing to this, including construction warranty repairs and initial spalling due to late sawing of the joints. This spalling is consistent with observations of the early annual reviews, where cracking was observed within inches of the joint. There are some faults, but they are isolated and minimal. As shown in Figure 11, like M-13, the progression of distress is steady. Accordingly, the field survey described the pavement's overall performance as fair*. The April 2022 field survey notes are shown in the Appendix, Figures A32 and A33. Pictures of the current pavement condition on M-99 are shown in Appendix Figure A36.

Figure A 36. April 2022 Field Evaluation Pictures for M-99

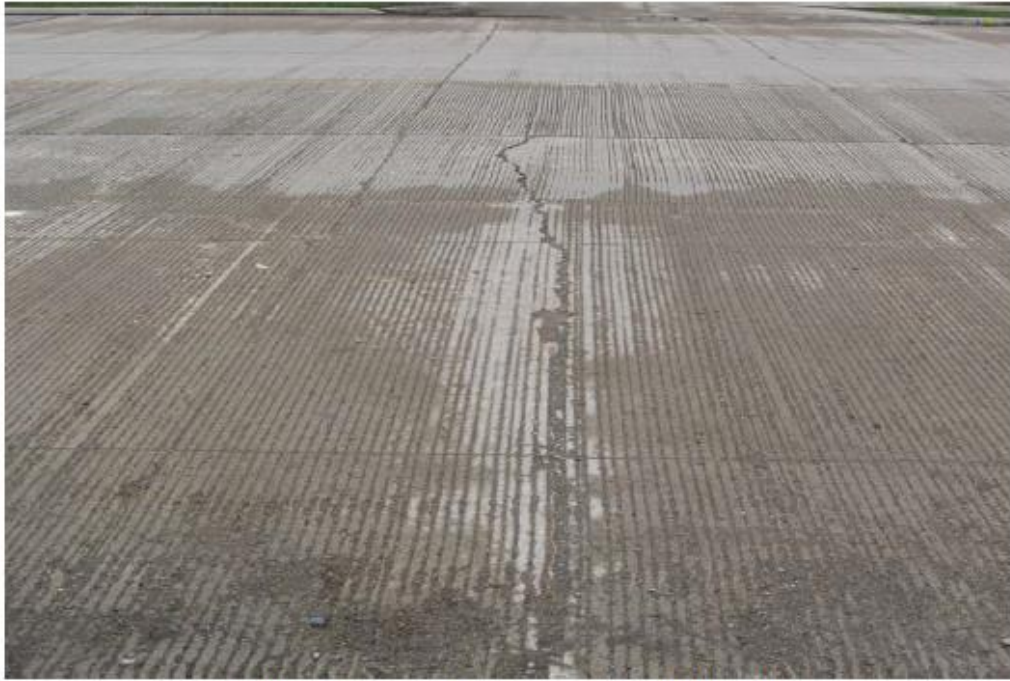
M-99 Transverse Cracking near POE, NB-1

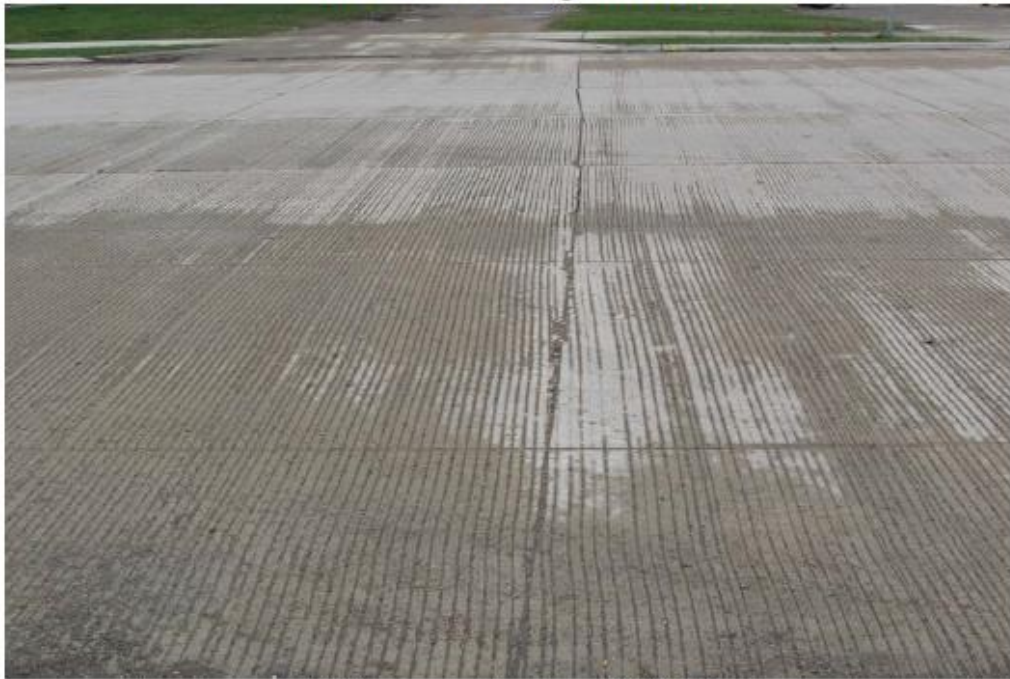
Additional cracking near POE NB-1

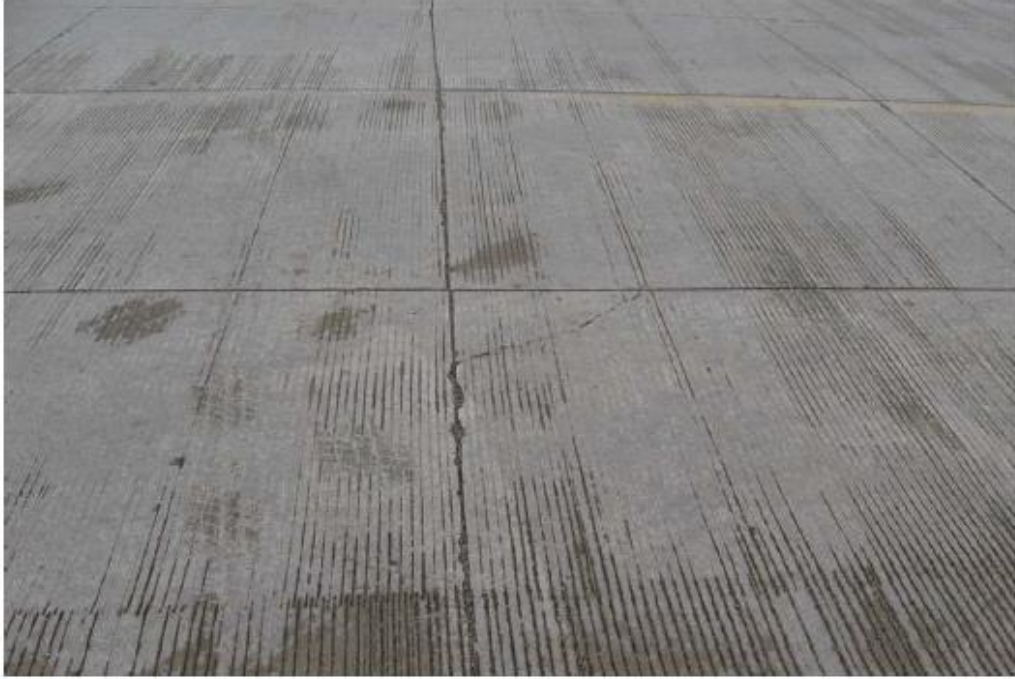
Corner Cracking 64' from POE NB-1

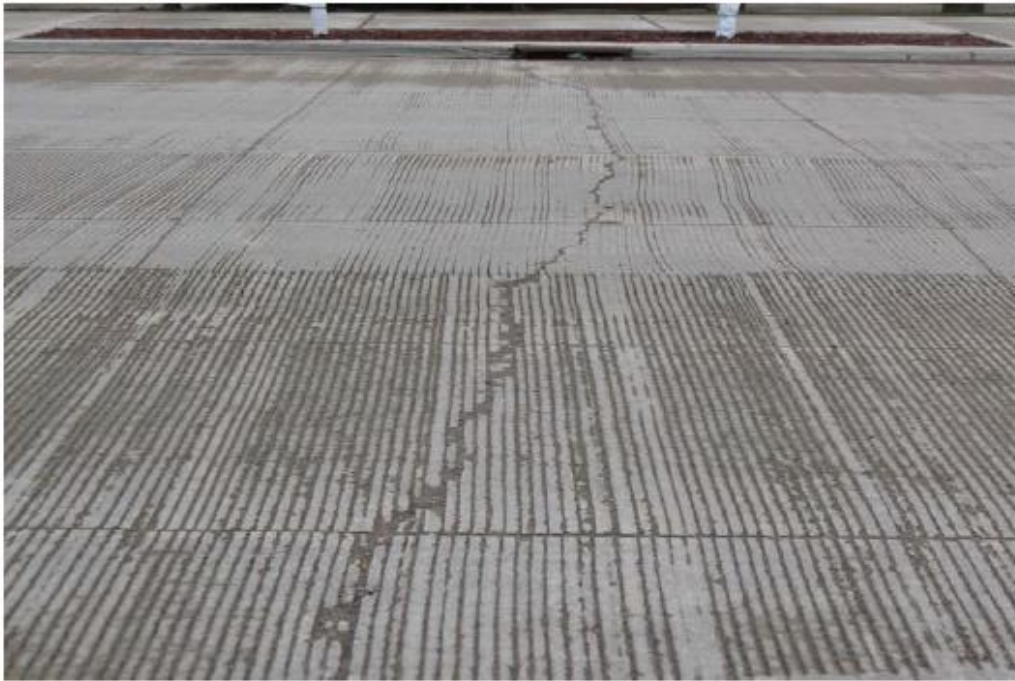
Transverse crack 90 from POE, NB-1

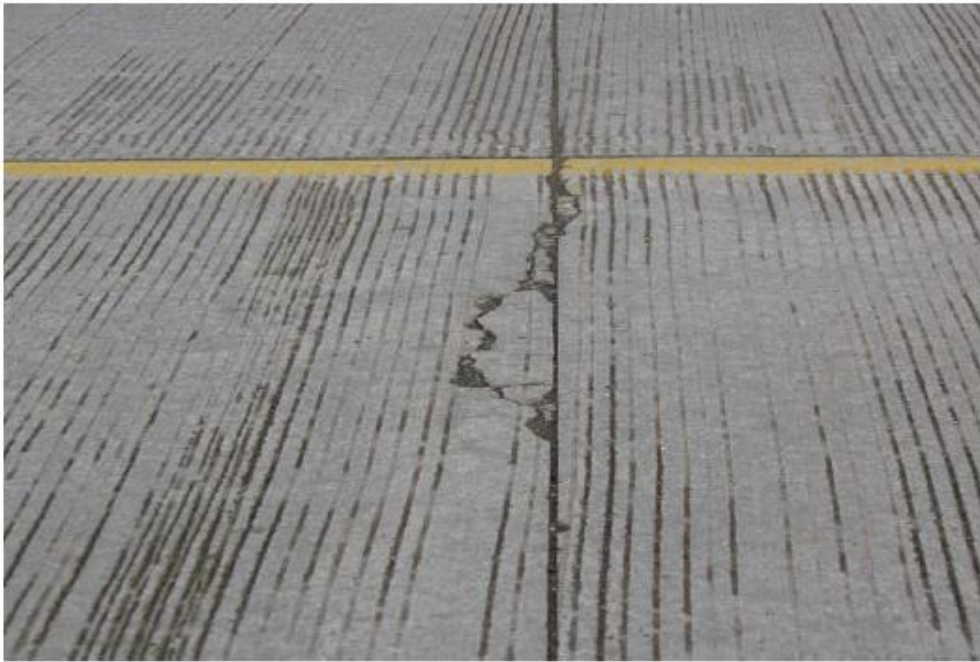
Spall 30' north of Pearl St. SB-1

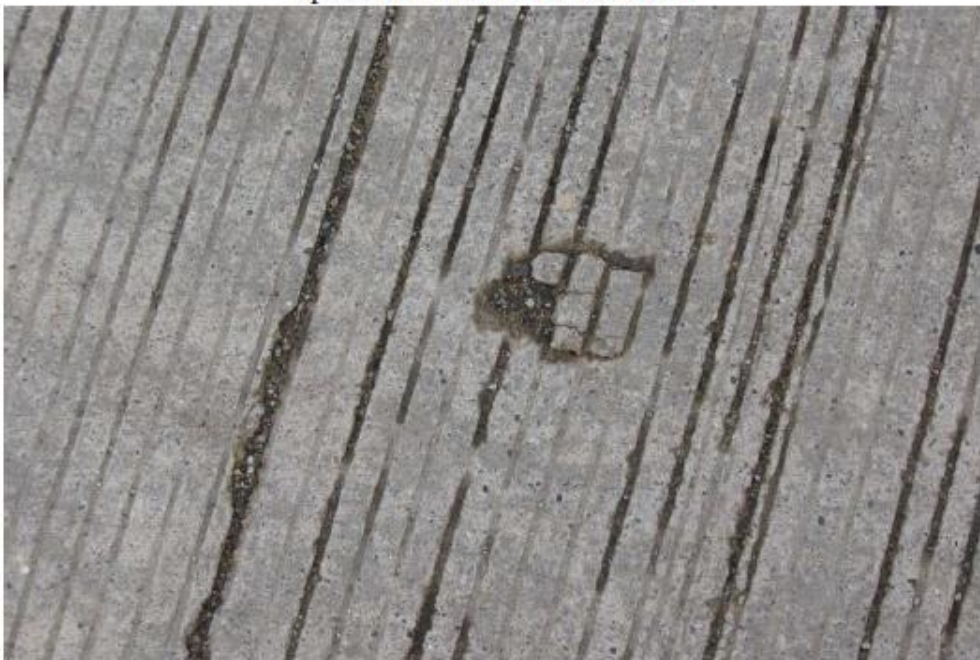
Spall 80' north of Pearl St. SB-1

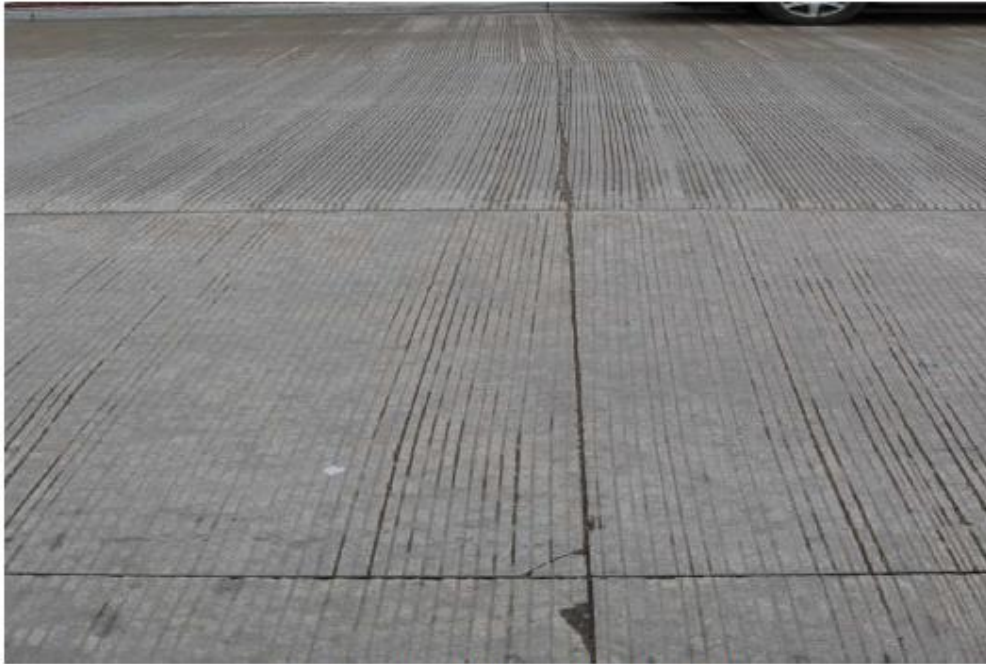
Corner Cracking 100' north of Pearl SB-1

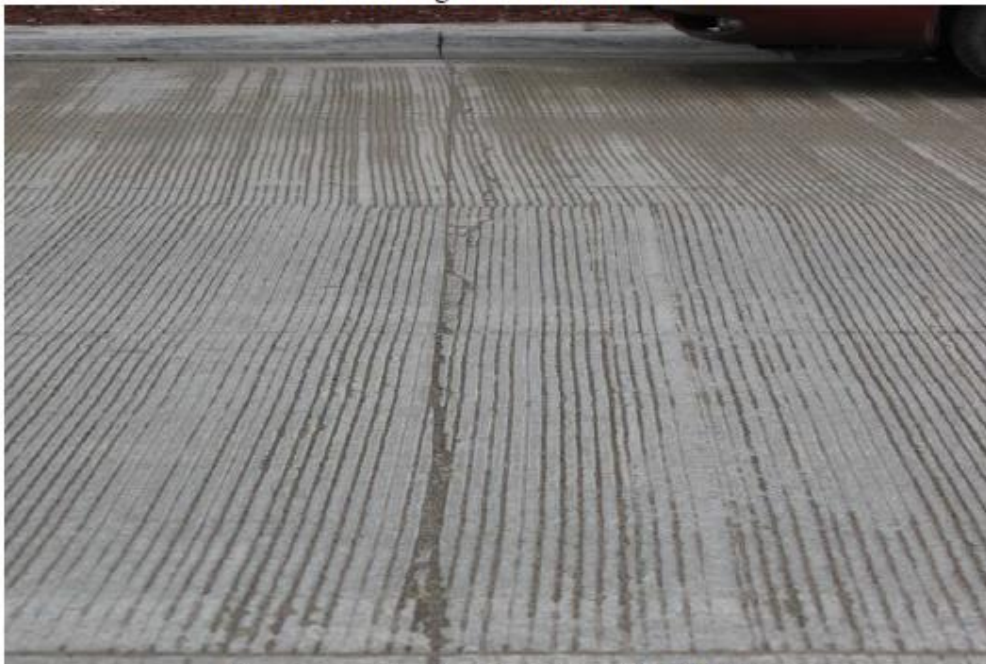
Transverse Crack 100' north of Pearl NB-1

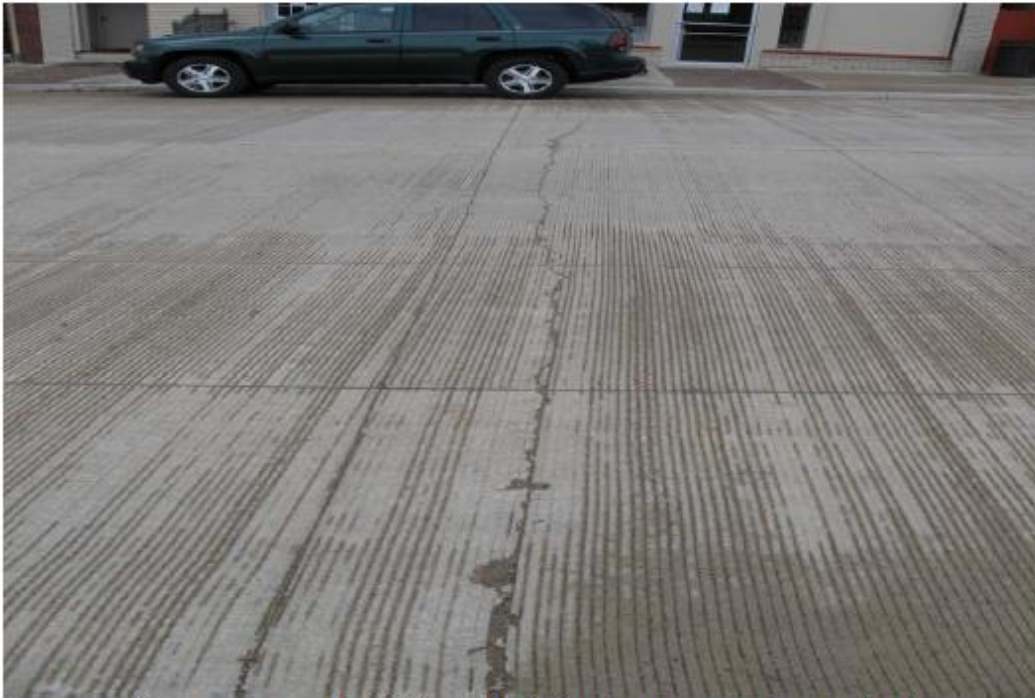
Transverse crack 130' north of Pearl across entire roadbed

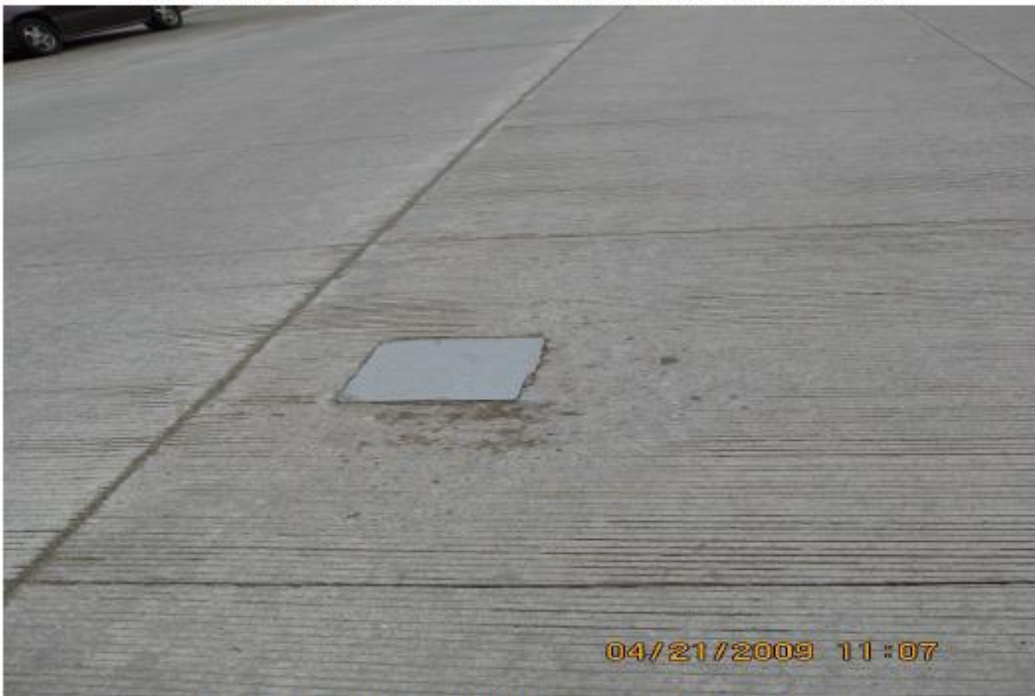
Scaling around patch in CL near 136 Main Street

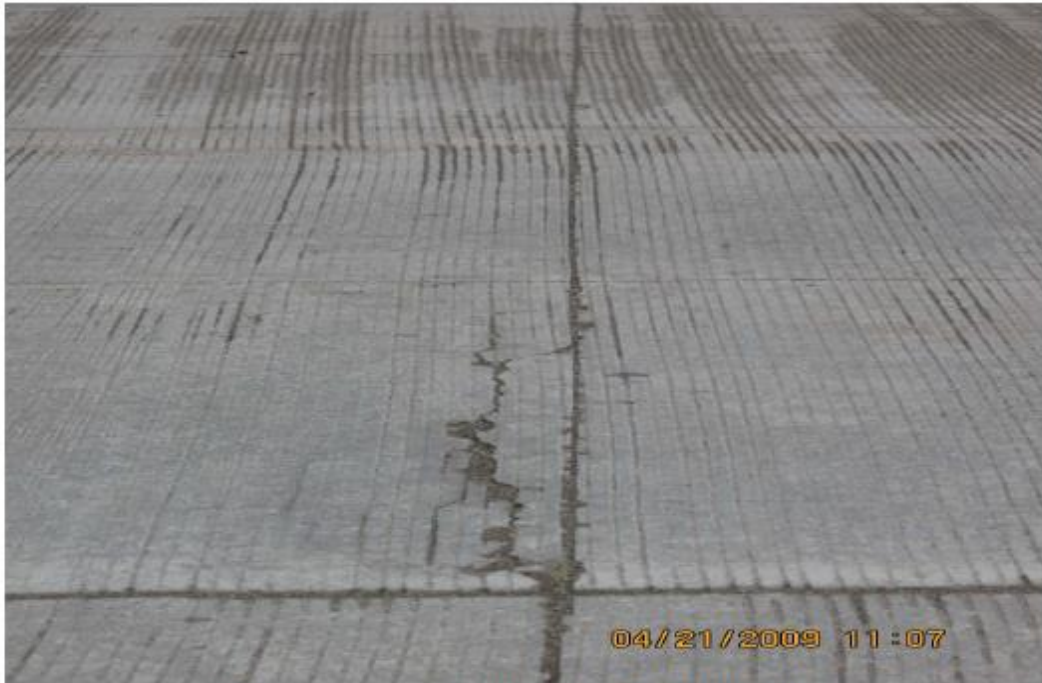
Transverse crack 180' north of Pearl St. NB-1

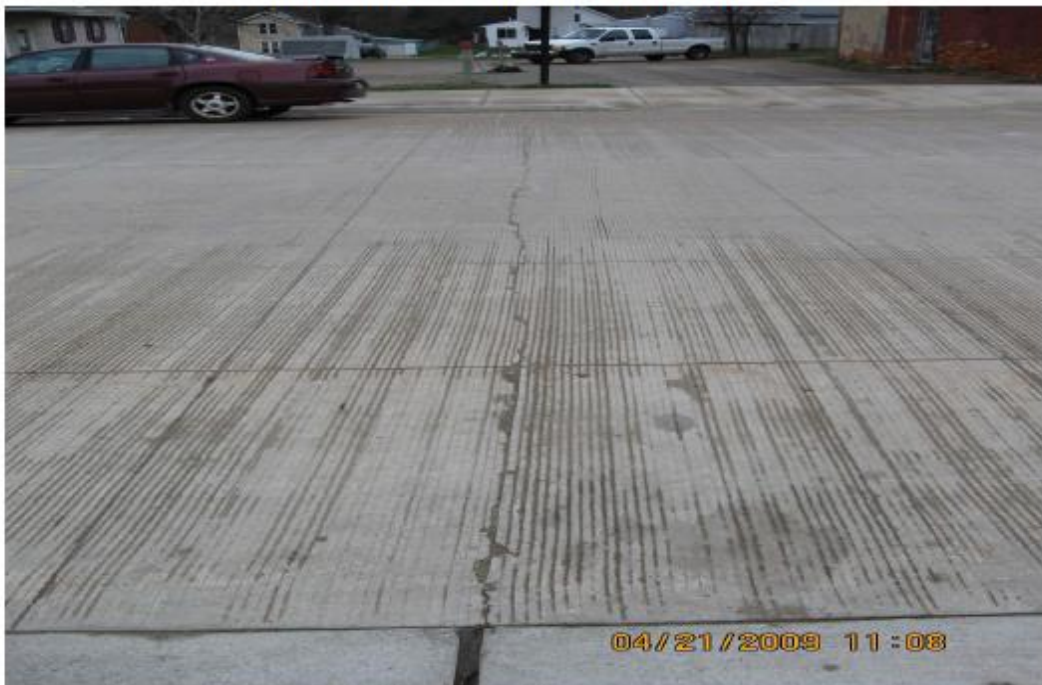
Transverse crack 225' north of Pearl St. across entire roadbed

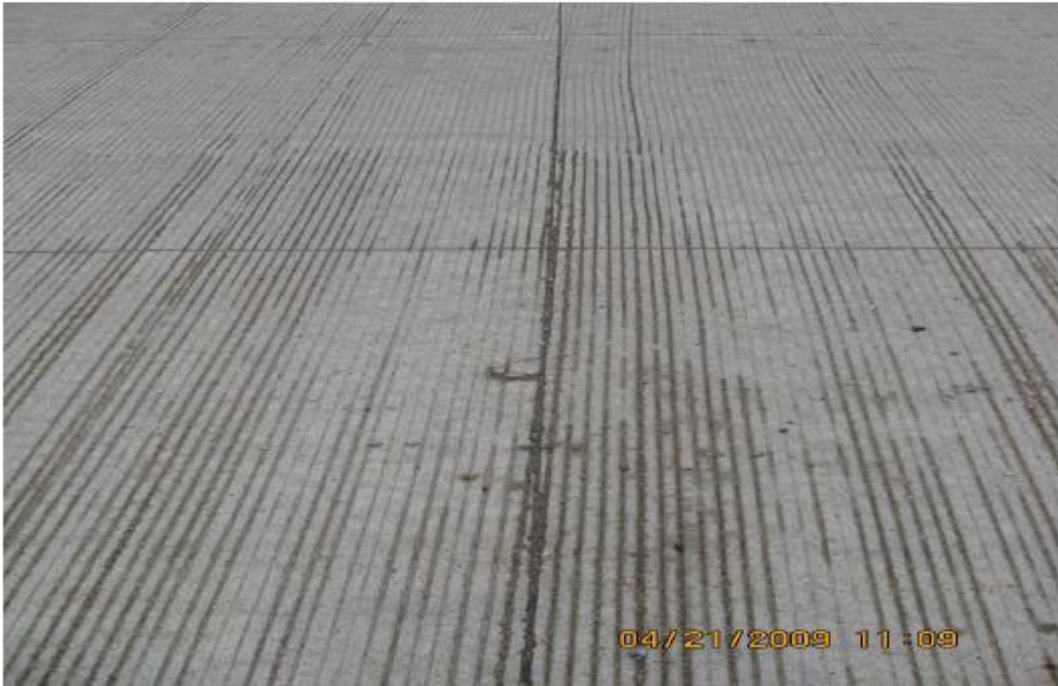
Spall 75' south of Maple SB-1

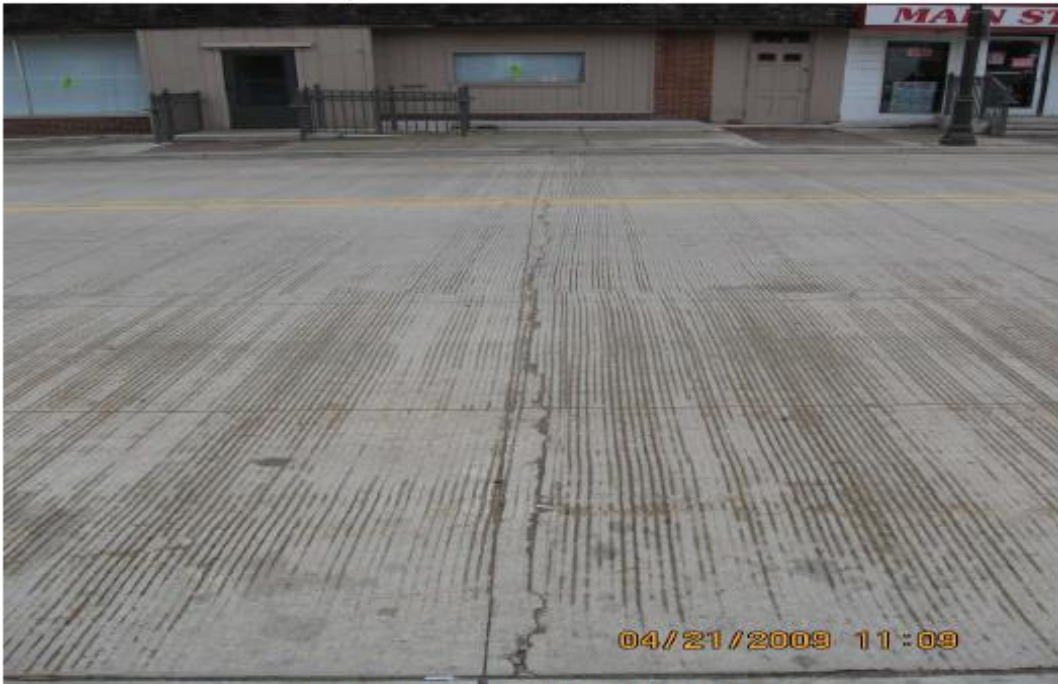
Transverse crack 150' south of Maple

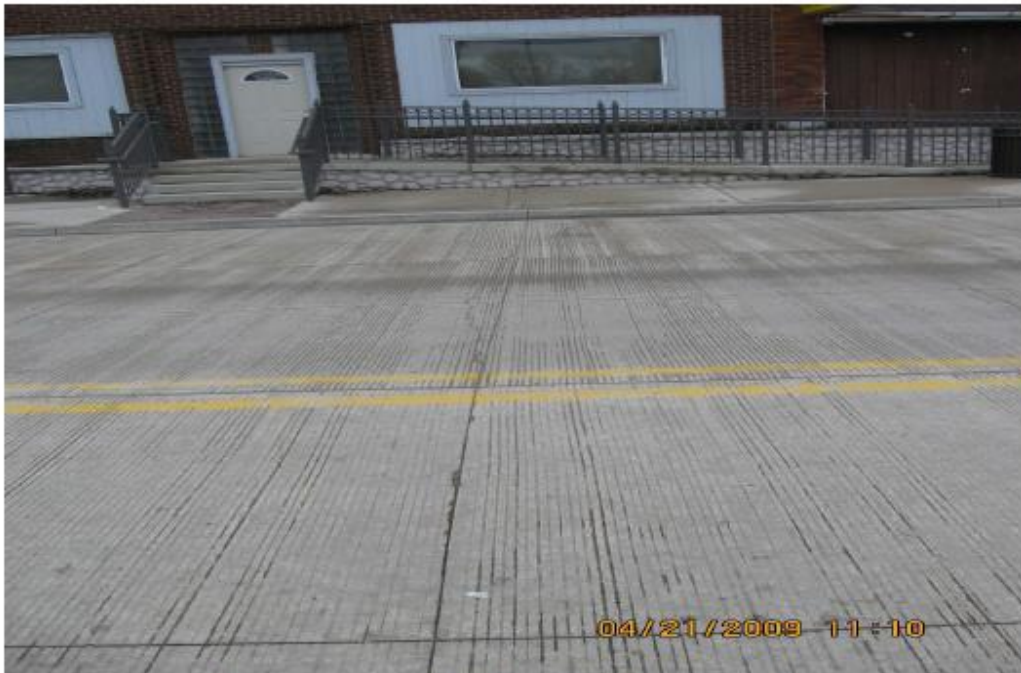
Transverse crack 200' south of Maple in SB-1

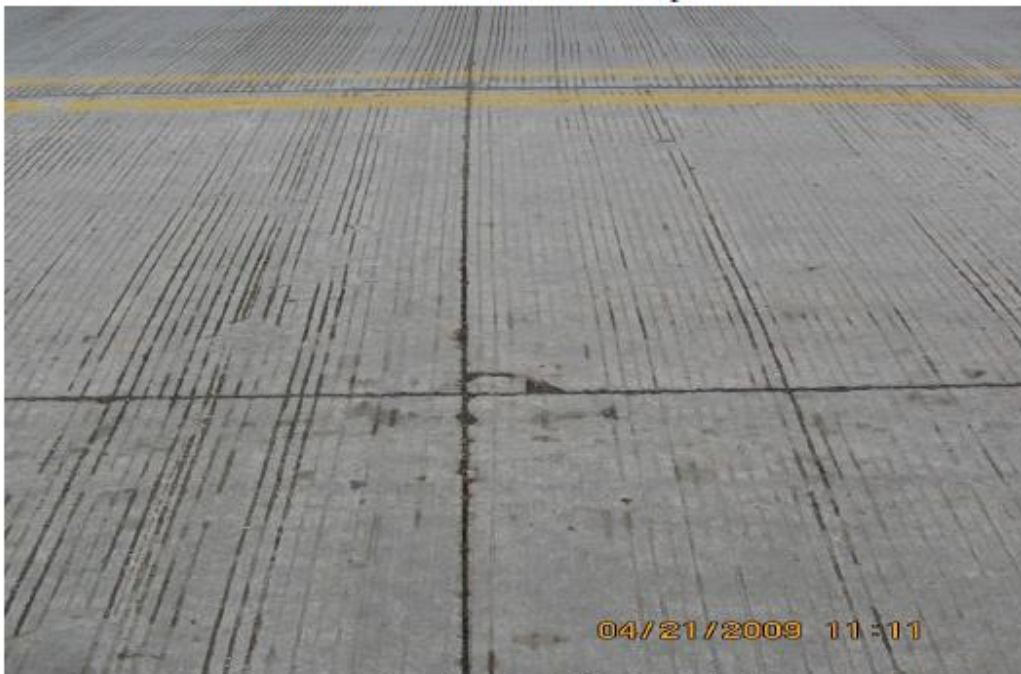
Corner crack 75' south of Maple St. in SB-1

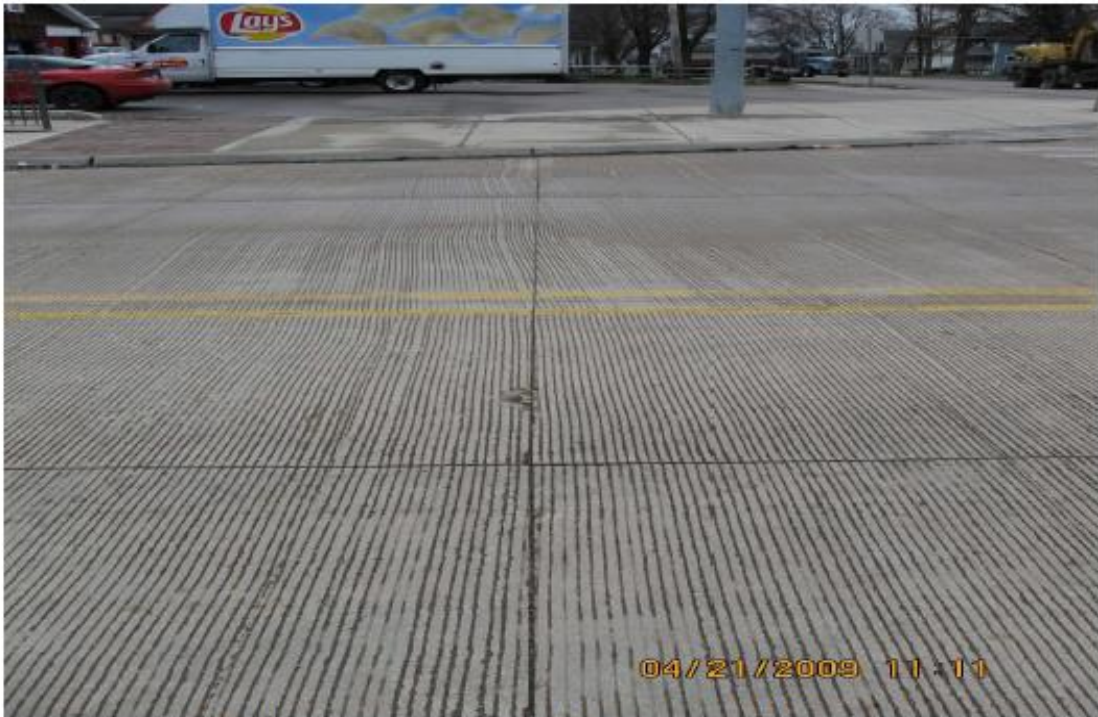
Spall near springpoint of Maple/M-99 NE quad

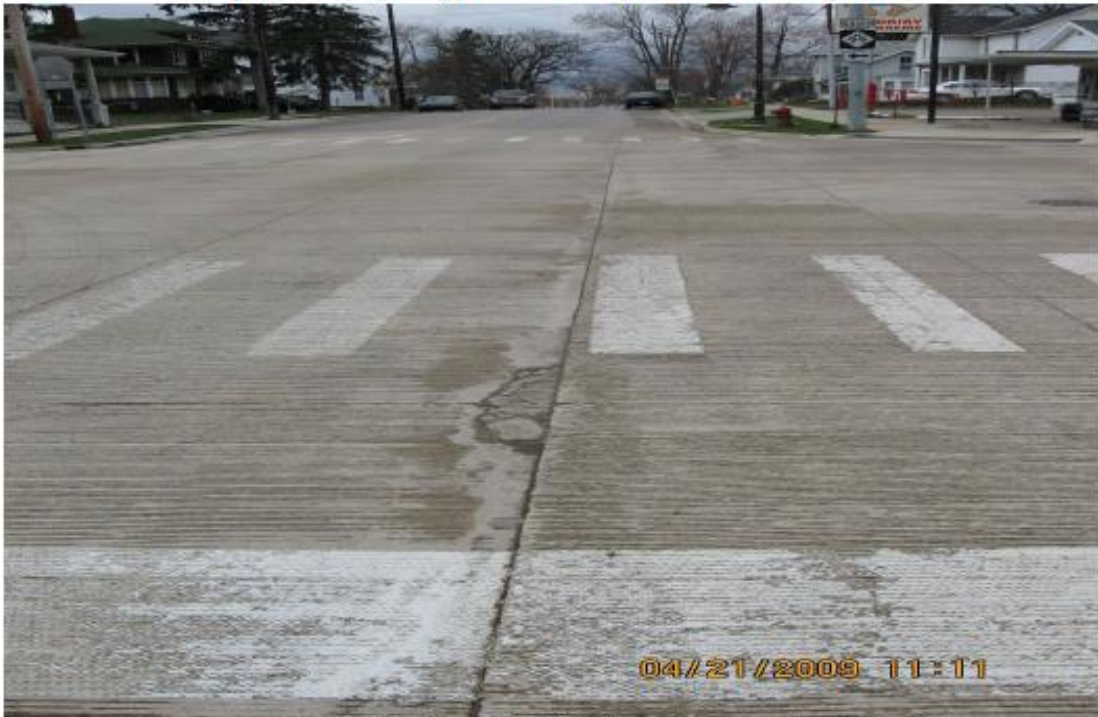
Transverse Crack/Spall at Maple/M-99 intersection North leg

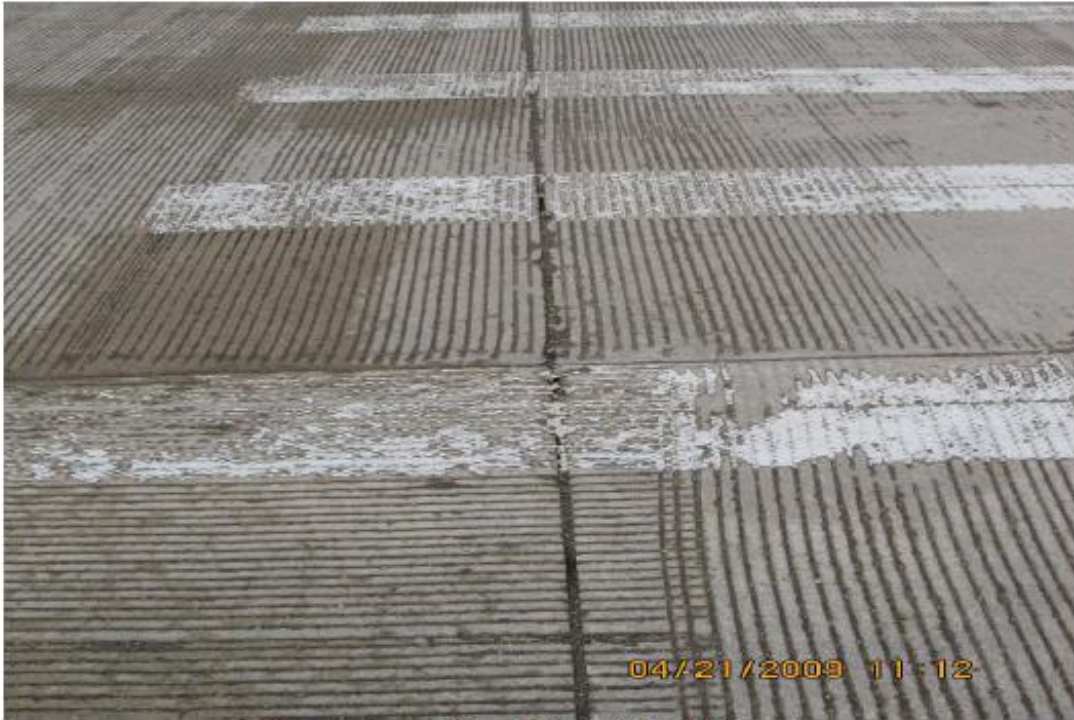
Joint sealant failure Maple/M-99 North leg

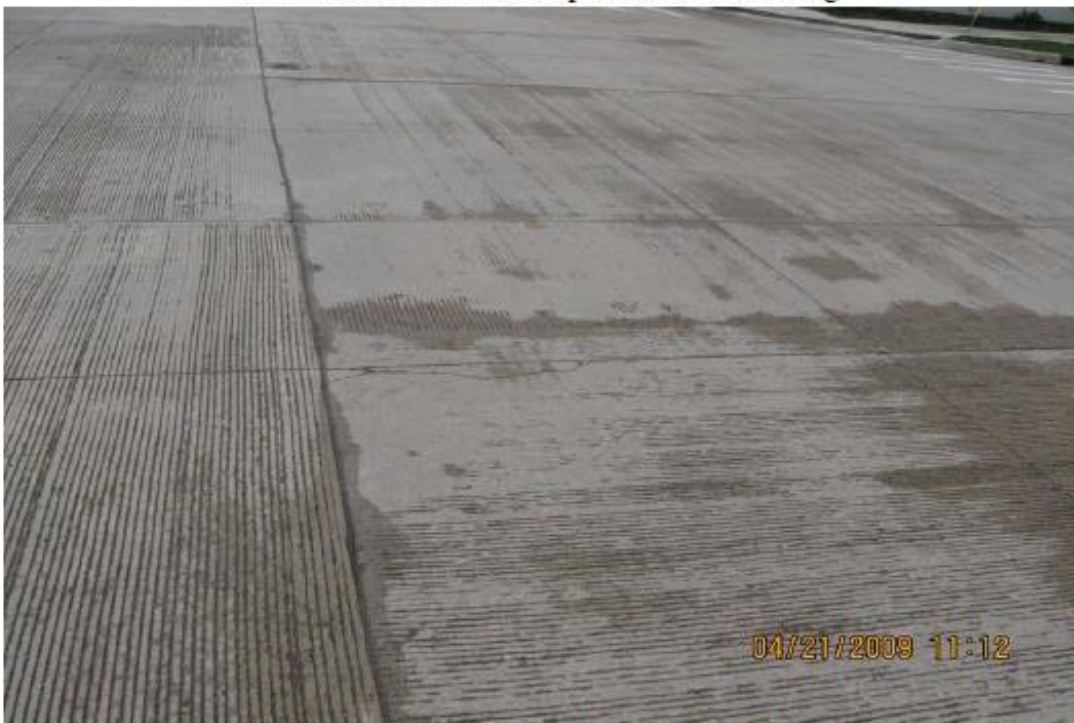
Transverse Crack North leg of M-99/Maple

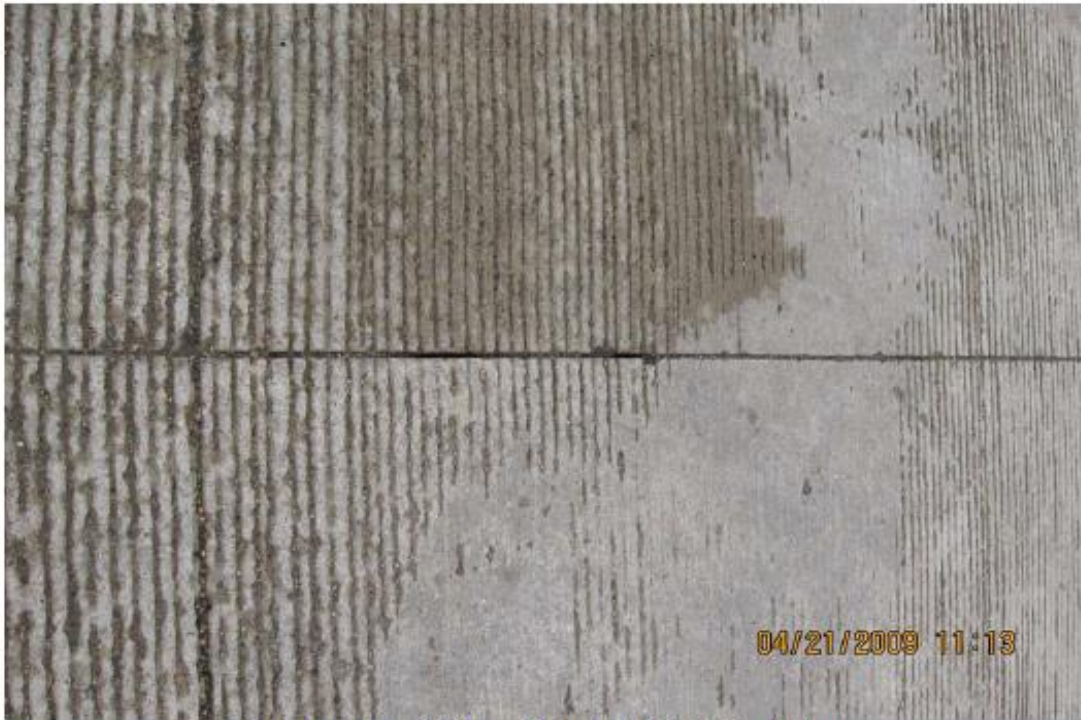
Joint sealant failure Maple/M-99 North leg

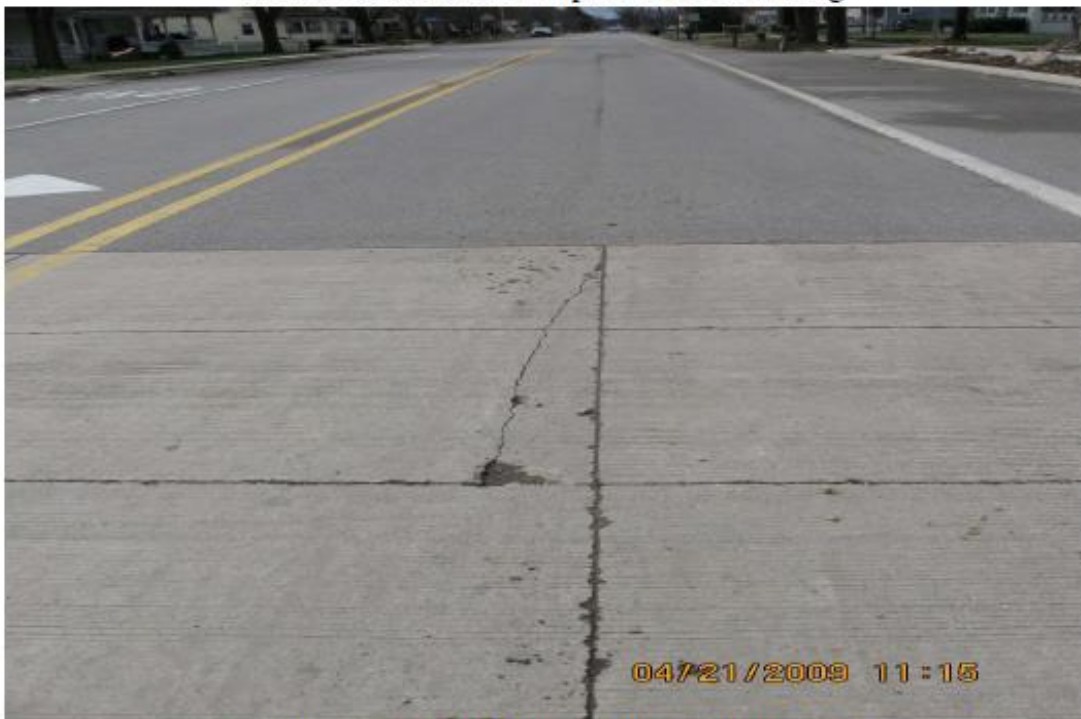
South leg of M-99/Maple, Longitudinal crack

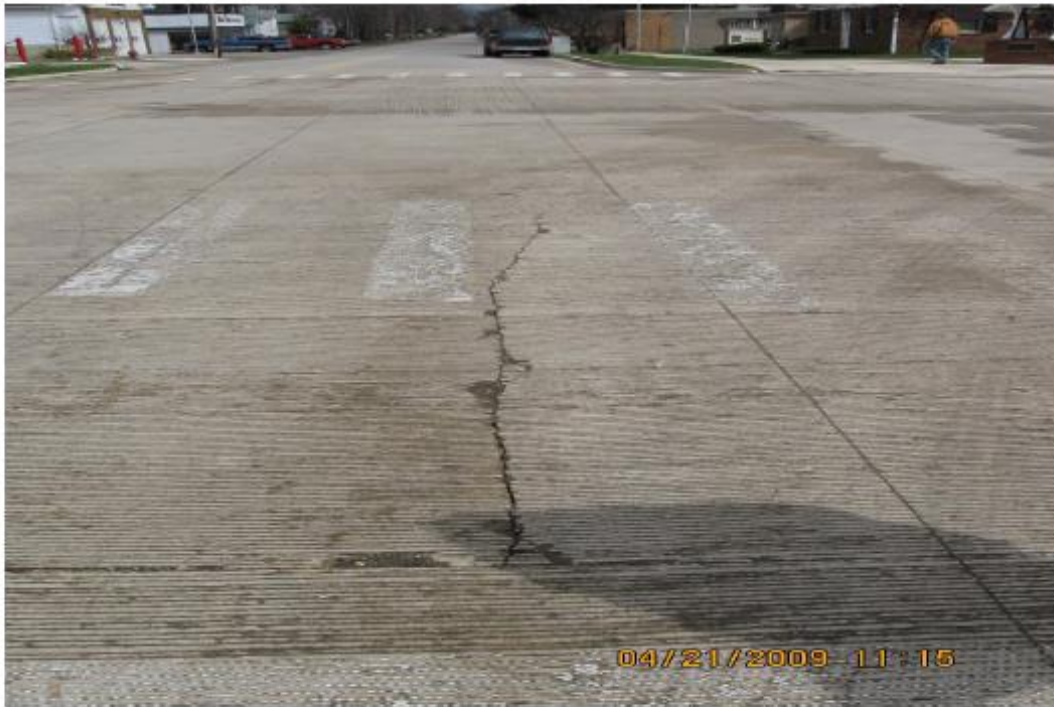
South Leg of M-99/Maple additional Long. crack

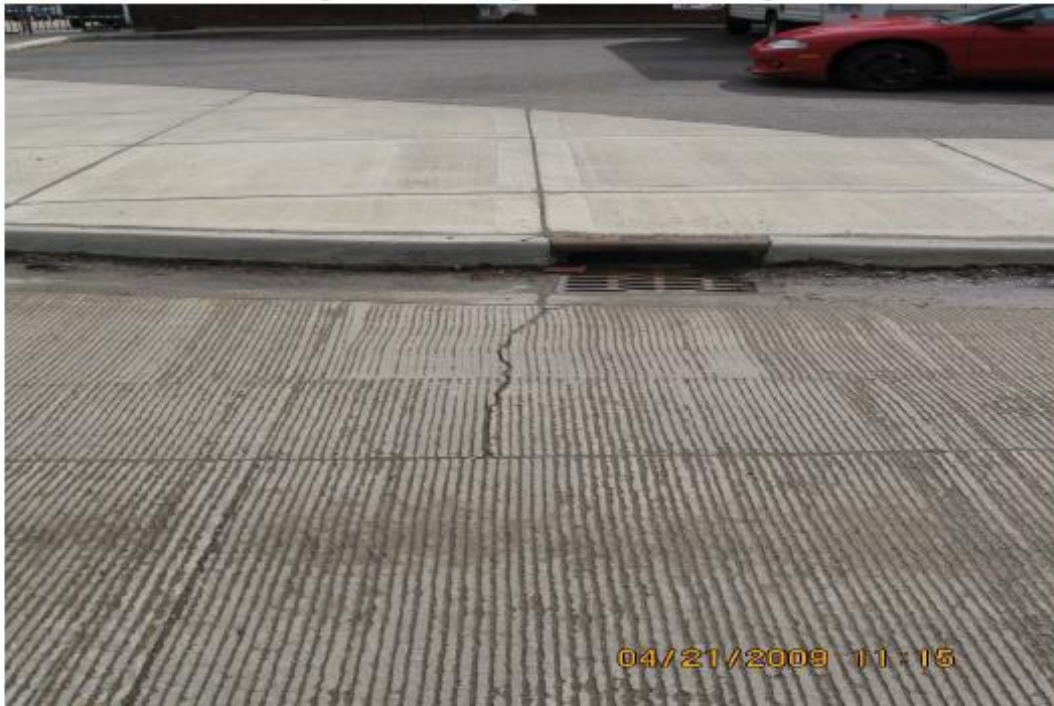
South leg of M-99/Maple, transverse crack
