**Pavement Demonstration Program Project Finalization
Low Volume (Thin) Concrete Reconstruction Projects –
M-13 & M-99
(MDOT Job Numbers 53356 & 75184)**

Final Technical Report

Report No. OR23-304, B

April 2024

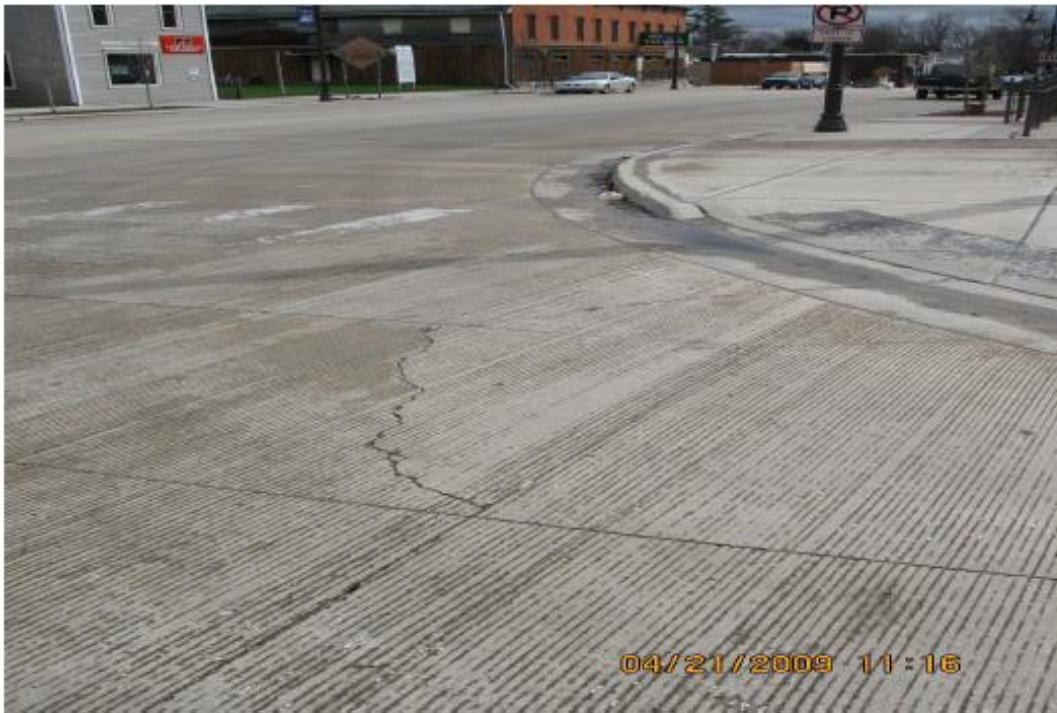
Corner crack/Transverse crack in SE radius of M-99 and Maple

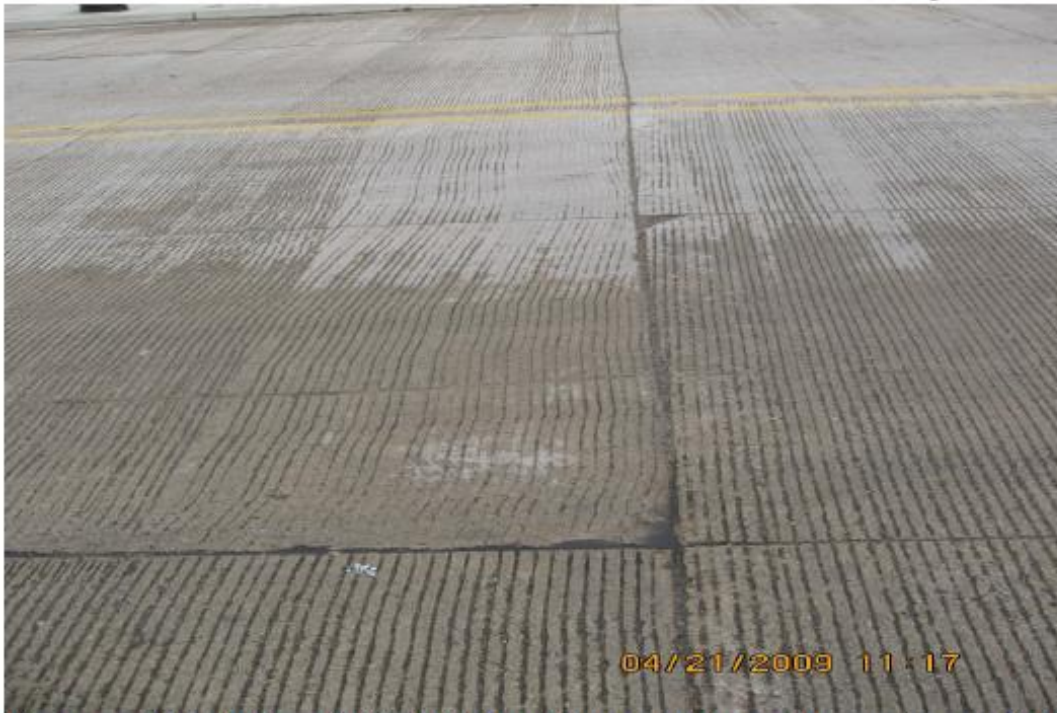
Picture of slab that has faulted with out signs of distress. East spring point of SE quad of M-99 and Maple.

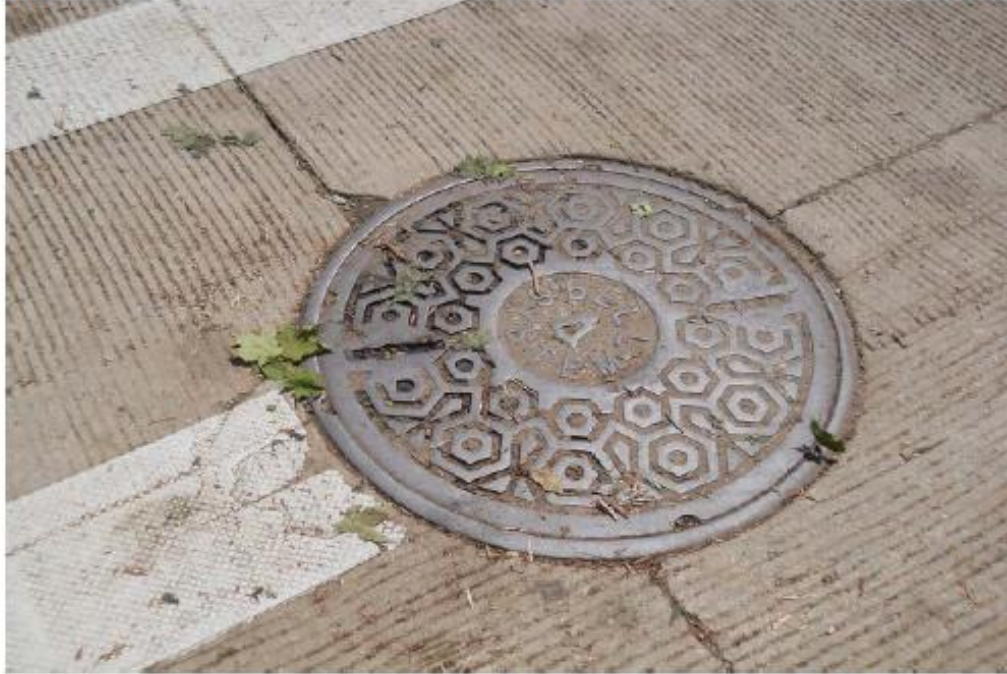
Picture #1: Spall and cracking around MH.

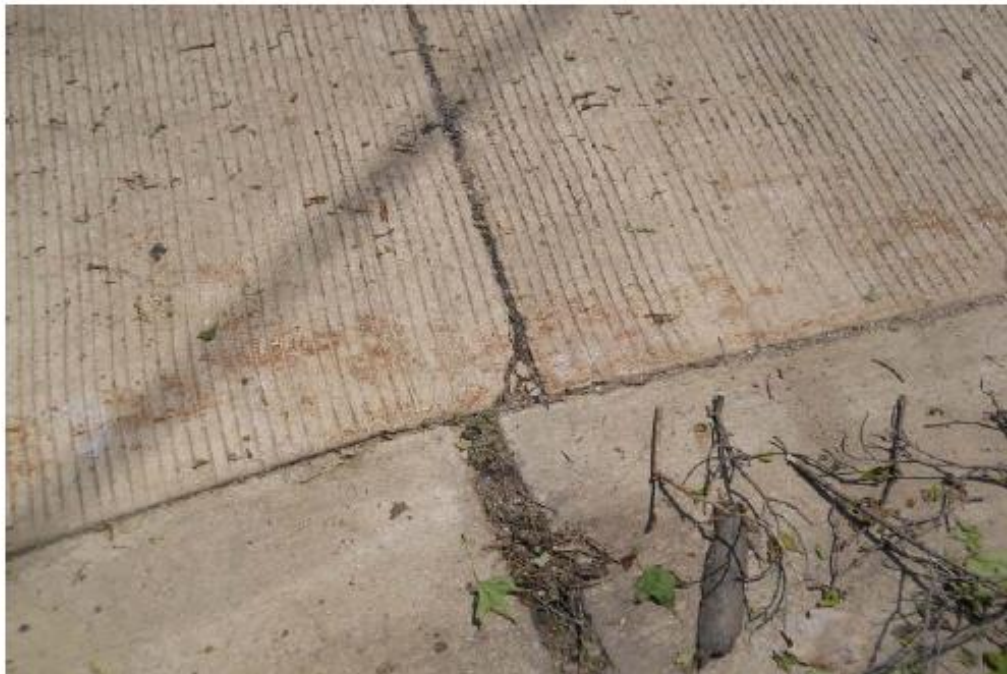
Picture #2: Corner spall near gutter pan.

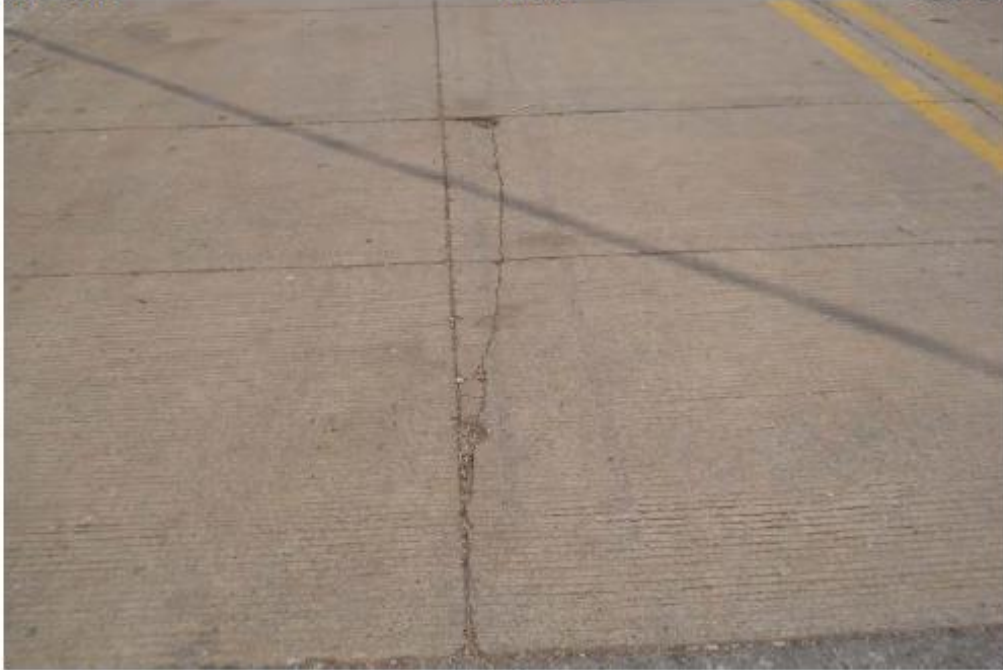
Picture #3: Longitudinal cracking (two panels).

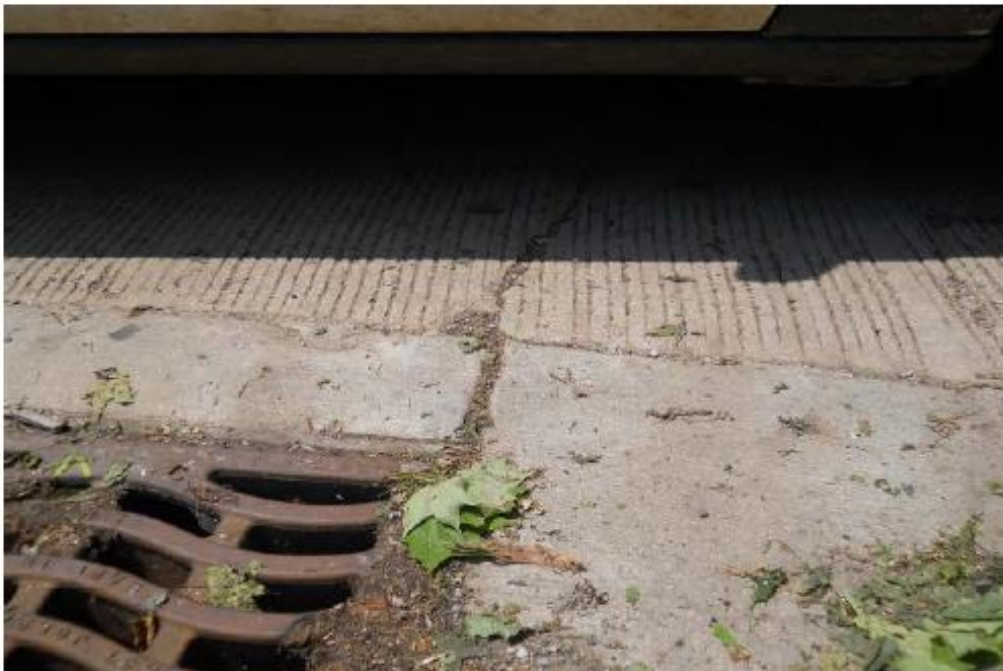
Picture #4: Transverse cracking to edge of panel.

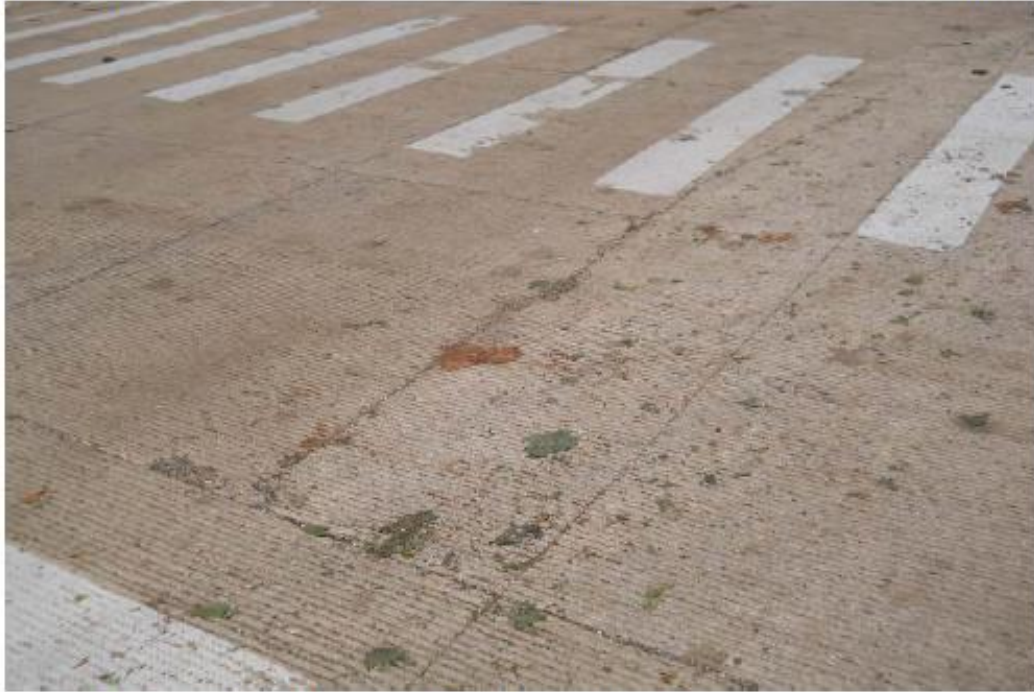
Picture #5: Longitudinal cracking (three panels).

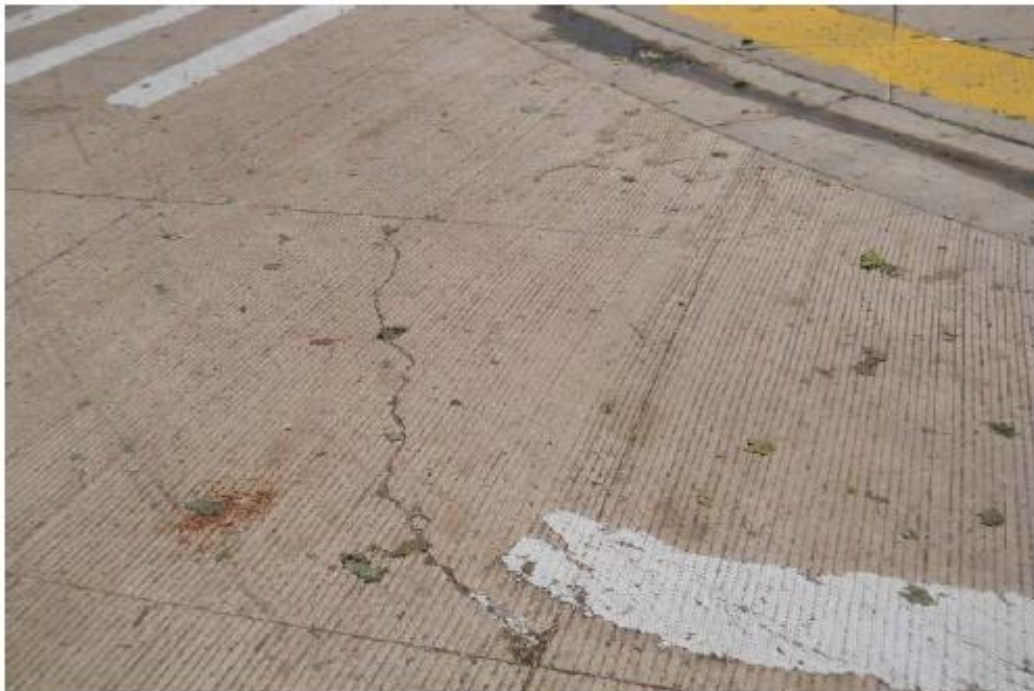
Picture #6: Cracking from curb joint through two panels.

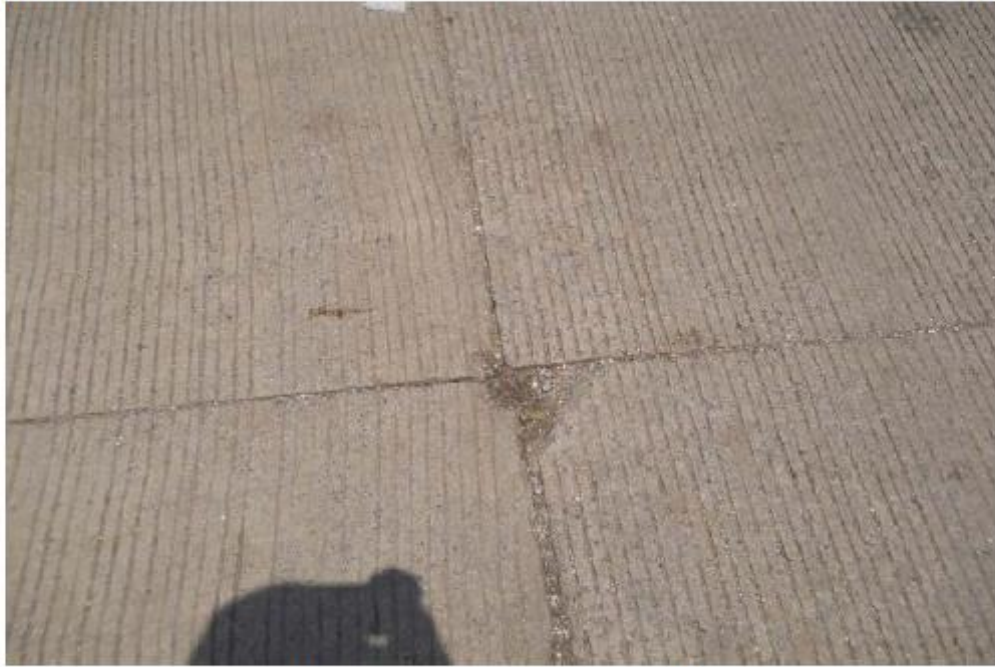
Picture #7: Corner spall.

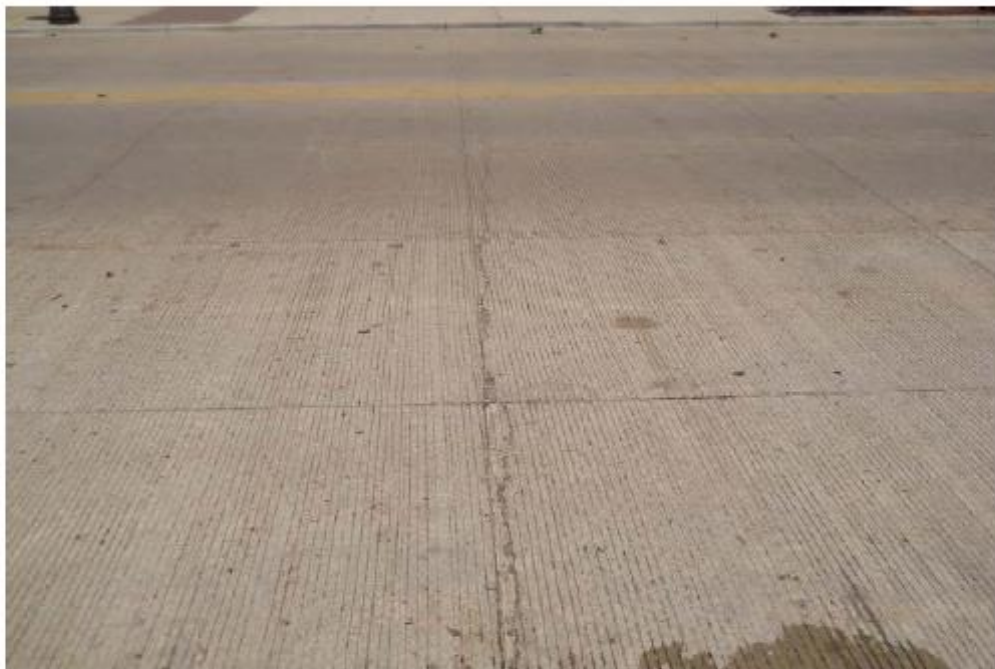
Picture #8: Transverse crack near joint.

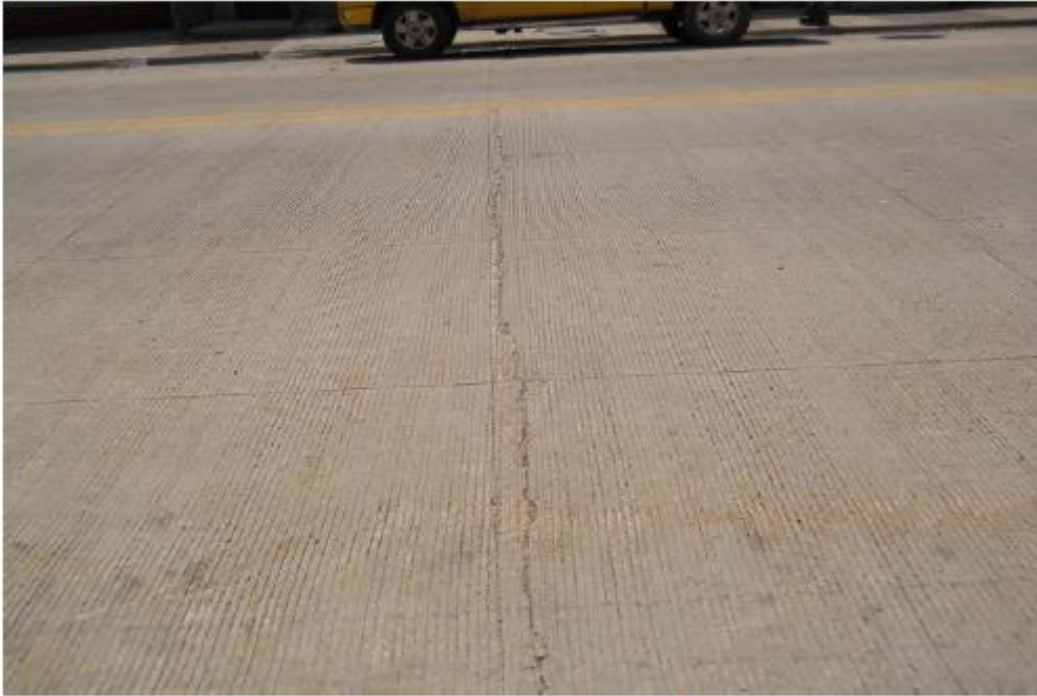
Picture #9: Transverse crack near joint.

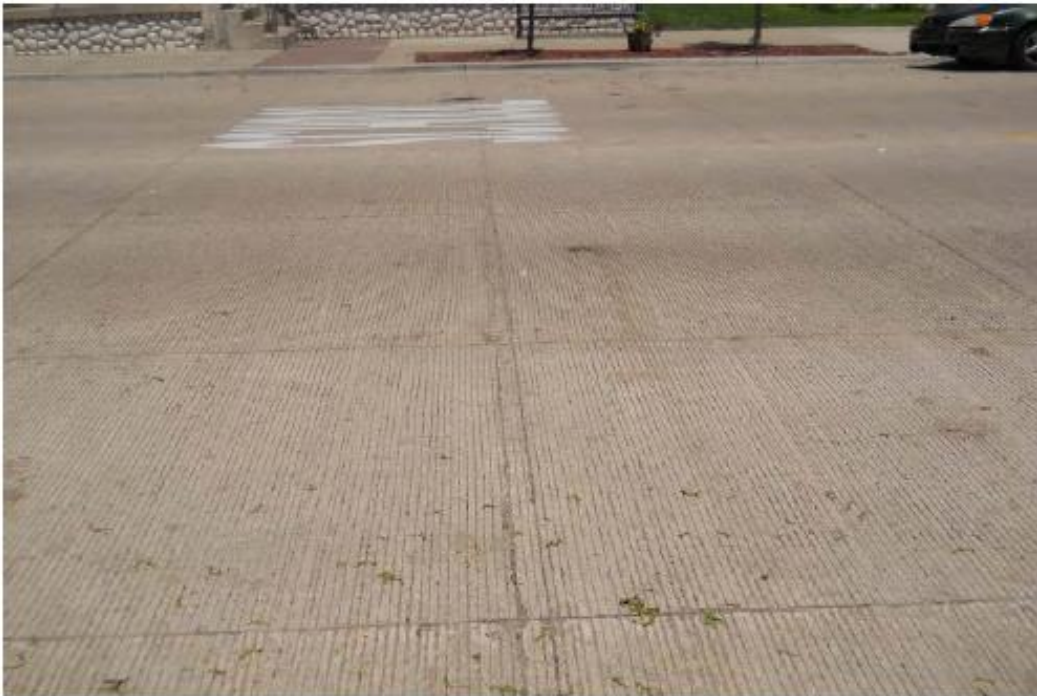
Picture #10: Transverse crack near joint.

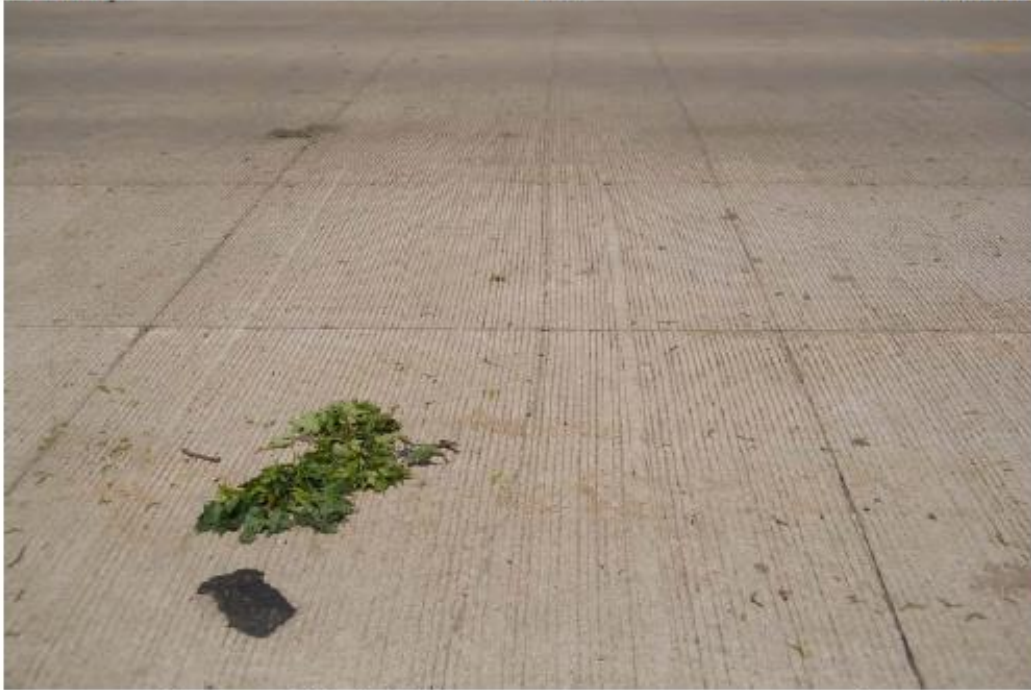
Picture #11: Mid-panel transverse crack.

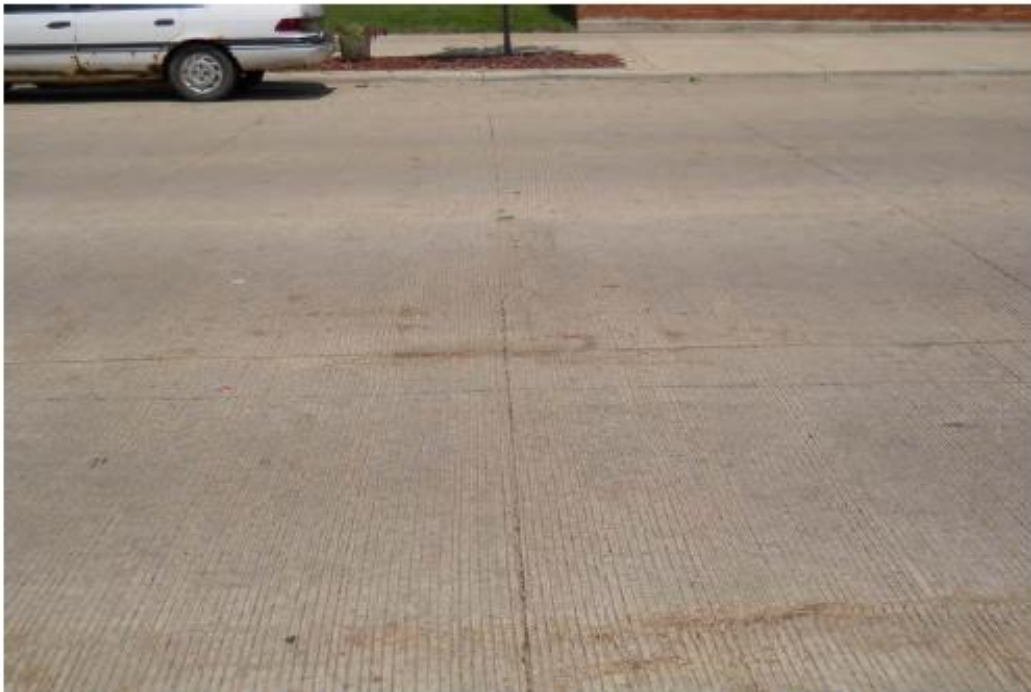
Picture #12: Transverse crack, parallel with joint.

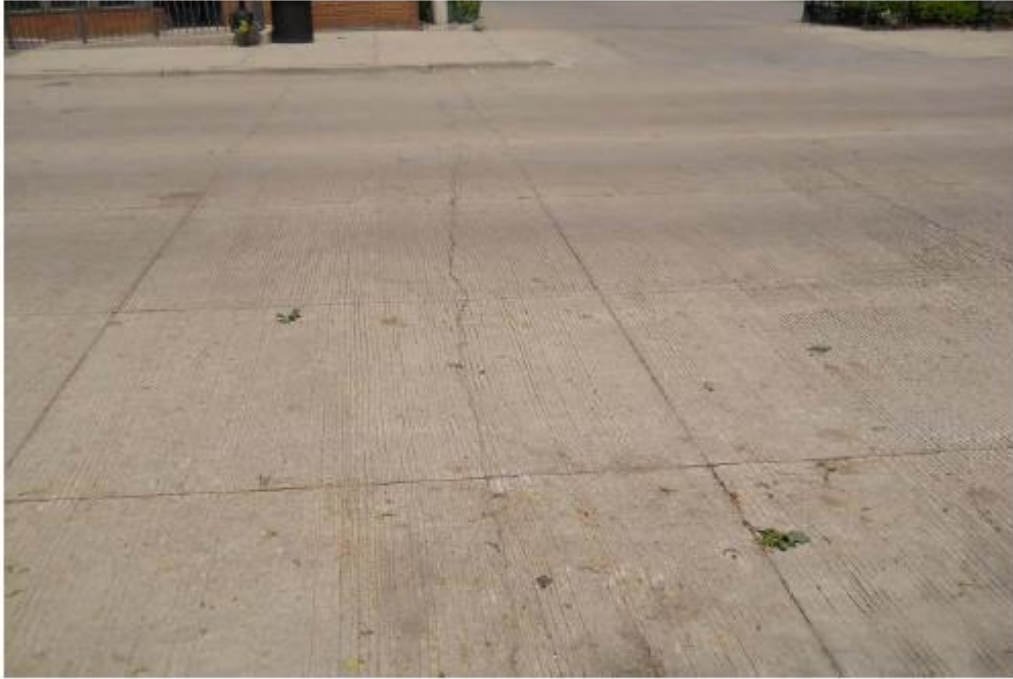
Picture #13: Mid-panel transverse crack.

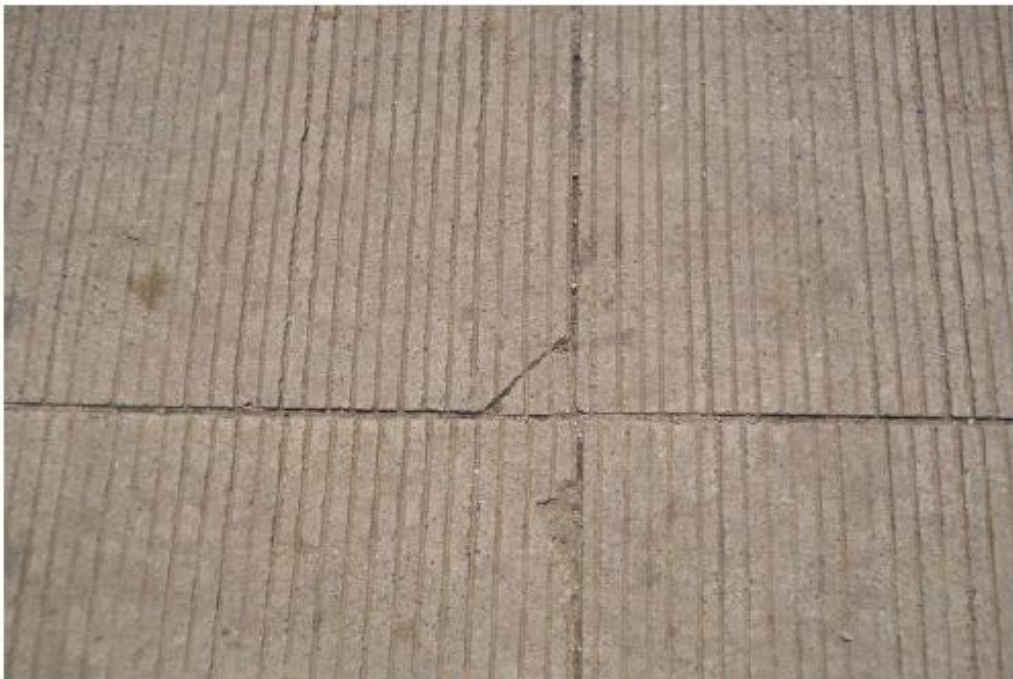
Picture #14: Corner crack.

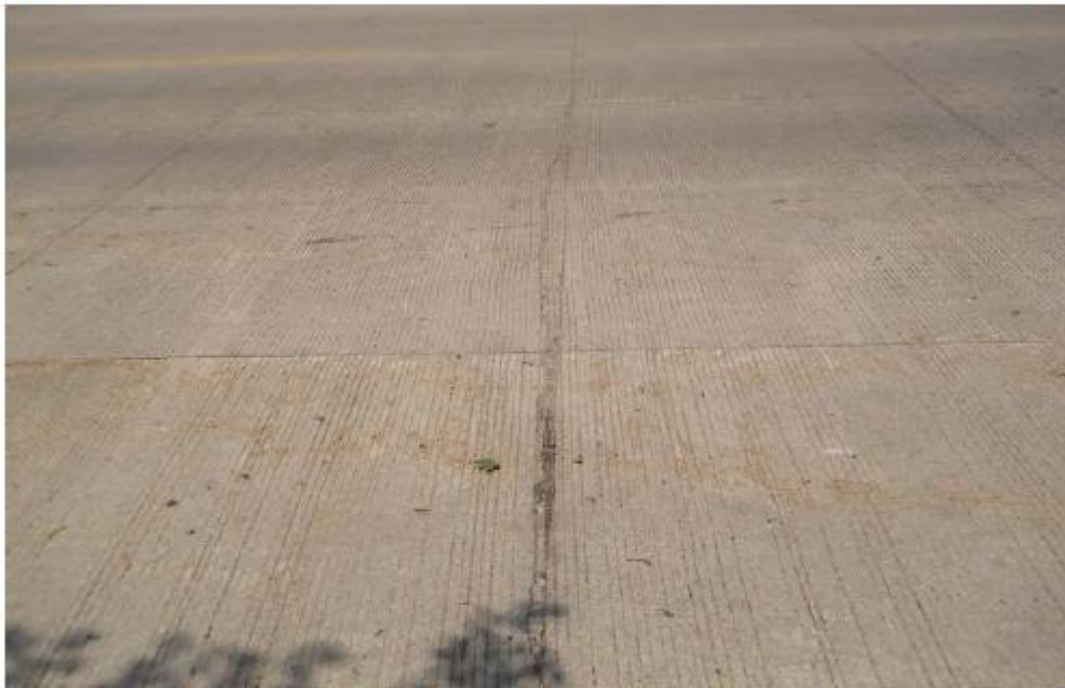
Picture #15: Transverse crack (3 slabs).

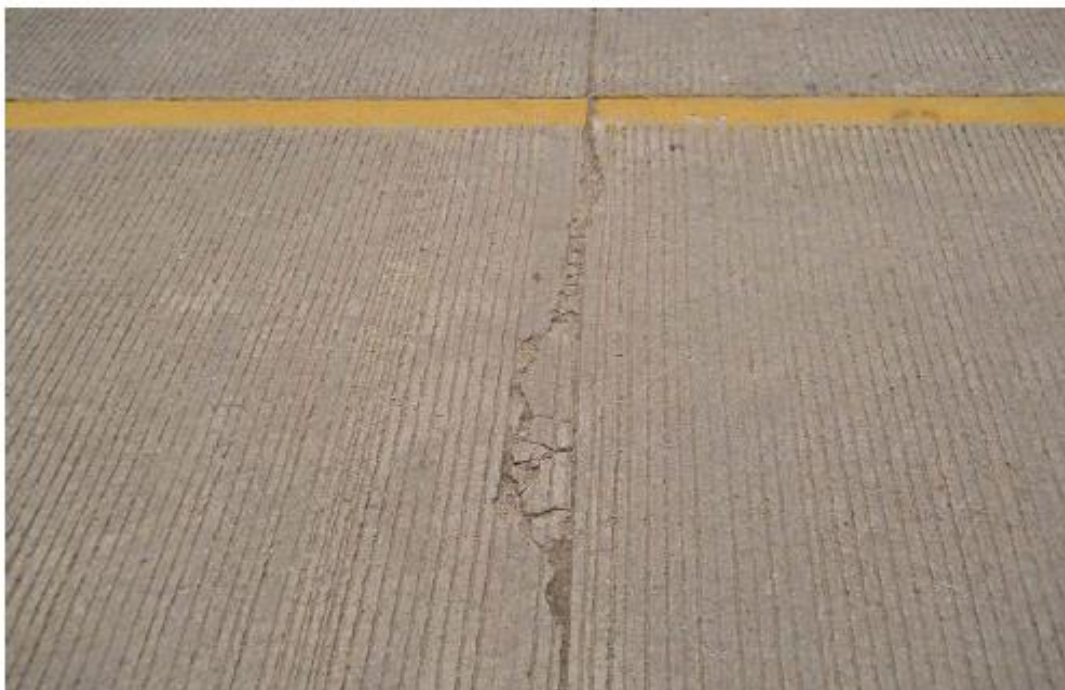
Picture #16: Raveling/spalling joint.

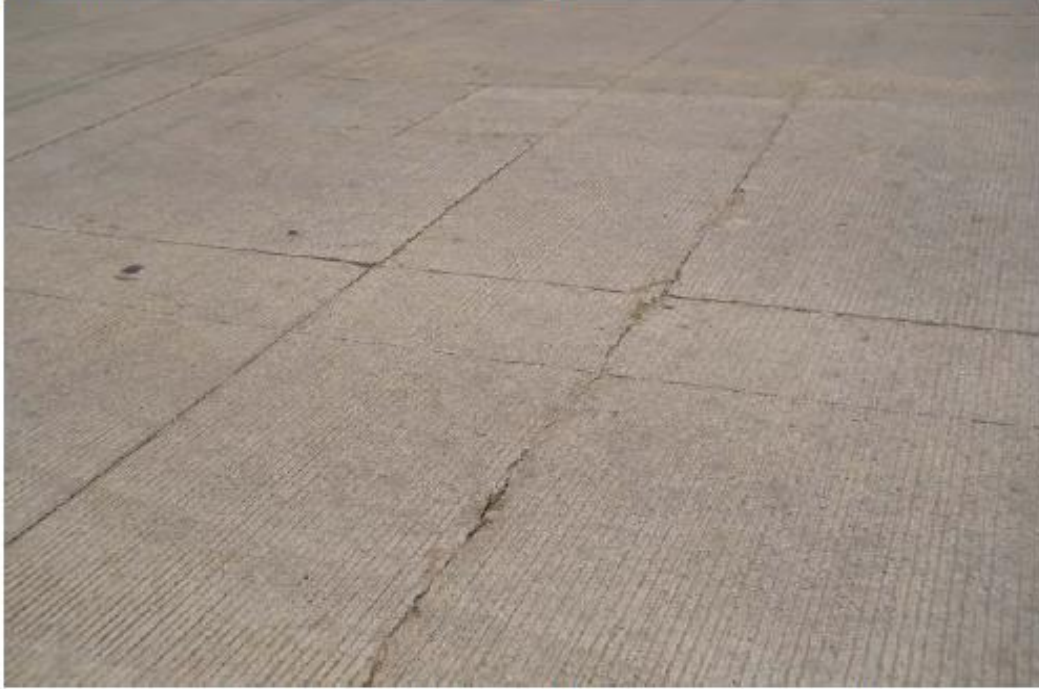
Picture #17: Mid-panel transverse crack.

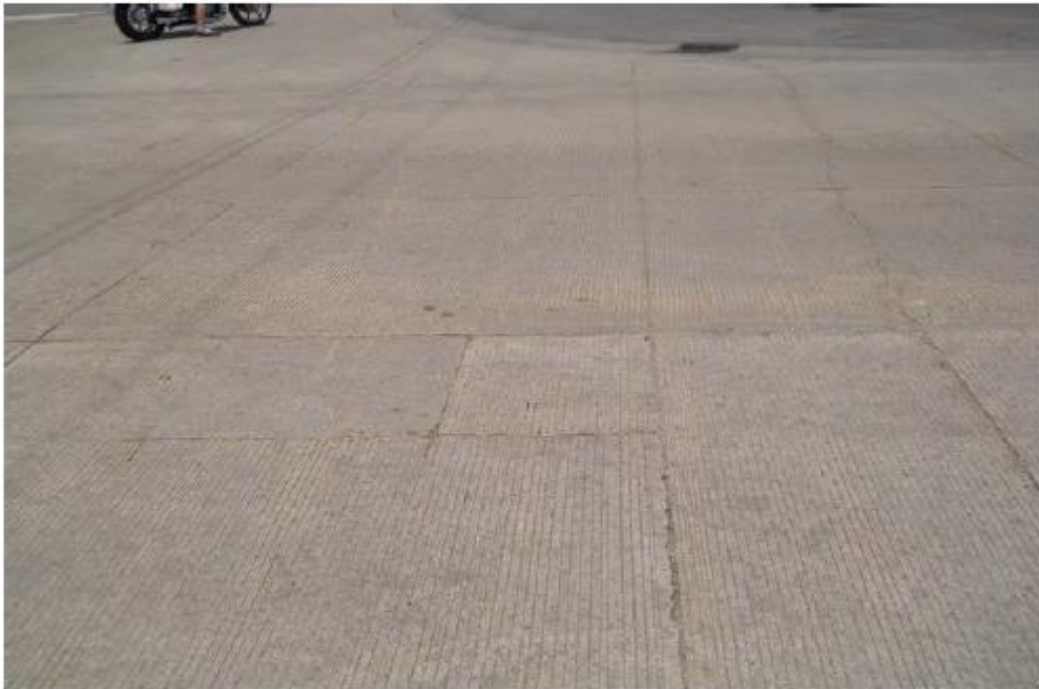
Picture #18: Longitudinal crack extending from previous patch.

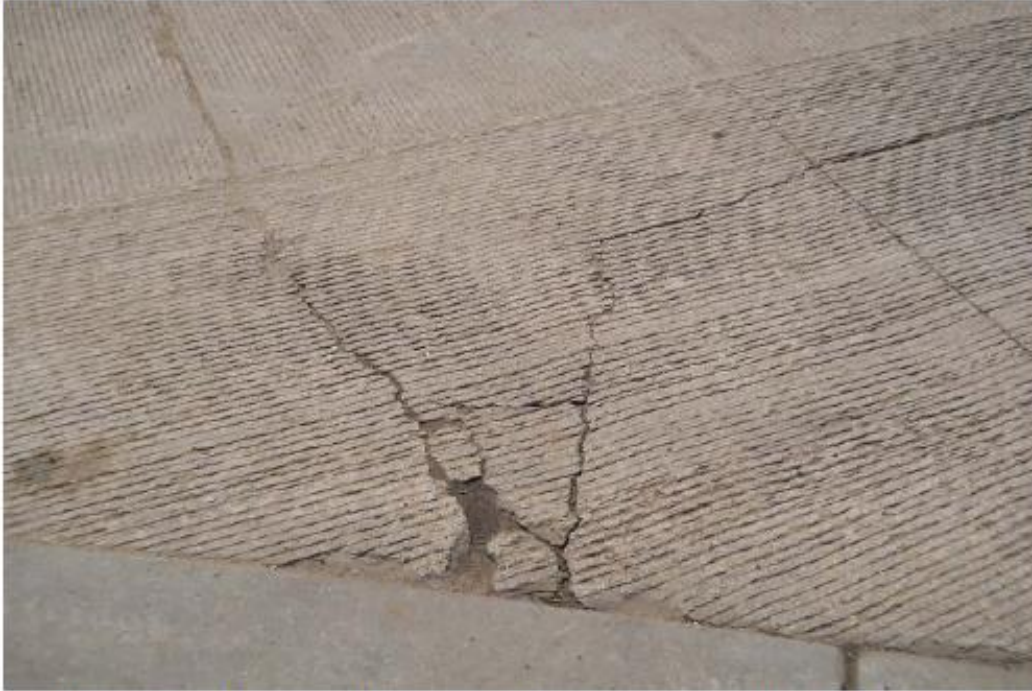
Picture #19: Cracking/spalling near curb and gutter.

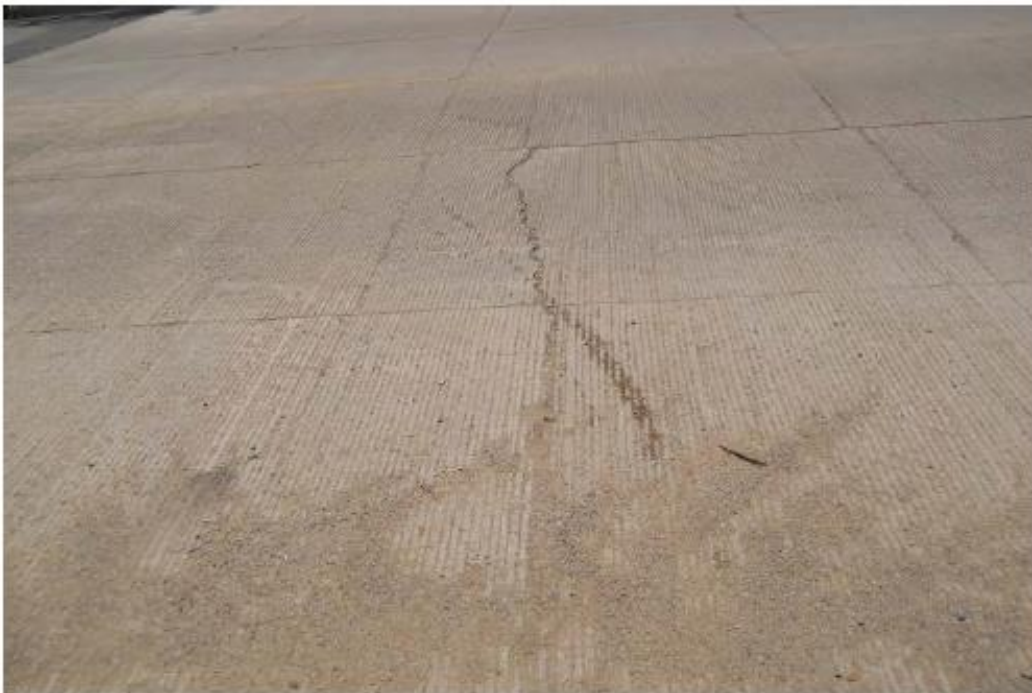
Picture #20: Longitudinal cracking, southbound only.

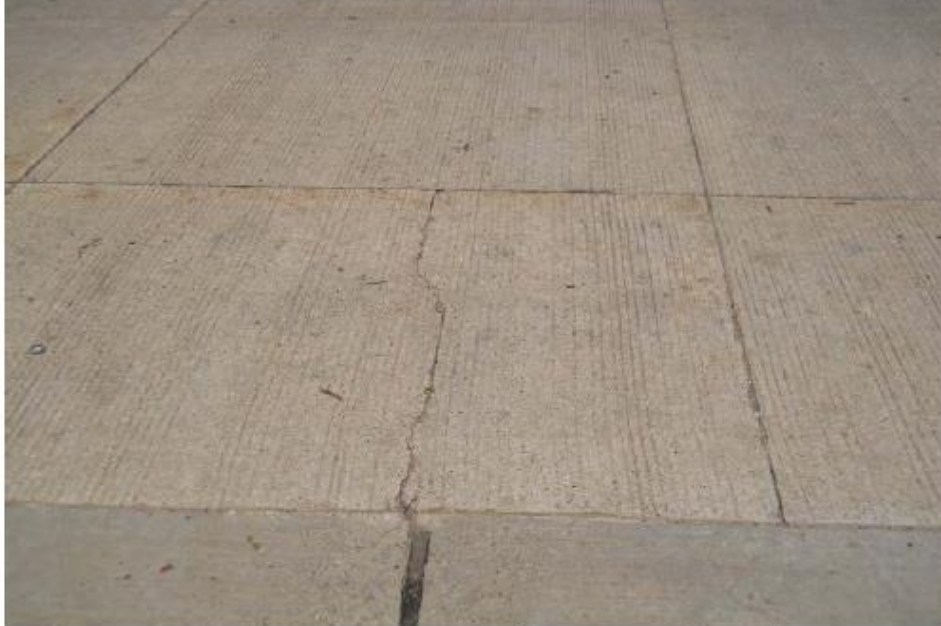
Picture #21: Transverse crack near curb and gutter.
