JOHN C. LODGE FREEWAY TRAFFIC SURVEILLANCE

STUDY 424
EFFECT OF INCIDENTS ON FREEWAY TRAFFIC

- I. LANE CLOSURE FOR MAINTENANCE
II. EFFECT OF ACCIDENT ON FREEWAY TRAFFIC FLOW

Conrad L. Dudek
Traffic Division
Michigan State Highway Department

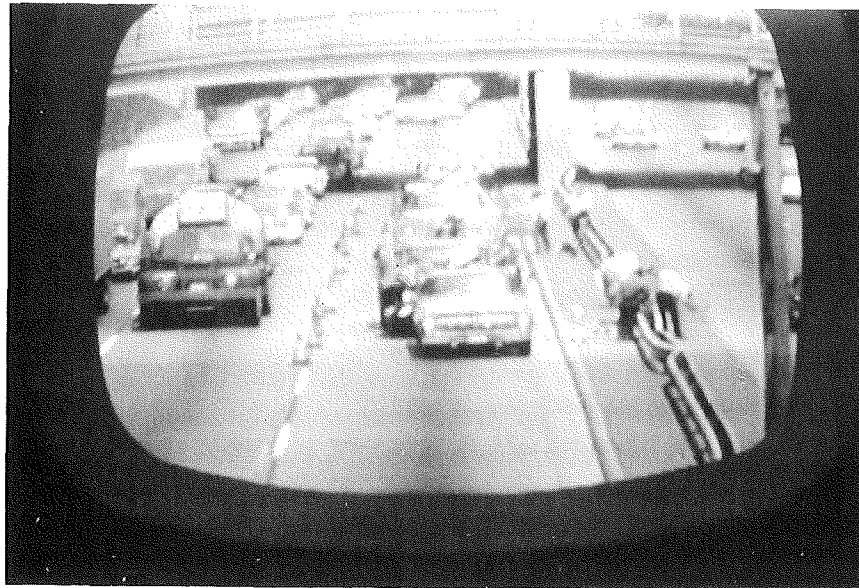
This incident occurred during the off-peak traffic period. The control system was activated to display a red "X" over the median lane.

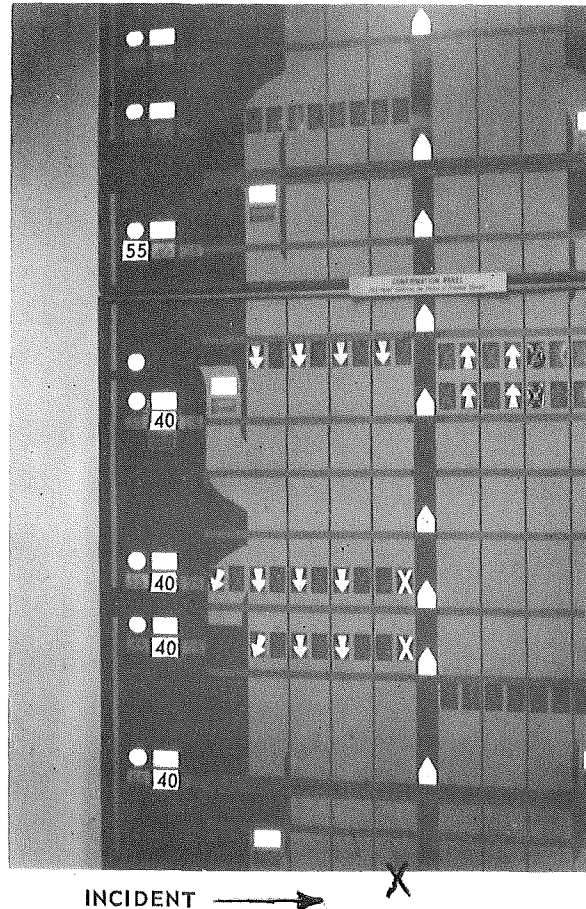
The operational procedure for the control system during this week was that of part system operation. That is, only that portion of the control system was used where needed in the vicinity of the incident. As a result, only three spans of lane control signals were illuminated in the direction effected. Figure 2 illustrates the Confirmation Panel displaying the location of activated signals

Note two spans in advance of the incident have "X's" displayed on the median lane in the southbound direction. The location of the incident is identified in the picture. The incident is viewed from the Grand Trunk Railroad camera location. Green arrows are displayed over the shoulder and center lanes.

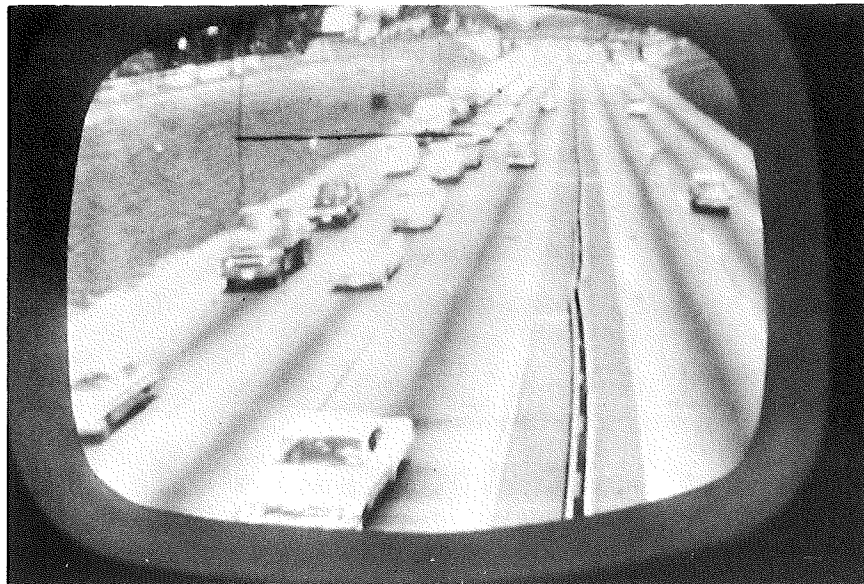
The following is a series of photos at adjacent camera locations in advance of the maintenance operations. Figure 3 presents the traffic flow from the West Grand Boulevard camera which views a field from 400 feet to 1640 feet in advance of the maintenance operation.

This traffic has passed under the two spans of signals displaying the red "X" over the median lane. Note the heavy traffic in the center and shoulder lane as traffic has moved from the median lane because of lane closure by the signals.

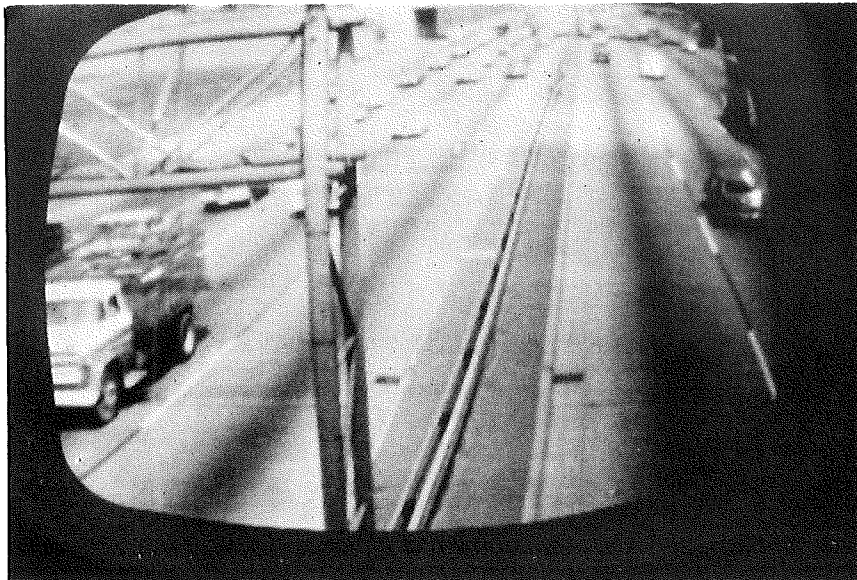
Figure 4 presents traffic as viewed from the Pallister camera location covering the area from 1640 feet to 2345 feet in advance of the incident. Traffic here has passed under one span displaying the red "X" in the median lane and is approaching the second span of signals on the truss visible in the picture. Note the median lane is clear of traffic in the near field of the photo.

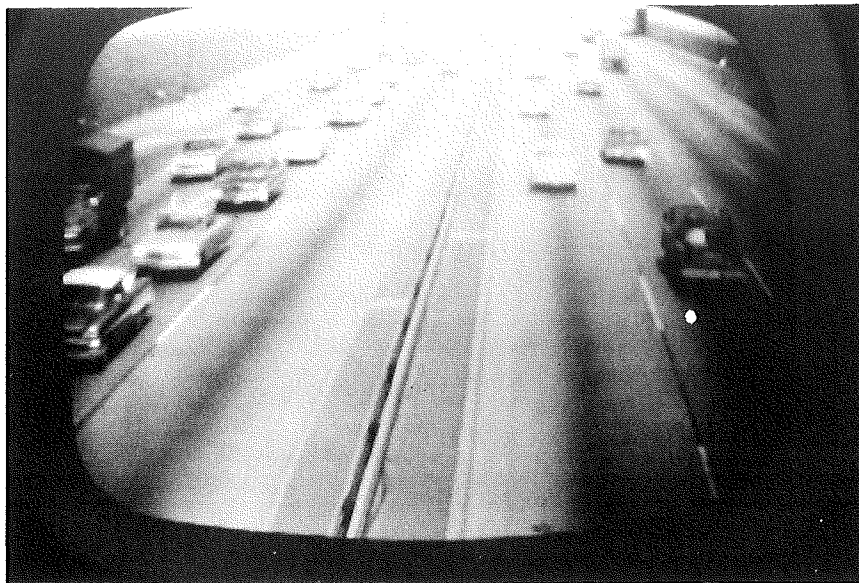
Figure 5 presents traffic flow approaching the first signal span displaying the red "X" from the Seward camera location. This span is located approximately 2400 feet in advance of the incident and the camera field in this photo covers from 2345 feet to 3170 feet in advance of the incident. Even this distance in advance of the incident, it is apparent that motorists have responded to the red "X" in an efficient manner, as indicated by the heavy traffic in the shoulder and center lane.

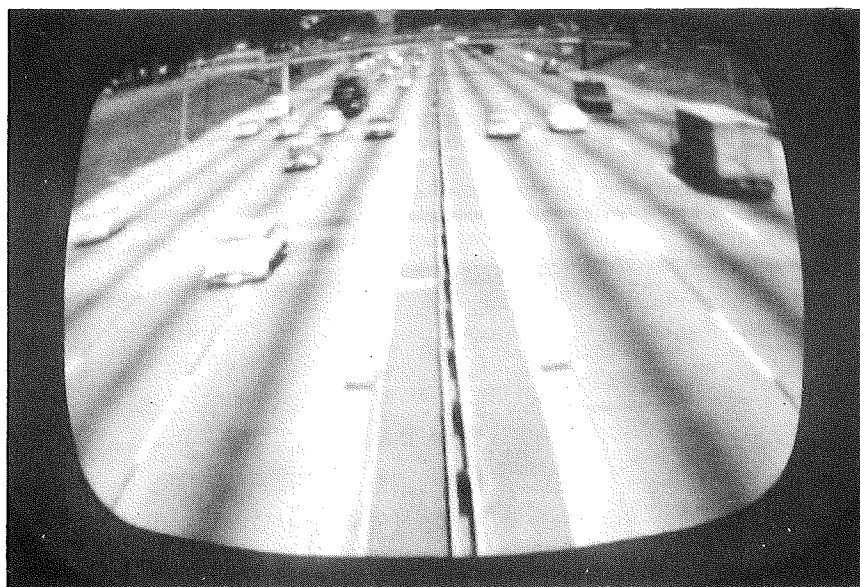
Figure 6 presents traffic flow as viewed from the Euclid camera location. The field covered by this camera is from 3170 feet to 4425 feet in advance of the incident. Traffic can easily view the first span of signals displaying the red "X". Here motorists are moving from the median lane into the center lane.

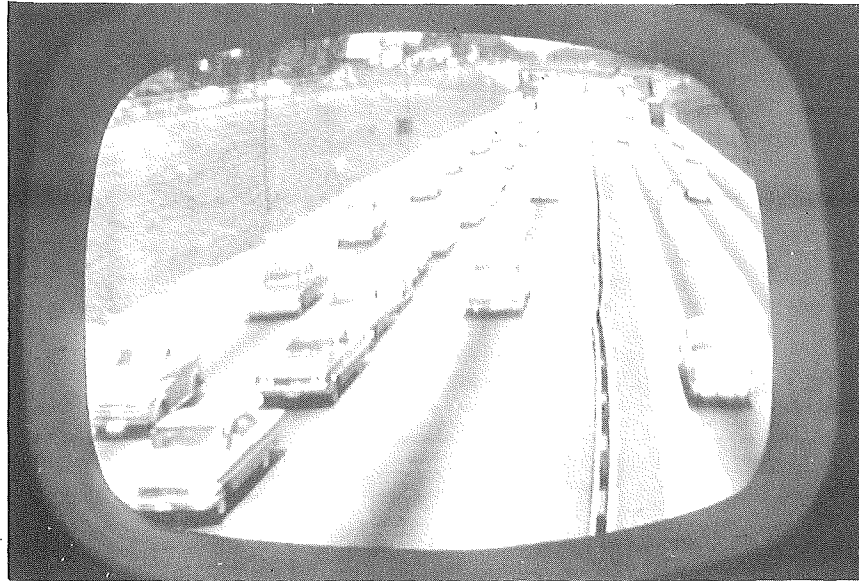
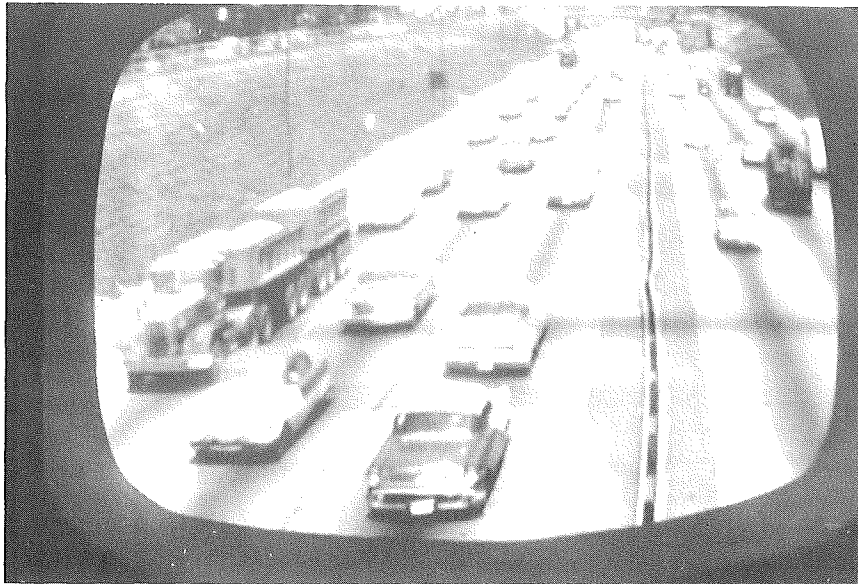
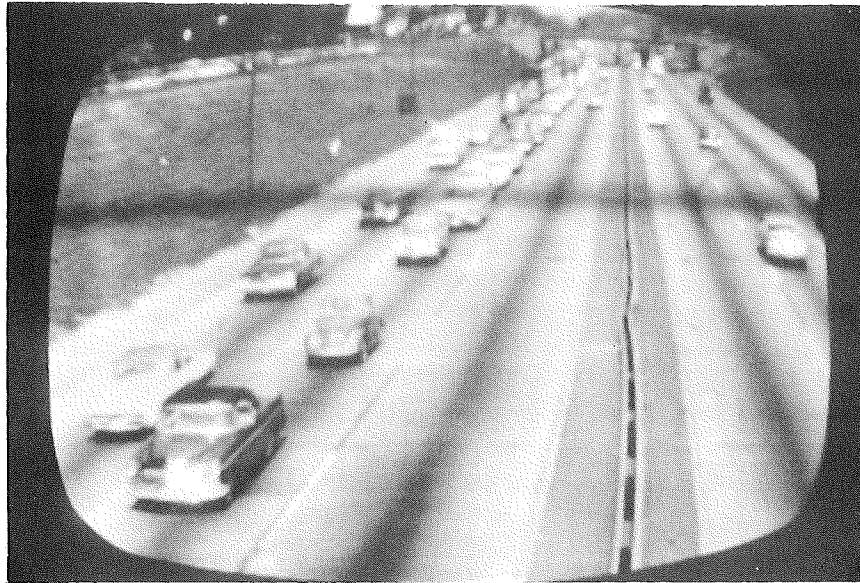
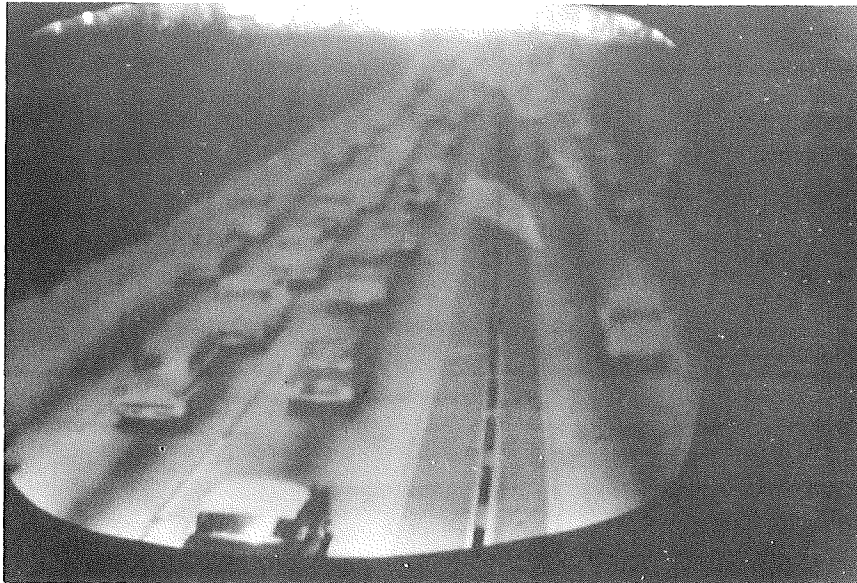
To illustrate the situation in the foregoing paragraph, a series of pictures taken during the same maintenance operation but at a later time presents the build up of congestion in the center and shoulder lanes and illustrates the forced violation of the red "X" by motorists in the median lane due to the lack of room to merge into the adjacent lanes. Figures 12 through 15 present traffic flow viewed from the West Grand Boulevard camera location covering the area directly in advance of the maintenance operation. The lack of space to merge into the adjacent lanes running full, restricts the median lane traffic from merging and results in the situation depicted in figures 13 and 15.

impending lane closures, particularly during congested periods when capacity is being exceeded. The ability to reduce freeway traffic under such circumstances by entrance ramp closure can be very beneficial. Ramp signals for closing ramps were not installed at the time of these pictures, but are to be installed in the next two months. More control of entering traffic will assist in reducing situations such as described herein.

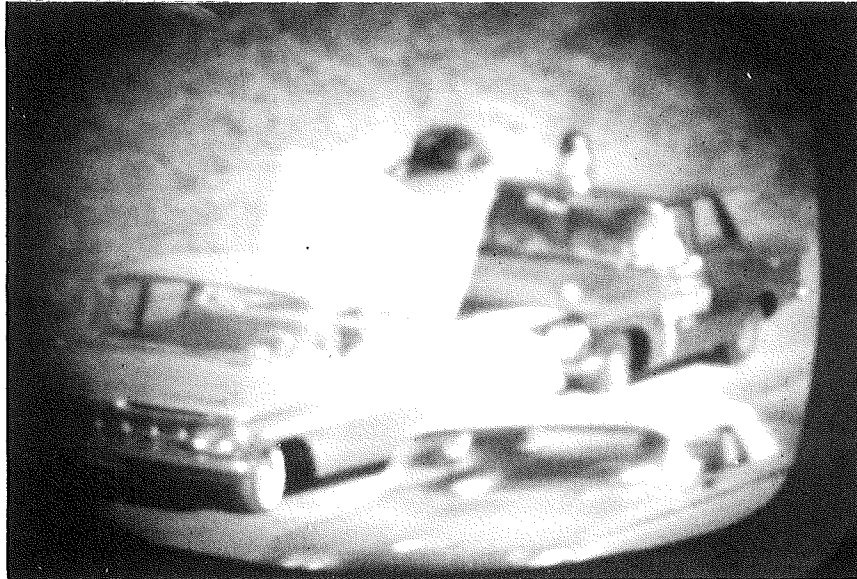
Figure 2 is a closeup illustrating the telephoto feature of the TV and the possible details discernible using this lens.

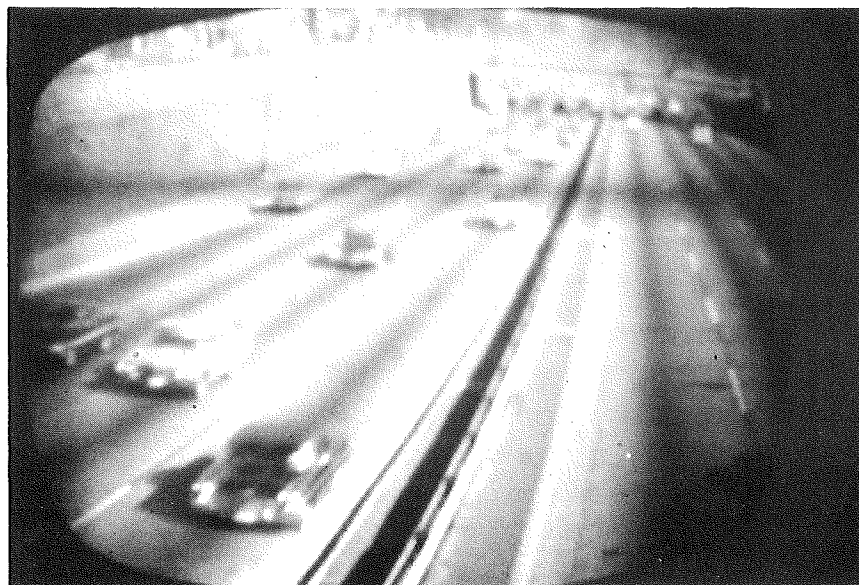
Figure 3 presents the traffic flow in the area immediately beyond the accident vehicles location in the field by the Seward camera. Note the traffic in the near portion of the picture is free flowing whereas the traffic in the rear portion is much more closely spaced.

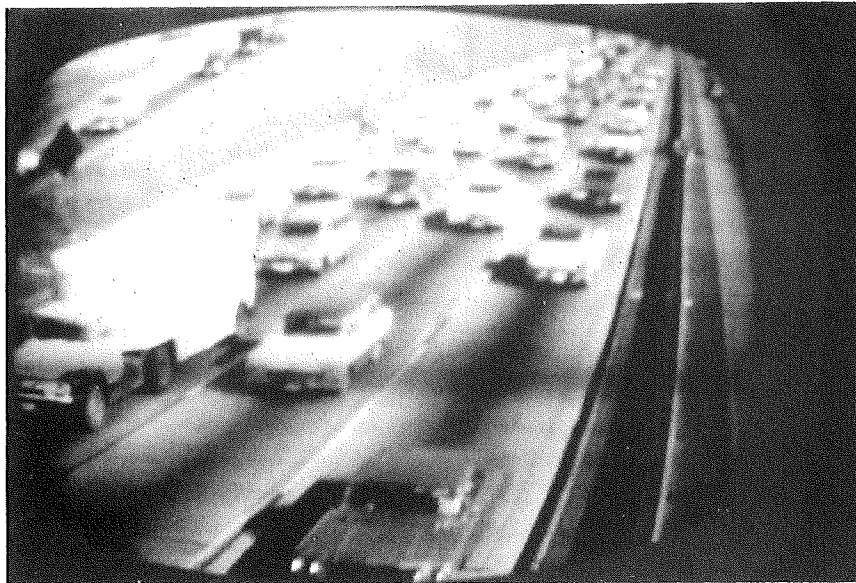
Figure 4 presents traffic flow in the area viewed by the Gladstone camera. This covers a distance from 1055 feet to 2115 feet in advance of and approaching the accident vehicles on the shoulder. Note the close spacing of vehicles as congestion begins to build up.

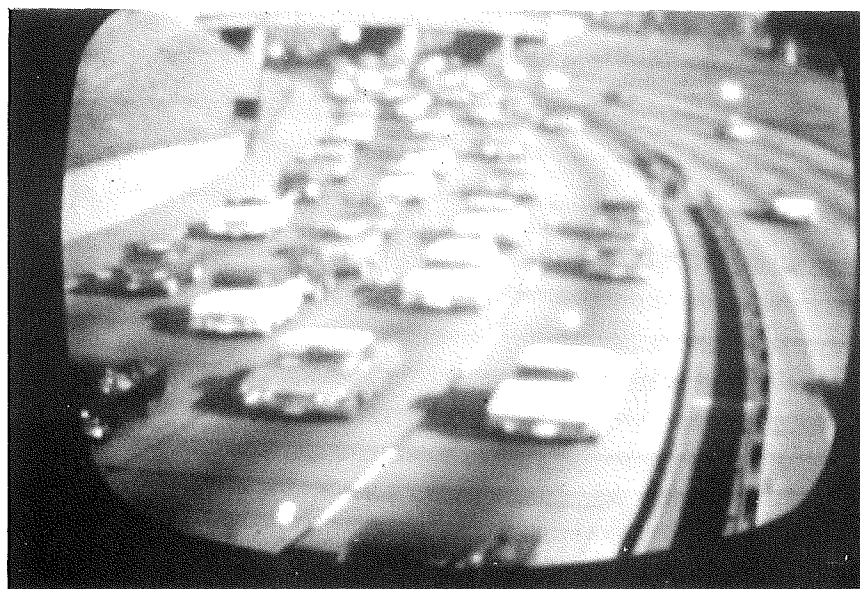
Figure 5 presents the traffic flow in the area viewed by the Clairmount camera. This covers a distance from 2115 to 2975 feet in advance of and approaching the accident vehicles on the shoulder. Pictures 1 to 5 were taken in rapid succession.

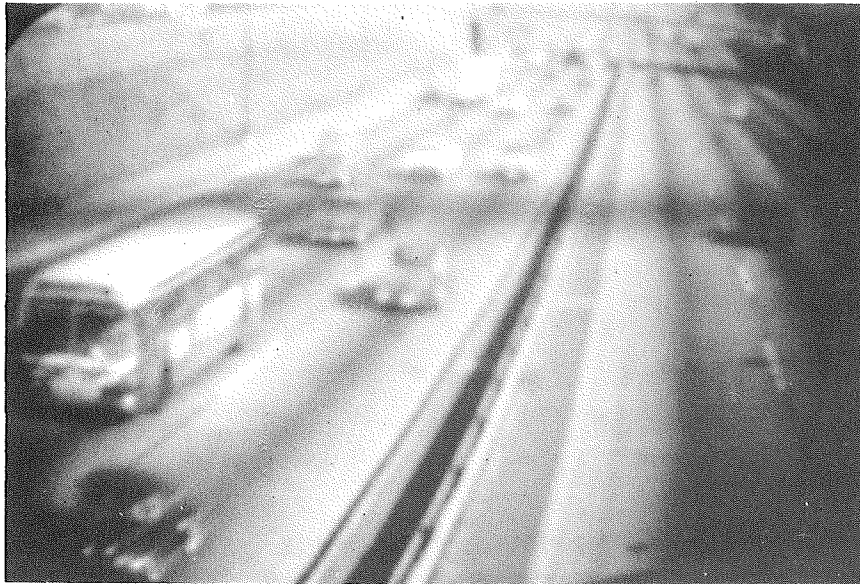
Figure 6 presents again the traffic flow in the area viewed by the Seward camera. This is the same location as Figure 3 and is immediately beyond the accident vehicles on the shoulder.

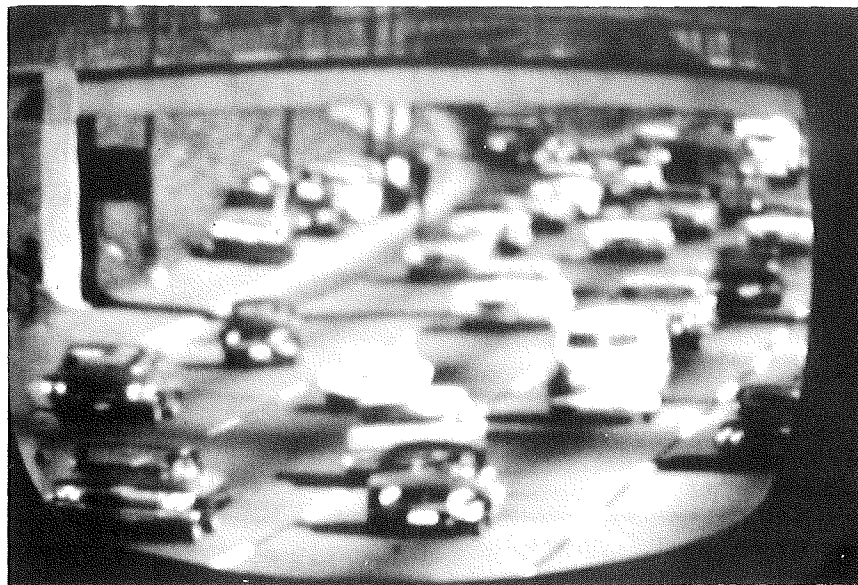
The second accident occurred a short time following the first incident. The photos here were taken after the vehicles of the first incident had left the shoulder. The second accident occurred in the area viewed by the Euclid camera. The accident occurred under the Gladstone Bridge in the southbound direction. Figure 7 presents the accident vehicles and the police on the shoulder. Note the difference in spacing of the vehicles in advance of and south of the location of the vehicles on the shoulder. The spacing of vehicles after they pass the vehicles has lengthened.

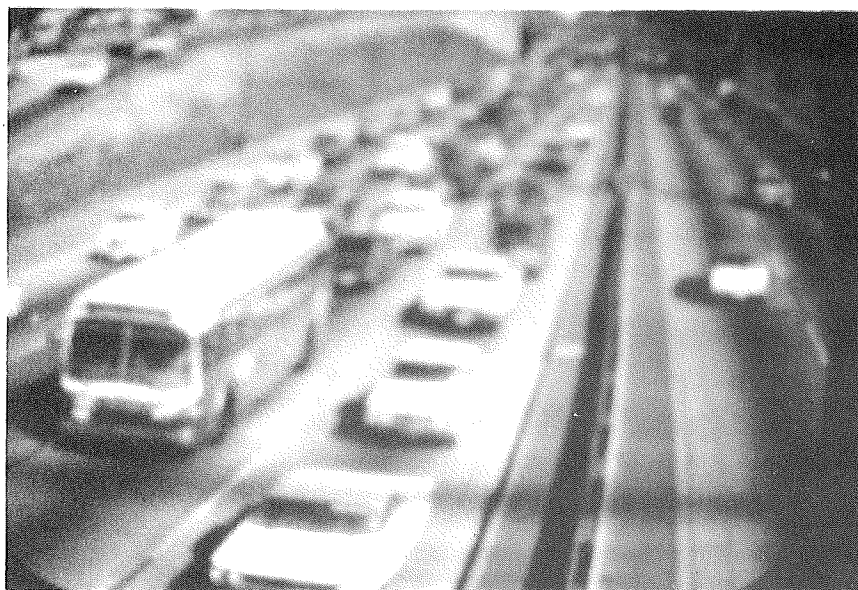
Figure 8 presents traffic flow in the area viewed from the Gladstone camera location and illustrates the congestion directly in advance of the vehicles on the shoulder.

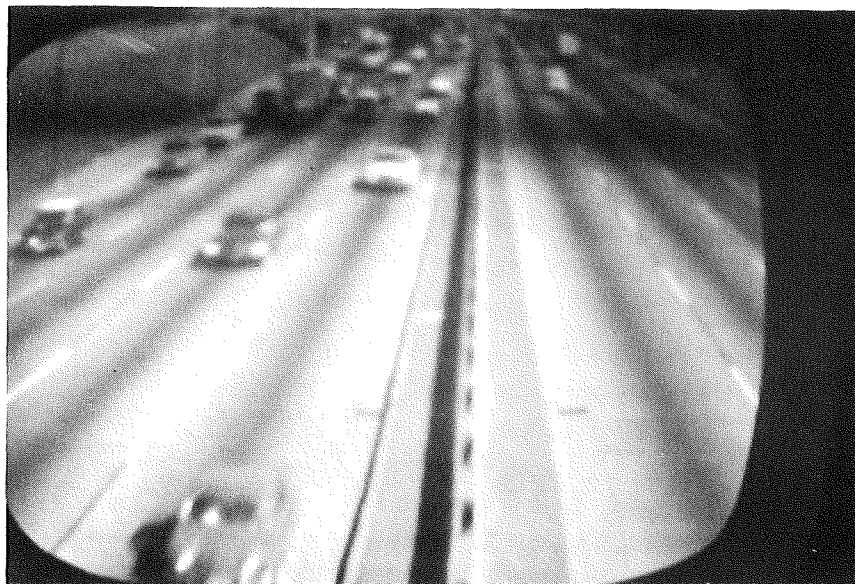
Figure 9 presents the traffic flow in the area viewed from the Euclid camera immediately beyond the incident. This photo illustrates the traffic clearing after it has passed the incident and is proceeding in a free flowing condition as compared to the traffic in the rear portion of the picture adjacent to the incident.

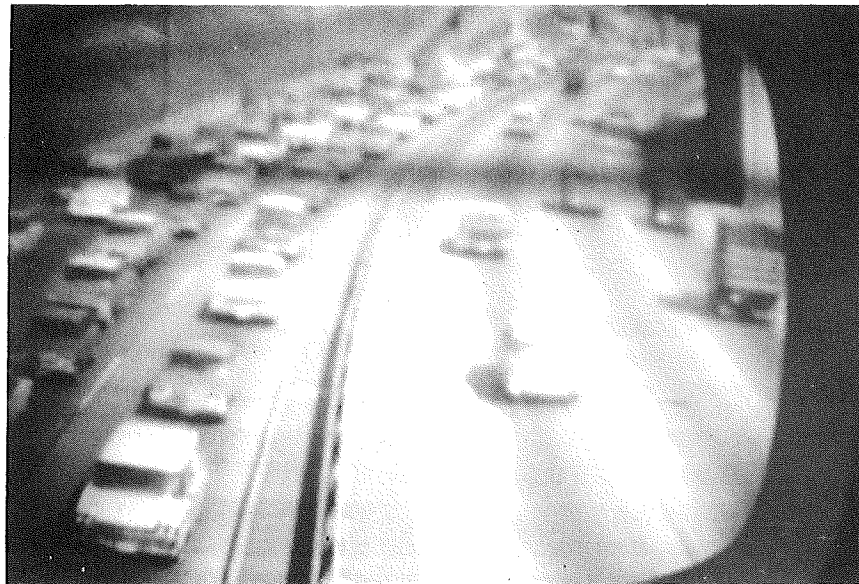
Figure 10 presents the traffic flow in the area viewed from the Calvert camera covering a distance from 4200 feet to 5620 feet in advance of the incident. Note how the traffic congestion generated back one mile in advance of the incident.

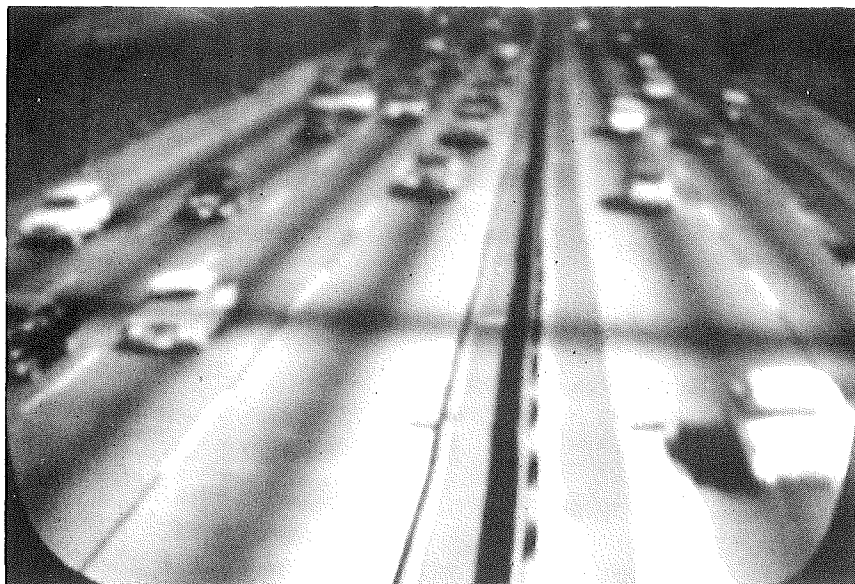
Figure 11 presents traffic flow in the area viewed by the Euclid camera directly south of the incident. This is the same area as presented in figure 9.
