Michigan Department of Transportation - M•DOT

Issue No. 62

April 1992

CANTILEVER SIGN SUPPORTS

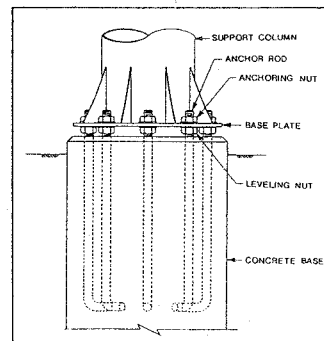
Figure 2.

Some of the nuts on the high strength bolts that connect the horizontal arms to the vertical upright and on the anchor bolts that connect the base plate of the vertical upright to the concrete foundation (Fig. 2) can become loosened.

Causes of these loose nuts could be due to inappropriate erection procedures, inaccurate tightening methods, or vibration from vortex shedding. Even though the causes of loose nuts are not known for certain, the effects are dramatic.

A bolt tightening procedure was included in the specification. This bolt tightening procedure is similar to that used in tightening the lug nuts on the wheel of a car. Turning the nut 1/3 turn past the snug position was instituted as a bolt tightening procedure to ensure proper tightness of the nut and to prevent loosening of the nut. This tightening procedure also has the beneficial effect of increasing the fatigue resistance of the anchor bolt (capable of withstanding more cycles of a given stress).

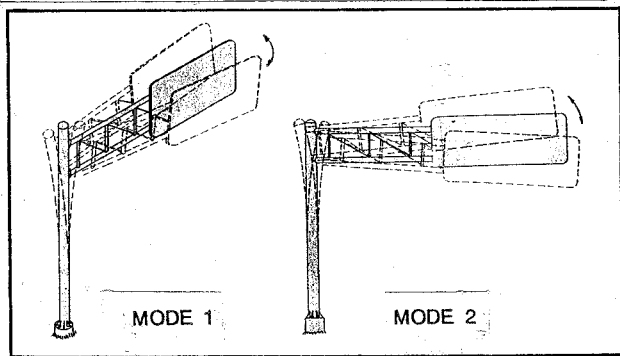
Figure 3.

Analysis of Current Design. In order to include the effects of vortex shedding in the analysis of the sign support structure, the vibrational and aerodynamic characteristics of the structure were investigated. A finite element program was used to determine the vibrational characteristics of the structure. This included calculation of the mode of vibration, along with the associated natural frequency of that mode. It was determined through this finite element analysis that two basic modes of vibration are experienced by the sign support (Fig. 3).

The fundamental mode of vibrations is a rotational mode whereby the horizontal arms pivot about the vertical upright in a horizontal plane with a natural frequency of just over 1 Hz (Hertz, or cycle/second). The second fundamental mode of vibration is a rocking motion in the plane parallel to a sign with a frequency of just under 2 Hz. This approach to determining the vibrational characteristics of the sign structure had been verified by previous research.
