EFFECTIVENESS OF SAWED-SEALED LONGITUDINAL JOINTS  
BETWEEN BITUMINOUS SHOULDERS AND RIGID PAVEMENT  
IN REDUCING LONGITUDINAL SHOULDER CRACKING  
First Progress Report

Research Laboratory Division  
Office of Testing and Research  
Research Project 66 E-37  
Research Report No. R-637

State of Michigan  
Department of State Highways  
Lansing, May 1967

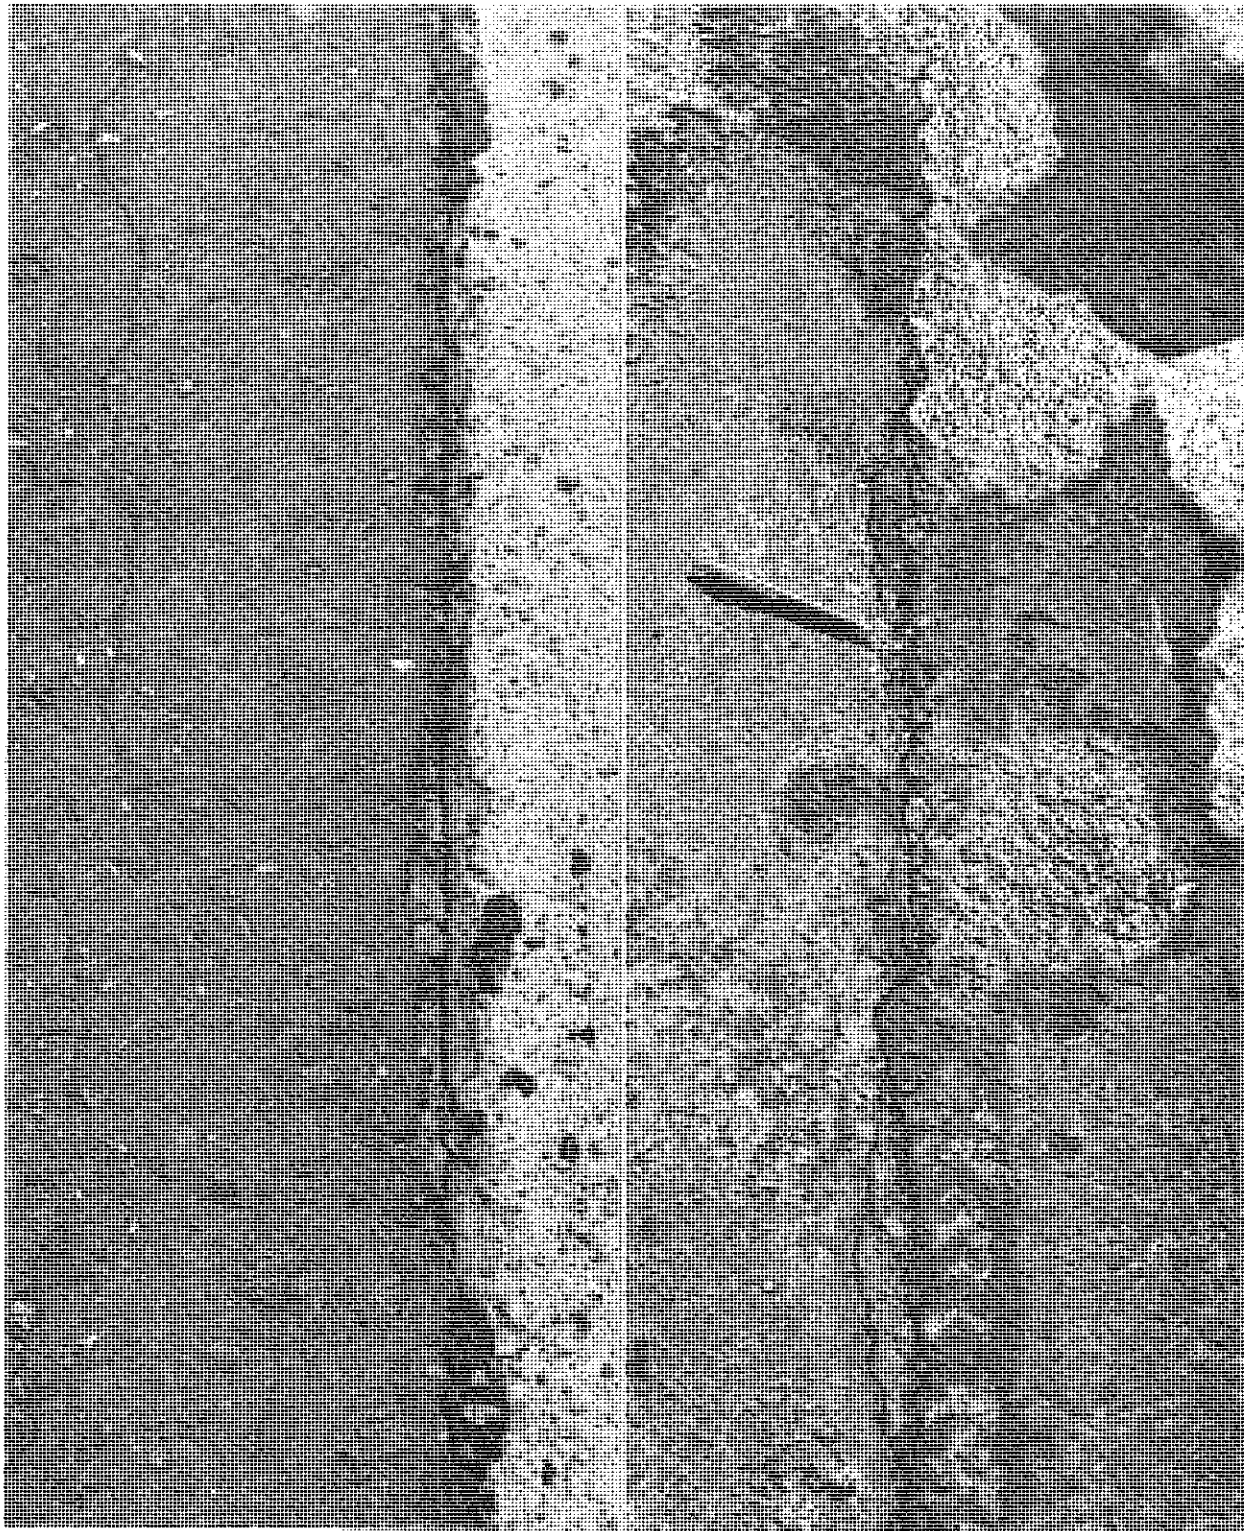
Sta. 1064+00  
Project 1: EB Roadway  
Age: 11 months

Sta. 2357+00  
Project 2: NB Roadway  
Age: 6 months

Figure 2. Typical longitudinal shoulder cracks 6 to 8 ft in length, located 6 to 9 in. from unsealed conventional longitudinal joints. Cracks were open less than 1/4 in. when photographed (May 1963).

1. Longitudinal cracks 3 to 9 in. from the conventional joint (Fig. 2).
2. Bituminous shoulders splitting away from the concrete pavement and leaving opened joints, wide enough for salt and water infiltration (Fig. 3).

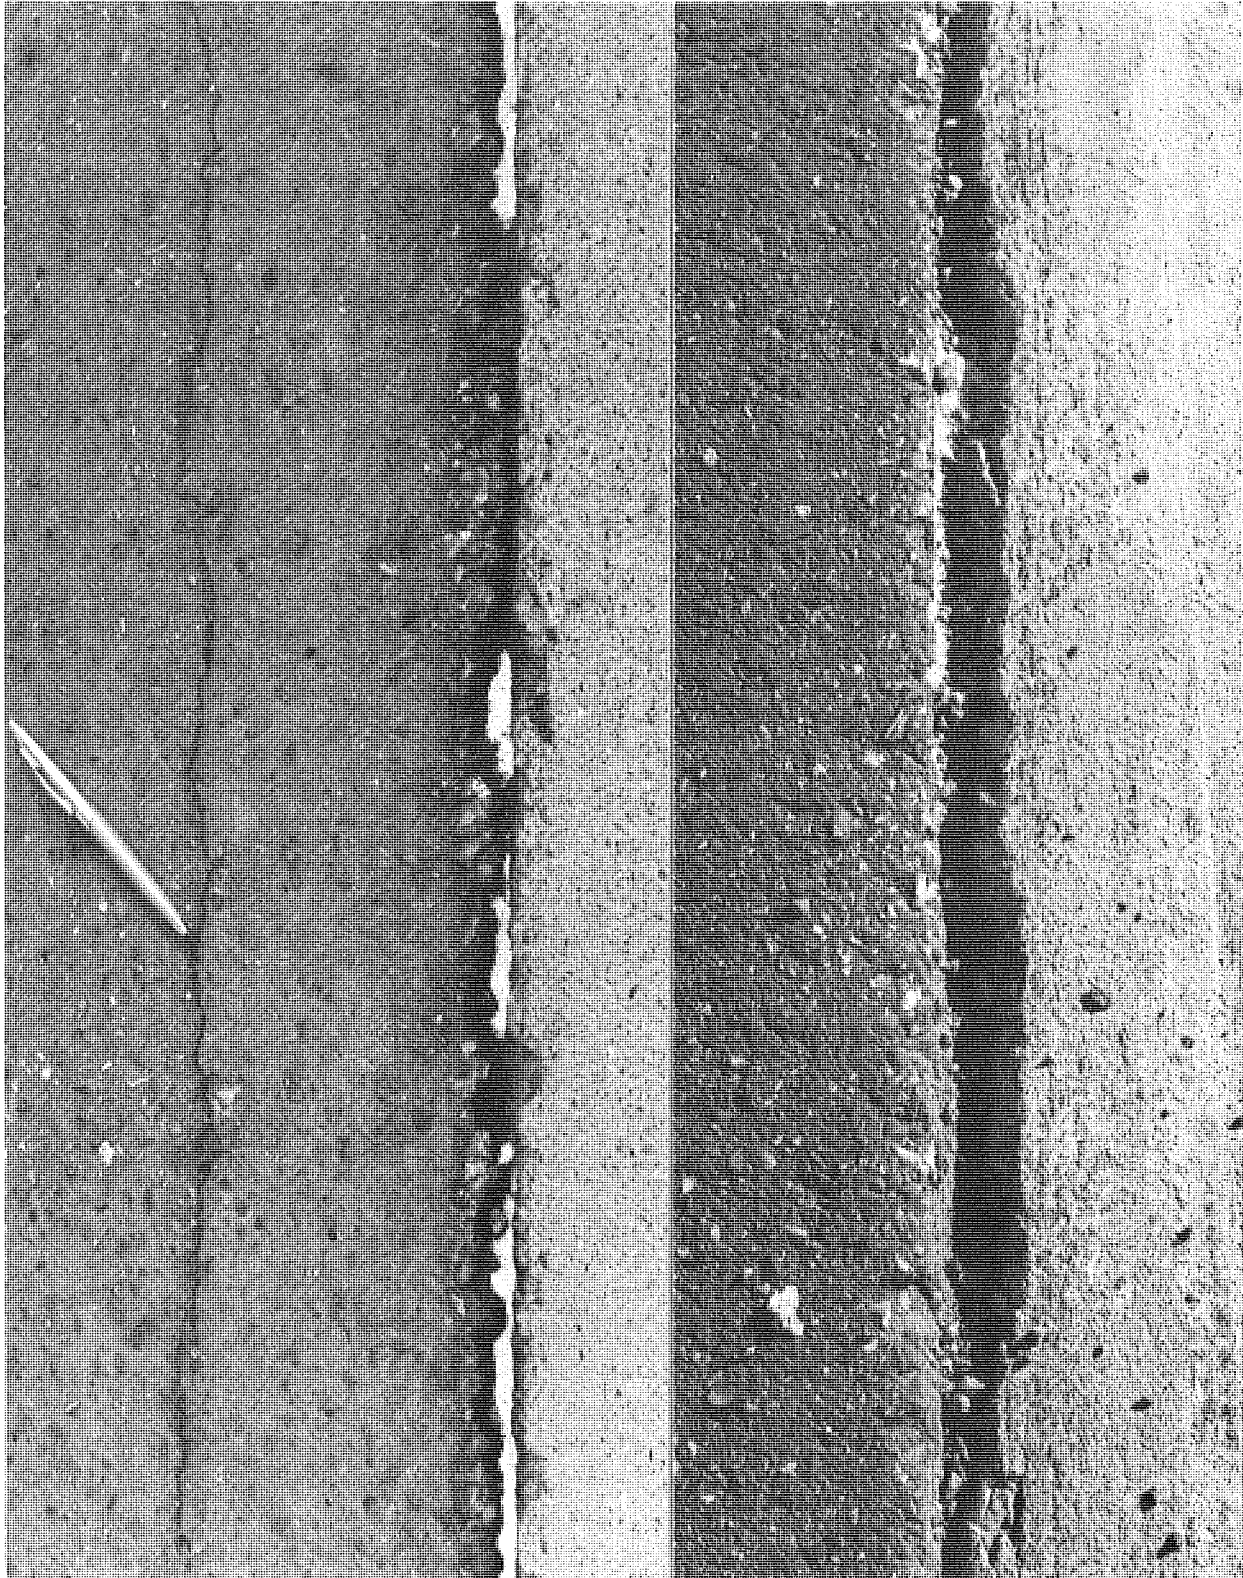
Figure 3. Typical splitting away of conventionally constructed bituminous shoulders from concrete pavement at two Project 2 locations, leaving opened joints wide enough for infiltration of water, sand, gravel, salt, or other incompressible material resisting normal joint movement. At left, typical longitudinal crack has developed parallel to open joint. Photographed 4 months after construction (May 1963).

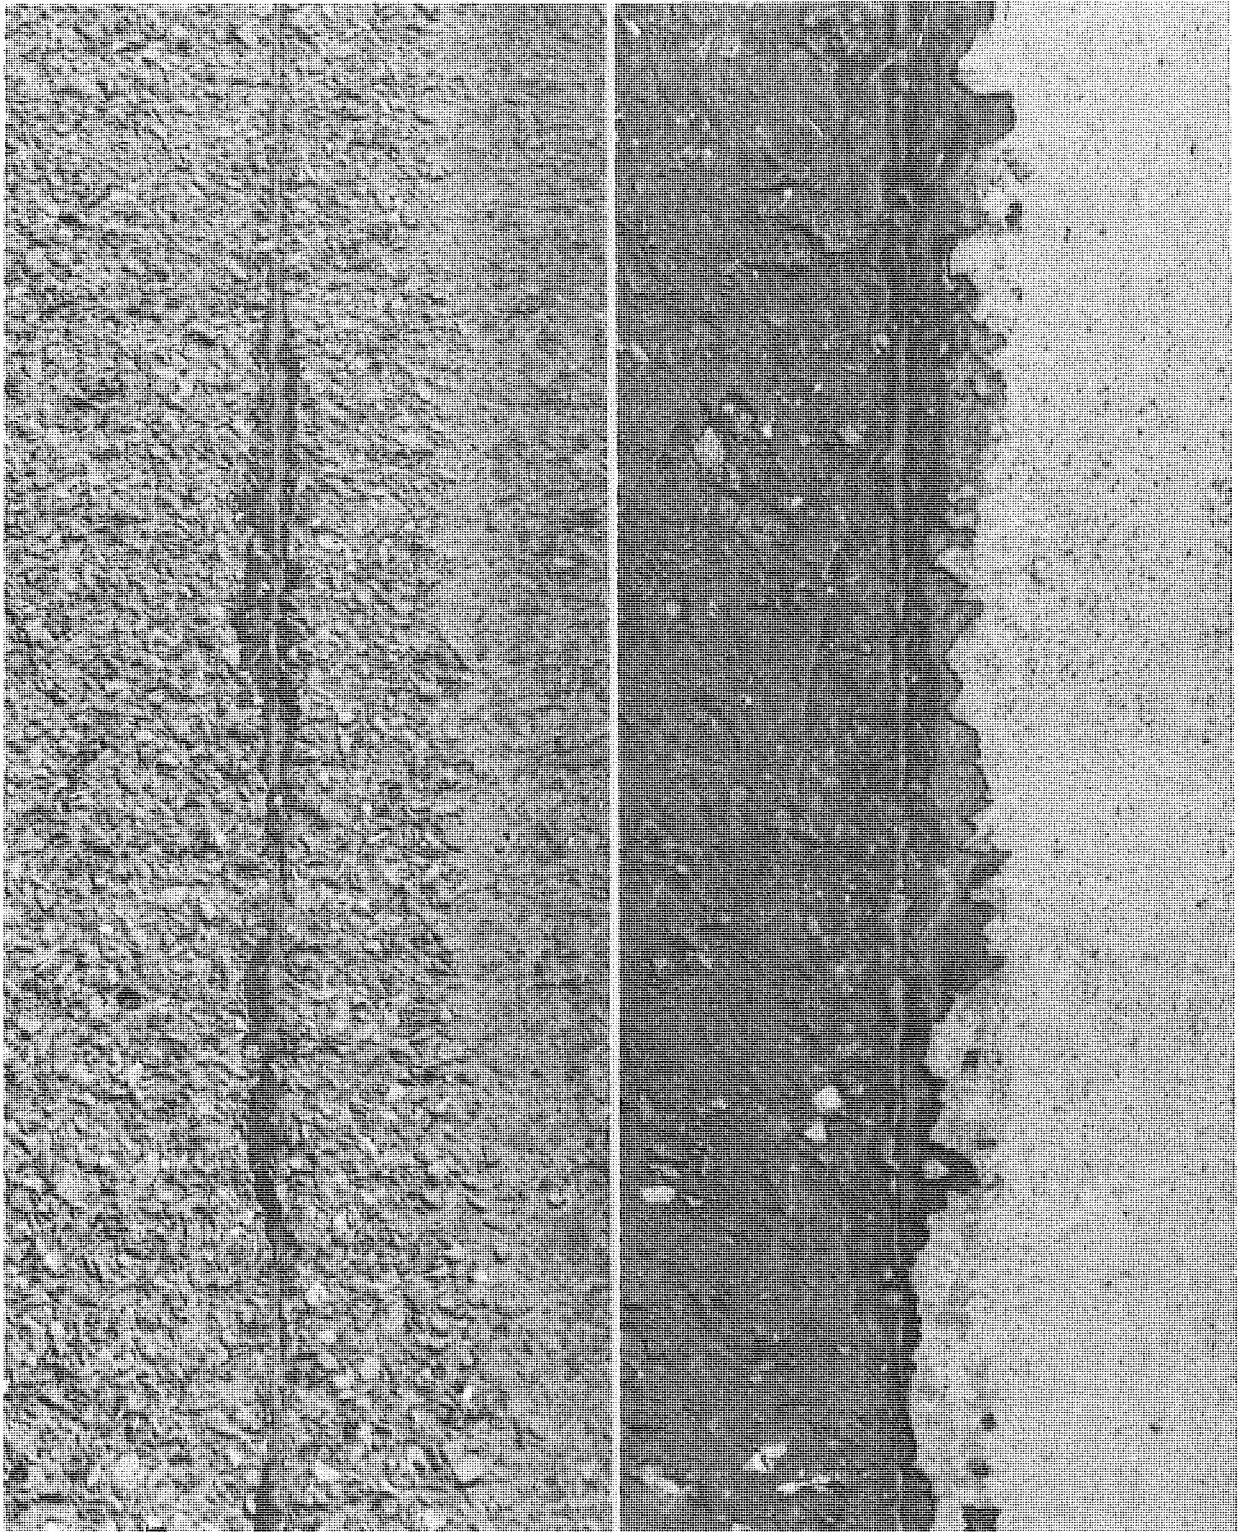
It was agreed that sealed joints between concrete pavement and bituminous aggregate shoulders, as illustrated in Figure 1, might be a possible solution to the problem of longitudinal shoulder cracking. Typical sawed-sealed joints that are performing well are shown in Figure 4.

Sta. 2230+00  
Project 2: NB Roadway  
Age: 7 months

Sta. 1123+50  
Project 1: WB Roadway  
Age: 11 months

Figure 4. Sawed and sealed 1/8-in. longitudinal joints between shoulder and concrete pavement (with and without bituminous overlay), show good adhesion without evidence of parallel longitudinal cracking of the shoulder (photographed May 1963).

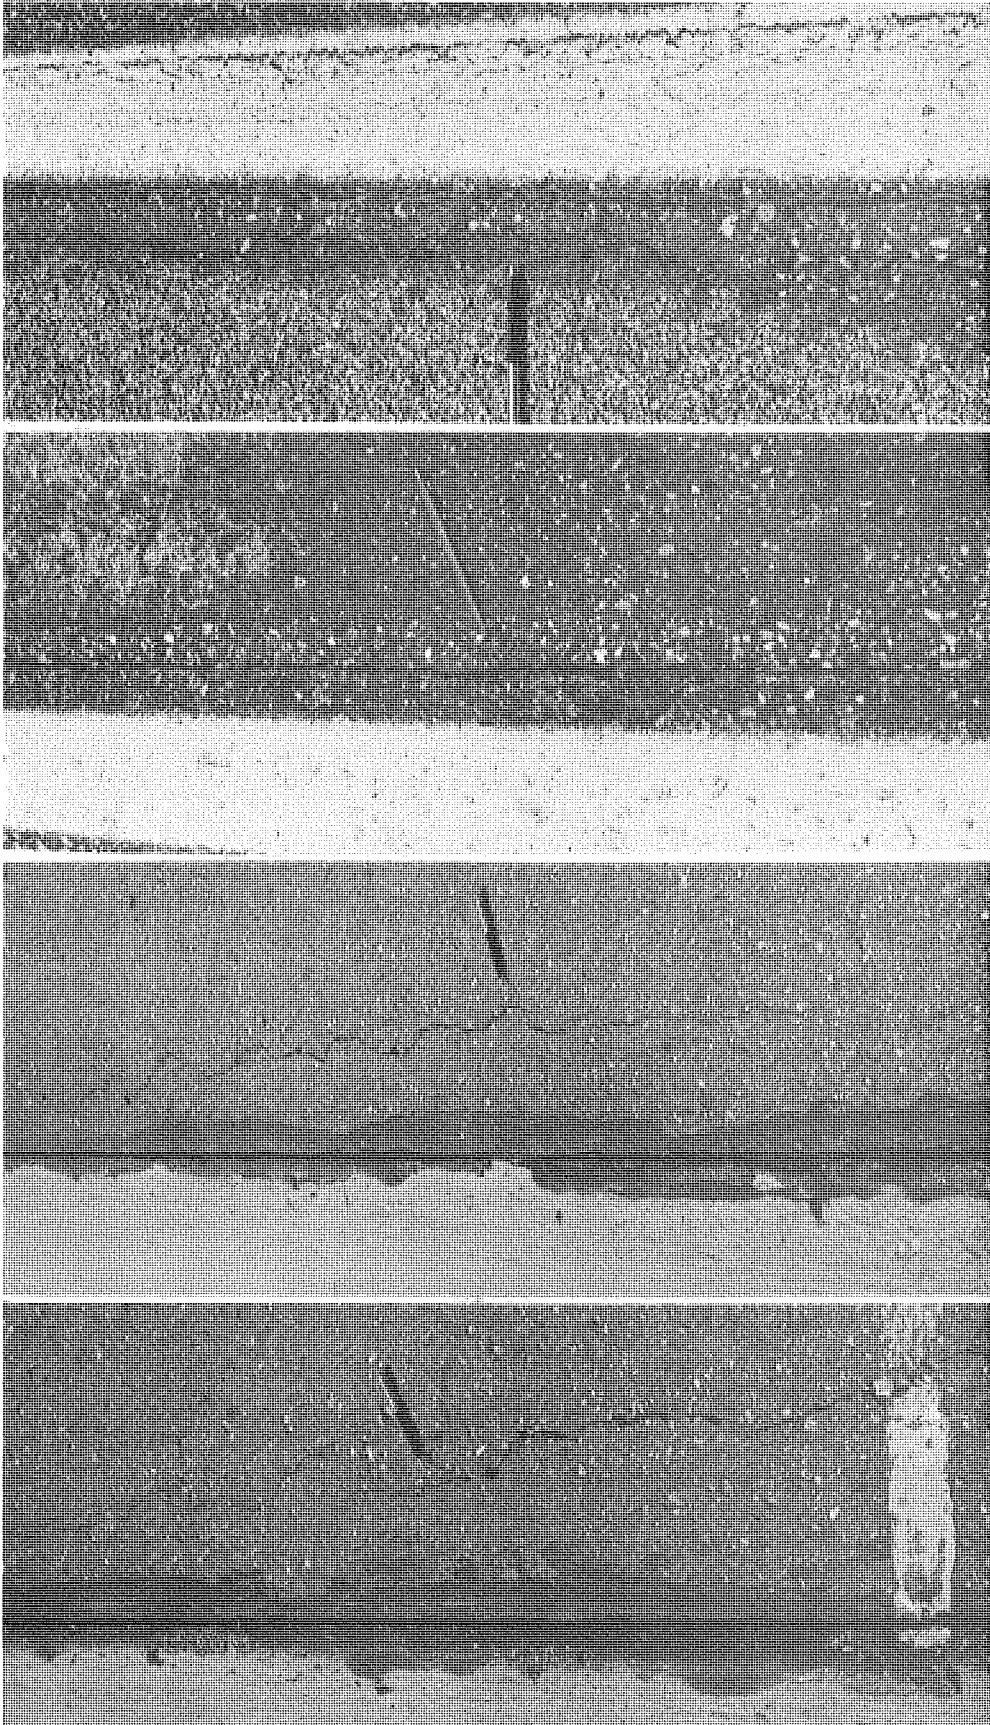
Figure 5. Good performance of sealer in 1/8-in. wide sawed longitudinal joints. At left, in two views at adjacent locations, joint and sealer remain in good condition although 10-ft crack, opened 1/4 in., has formed 6 in. from joint. At right, two views of bituminous shoulder adjacent to concrete pavement with bituminous overlay show good adhesion of sealer. At far right, crack 30 to 40 ft long has opened 3 to 6 in. from sound joint.

After a detailed review of each project's background, the test areas were inspected with special attention to conditions of the bituminous shoulders, joints, and sealing compound. Figure 5 shows good sealer performance, while Figure 6 illustrates typical cases of sealer deterioration. In general, performance of the sealing material appeared to be affected by several factors, which may be grouped as follows:

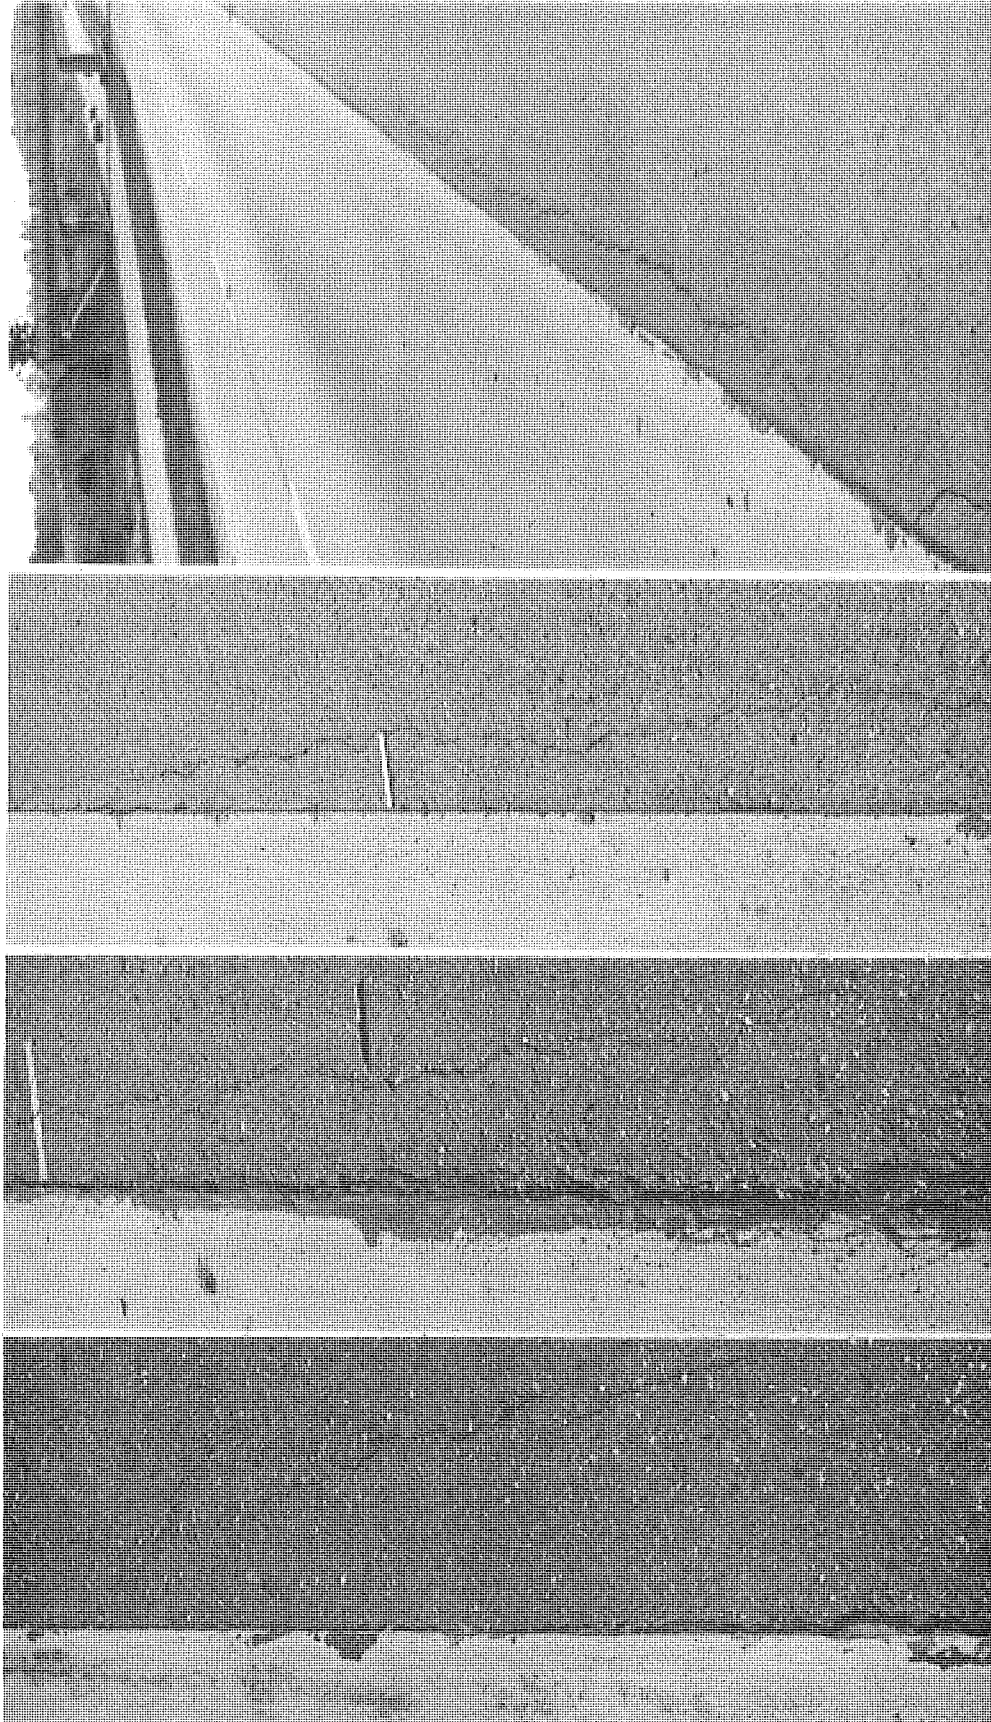
Sta. 1084+10  
Project 1: WB Roadway  
Age: 4 years 2 months

Sta. 1084+20  
Project 1: WB Roadway  
Age: 4 years 2 months

Sta. 253+00  
Project 3: EB Roadway  
Age: 1 year 11 months

Sta. 188+00  
Project 4: EB Roadway  
Age: 3 years 9 months

Figure 6. Minor deterioration or failure of sealer in 1/8-in. wide sawed longitudinal joints. At left, a 3-ft long crack has opened 3 to 9 in. from the joint; sealing material is gone but joint remains closed. At left center, an 8-ft crack runs 6-in. from the joint, with sealer showing inadequate adhesion and structural strength. At right center, sealer has disintegrated and 25-ft crack runs 3 to 9 in. from the joint. At right, with some sealer deterioration, a 30-ft crack up to 1/2 in. wide has opened about 3 in. from the joint.

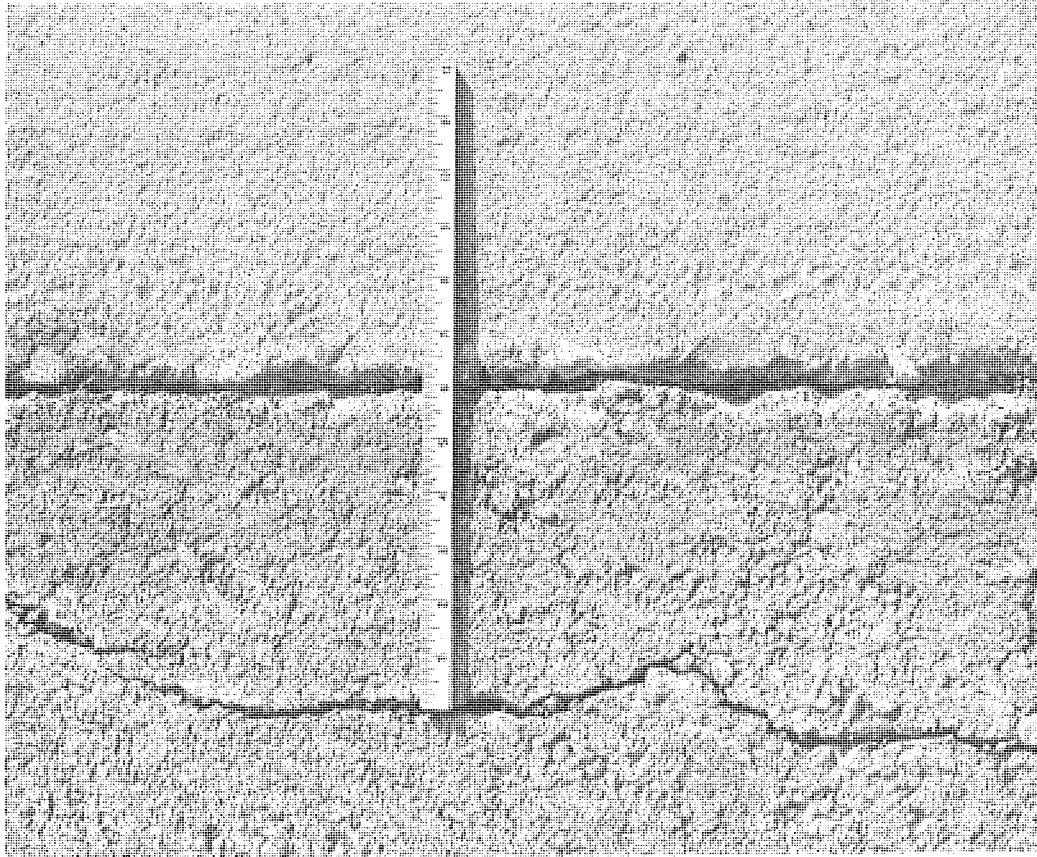
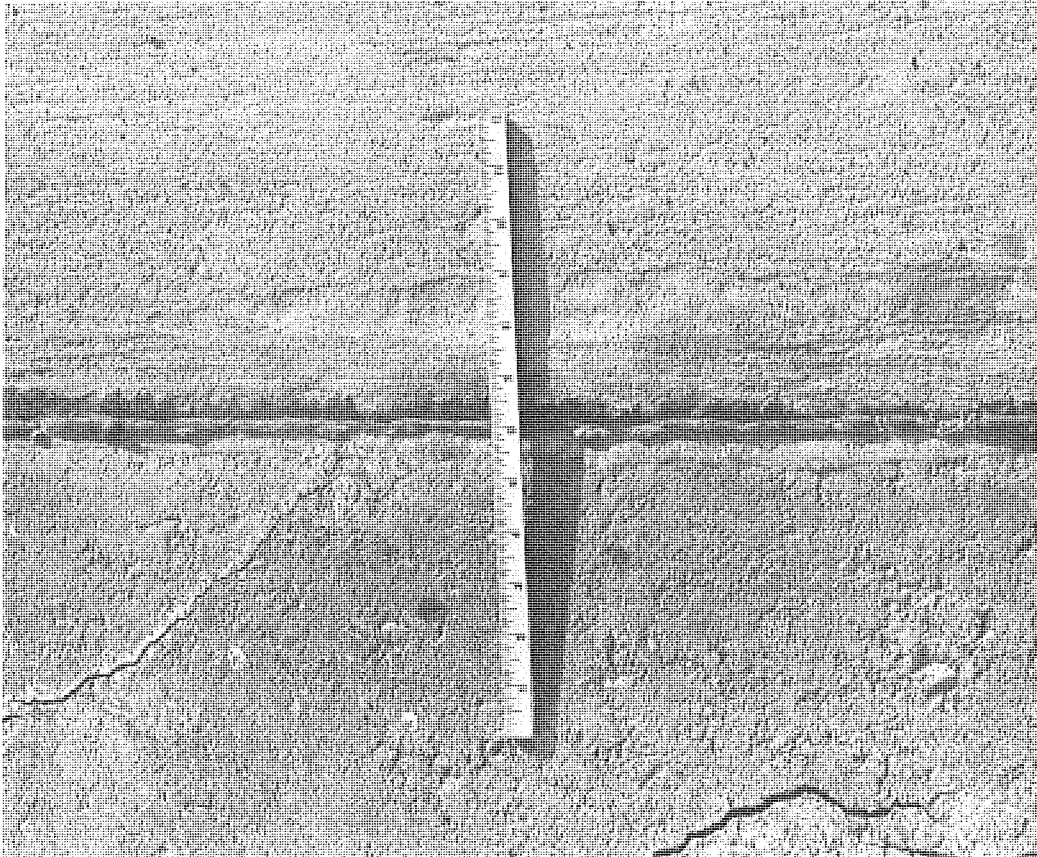
In November and December, field surveys at the test site included random measurements of elevation change, lateral joint displacement, and extent of cracking. Figure 14 illustrates diagonal and longitudinal cracking after only two months of service. The extent of longitudinal cracks in linear feet and percent of shoulder length surveyed in 1966 is listed under the Phase II portion in Table 1.

Sta. 461+40  
NB Roadway

Sta. 502+20  
NB Roadway

Figure 14. Typical Project 5 sealed and unsealed longitudinal joints after two months of service. The seal exhibits good adhesion (left), with minor diagonal cracks on the shoulder. Pavement and shoulder edges have spalled at the unsealed joint (right), and a 30-ft crack, 1/4 in. wide, has developed 6 in. from the joint (December 1966).
