OFFICE MEMORANDUM

MICHIGAN
DEPARTMENT OF STATE HIGHWAYS

Subject: Final Progress Report on Polymer Plastic Marker Posts.
Research Project 63 NM-87. Report No. R-669.

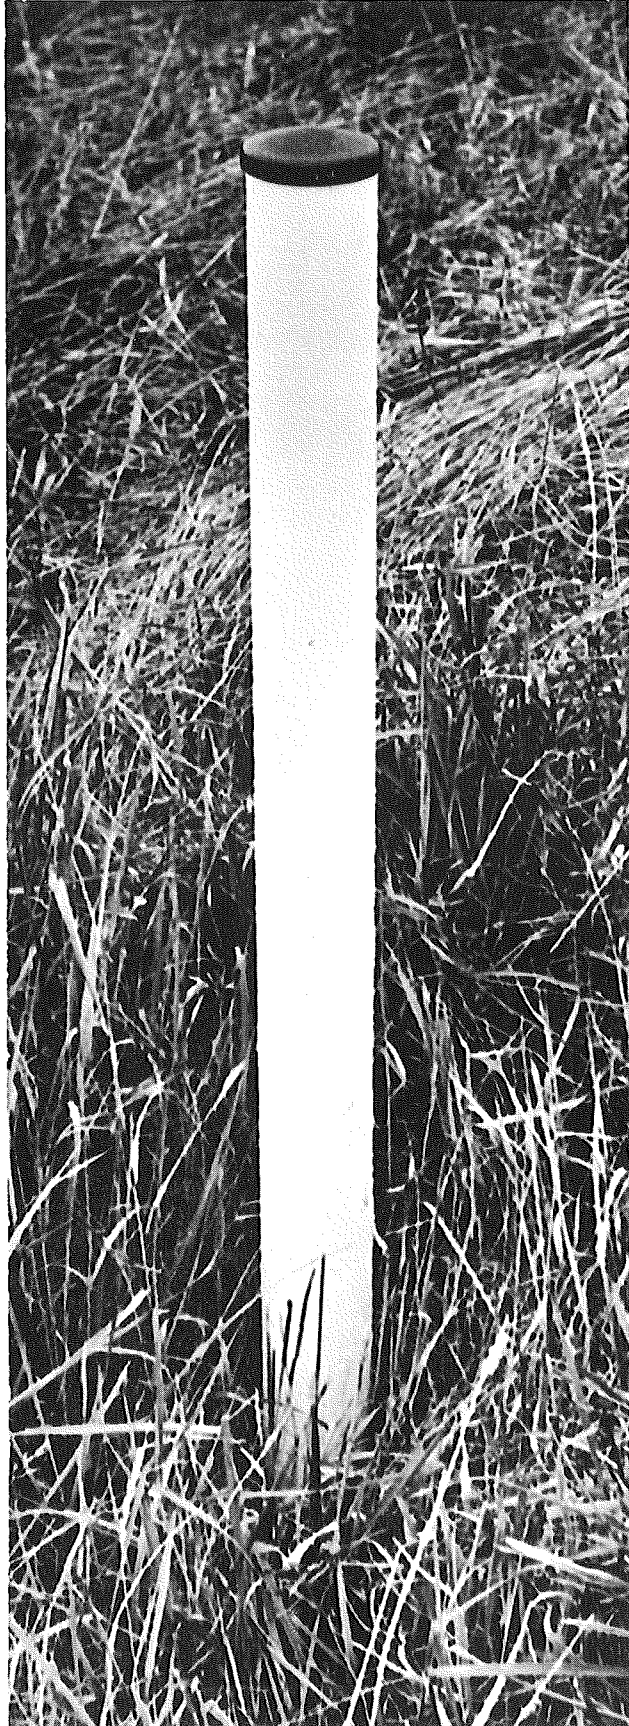
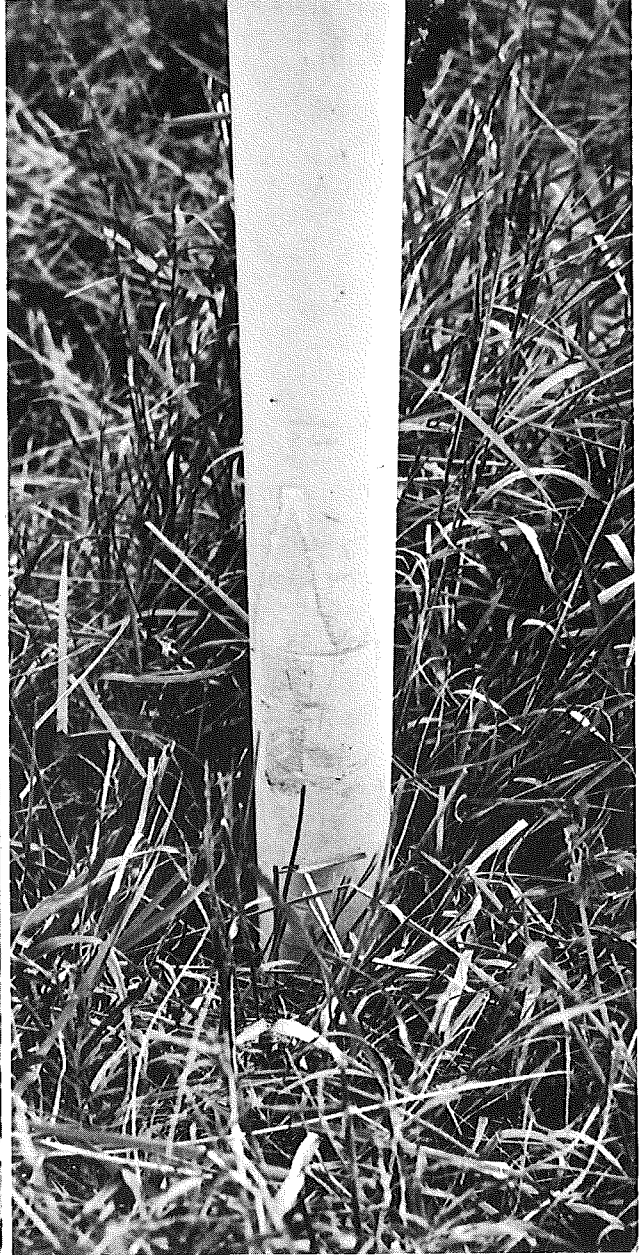
A field inspection was made September 28, 1967 and it was found that all of the painted posts were destroyed and missing except for one at location 8 which had been broken off and pushed back into the ground to a depth of about 3 inches. The white-pigmented posts at locations 9 and 10 were still in place with excellent appearance. The post at location 10 had been struck near the base with no apparent damage except for a shallow gouge (Fig. 1).

Figure 1. Post at location 10 typifies the good condition of the two white-pigmented posts after 3-plus years of service. Base of post shows impact damage that did not result in breakage.
