**TESTING AND RESEARCH DIVISION
RESEARCH LABORATORY SECTION**

**BASE AND SUBBASE PROPERTIES AFFECTING
LONGITUDINAL CRACKING OF I 275**

**Research Laboratory Section
Testing and Research Division
Research Project 79 TI-622
Research Report No. R-1152**

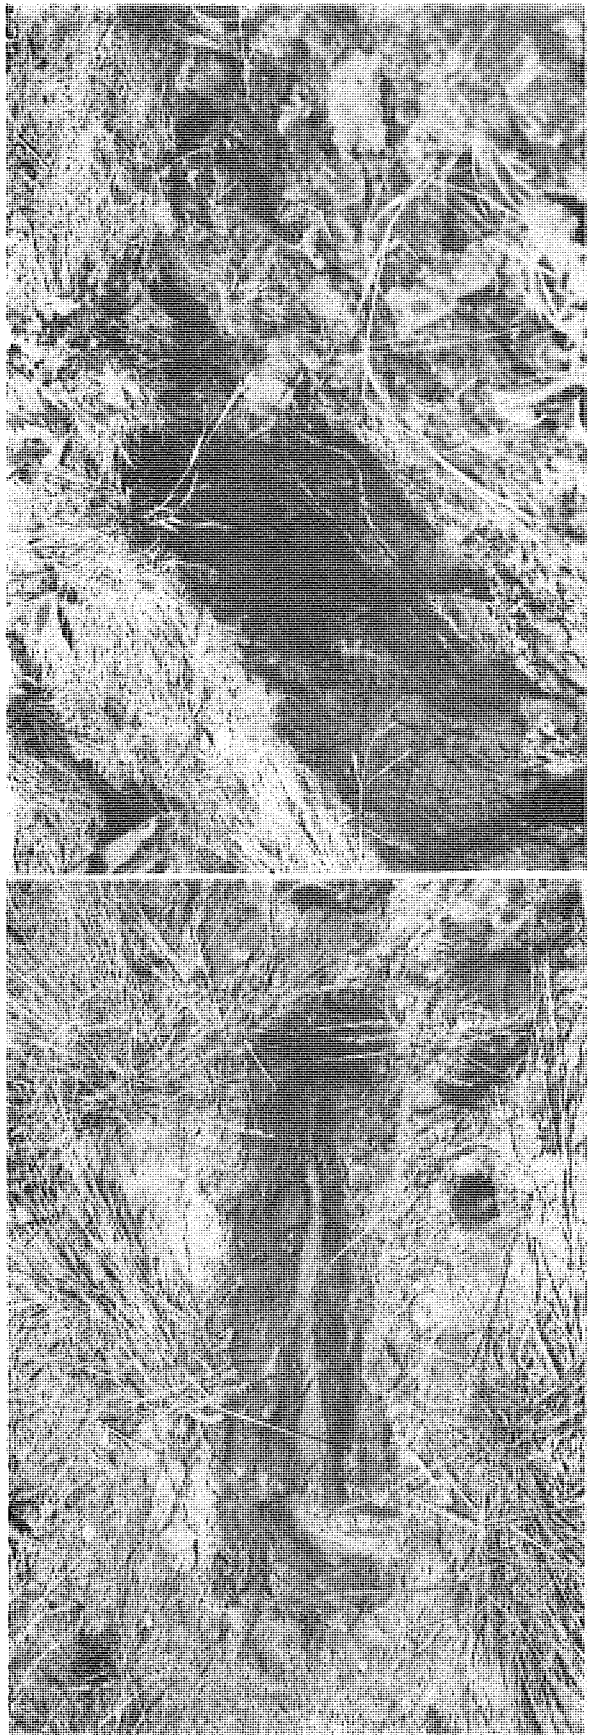
Figure 2. Clay and topsoil cover which restricts drainage at toe of the subbase.

For a majority of sites in the six test sections included in this study, the side slopes are covered with clay and/or topsoil which restricts drainage of the subbase layer. In many cases a clay cover of 6-in. or more was found (Fig. 2). In Section 1, removing the clay side slopes allowed free water to drain out of the 14-in. coarse limestone base, as shown in Figure 3. In addition, the side slope area usually contains waste dense-graded base material, topsoil, clay and other poorly drained materials, so that subbase drainage is also restricted internally by the presence of these relatively impervious materials. The subbase layer under the pavement was, generally, a uniform sand. Surface infiltrating water tends to be trapped under the pavement due to its inability to flow laterally through the impervious side slopes. This problem is further aggravated by the flat side slope which further retards subbase drainage. The trapping of water under the pavement was observed in several cases where, after a rain, the free water level was at the bottom of the CRC slab (Fig. 4).

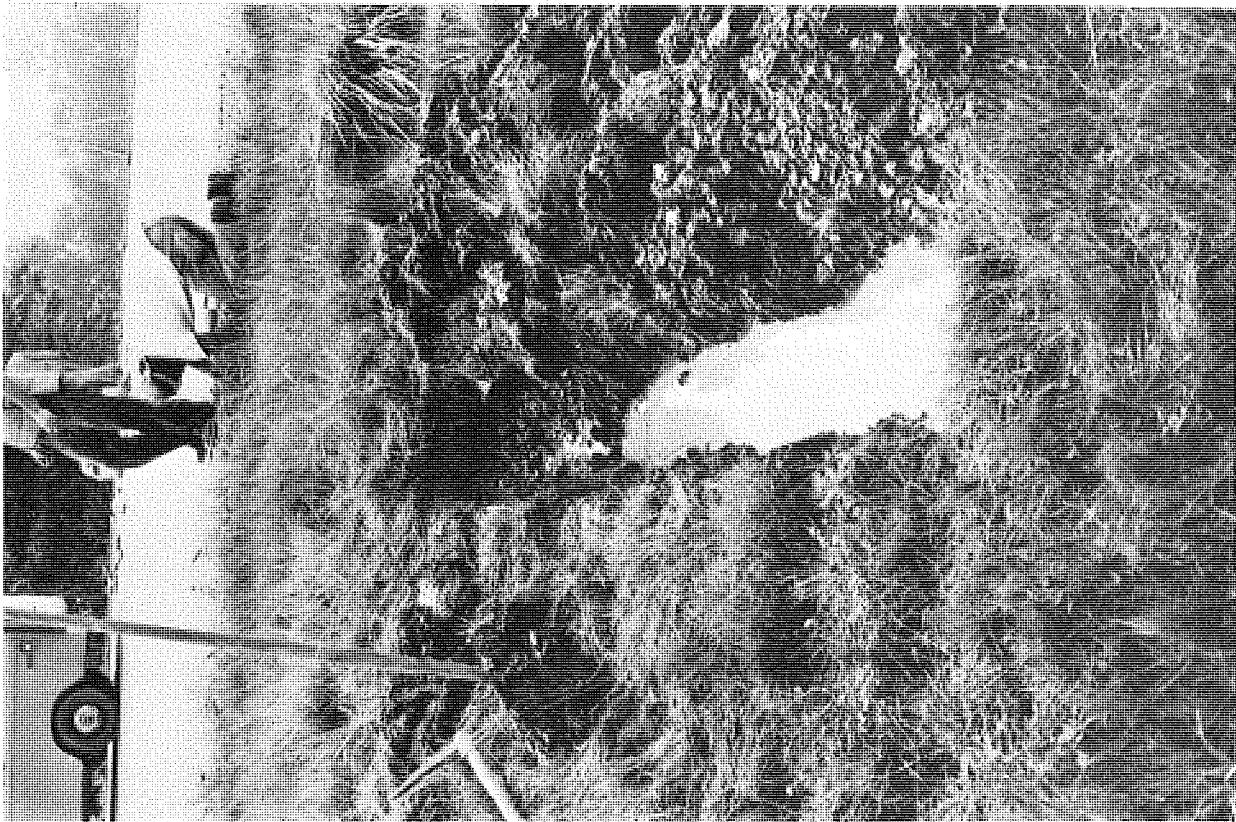
Figure 4. Free water, seen at the bottom of the core hole, is located about 9 in. from the pavement surface a day after a summer shower.

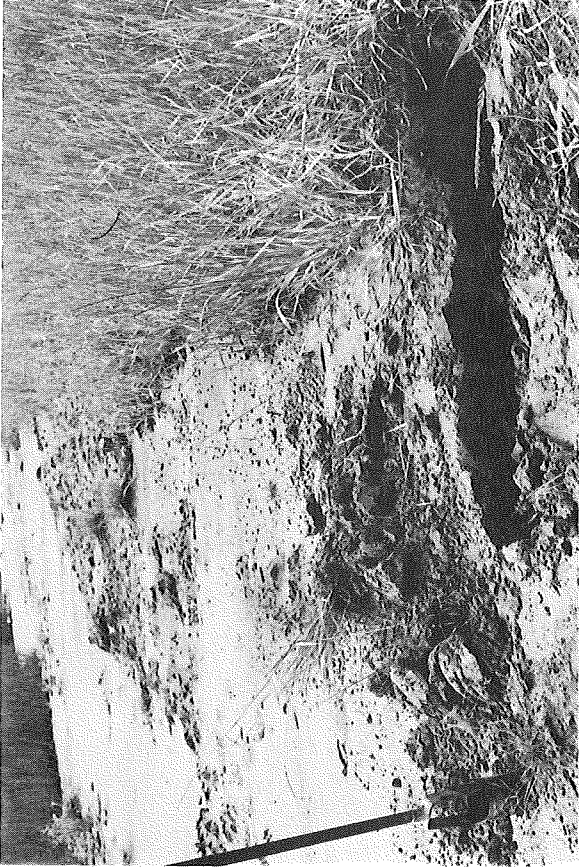
It was also found that in all areas where the subbase was properly constructed, with sod covering the exposed face of the subbase layer, vegetative cover was sparse to completely barren from the toe of the subbase layer to the ditchline (Fig. 5). Analysis of soil from sparsely vegetated areas indicated salt contents as high as 6 percent. The vegetative die-off could not be caused by surface run-off of deicing salts since there is good vegetative cover from the toe of the side slope up to the outer edge of the shoulder. The large salt concentration and vegetative die-off occurred where the subbase has poor drainability and/or restricted internal drainage. The general sequence of events is that saltwater infiltrates the pavement surface during the winter and accumulates in the subbase layer. Later, during the growing season, the saltwater slowly seeps out the toe of the subbase layer where evaporation causes such a high salt concentration that it kills the vegetative cover.

Completely barren side slope and subbase erosion.

Figure 5. Range of side slope conditions directly below the toe of properly constructed subbase layers of low drainability.

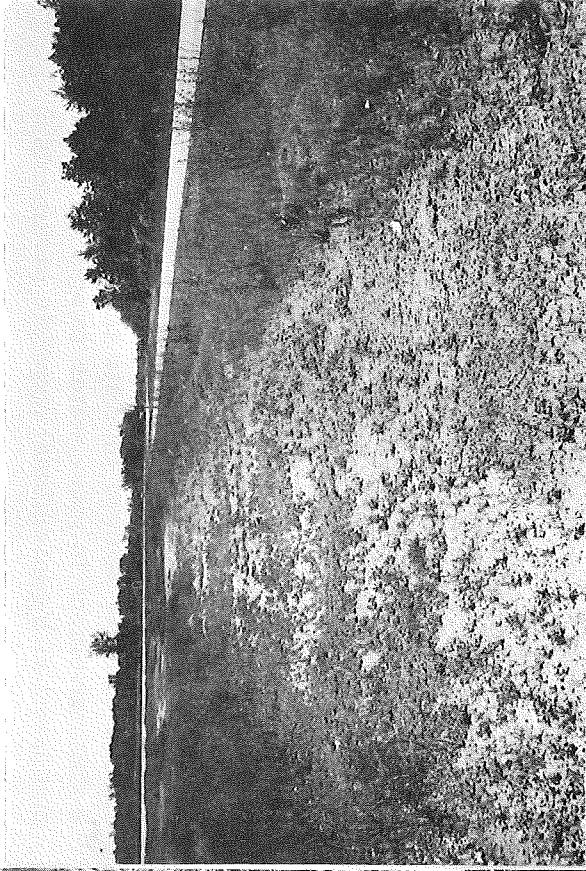
Sparse vegetative cover and no subbase erosion.

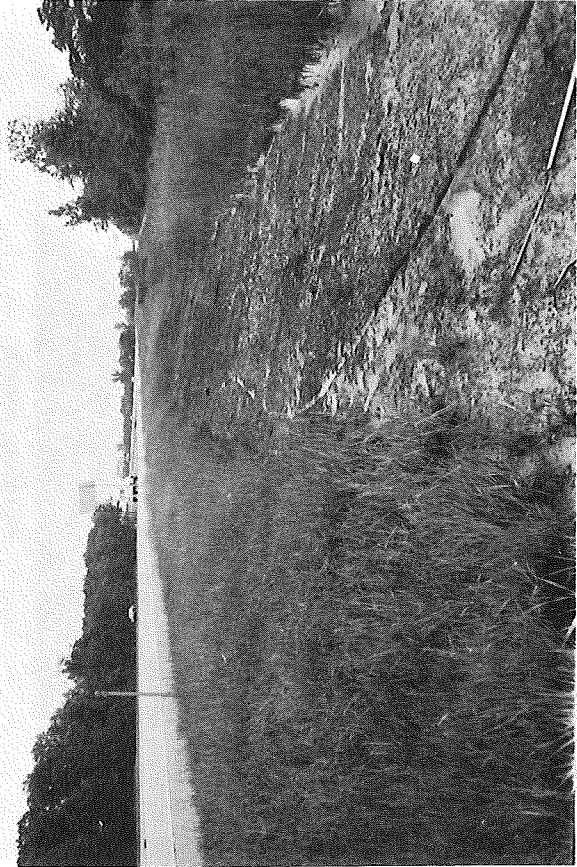
No vegetative cover or subbase erosion.

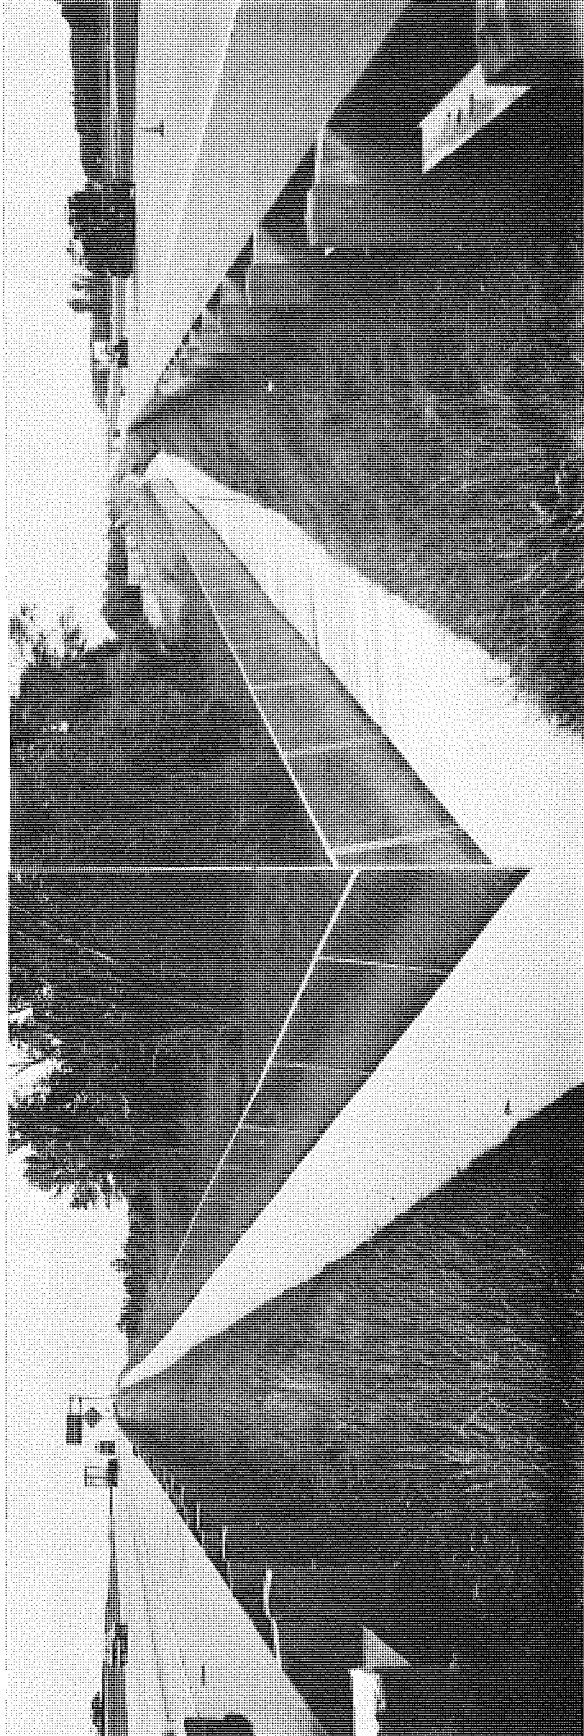
Figure 6. Foundation drainage condition is indicated by the presence or absence of subbase seepage water on the bicycle path. Both pictures were taken from the same location.

During field testing, it was observed that complete subbase saturation could occur as a result of a brief shower and that days later the subbase remained saturated. Therefore, the subbase, in at least some areas, can sorb water faster than the water can be drained away. It was also found that the subbase of a portion of Test Section 3 was much drier than the subbase of the other test sections. The dry subbase starts about half way up a long, vertical grade, shown in the view looking south in Figure 6. Looking north from the same point, the wet subbase condition is reflected by the wet condition of the bicycle path shown in Figure 6. It was found that while constructing the bicycle path, excessive side slope seepage was corrected by placing a drain directly under the path. The need and effectiveness of these drains are clearly illustrated in Figure 6.

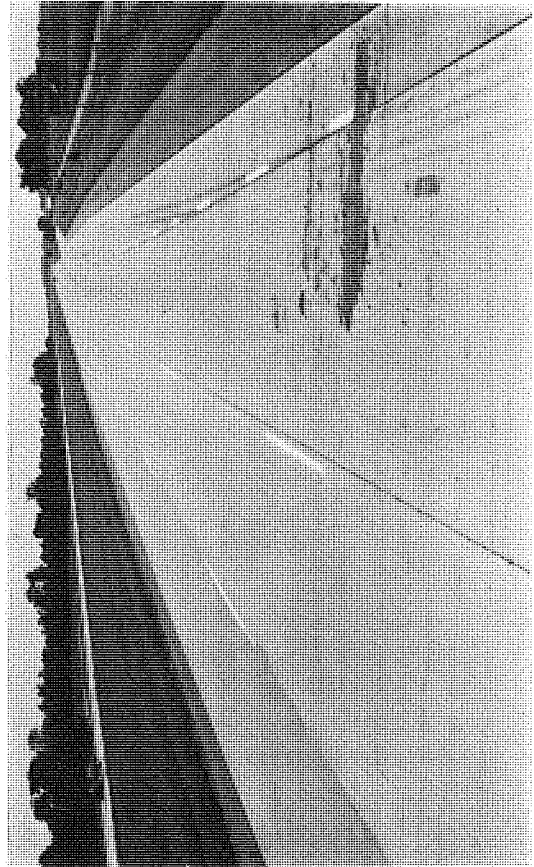
Figure 7. Wet condition of transverse cracks three days after a summer shower indicate the greater ability of a CRC pavement to move water to and from the base compared with conventional concrete pavements.

Another observation was that transverse cracks in the CRC pavement act as wicks that feed water, by capillary action, to the base when the base is drier than the pavement surface. This process is reversed when the pavement surface is drier than the base. The wet condition found around transverse cracks for days after a summer rain (Fig. 7) indicates that the capillary size transverse cracks are removing water from the base layer. For this reason, transverse cracks should influence the moisture condition of the base layer. Movement of water by capillary size transverse cracks can be eliminated, essentially, by use of a base material having no capillary potential, i. e., material whose voids are too large to move water by capillary action. A change from dense-graded to open-graded base materials should prevent the detrimental movement of surface water to the base layer of CRC pavements.

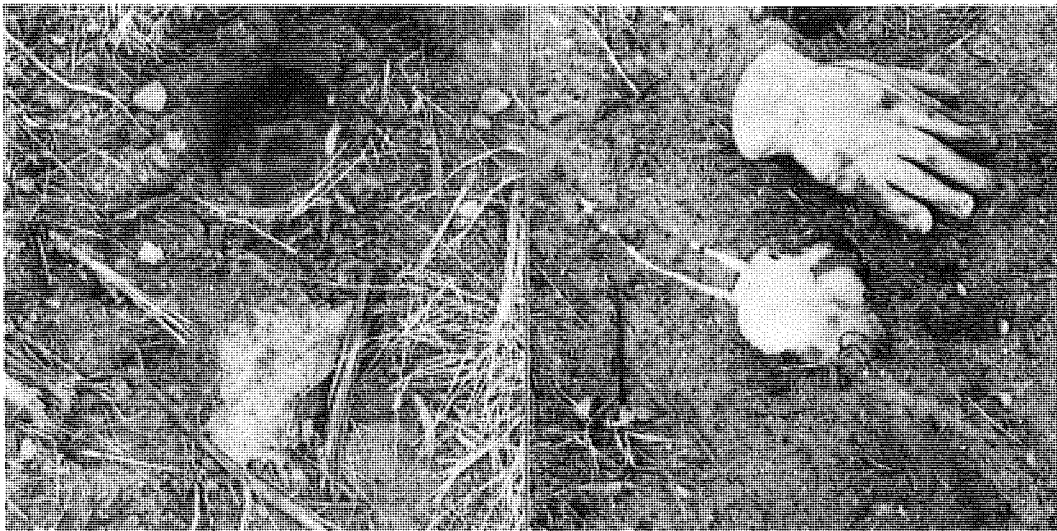
Light foam indicates low excess pore water pressure.

Heavy foam indicates high excess pore water pressure.

Figure 8. Foam develops when traffic-generated excess pore water pressure causes a surging action in free water found in holes augered into the subbase layer between the edge of shoulder and the toe of the subbase.

distance from the load. By contrast, at other sites, the passing of trucks developed such a strong surging action that a foam quickly developed on the free water surface. This condition indicated that several weeks after complete subbase thaw, excess pore water pressures are being generated by traffic loads for a distance of 15 ft or more from the edge of the pavement.

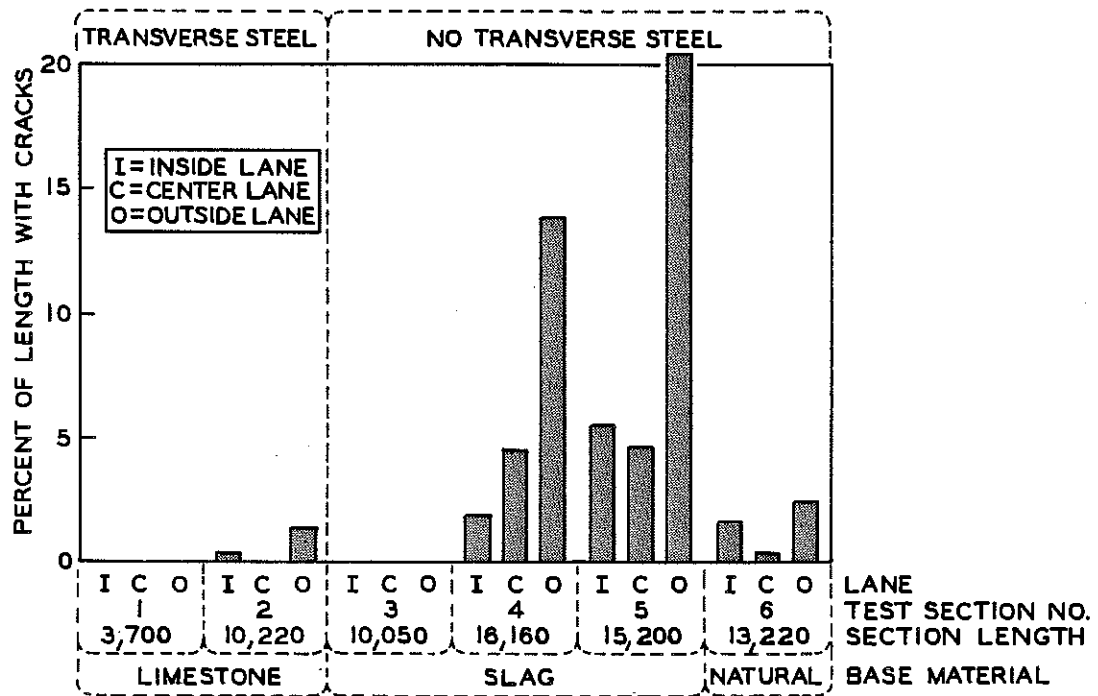
Figure 9. Percent of lane with longitudinal cracks on test sections 1 through 6 as of March 1979.

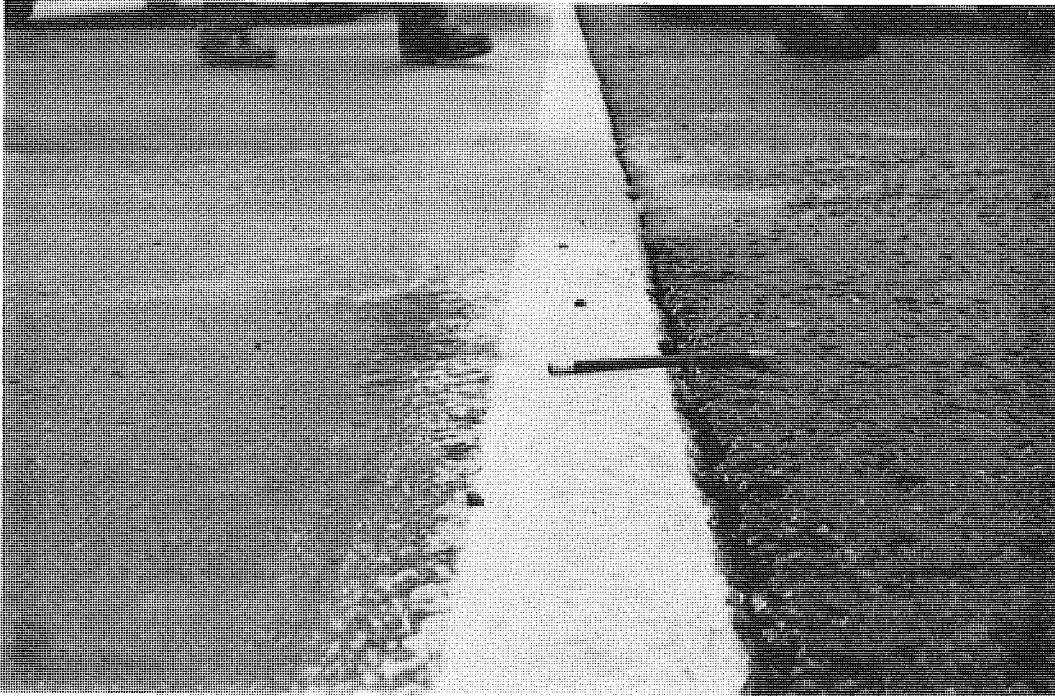
Figure 10. Permanent vertical displacement of the shoulder caused by frost action in the base layer.

Lateral displacement of base material from pavement to shoulder area and vertical shoulder pressures, too small to completely reconsolidate the base under the shoulder, are thought to be the reasons for the apparent permanent upward shoulder displacement.

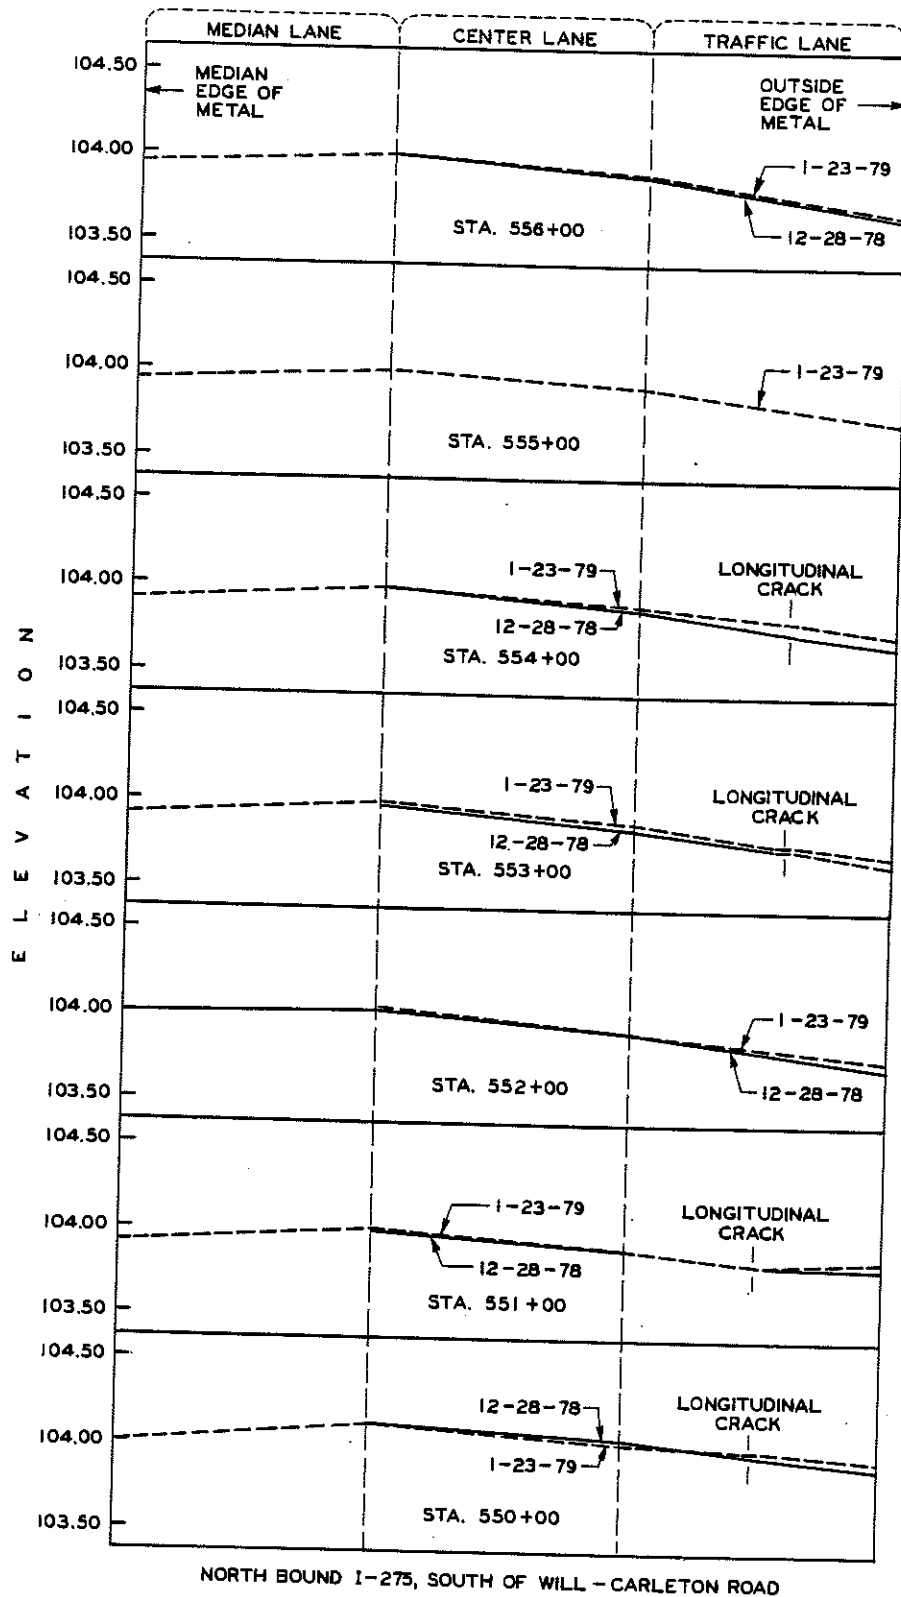
Figure 11. Transverse pavement profile at Sta. 552+00, 551+00, 550+00 indicating a tendency for the outside edge of metal to heave more than the rest of the pavement.

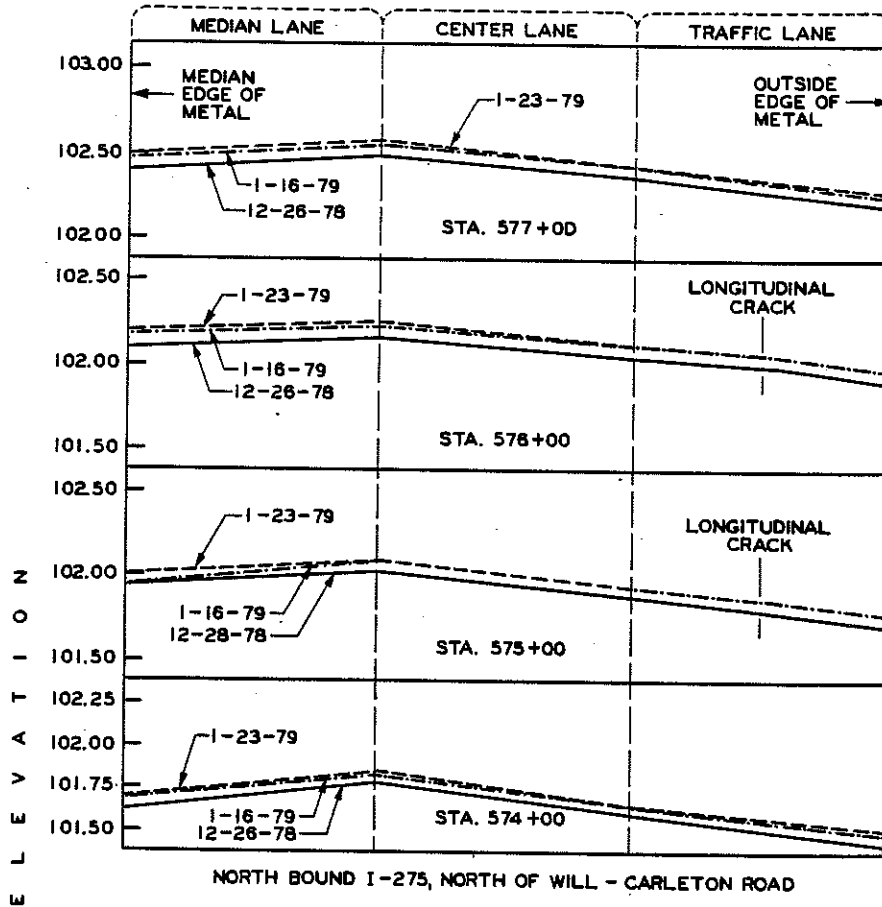
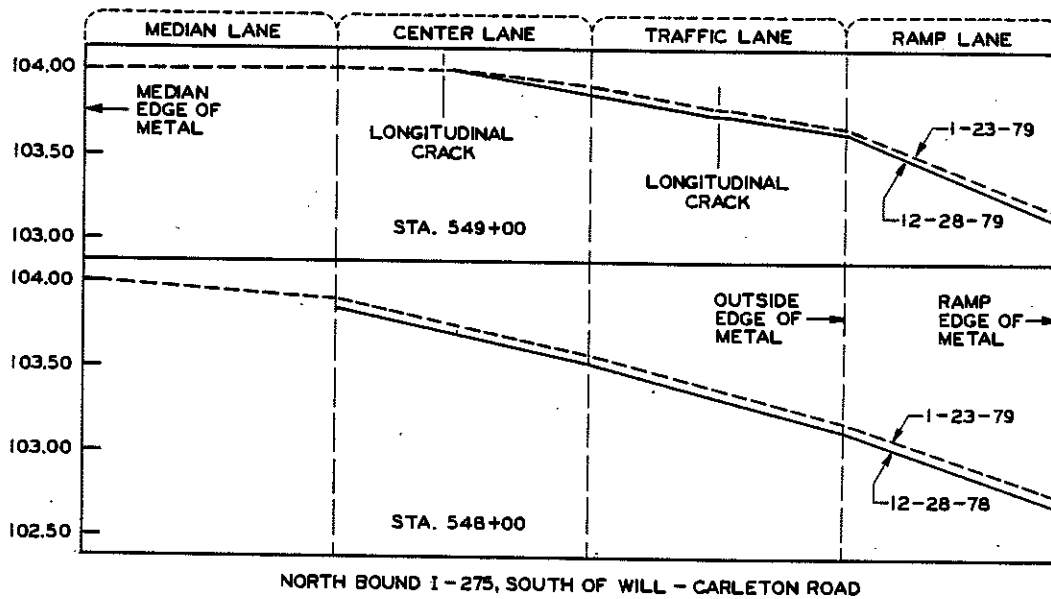
Figure 12. Transverse pavement profile at Sta. 577+00, 576+00, 575+00, 574+00 indicating no edge of metal tendency for the outside edge of metal to heave more than the rest of the pavement.

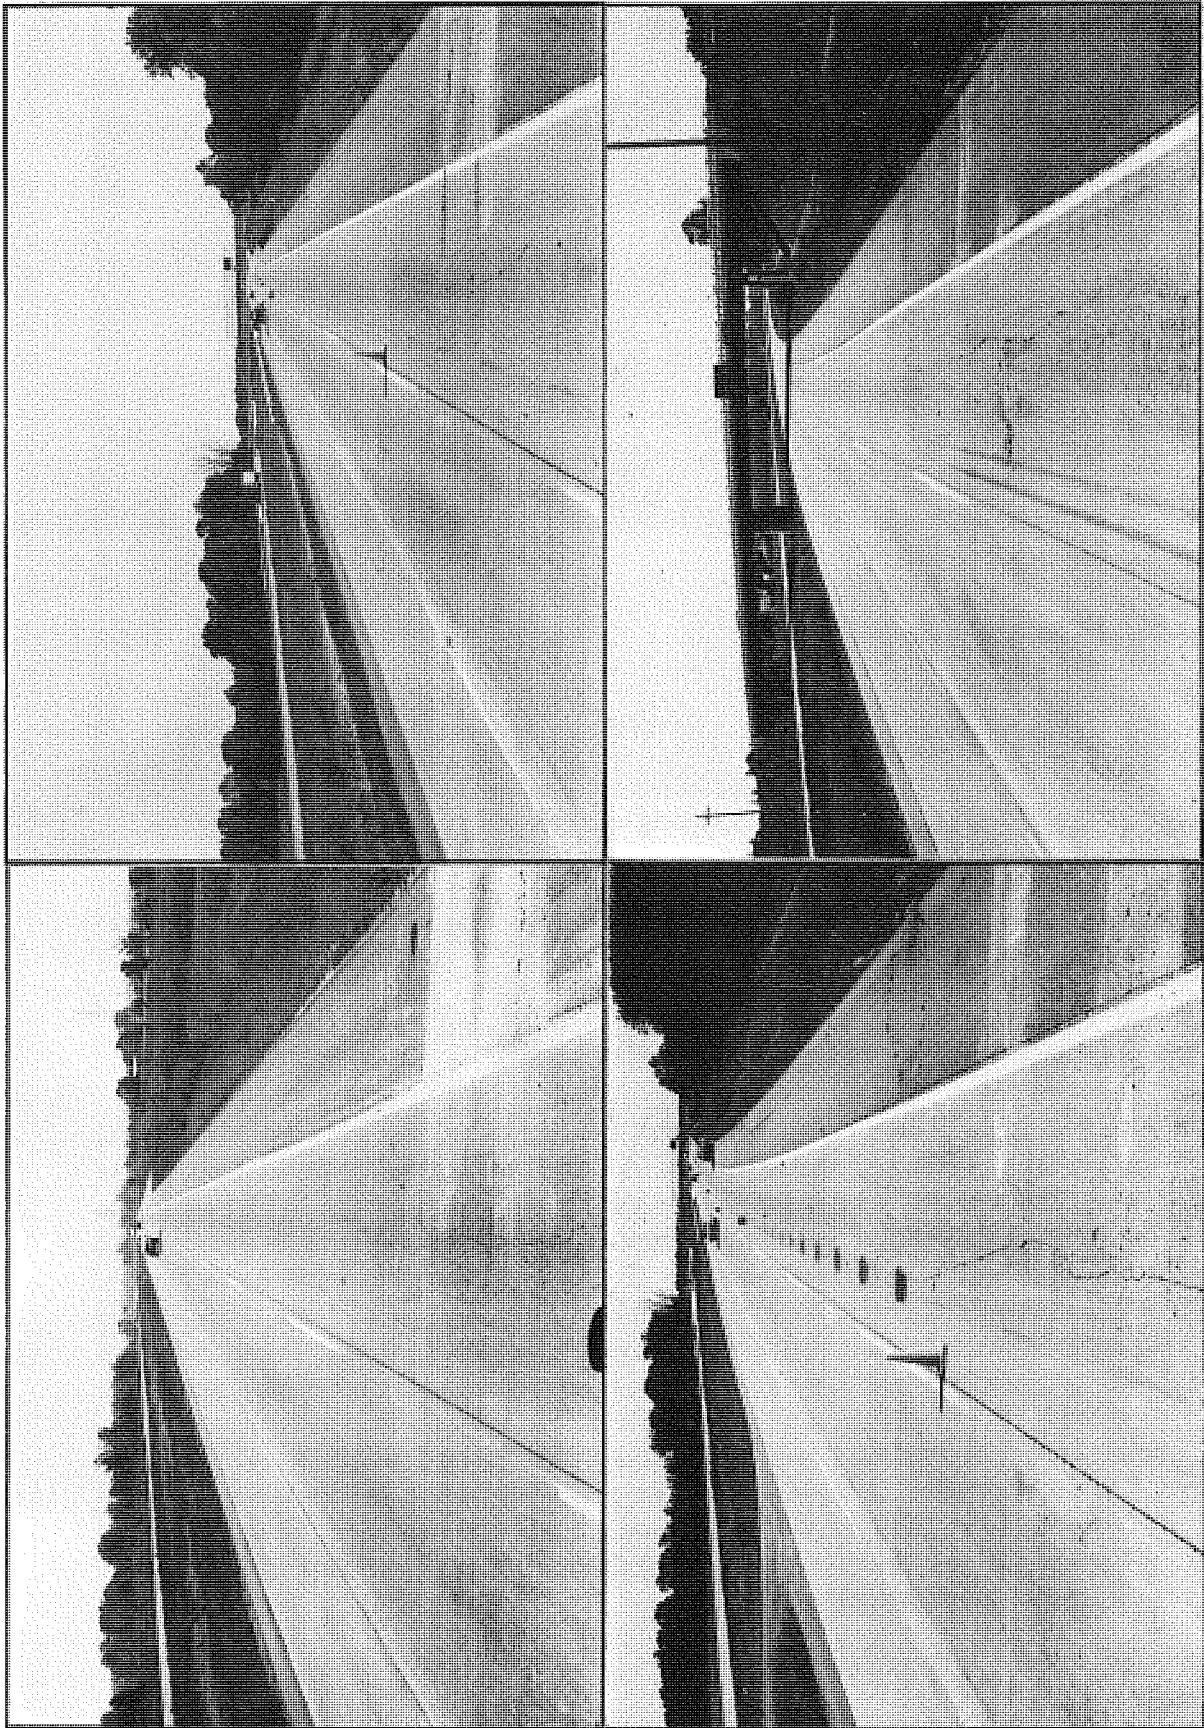
Figure 13. Longitudinal cracking which could be caused by 'frost tenting' action of the base at the longitudinal pavement-shoulder joint.

Differential frost heave in the base layer at the pavement-shoulder interface, due to 'frost tenting' action, is believed to be responsible for the occurrence of most of the longitudinal cracking. Such differential frost heave requires a critical combination of an abundant supply of surface saltwater, temperatures low enough to cause freezing of saltwater, and the proper combination of low permeability and base frost susceptibility. The absence of any one of these factors should prevent the occurrence of differential heave. In conducting winter studies of I 275 during the 1979-80 freezing season, it was noted that no significant differential frost heave occurred. This indicates that climatic conditions during the 1979-80 freezing season were not conducive to differential frost heave. However, extension of existing longitudinal cracks may occur as a result of the seasonally weaker base-subbase condition.

The attenuation of further longitudinal cracking may be accomplished by the installation of a specially designed drain under the lower pavement-shoulder interface which would remove all surface infiltrating saltwater, prevent the base from sorbing surface run-off saltwater, and provide positive subbase drainage. By depriving the base of its source of saltwater, the potential for differential frost heave at the low edge of the pavement should be removed and the occurrence of new longitudinal cracks attenuated. Pavement areas in need of drains may be identified as those areas where permanent shoulder displacement occurs. Positive subbase drainage should help attenuate extension of existing longitudinal cracks in those areas where the subbase is gravity drainable. However, the high capillary potential nature of the base and much of the subbase materials is such that longitudinal cracking could continue because of migration of fines and excessive pore water pressures, even with the installation of drains.

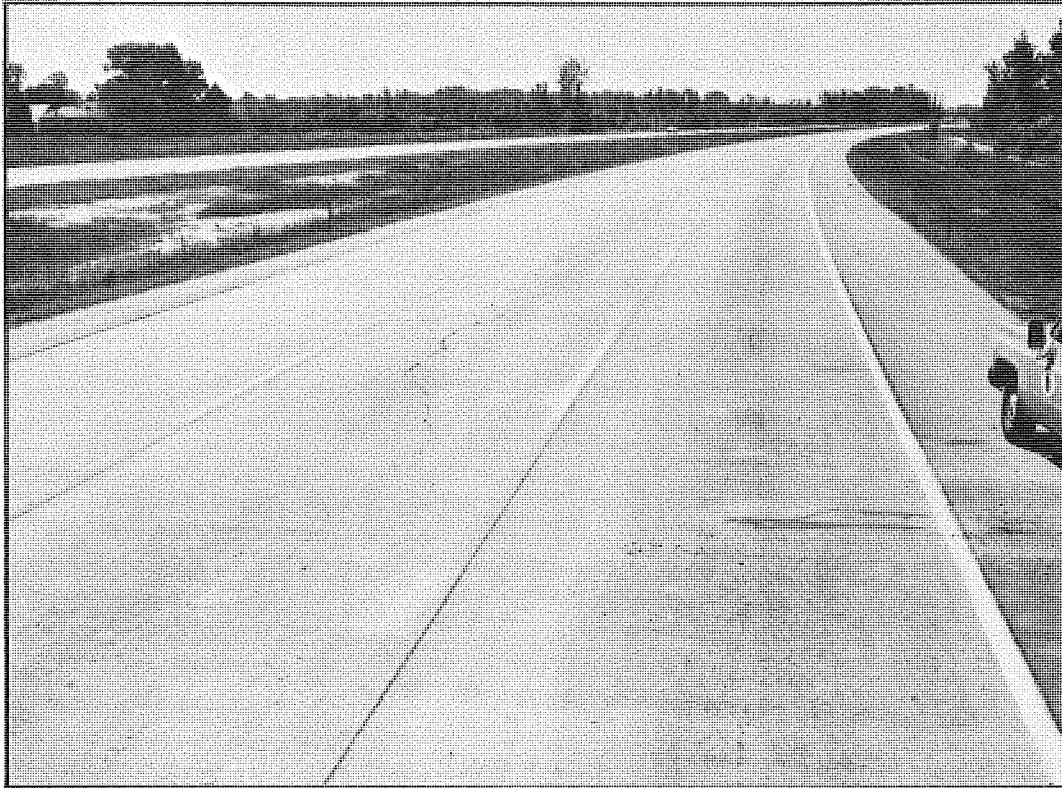
Figure 14. Longitudinal cracking not related to 'frost tenting' action.
