A CONDITION SURVEY OF EXPERIMENTAL CONTRACT

RESEALING AND PATCHING PROJECT

US-16 Nunica to Fruitport  
Project Mc 70-28, C3

Research Laboratory  
Testing and Research Division  
Report 197B  
Feb. 24, 1954

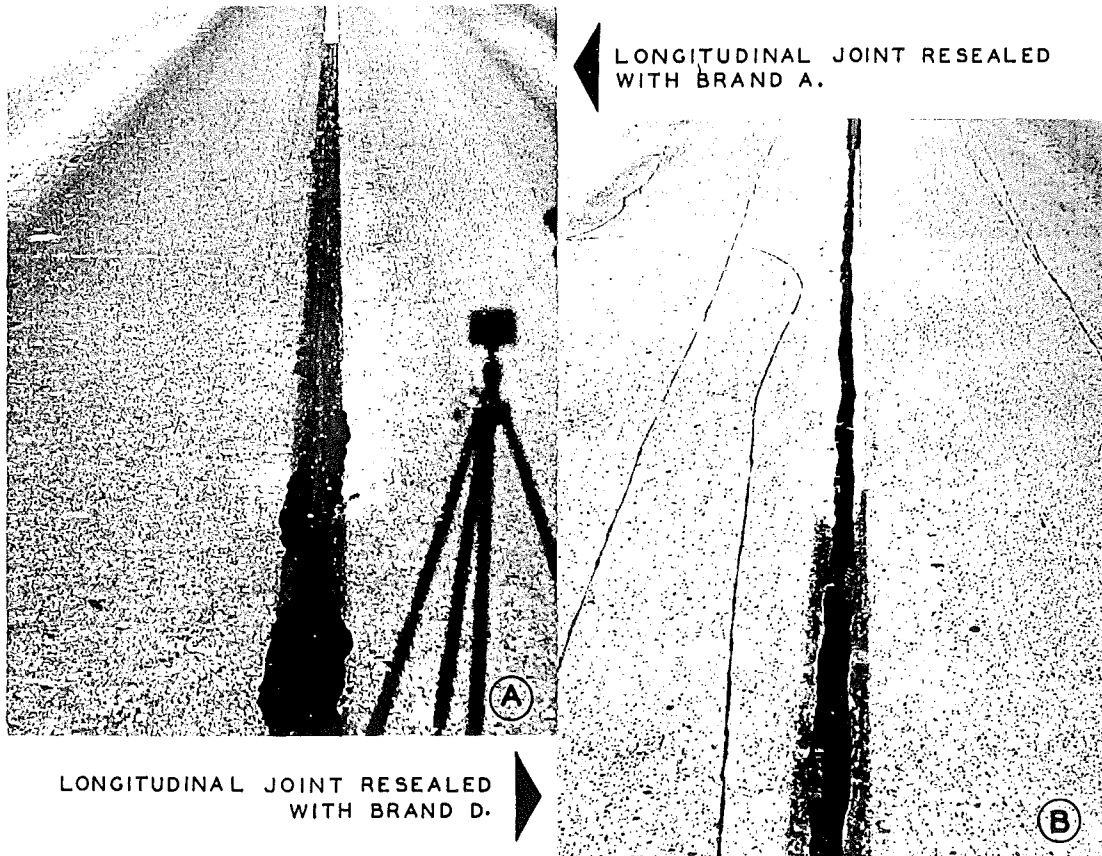
The entire longitudinal joint and all of the closed cracks appeared well sealed with no loss in adhesion between sealer and concrete regardless of the brand of sealer used (Figures 1 and 2).

FIGURE 1. TYPICAL APPEARANCE AT LONGITUDINAL JOINT ON FEB. 18, 1954

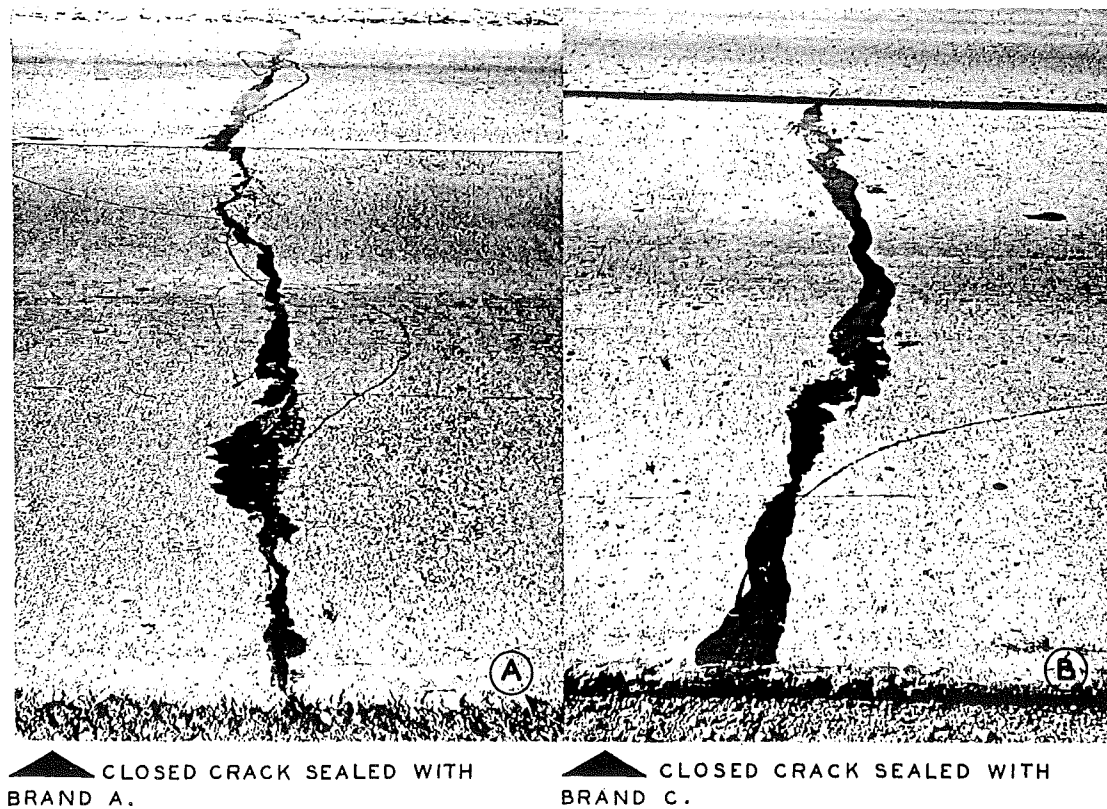
FIGURE 2. TYPICAL APPEARANCE OF CLOSED CRACKS ON FEB. 18, 1954

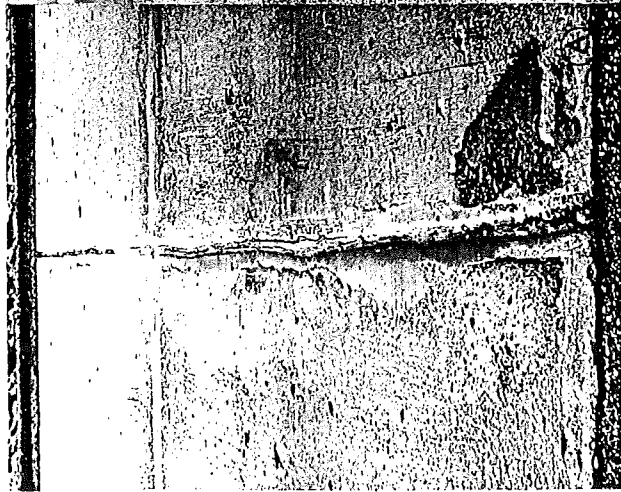
The Brand A material in transverse joints was badly cracked and separated from the joint faces (Figures 3A and 3B). The other five materials in transverse joints still had a fresh appearance and had maintained complete adhesion to the joint faces.

STATION 656 + 60. RESEALED WITH BRAND A. NOTE CRACKING IN SEALER AND SEPARATION FROM JOINT FACE.

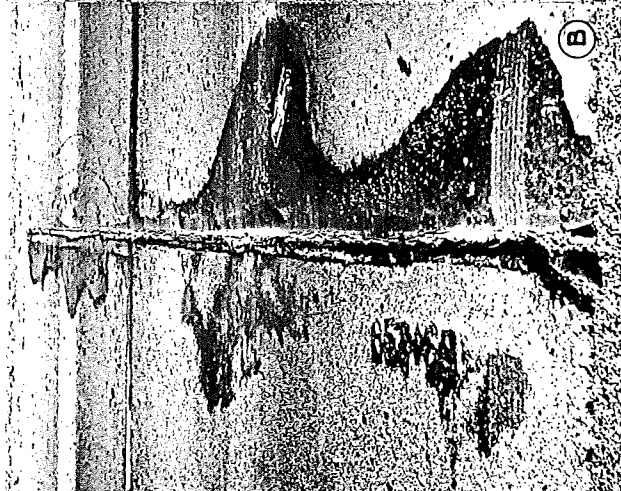
STATION 654 + 68. ANOTHER EXAMPLE OF TRANSVERSE JOINT RESEALED WITH BRAND A.

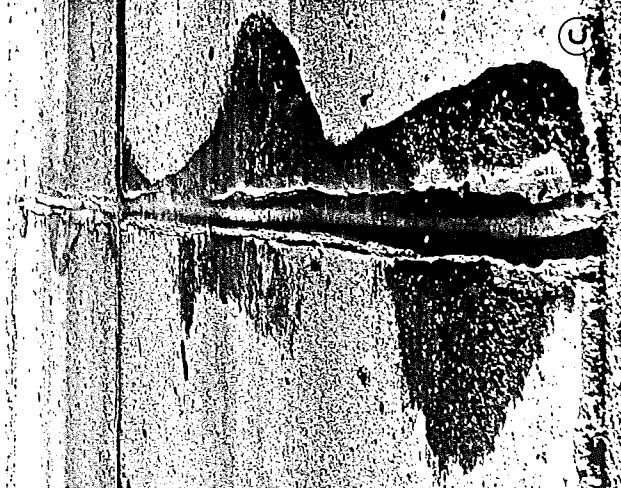
STATION 649 + 45. RESEALED WITH BRAND B.

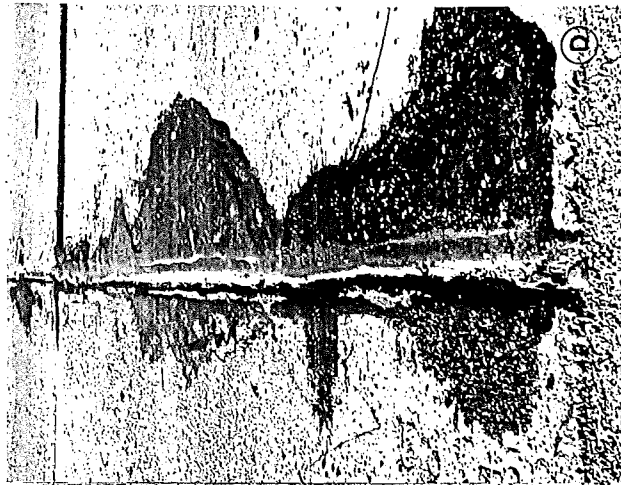
STATION 587 + 52. RESEALED WITH BRAND C.

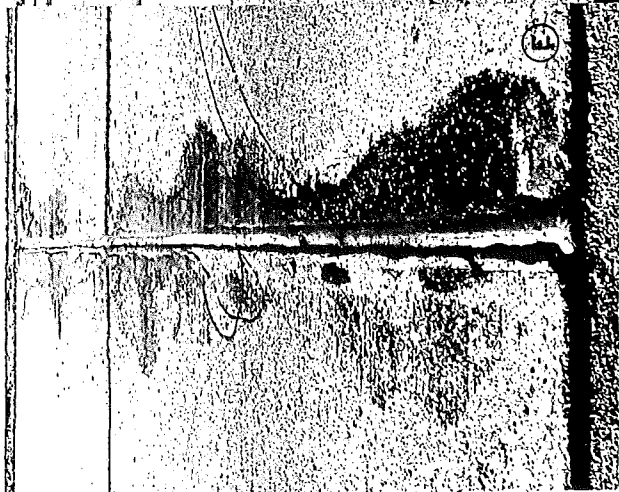
STATION 489 + 19. RESEALED WITH BRAND D.

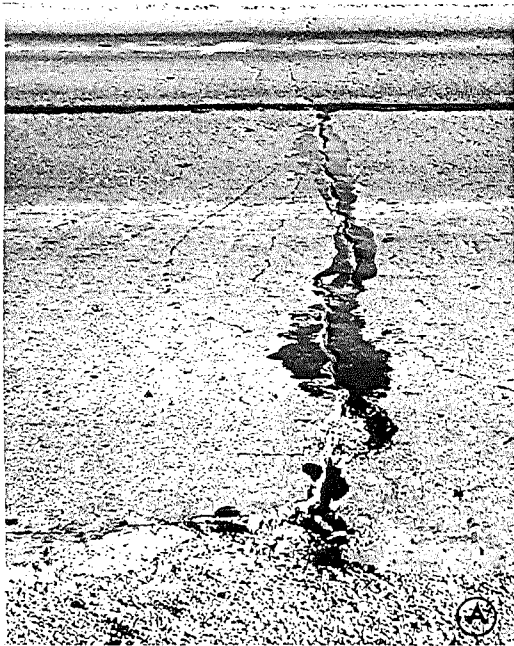
The Brand A material in open cracks had lost its adhesion to the concrete and, in some sections, had worked entirely out of the cracks (Figures 4A, 4B, and 4C). Other sealers used in open cracks had held up well and still maintained a perfect seal (Figures 4C, 4D, and 4E).

▲ STATION 653 +65. SEALED WITH BRAND A. NOTE LOSS OF SEALING MATERIAL.

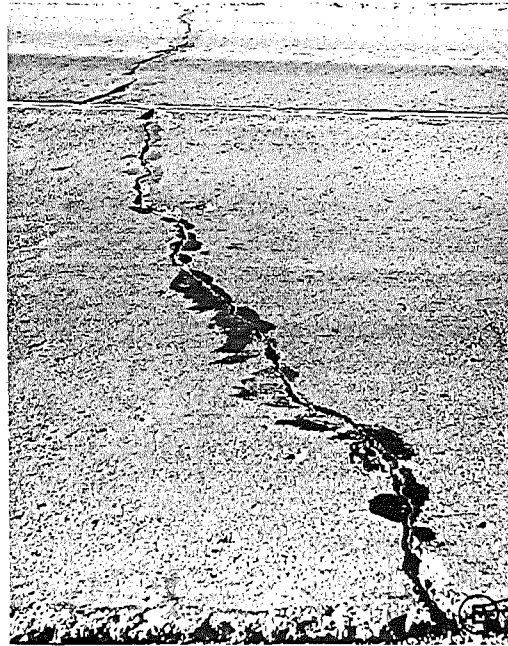
▲ STATION 651 +85. ANOTHER OPEN CRACK SEALED WITH BRAND A AND SHOWING LOSS OF MATERIAL.

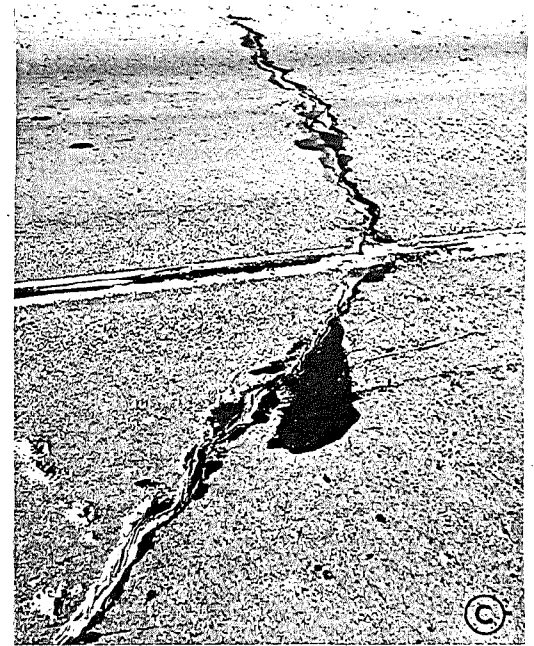
▲ STATION 649 +30. NEAR LANE SEALED WITH BRAND A. FAR LANE WITH BRAND B. SEAL WITH BRAND B IS INTACT.

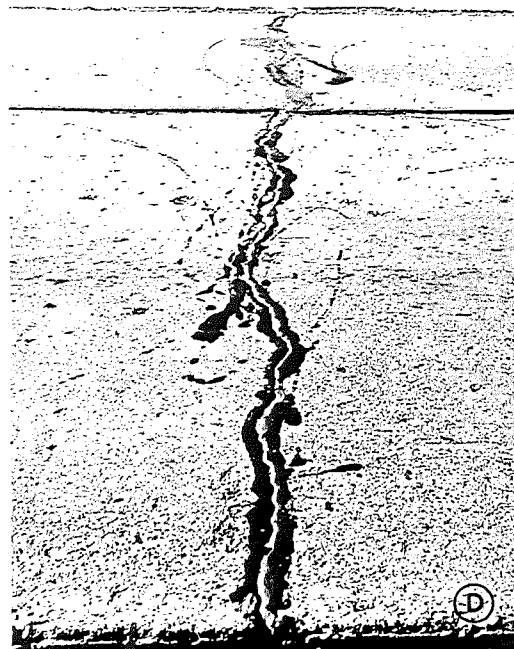
◀ STATION 454 +61. SEALED WITH BRAND E. PERFECT SEAL HAS BEEN MAINTAINED.

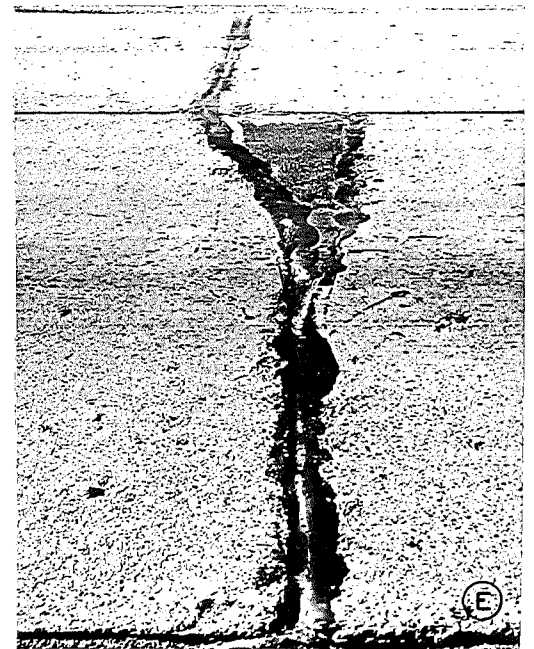
STATION 420 +45. SEALED WITH BRAND F. ANOTHER EXAMPLE OF AN INTACT SEAL. ▶

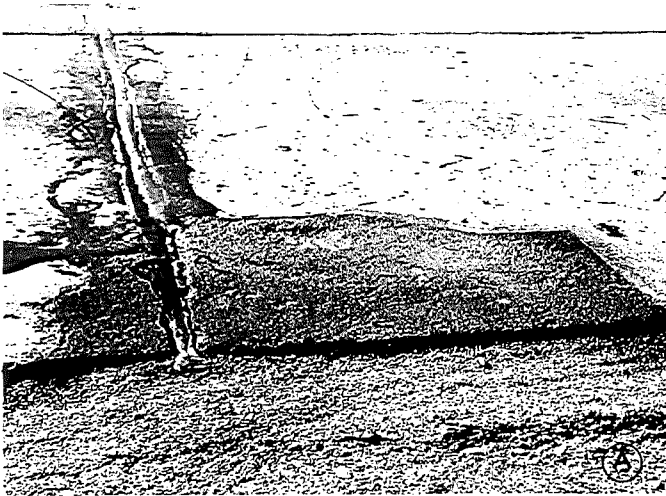
tendency for the joint seal to come loose from the patching material (Figure 5A) and also a small amount of spalling of the patching material at the joint (Figure 5D). In general, however, their condition was satisfactory.

▲ STATION 464 +16. SHOWING LACK OF ADHESION OF JOINT SEAL TO REPAIR MATERIAL.

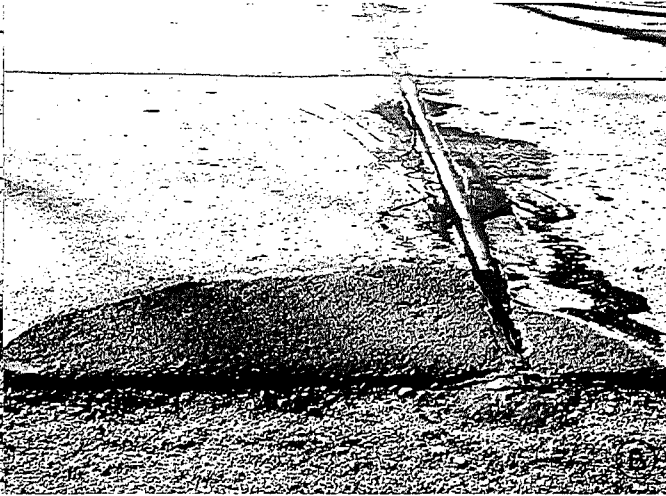
▲ STATION 461 +01. NOTE CONCRETE BUTTRESS AT END OF JOINT TO PREVENT SHOULDER INFILTRATION.

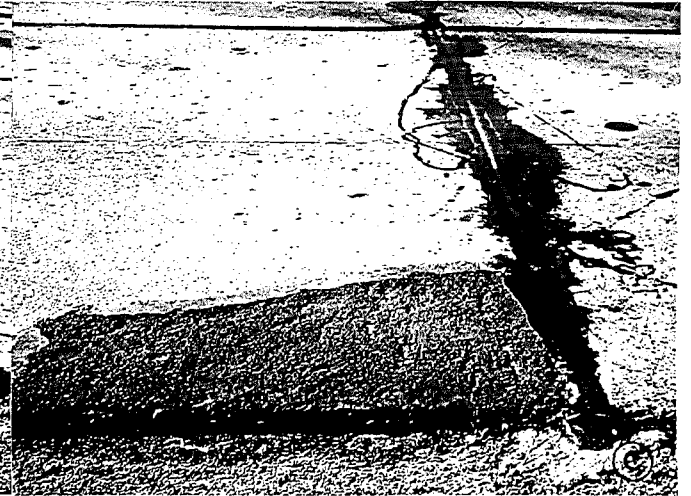
▲ STATION 463 +63. A SINGLE CORNER BREAK REPAIR.

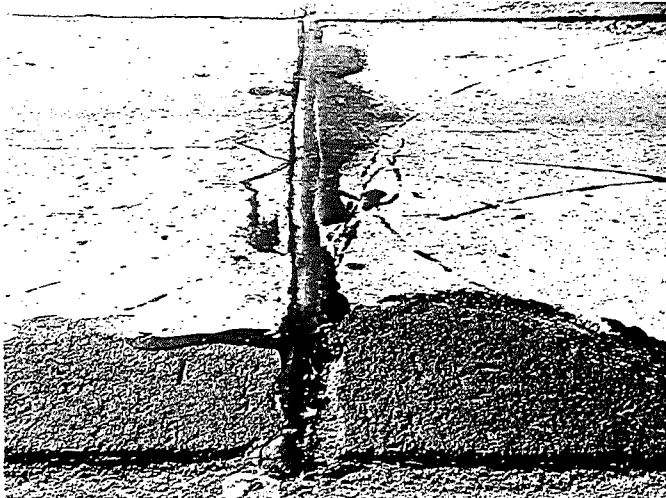
◀ STATION 450 +04. SHOWING SPALLING OF REPAIR MATERIAL AT JOINT.

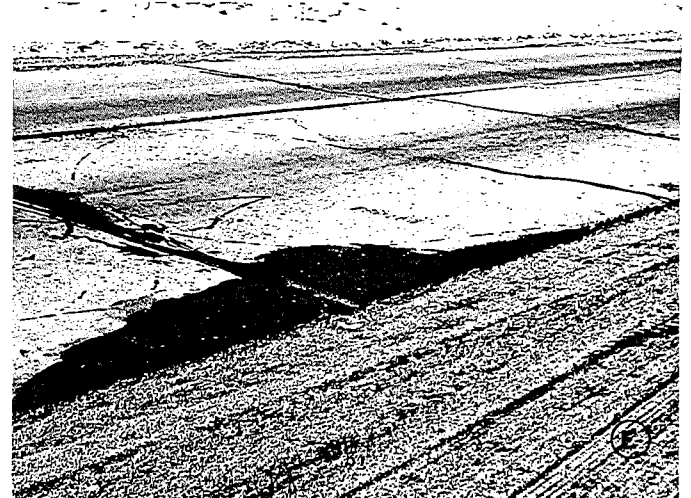
GENERAL VIEW OF REPAIR SHOWN IN D. ▶
