MICHIGAN
DEPARTMENT OF STATE HIGHWAYS

Subject: ASTM A 588 Steel in Bridge Structures in Detroit. Research Project
62 G-122. Supplement to Research Report No. R-740, dated May 11, 1970.

Subject: ASTM A 588 Steel in M 102 Structure over I 696 in Detroit. Research Project 62 G-122. Research Report No. R-740.

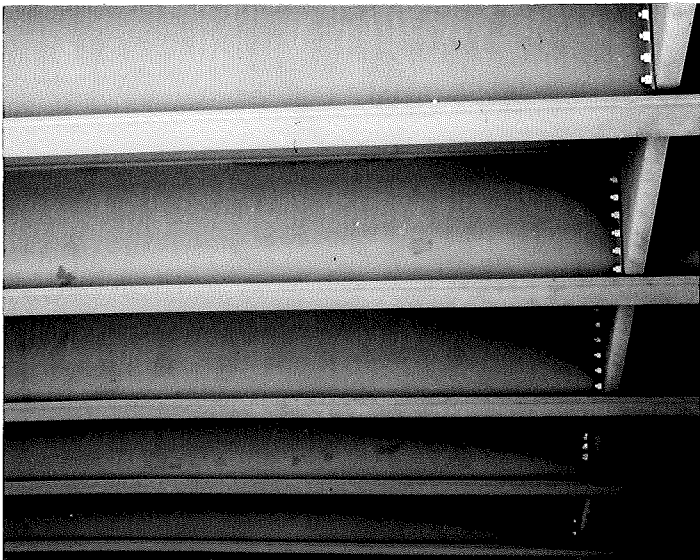
Messrs. N. C. Jones and A. J. Permoda report no noticeable abnormal rust scale formation and delamination on beams of I 75 over US 25 (Fort St) built in 1966. There were a few delamination spots, though no noticeable heavy scale formation, on three adjoining beams of eastbound M 102 over northbound I 75, as shown in the attached photograph. The structure was built in 1967. The latter will continue under observation and a closer inspection from a raised platform, if subsequently advisable.

Spots are noted on webs of 2nd, 3rd and 4th inner beams.

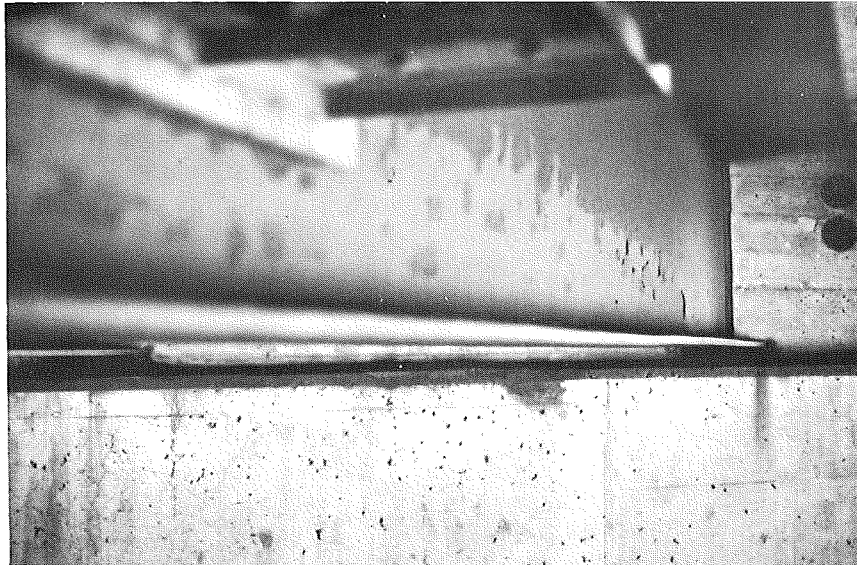
The inspection confirmed the rust scale formation (up to 30 mils thick) and the scale delamination (Fig. 1). This was confined to the west end of the lower structures carrying westbound and eastbound M 102 over I 696, extending into the center lane on the southbound roadway. This condition was also noted in some spots, under leaky joints, in the remainder of the structure. Other areas of the structure presented a tight oxide appearance.

Figure 1. Combination road dirt, salt, and oxide formation shows localized descaling on A 588 steel beams.

Bethlehem Laboratory personnel stated that the behavior in "2)" above was normal and expected; and that "1)" above was higher than expected and not normal. They believed the latter was due to a measured progressive accumulation of salt and road dirt on the beam surfaces which retained moisture and accelerated the corrosion rate. This was localized because of: a) lower clearance on the west end of the structure, b) greater traffic volume on southbound I 696 in the morning when dew-moistened steel would tend to entrap road dirt, and c) snow-fence effect near west abutment wall allowing dirt to pile-up on the steel beams.

The group felt that the noted localized abnormal corrosion behavior should continue under observation, but did not require other immediate action. Other similar structures should also be inspected to determine if a similar dirt accumulation occurs. Eventually, and probably after the next scheduled test panel removal, a recommendation would be made whether to remove the complicating dirt accumulation by either water or compressed air.
