ELECTROCHEMICAL CHLORIDE EXTRACTION

**Testing and Research Section
Construction and Technology Division
Research Project 97 TI-1864
Research Report R-1384**

BRIDGE S02 OF 38061 SUBSTRUCTURE, PIER FOUR

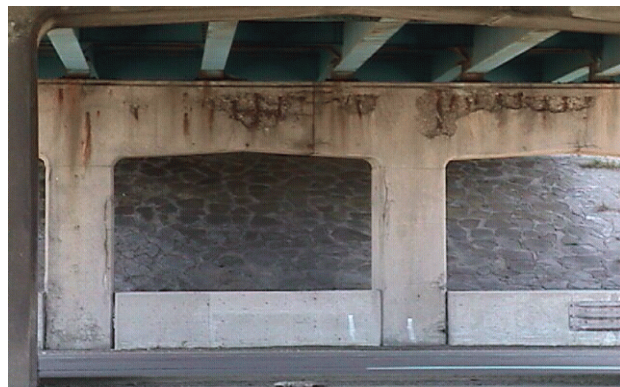
Half-cell corrosion potential measurements (-mV versus copper sulfate electrode, ASTM C876) were taken before treatment, and indicated active corrosion occurring at the locations where chloride levels at the reinforcement exceeded the corrosion threshold of 0.71 kg/m³. The initial half-cell potential measurements are shown in Table 2. Visual inspection of the pier confirmed the presence of corrosion on the reinforcing steel (Figure 1).

Figure 1 Effects of corrosion upon the substructure (Jackson, Michigan).

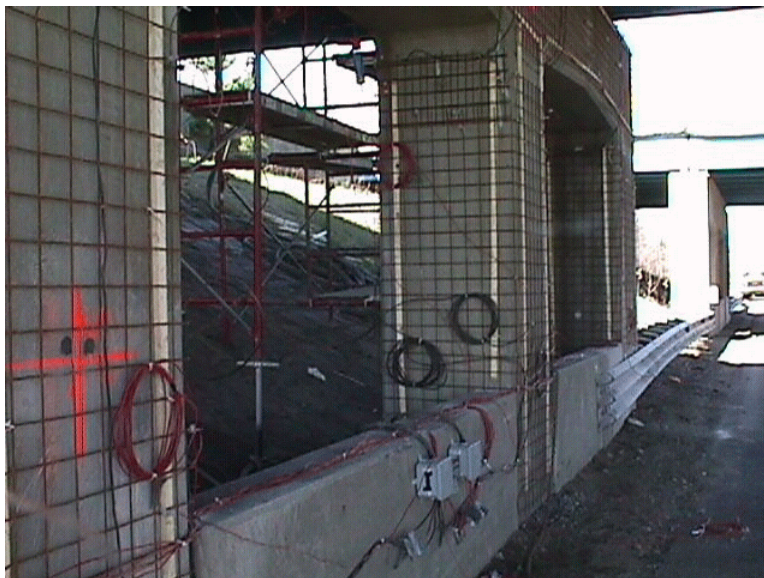
Figure 2 Installation of the Anode Mesh

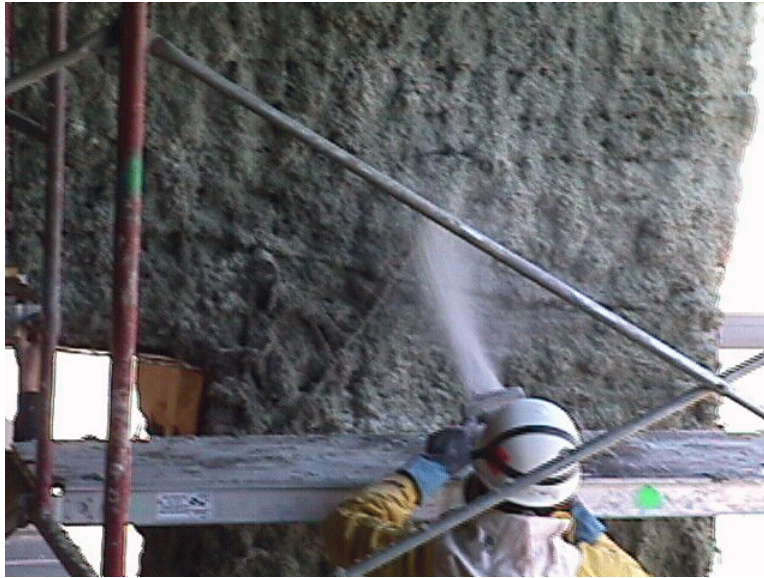
Figure 3 Application of Cellulose Fiber Mix.

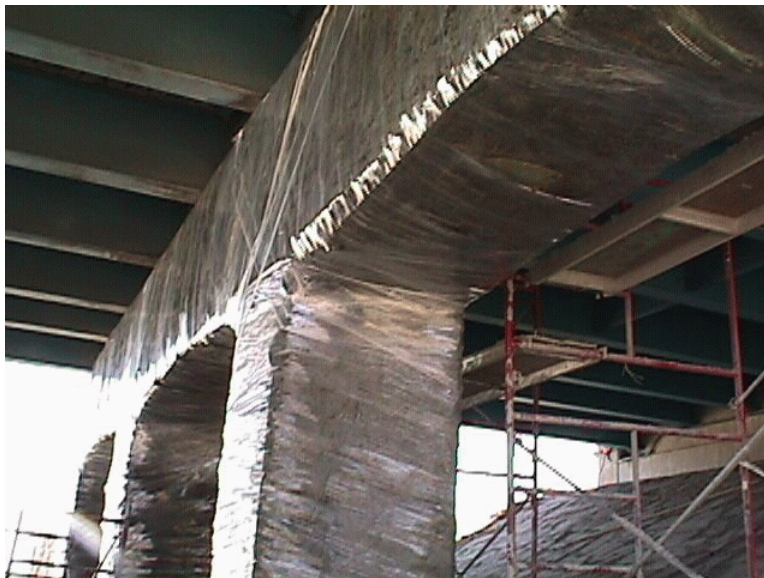
After application of the cellulose fiber mixture, the column was wrapped in 0.15 mm plastic sheeting (Figure 4). Column wrapping was done to reduce water evaporation. Drip hoses were then installed on top of the pier cap, to keep the cellulose fibers (electrolyte) wet during the process. These hoses were connected in series to a main metering pump. The water was supplied by a 3,800 liter tank. The tank was installed along the south embankment by MDOT personnel before the installation process, and removed after the ECE treatment. During treatment, the 3,800 liter tank was filled by MDOT personnel every three to five days. This limited water consumption to 760 liters per day.

Figure 4 Plastic Wrap to keep cellulose fibers moist.

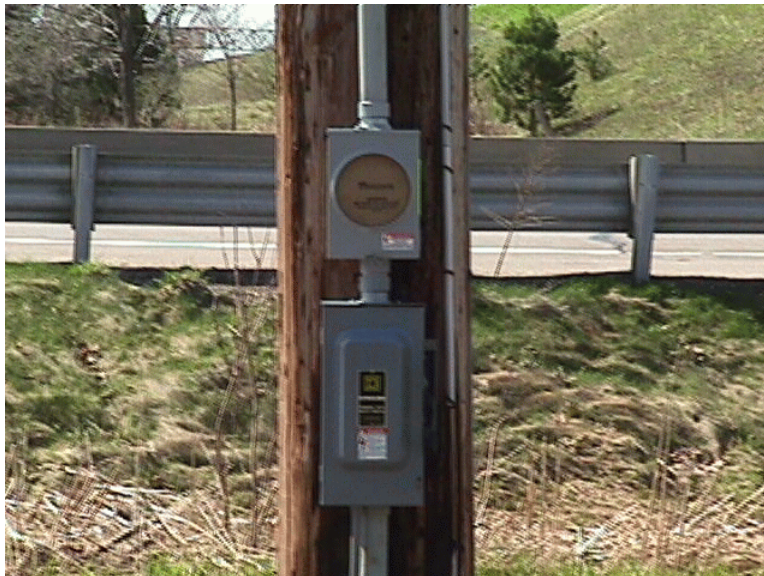
The electrical conduit running from the utility pole to the abutment wall was installed in 1998 by MDOT personnel. During the ECE installation, it was noticed that the meter socket hookup by the utility company had not yet been completed (Figure 5). This was scheduled to take place before the ECE installation. Several attempts were made to contact the utility company to arrange for the meter socket hookup. Because of the lack of electrical power during the installation period, generators were needed to operate the tools. The contractor ran two of their own gasoline-powered generators during the installation. The electrical hookup from the conduit to the ECE power distribution system was completed on April 14, 1999 by a licensed MDOT electrician. The meter socket was connected by the utility company on April 15, 1999.

Figure 5 Meter Socket not installed until 4/15/99.

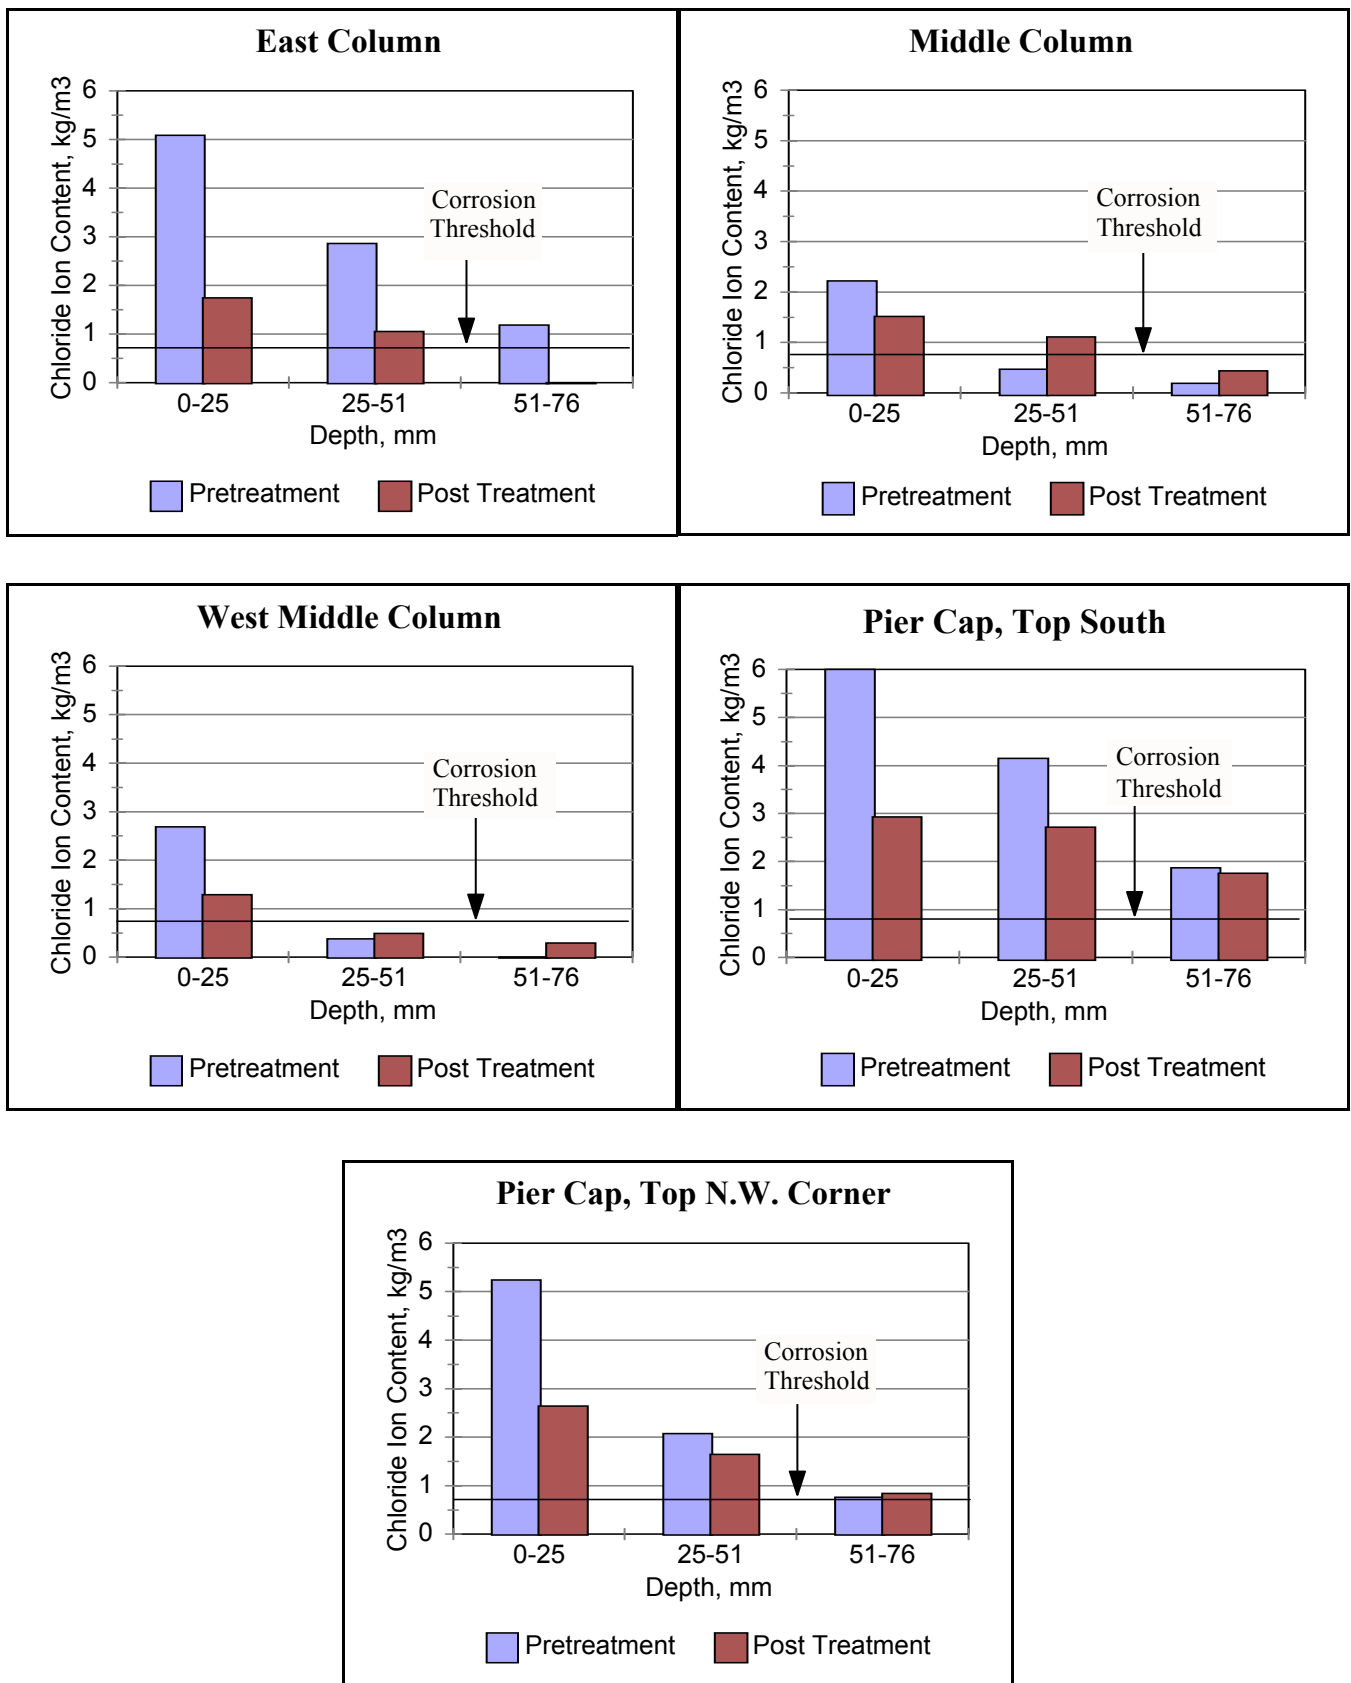
Figure 8. Pre- and Post Treatment Acid-Soluble Chloride Levels. Five Sampling Locations

One discrepancy in Table 3 is the apparent increase in chloride ion concentrations at the steel reinforcement level (51-76 mm). One possible explanation for the discrepancy may be due to the sampling technique. When drilling into the concrete, there is always the risk of scraping the side of the hole with the drill bit, contaminating the sample with concrete from the surface layer. Sampling errors would be more evident at depths where the chloride concentrations are very low. Another factor may be due to the ECE process itself. Chloride ions are migrating, resulting in redistribution of chloride ions throughout the concrete. One anode sub zone may have redistributed chloride ions, possibly due to uneven current distribution or variable resistance in the concrete from changing moisture levels. Since each sub zone was electrically isolated from another, it is unlikely that chloride transport across sub zones occurred. For most locations, chloride redistribution, rather than removal, has occurred at the level of reinforcement. The east column was the exception, with complete chloride removal at the level of reinforcement. Chloride removal was greatest near the surface, diminishing toward the level of reinforcement. The ECE process should remove about 20 to 50 percent of the chloride present, and removing chlorides around the reinforcement is an important benefit. The lack of chloride removal at the level of reinforcement, however, was minimized by hydroxyl ion (OH^-) generation.

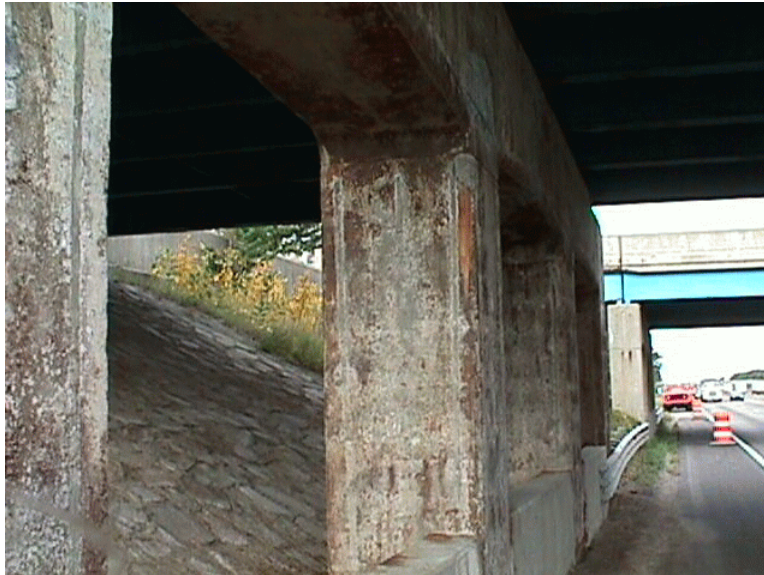
The rust stains from corrosion of the sacrificial steel anode mesh are clearly visible in Figure 9, which posed an aesthetic problem. The stains were not removed when the substructure was power washed after treatment, but were removed upon subsequent sand blasting before the sealant application. Penetrating sealants will protect the pier from future ingress of chloride ions, and should last at least five years. Masterseal GP from Master Builders, a two component epoxy based penetrating sealer, was used for the pier surfaces, except the top of the pier cap. This product is believed to be an effective barrier to chlorides from deicing salts. AkaCote 700, a two component epoxy-polyamide based light grey colored penetrating sealer from Akemi, was used for the pier cap top. The sealer application was completed on October 26, 1999. Figure 10 shows the final product, with a slight amber tint, as compared with the other substructure components. The sealants, however, highlighted areas where epoxy was injected into cracks during the ECE installation. Patched areas also appear darker than the surrounding concrete.

Figure 9 Rust Stains from the ECE Process

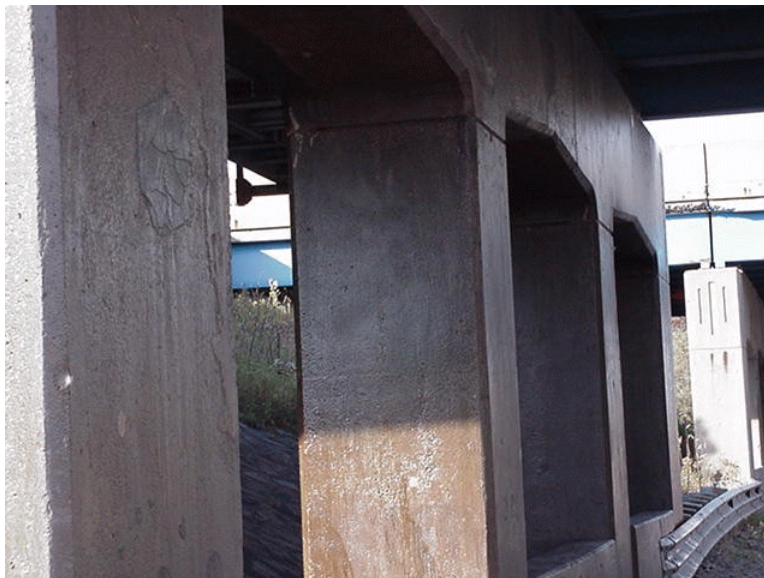
Figure 10 ECE Treated Pier with penetrating sealants applied.
