OFFICE MEMORANDUM

STATE HIGHWAY DEPARTMENT

Subject: Paint Peeling Off Pressure-Treated Wood Posts.
Research Project R-62 G-114. Research Report No. R-483.

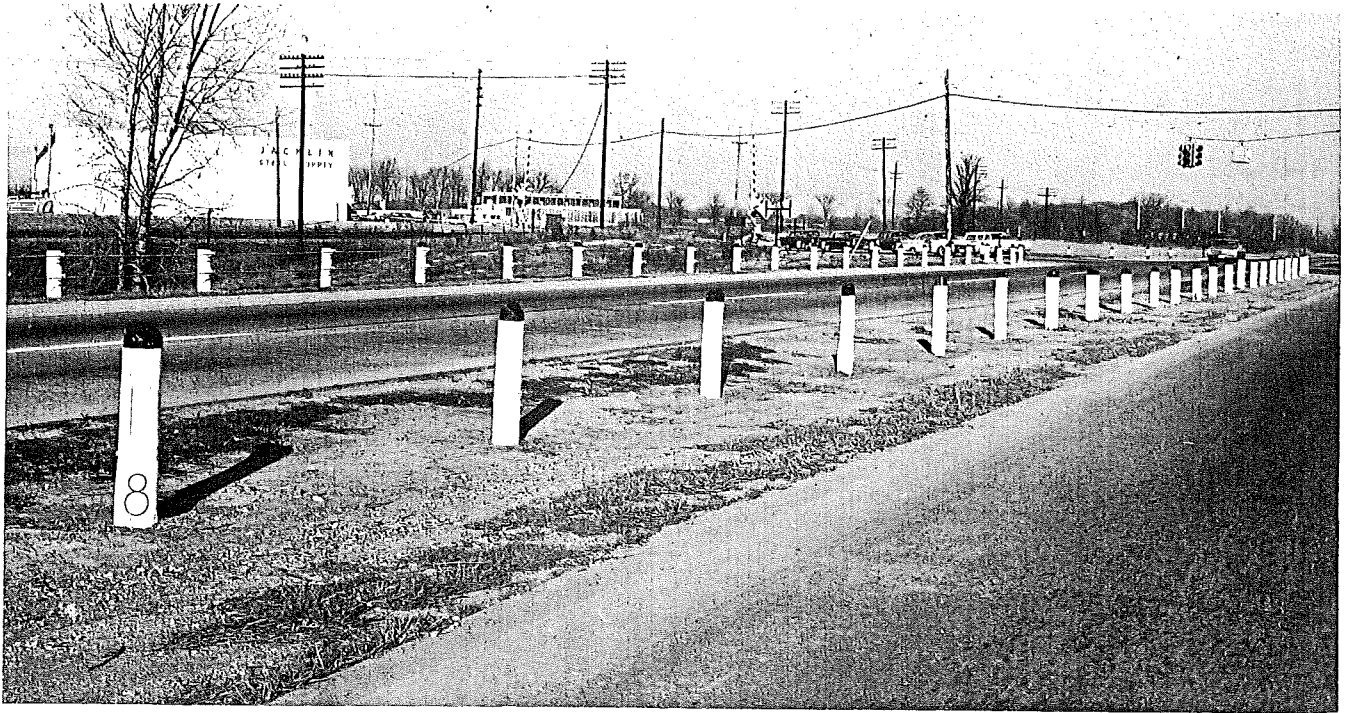
Figure 1. Eight test posts in median installation on US 27.

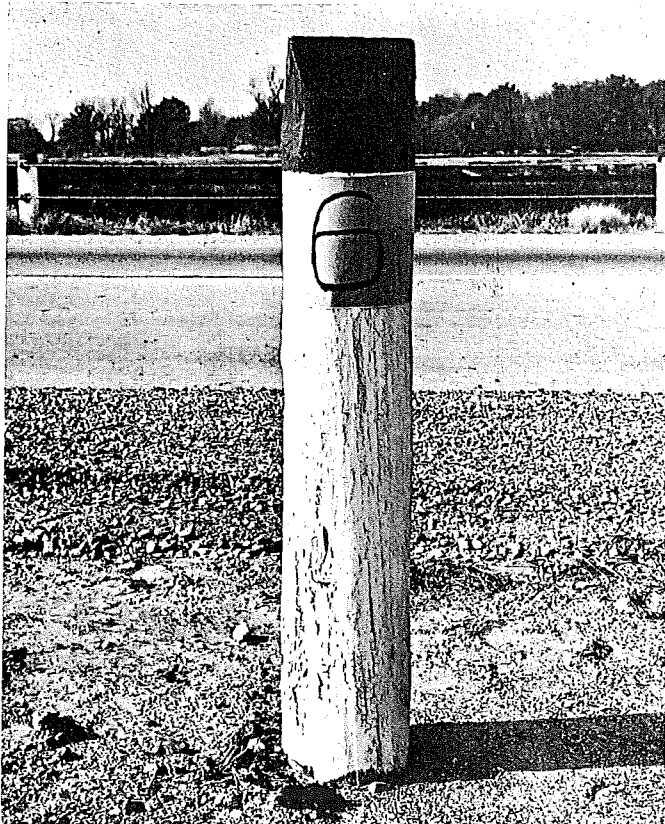
The second inspection showed that the penta-treated and untreated posts had greater staining of the white paint, paint failure due to cracking was present on the penta-treated posts (Fig. 2), and paint on the untreated posts had lost adhesion and could be pulled off (Fig. 3) displaying moisture at the wood-paint interface.

Figure 2. Failure and staining of white paint No. 6B-4 on penta-treated post after almost two years of service. Post was air-cured for several months before painting.

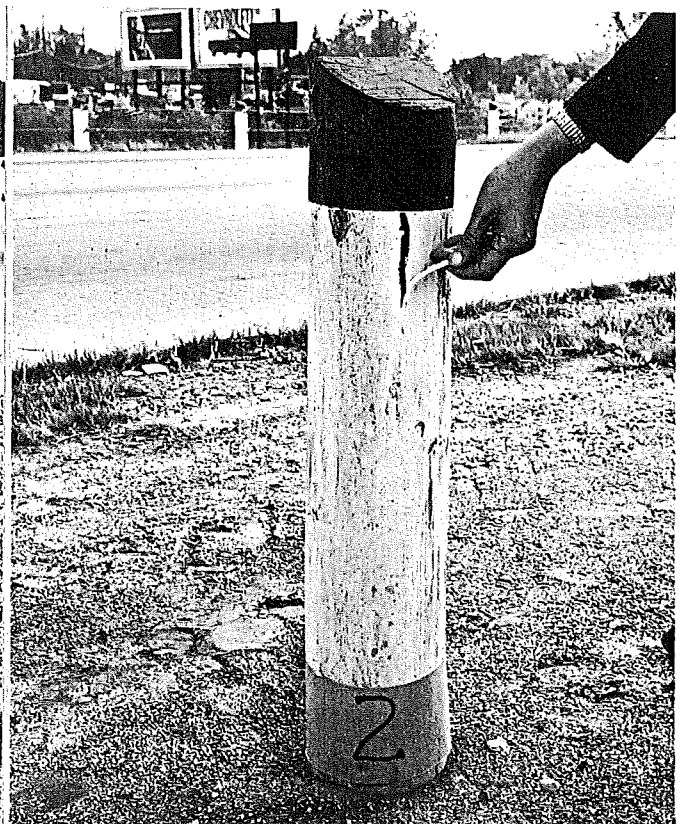
1. Water rising in the post, as in a wick, hydrolizes the paint, changes wood dimensions, and disrupts the bond, as evidenced by the presence of moisture at the wood-paint interface. A similar phenomenon occurs on water-soaked house siding.

Figure 3. Breathing white paint exhibited staining and could be peeled off untreated post after almost two years of service.
