# OFFICE MEMORANDUM

STATE HIGHWAY DEPARTMENT

March 20, 1962

Subject: Lenz's Proprietary Paints for Creosoted Wood Posts and for Structural Steel. Research Project 49 G-50(2). Research Laboratory Report No. 376.

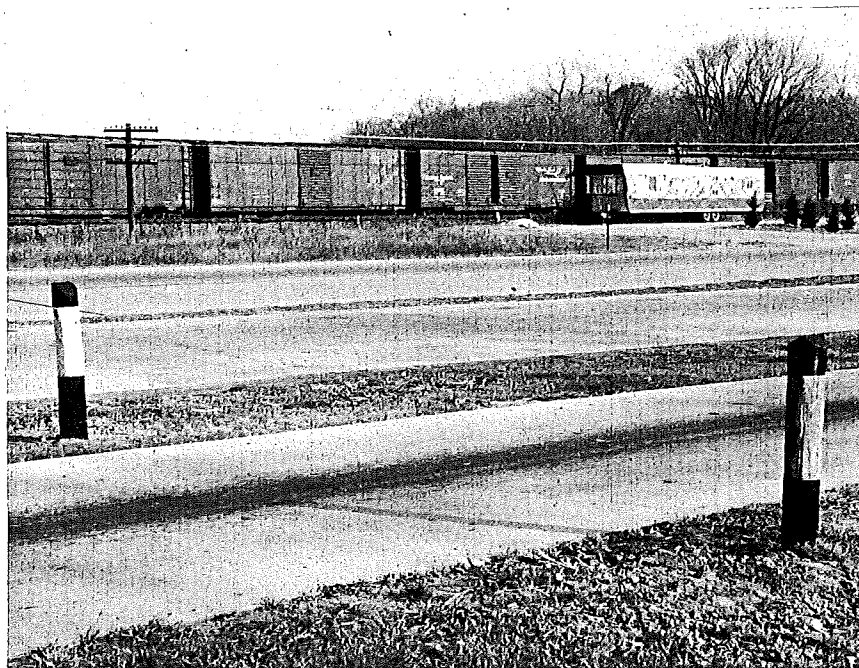
2. Creosoted Wood Posts: Test white paint was evaluated against specification white No. 6B-4 as a coating on creosoted wood posts. Two coats of each paint were applied on separate posts, previously creosoted, which were then field installed at the US 27 weigh station south of Lansing. At time of installation and after about 5 months of field service, the proprietary white paint proved significantly more bleed resistant than No. 6B-4 white, as shown in Figure 1. Further evaluations were not made because test post were damaged in service and maintenance repainted.

1. Test proprietary white paint, based on a fast drying modified alkyd vehicle, proved noticeably more bleed-resistant as a coating on creosoted wood posts than the comparative specification white paint No. 6B-4.

Figure 1. Condition of white coatings on creosoted wood posts exposed for about 5 months on US-27. Left post was coated with test proprietary white paint while right post, showing considerable discoloration or bleeding, was coated with No. 6B-4 white paint.

The paint is not recommended for use on posts by maintenance crews because its fast drying gave it poor brushability and also could be expected to lead to

excessive skinning in partially emptied containers. Its use would require that special solvents be carried for brush clean-up.

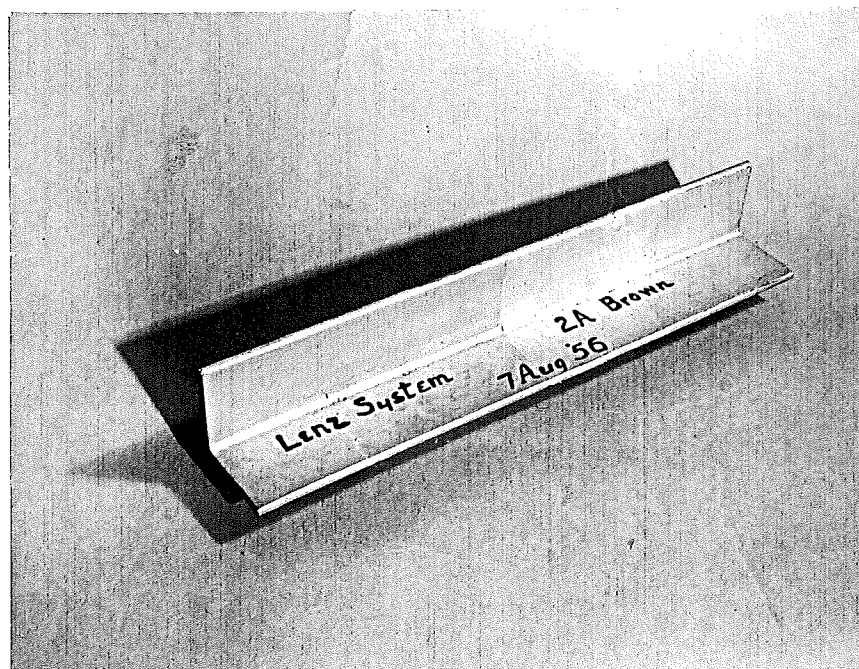
3. Steel Coating: Test paints were evaluated as a 2 coat system on a steel base against a specification system. The test paints, using the white as a prime coat and aluminum as topcoat were applied to a portion of angle iron with remaining half painted with specification system consisting of No. 2A Brown prime and No. 5B Aluminum topcoat. The angle iron was then exposed on roof of laboratory for about 4-1/2 years. Figure 2, giving condition of test specimen at end of this exposure, shows that test paints were in good condition and gave about equivalent service to specification system in test exposure.

2. Test proprietary paint system of white prime and aluminum topcoat performed well on one structural steel specimen exposed for about 4-1/2 years on roof of laboratory. It gave approximately equivalent service to comparative system consisting of a prime coat of No. 2A Brown and topcoat of No. 5B Aluminum.

Figure 2. Condition of coatings on steel angle iron exposed for about  $4\frac{1}{2}$  years on roof of laboratory. Left half had proprietary test paints or white primer and aluminum topcoat while right half had comparative system of No. 2A Brown primer and No. 5B Aluminum topcoat. Both systems appear in good condition.

The fast drying of the proprietary paints would prevent their application by brush on large area surfaces of structural steel, and for that reason and because they do not appear superior to current Department system the test paints are not being recommended for coating of structural steel.
