# OFFICE MEMORANDUM

MICHIGAN  
DEPARTMENT OF STATE HIGHWAYS

June 21, 1972

Subject: Demonstration of Vermeer Saw (I 75, Genesee County).  
Research Report No. R-822, Research Project 68 F-102.

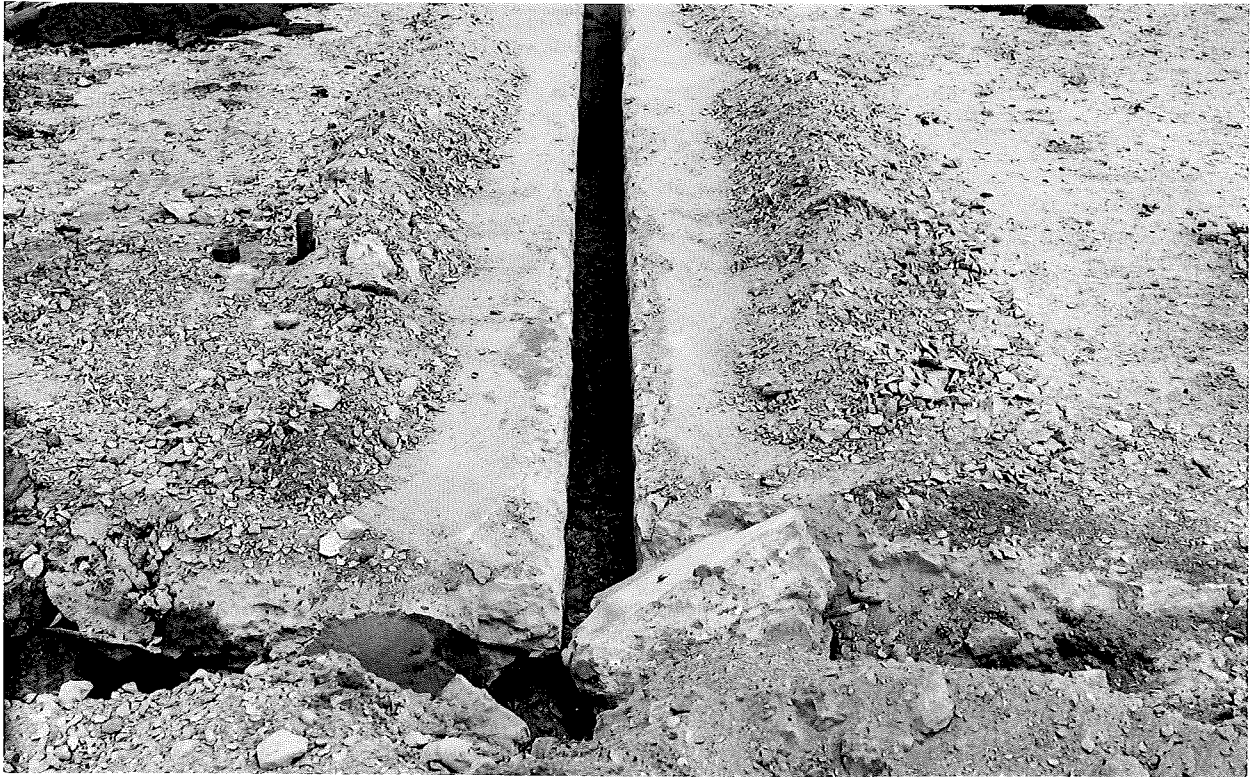
The surface edges of the cut were ragged, and the corners at the shoulder edge spalled as the wheel cut through (Fig. 1). The spalls along the surface edge were shallow, in most cases, but a few were as much as 2 in. deep. The spall width varied from 1/2 to 3 in. Undercutting of the slab occurred, especially in the area where the cutting wheel was lowered through the slab. The most severe spall of this type was about 3 in. deep (Fig. 2). The typical condition of the top and bottom surface edges can be seen in Figure 3. Ledges or "stepping" were present in the vertical edge of the cut at the pavement centerline (Fig. 4). The condition of the completed joints in the traffic lane is shown in Figure 5.

Figure 1. Vermeer sawcut on south side of repair in passing lane. Corner spall can be seen to the right of cut.

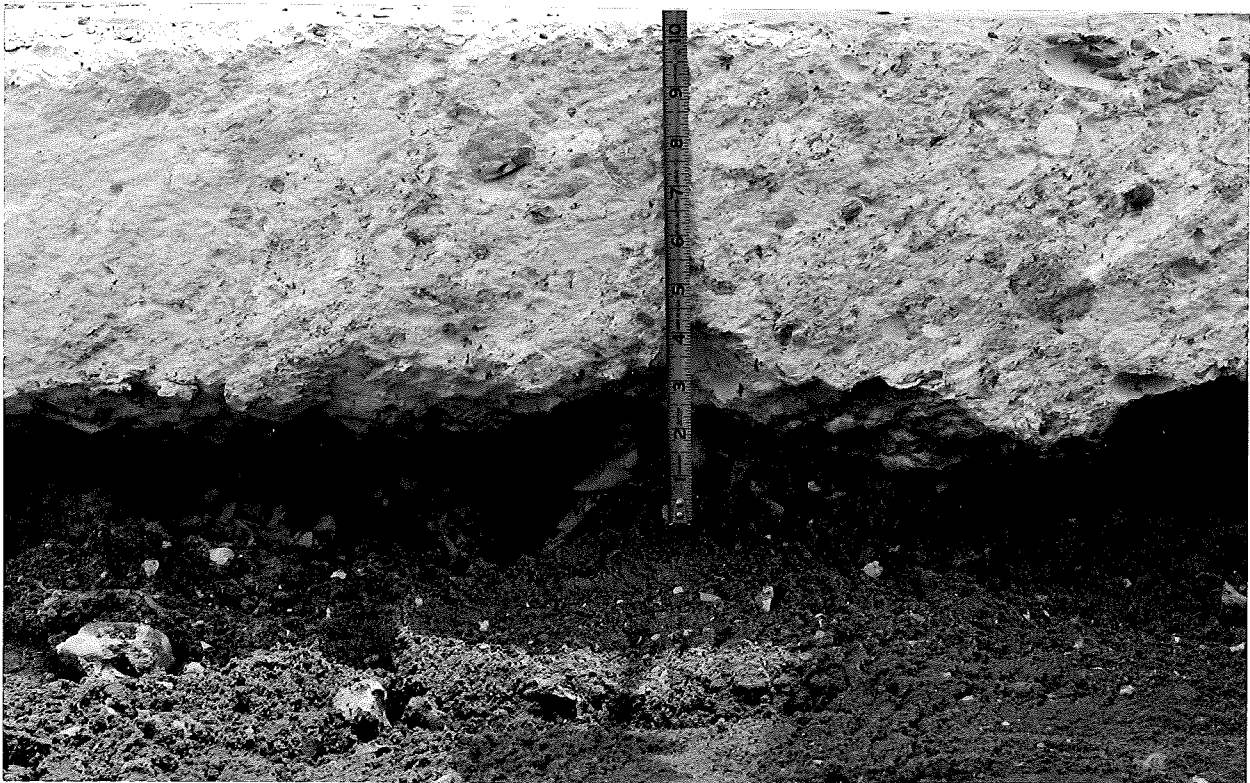
Figure 2. Undercutting of slab bottom. The most severe breaks occurred where the cutting wheel was lowered through the slab.

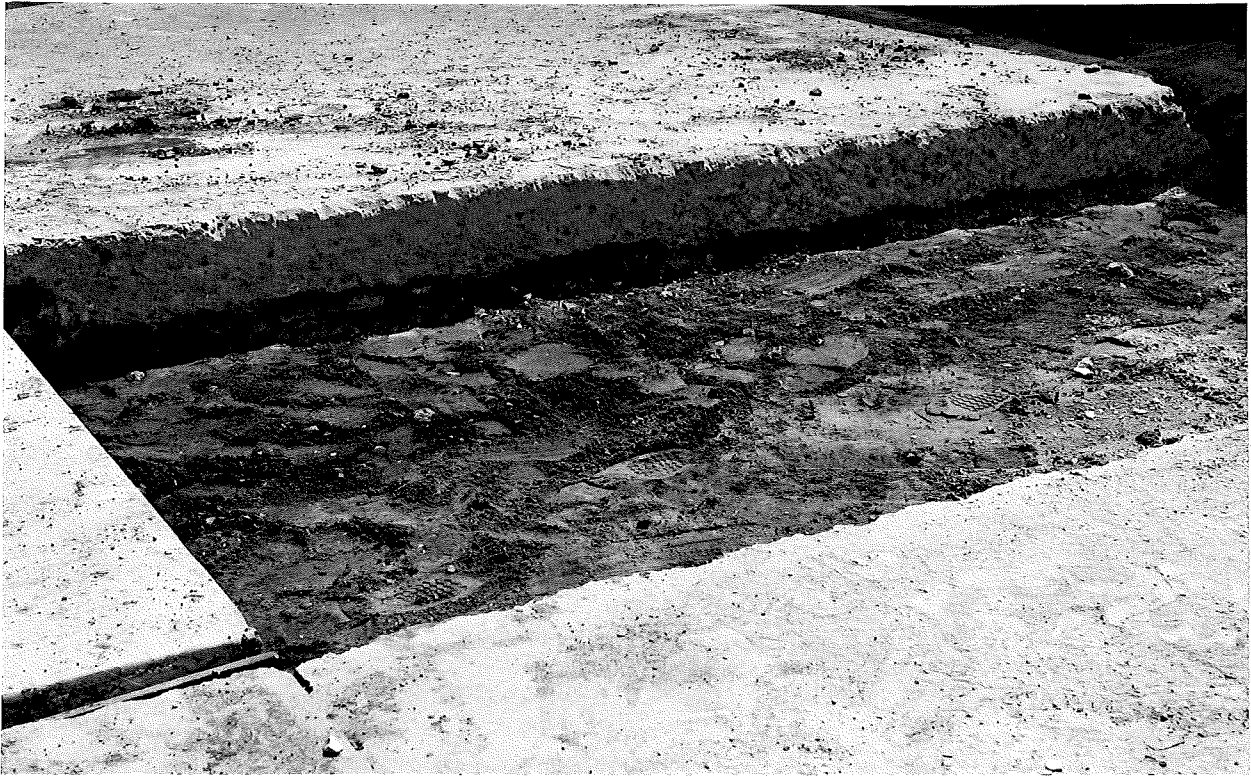
Figure 3. Typical condition of Vermeer sawcut.

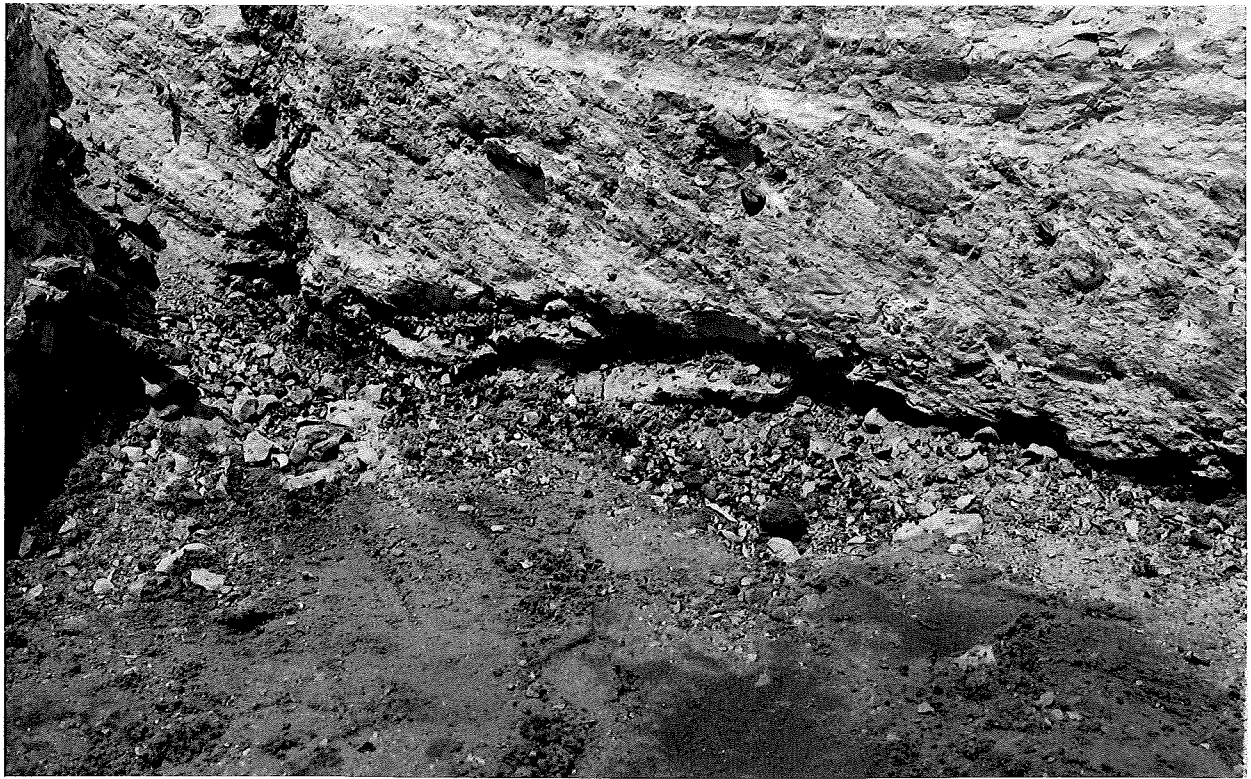
Figure 4. Ledges or "stepping" in vertical edge near centerline of the pavement.

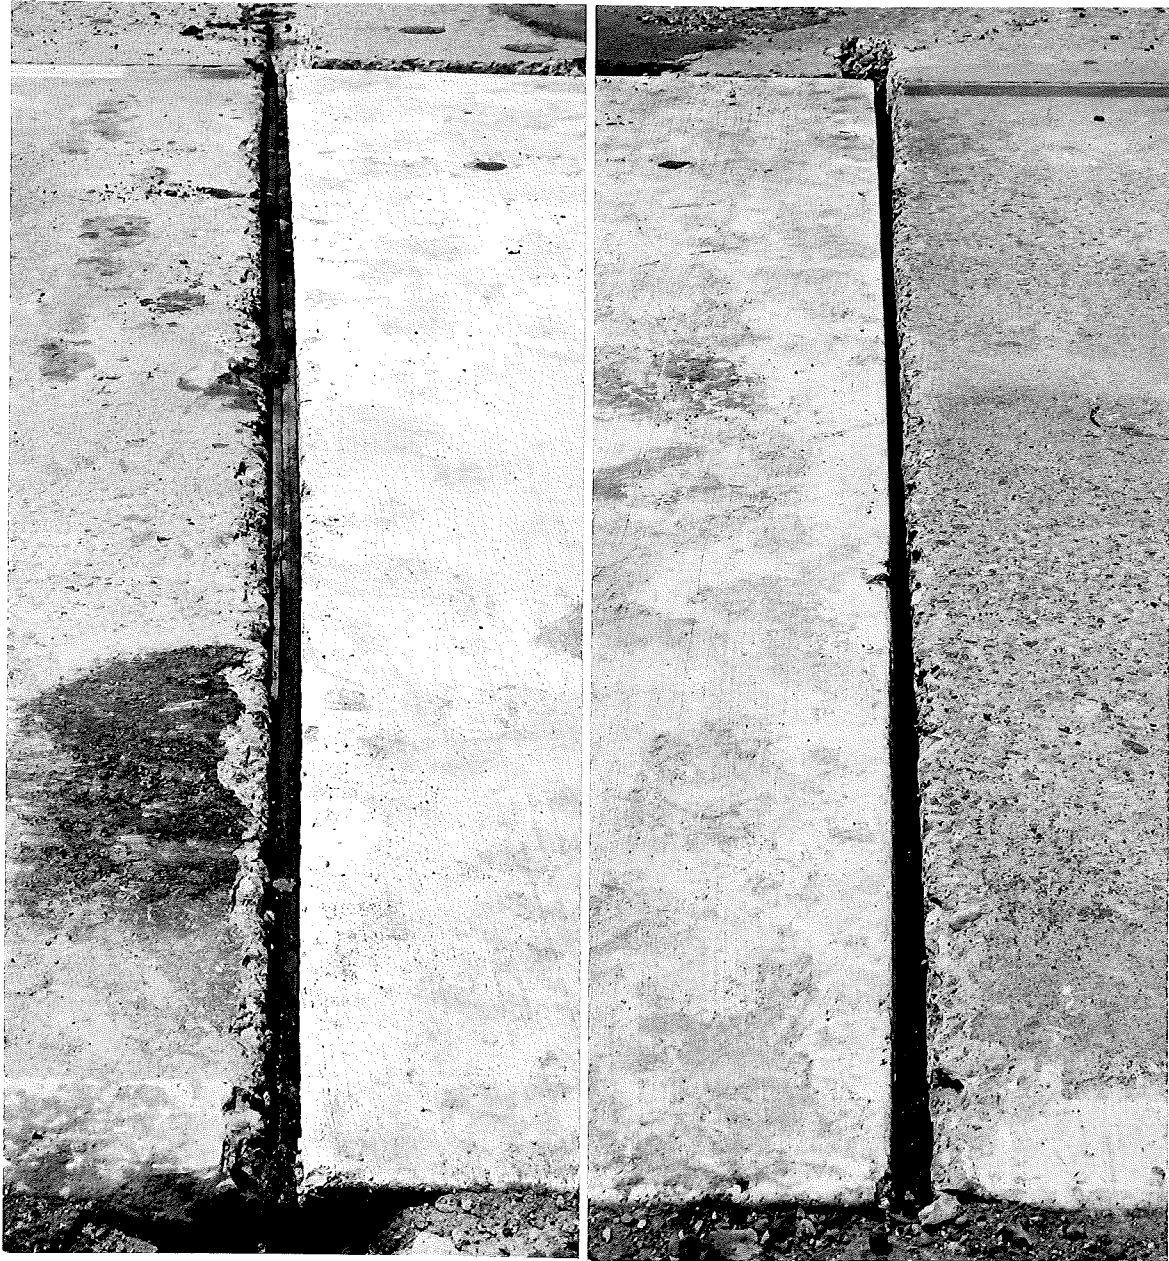
On the basis of the above information, it is evident that the quality of the Vermeer sawcut does not measure up to that of a diamond blade cut. It appears that the unevenness of the cut and undercutting of the slab may eventually result in high localized compression forces across the slab face which could lead to formation of corner breaks and spalls. This problem could probably be reduced by installing more expansion space at each repair than presently used. The ragged surface edge will more than likely result in noisy joints, but if further spalling does not occur the smoothness of the joints should get better as they close.

Figure 5. Condition of completed joints; south joint is shown to the left and north joint to the right.
