EXPERIMENTAL CONTRACT RESEALING OF JOINTS AND  
CRACKS ON US-16  
Nunica to Fruitport  
Project Mc 70-28, C3

Research Project 53 G-68

Research Laboratory  
Testing and Research Division  
Report 197  
October 9, 1953

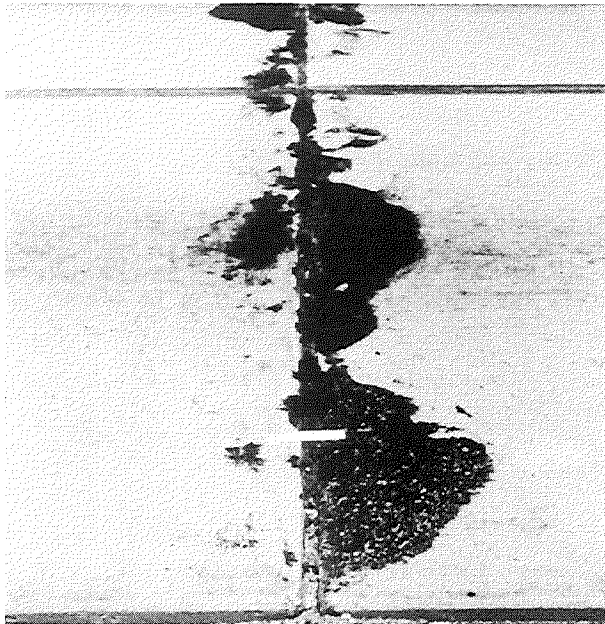
The pavement on which the sealing operations were performed was constructed in 1933 and 1934 and was in good condition for a pavement of that age. It was built on a sand subgrade and was of 9:7:9 cross section containing 60 lb. of reinforcing steel mat per 100 square feet, with expansion joints at 100 foot intervals and with no intermediate joints. The expansion joints contained no load transfer devices and were all slightly faulted causing extruded or displaced joint sealer to be spread over the pavement surface on the lower side of the joints. A typical transverse joint is shown in Figure 11.

▲ FIGURE 11. TYPICAL EXPANSION JOINT CONDITION.

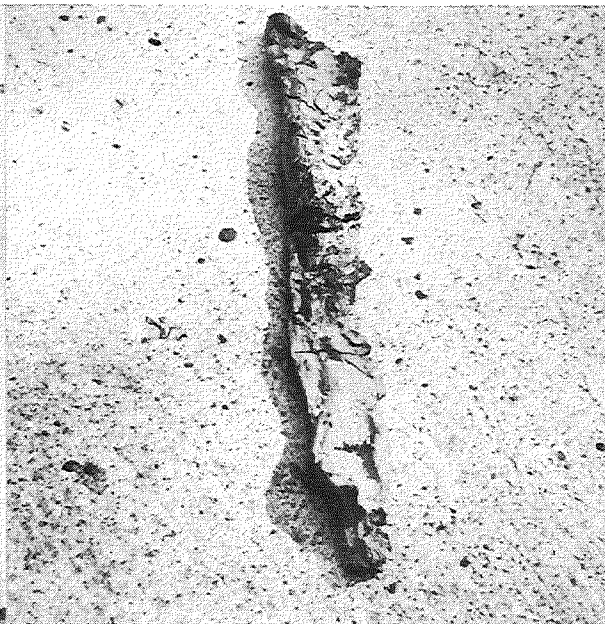
Most of the joint filler in the expansion joints had been forced downward, apparently by infiltration of gravel followed by compaction from traffic. It was found that the joint filler near the edges of the pavement had been forced slightly into the subgrade. A piece of filler that had been found in such a position is shown in Figure 12. The transverse joints

▲ FIGURE 12. SECTION OF OLD JOINT FILLER RECOVERED FROM SUBGRADE UNDER EXPANSION JOINT.

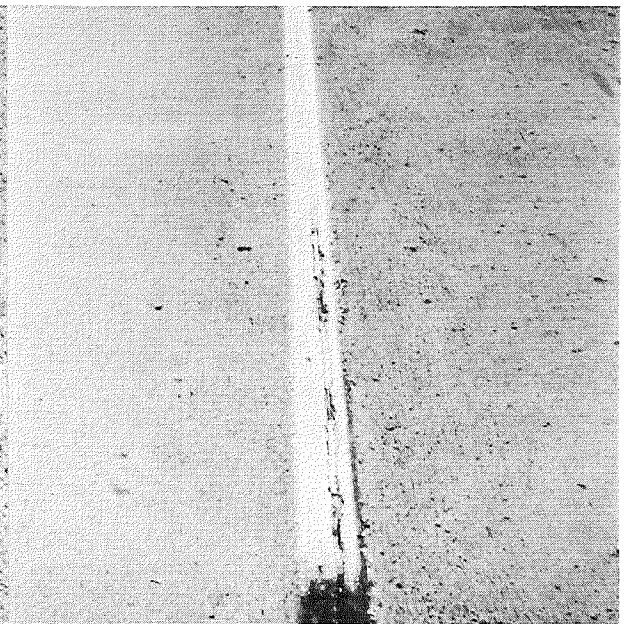
▲ FIGURE 13. SECTION OF TYPICAL LONGITUDINAL JOINT.

The longitudinal joint was a plane of weakness joint containing a premolded filler material at the top. In many places this filler was partly gone leaving the joint susceptible to infiltrations of foreign materials. A section of typical longitudinal joint is shown in Figure 13.

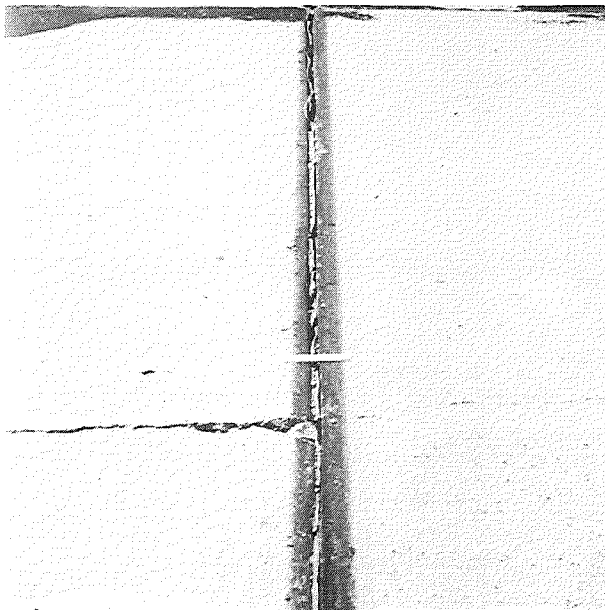
▼ FIGURE 14. EXCESS WIDENING OF LONGITUDINAL JOINT. SLAB DISPLACED SIDEWAYS.

Figure 14 shows a longitudinal joint condition frequently encountered in which a section of concrete between an expansion joint and a nearby transverse crack has become laterally displaced causing the adjacent longitudinal joint to open excessively.

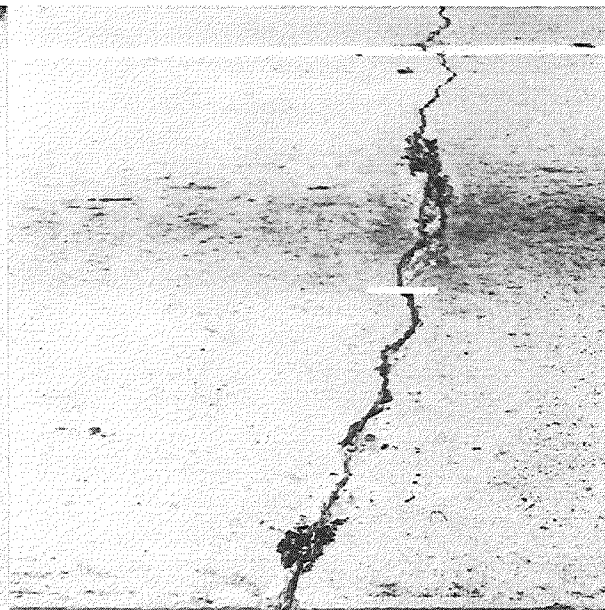
▼ FIGURE 15. TYPICAL OPEN TRANSVERSE CRACK.

Cracks in the pavement were almost entirely transverse cracks and were of two distinct types, open 1/4 inch or more, and closed tight. A typical open crack is shown in Figure 15. Although the closed cracks were tight enough to prevent infiltrations of dirt and gravel, many of them were becoming badly spalled at the edges and were in need of sealing. Such a crack is shown in Figure 16.

1. Sandblast vertical faces of crack to at least one inch depth and the pavement surface to at least one inch each side of crack.
2. Blow out with compressed air and seal in at least two pours.

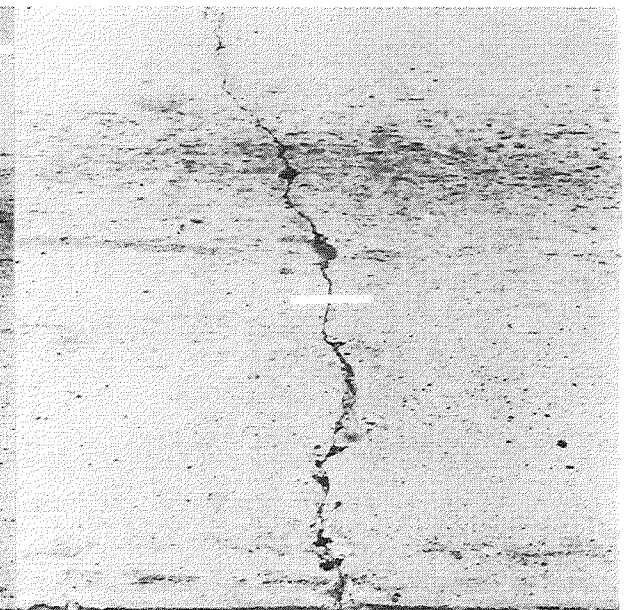
▼ FIGURE 16. TYPICAL SPALLED CLOSED CRACK.

1. Sandblast until a V-shaped groove is formed along the crack. The groove should be  $3/16$  to  $1/2$  inches deep and  $1/2$  to  $3/4$  inches wide. The pavement surface should be sandblasted about  $1/2$  inch each side of the groove.
2. Blow out with compressed air and seal in one pour. Fill until sealer overlaps surface of pavement about  $1/8$  inch.

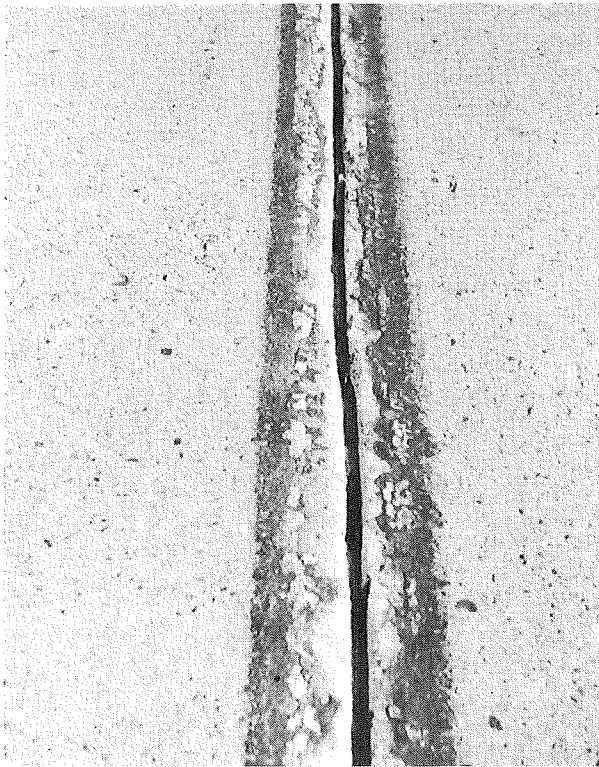
▲ FIGURE 17. CLOSEUP OF LONGITUDINAL JOINT, CLEANED AND READY FOR SEALING.

1. Flow out old felt to a depth of 3/4 to 1 inch, preferably making one pass each way.
2. Make one pass with Tennant machine using single row of 4-inch cutters in head to clean vertical faces of joint and to further remove felt.
3. Sandblast vertical faces of joint and about 1 inch each side of joint to remove traffic paint. If necessary, use hand tools to remove any felt left in top inch of joint.
4. Blow out with at least 90 psi compressed air and seal in two pours.

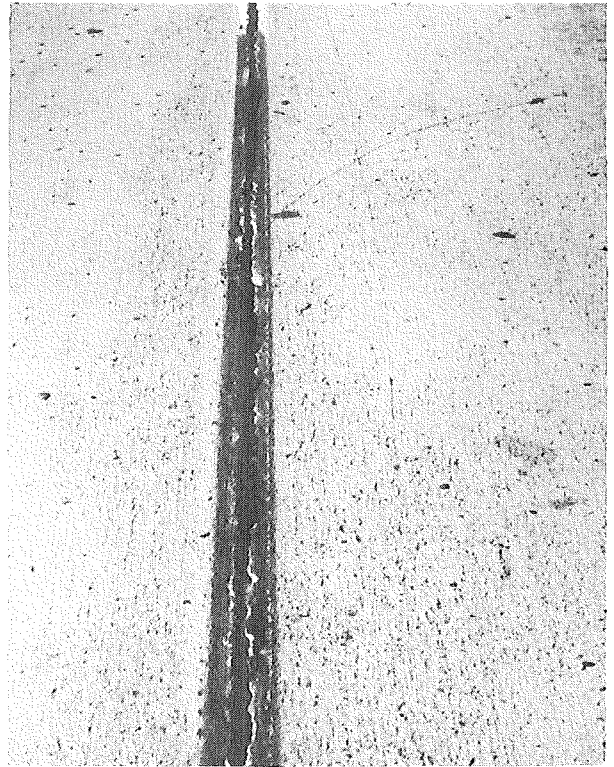
▲ FIGURE 18. LONGITUDINAL JOINT AFTER RESEALING.

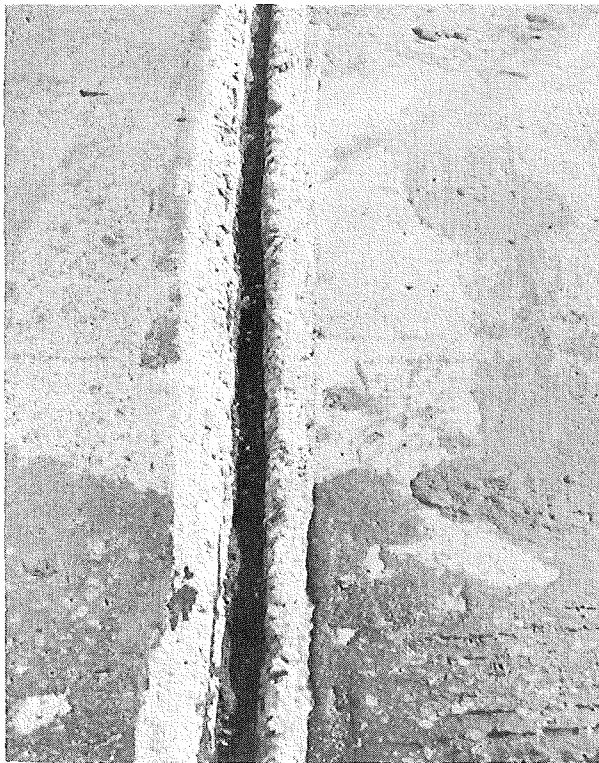
▲ FIGURE 19. CONDITION OF EXPANSION JOINT JUST PRIOR TO POURING.

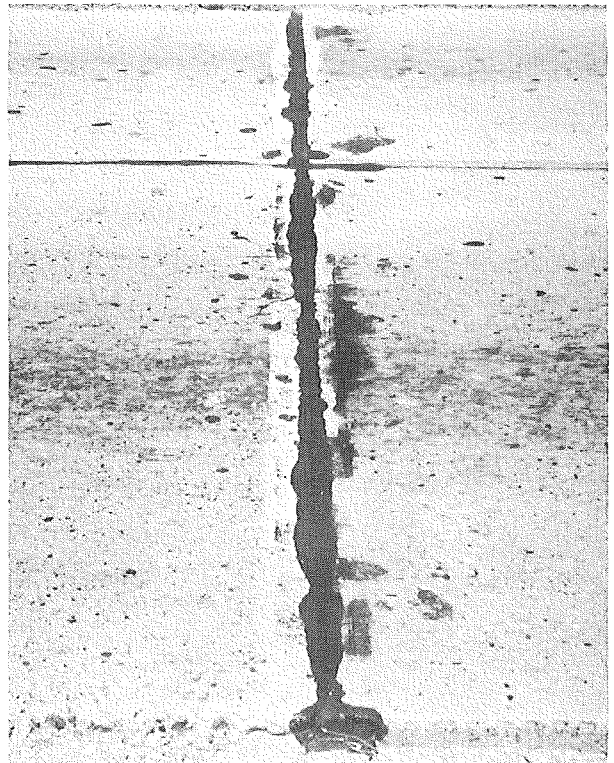
▲ FIGURE 20. EXPANSION JOINT AFTER RESEALING.

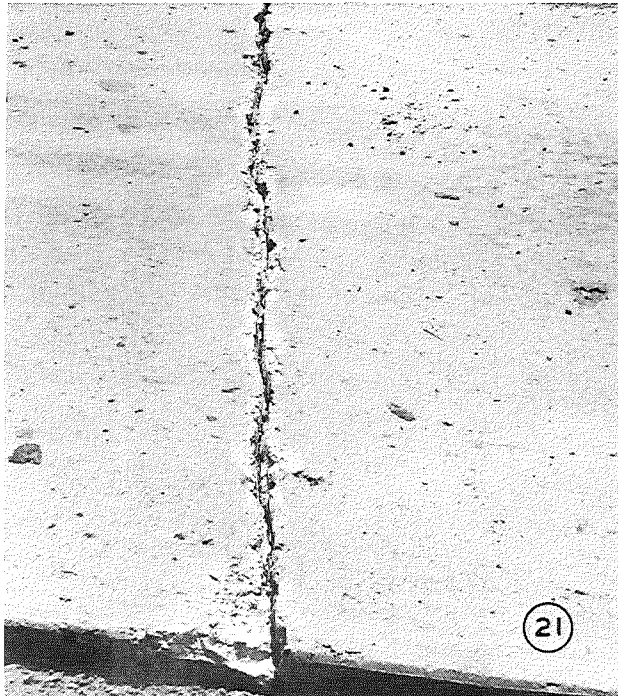
One open crack at station 658/75 was cut out with the Hecker machine using 1/2 inch cutters at a depth of 1/2 inch. Another open crack at 640/94, Figure 21, was routed out with the Tennant machine using a single row of 4-inch cutters. The crack prepared with the Hecker machine was satisfactory in appearance but did not appear much different from one treated with sandblast only. The crack routed with the Tennant machine was opened much wider than necessary at the top. As a result of these two experiments it was decided to prepare all open cracks with sandblast only, followed by blowing out with air.

FIGURE 21. OPEN CRACK CUT OUT WITH TENNANT MACHINE, READY FOR SEALING.

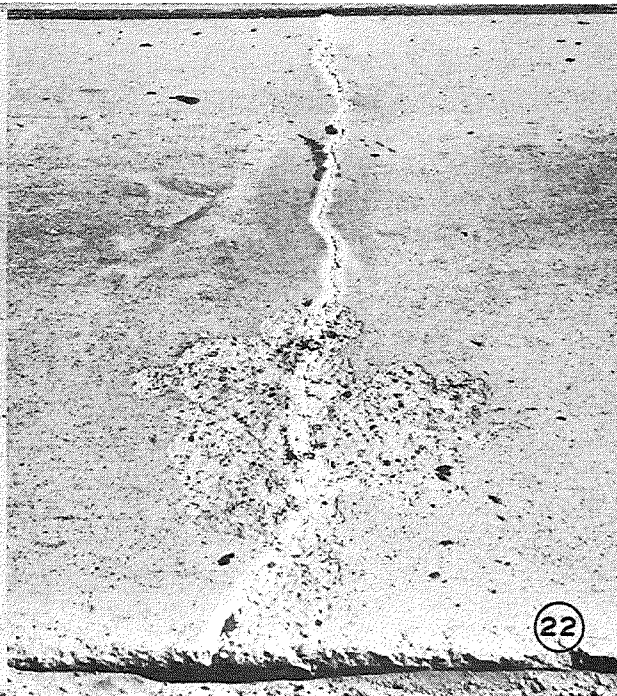
FIGURE 22. CLOSED CRACK AFTER SANDBLASTING V-SHAPE GROOVE ALONG CRACK.

As soon as a decision had been made to seal closed cracks, two such cracks were sandblasted until a V-shape groove was formed along the crack. The groove was 3/16 to 1/4 inches deep and 1/2 to 3/4 inches wide at the top. The pavement surface was cleaned with sandblast about one half inch each side of the groove, blown out with air, and the crack sealed. Sealing material was applied in one pour to a level sufficient to allow an overlap on to the pavement surface of about 1/8 inch. This allowed the top surface of the sealer to be slightly higher than the pavement surface. After traffic had crossed these two cracks for 24 hours it appeared that the sealing material tended to become even more firmly wedged down into the groove and seemed to form a very tight seal. As a result all closed cracks from station 581/65 to the west end of the project were treated in this manner. A crack of this type ready for sealing is shown in Figure 22 and after sealing in Figure 23.

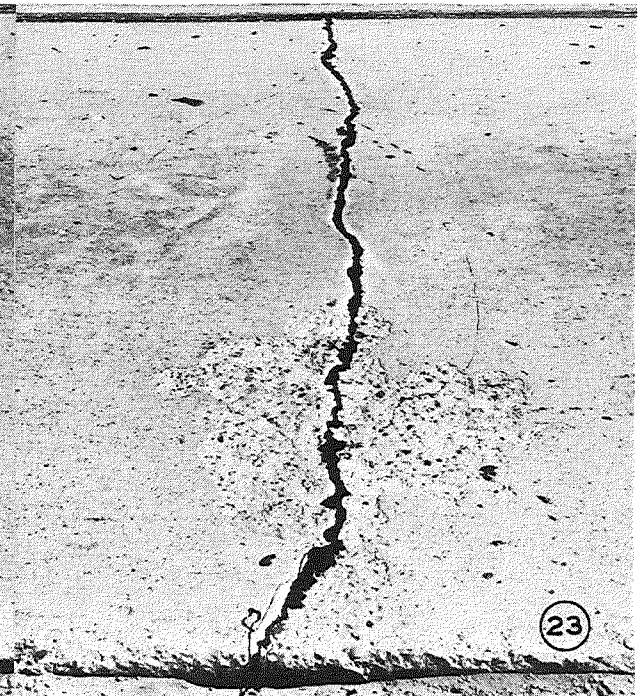
FIGURE 23. SAME CRACK AS FIGURE 22 AFTER SEALING.

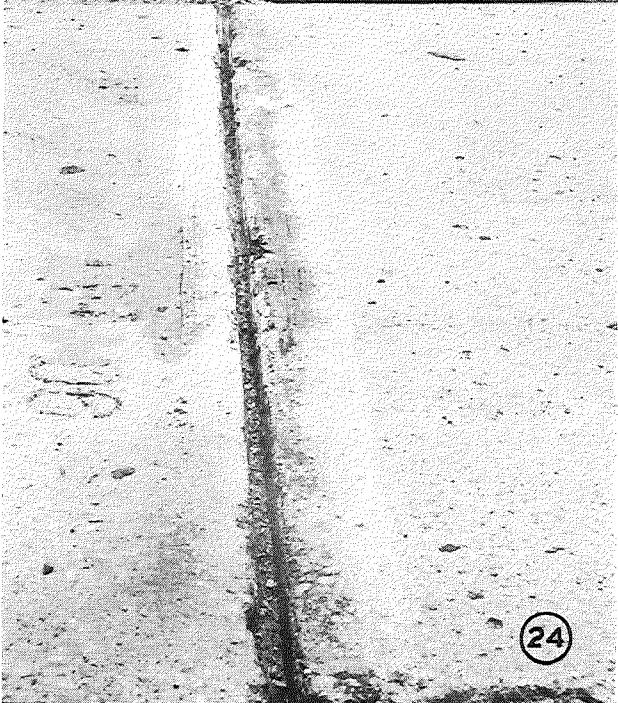
FIGURE 24. INFILTRATION OF GRAVEL AT PAVEMENT EDGE IN TRANSVERSE JOINT.

The old joint materials in almost all of the transverse joints had been displaced by gravel and dirt for all or most of the pavement depth for about two feet from each edge of the pavement, Figure 24. This necessitated extra sandblasting, blowing and hand raking in these sections to remove as much of the foreign material as was practicable. Figure 25 shows a joint cleaned and ready for sealing in which the depth of cleaning can be noted.

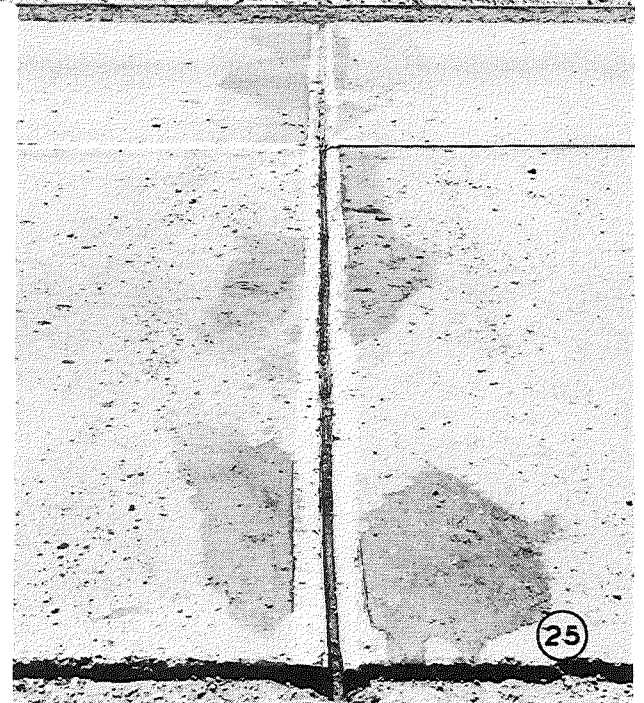
FIGURE 25. SHOWS DEPTH OF CLEANING IN TRANSVERSE JOINT NEAR PAVEMENT EDGE.
