ALLEGED DAMAGE TO THE RESIDENCE OF
G. McAVON DUE TO TRAFFIC INDUCED VIBRATIONS

MICHIGAN DEPARTMENT OF STATE HIGHWAYS

Research Laboratory Section
Testing and Research Division
Research Project 72 TI-82
Research Report No. R-829

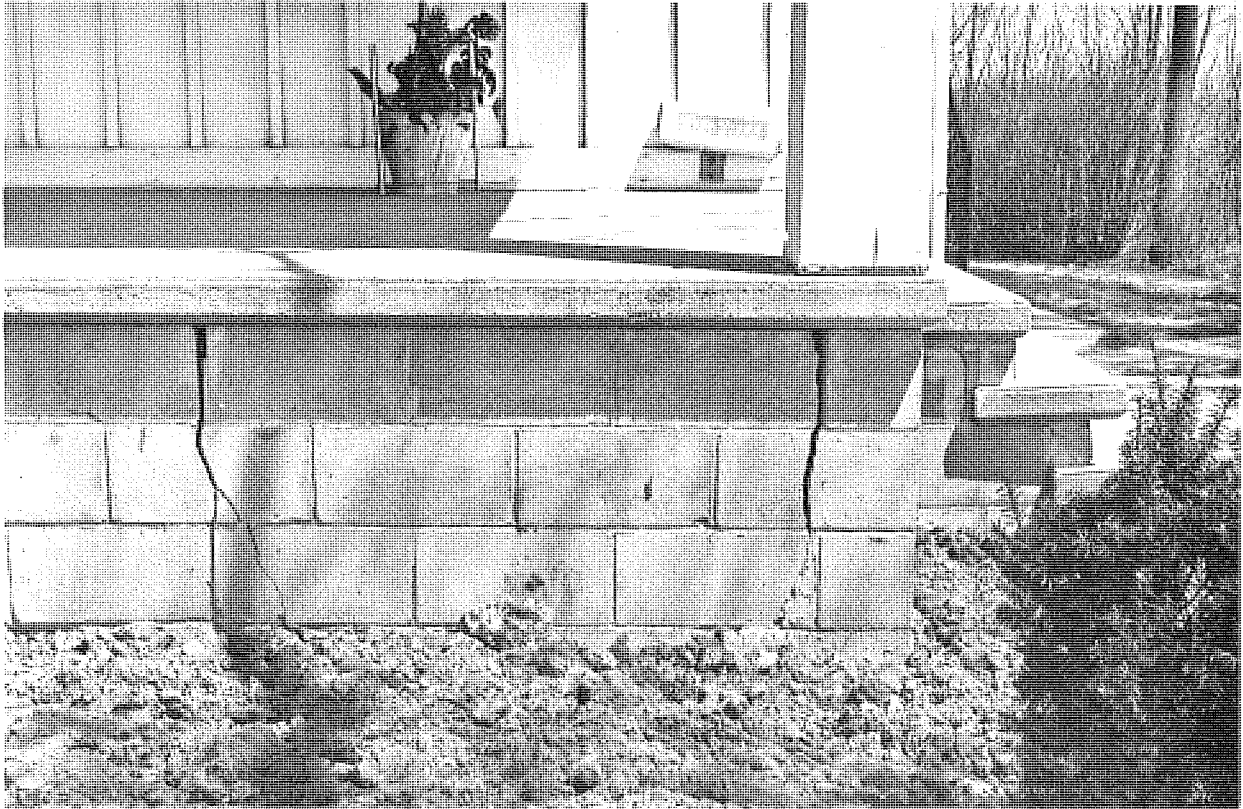
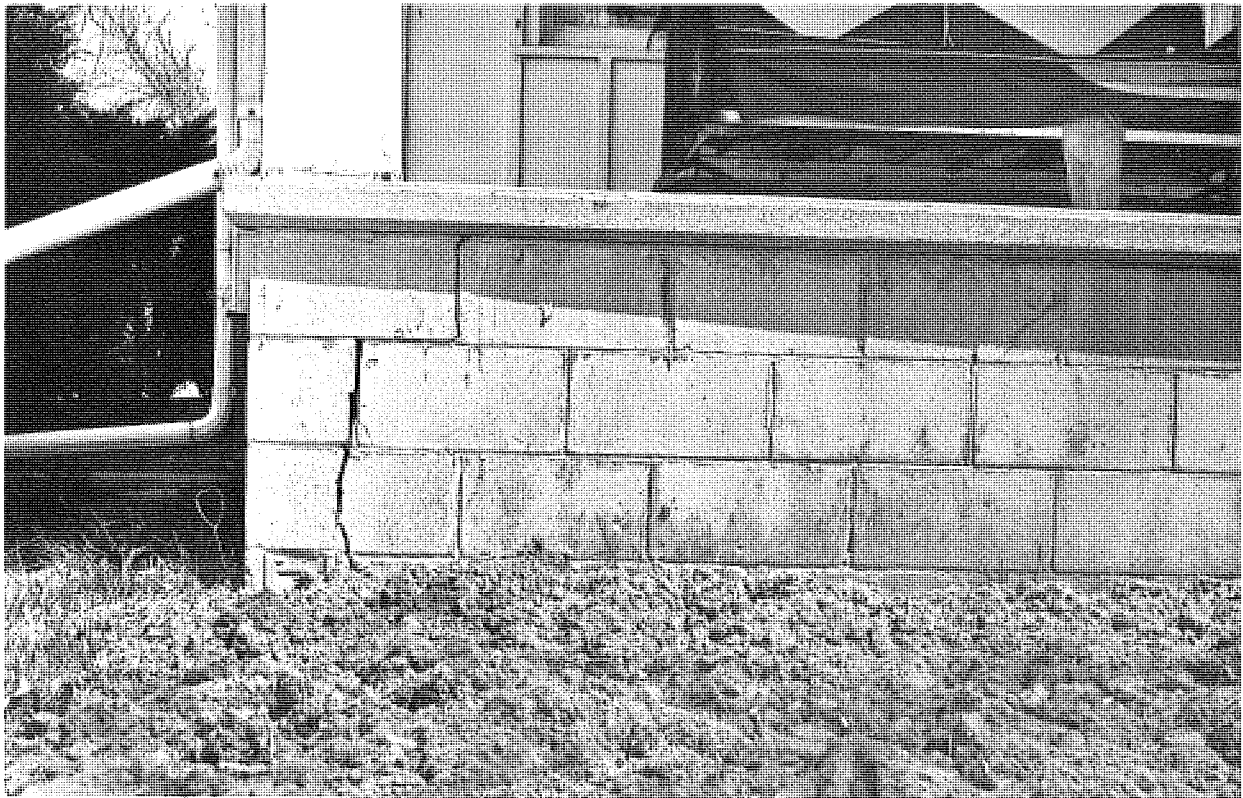
Damage to the McAvon house consists primarily of differential settlement of the front porch and the foundation for the front wall of the house. The owner reports that the porch roof has pulled away from the house, al-

lowing water to enter the front wall and leak inside the house. The porch wall is cracked in many places, as indicated in Figure 1. The basement wall also is cracked, as shown in Figure 2. Figure 3 shows the front porch steps, and adjacent sidewalk settlements that indicate to some extent the nature of the soil problems that exist. Note that the downspout empties into the area that has subsided.

Figure 1. Condition of porch foundation showing cracking at the southeast (upper) and southwest (lower) corners.

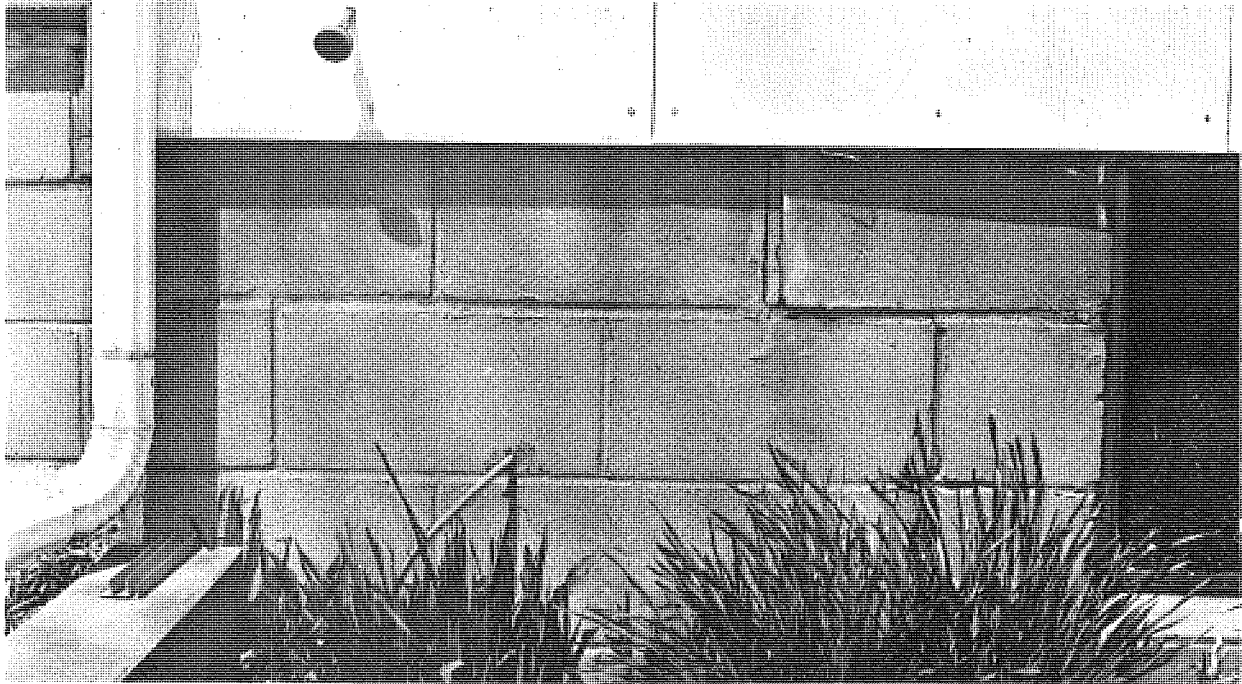
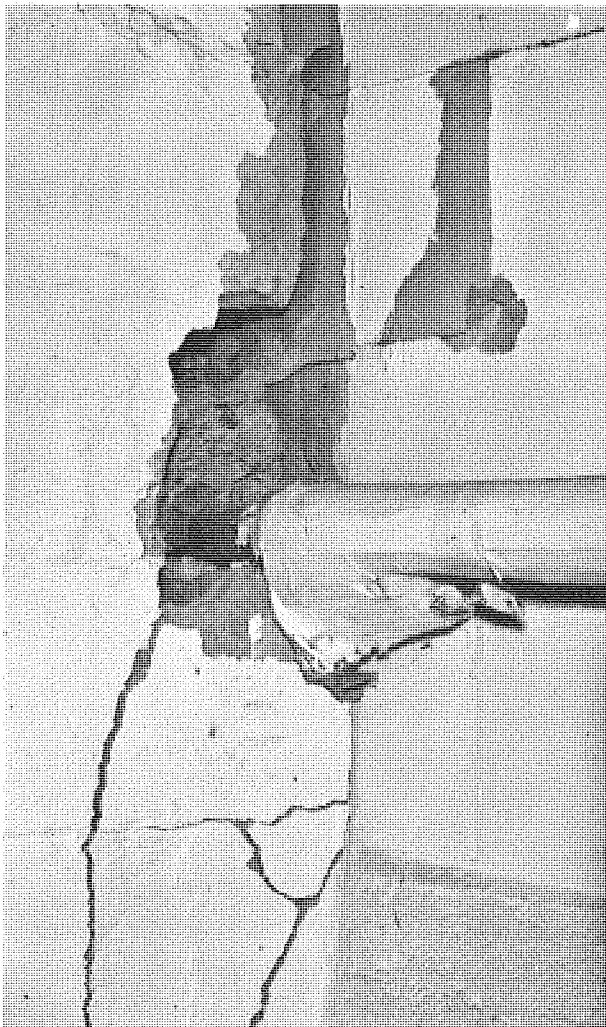
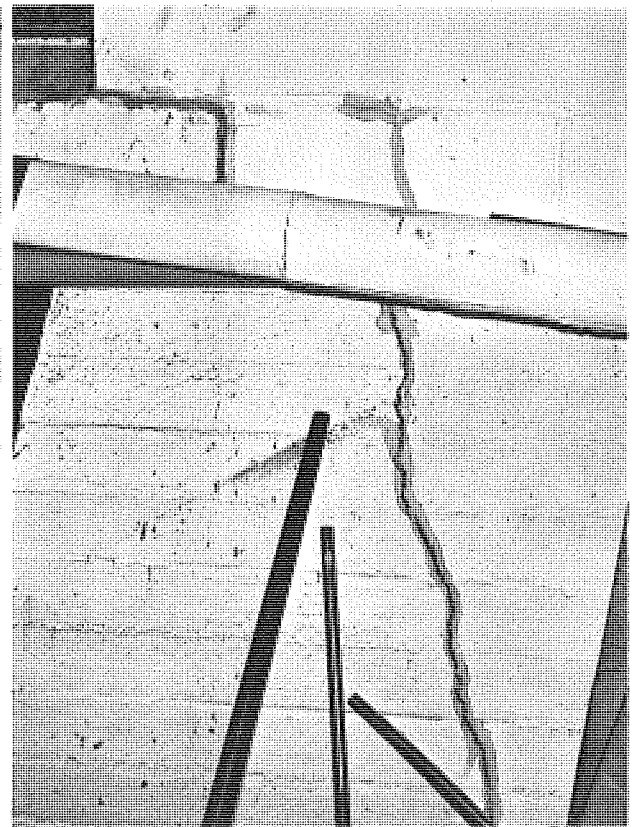
Figure 2. Condition of basement walls showing cracking at the southeast corner (upper, exterior). The center-front (left), and on the west side wall, near the southwest corner (above).

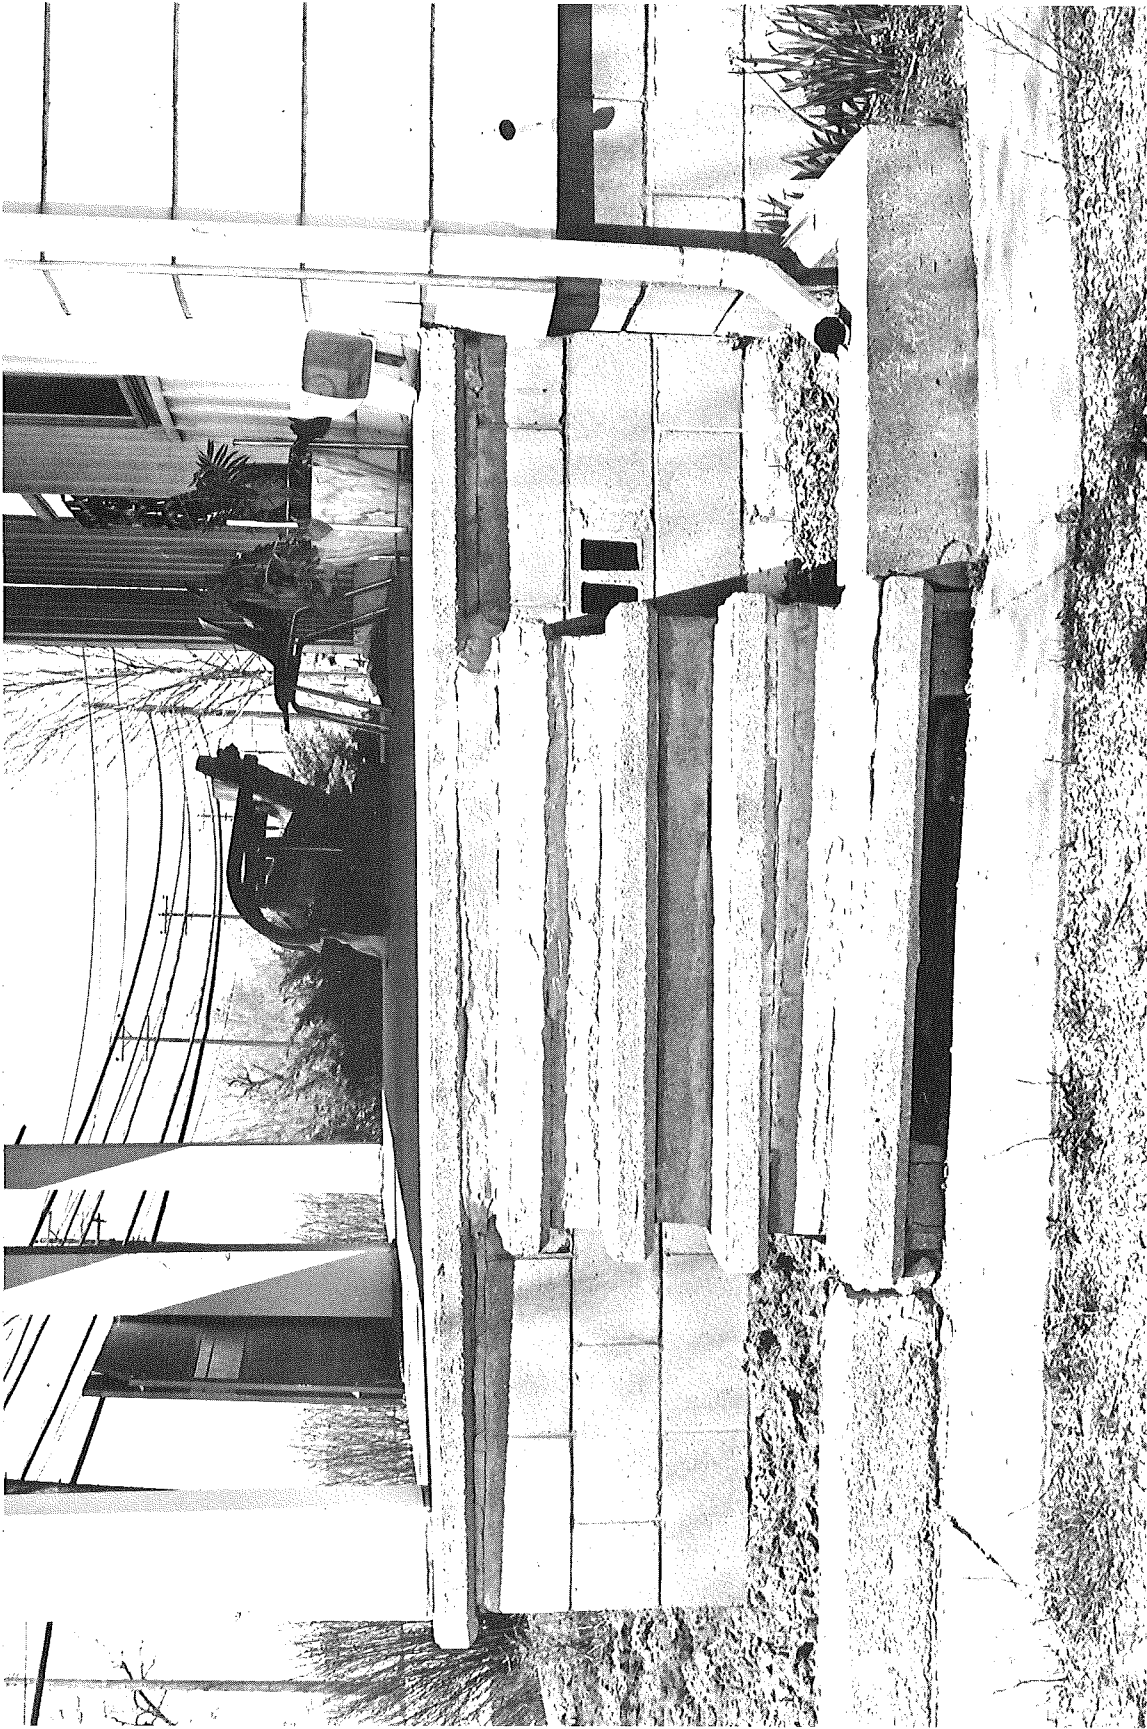
Figure 3. East end of front porch showing settlement of sidewalk and steps.
