MICHIGAN
DEPARTMENT OF STATE HIGHWAYS

Subject: Field Inspection of Telespar Sign Posts, "Watch for Ice on Bridge"
Type. Research Project 74 TI-237. Research Report No. R-938.

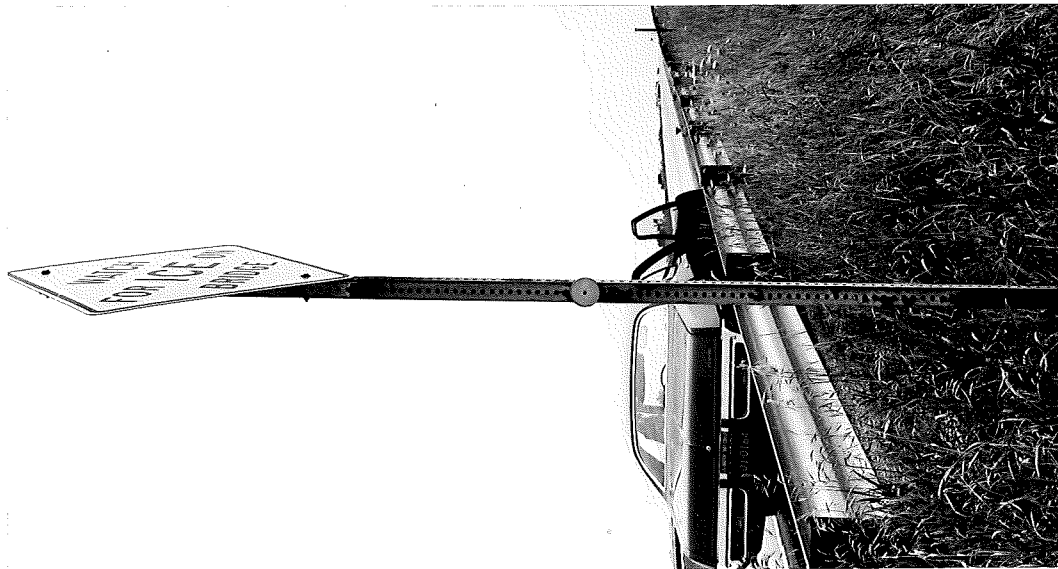
A few of the observed six-year old perforated Telespar posts showed about 30 percent loss of coating on some faces, though most showed only minor loss of coating except at contact points, which apparently accounts for the noted rusting together of post and ground-driven boot. Figures 1 and 2 show performance of the posts.

Figure 1. Six-year old post on old M 78 west of M 71 shows appreciable loss of coating on the side facing traffic, especially at contact points.

Short Term Exposures - Because of the generally acceptably good galvanized coating performance noted on six-year old Telespar post installations, we recommend their approval for use in relatively short term exposures including construction signing.

Long Term Exposures - Because the Telespar post has only about 1/3 the galvanized coating thickness of our normally specified hot-dip coating for posts, we do not recommend the current version for consideration in standard exposures exceeding 10 years; unless the advantage of the square cross-section outweighs the coating's limited durability.

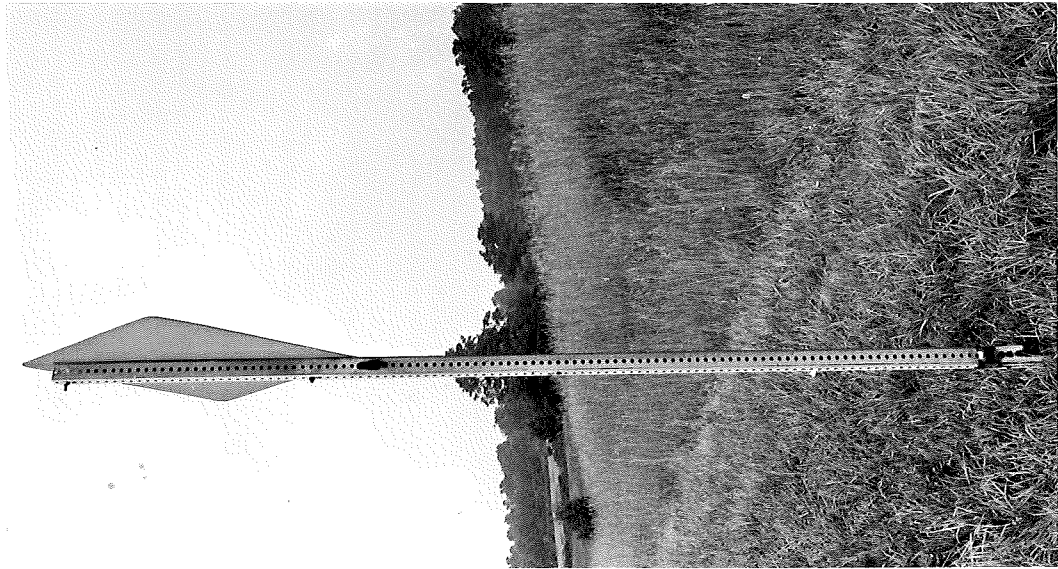
Figure 2. Six-year old post on west-bound I 96 west of Grand River Ave shows insignificant loss of coating except at contact points (sign and boot) and is representative of the majority of these installations.

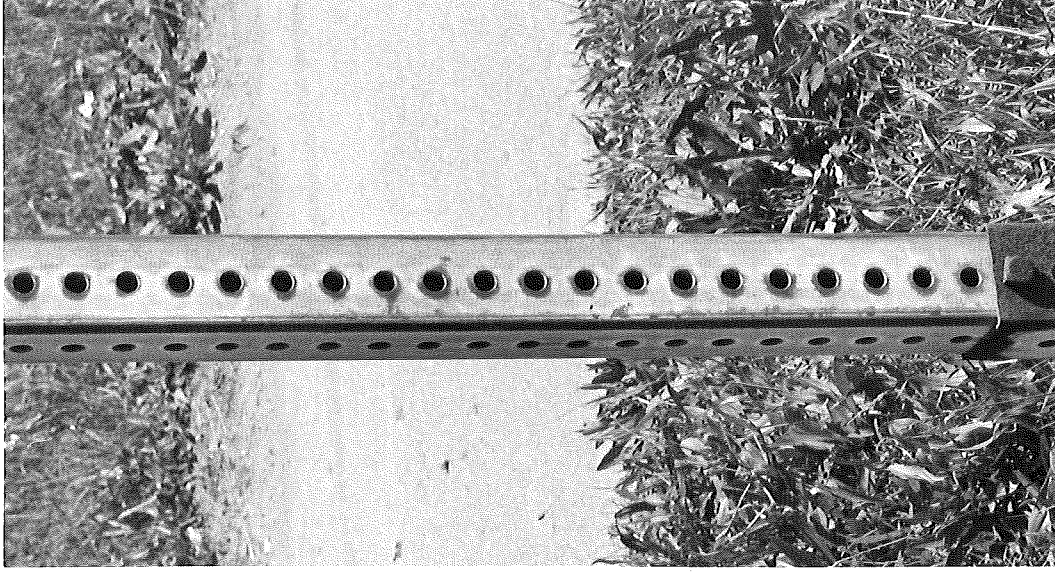
Figure 3. Posts show initial coating failures as indicated in Figures 1 and 2 plus a spreading type failure from the perforations and from the corner longitudinal weld, which is overcoated in the factory. Photo is of an eight-year old post on north-bound US 27 north of Shiawassee St.

General Comments - Marginal improvement in durability of the galvanized coating on Telespar posts could be obtained if the non-perforated type was acceptable, see Figure 3 for authenticated reason.
