MICHIGAN DEPARTMENT OF TRANSPORTATION
MDOT
EVALUATION OF GALVANIZED PEDESTRIAN BRIDGES

EVALUATION OF GALVANIZED PEDESTRIAN BRIDGES

Research and Technology Section
Materials and Technology Division
Research Projects 73 G-197
Research Report No. R-1335

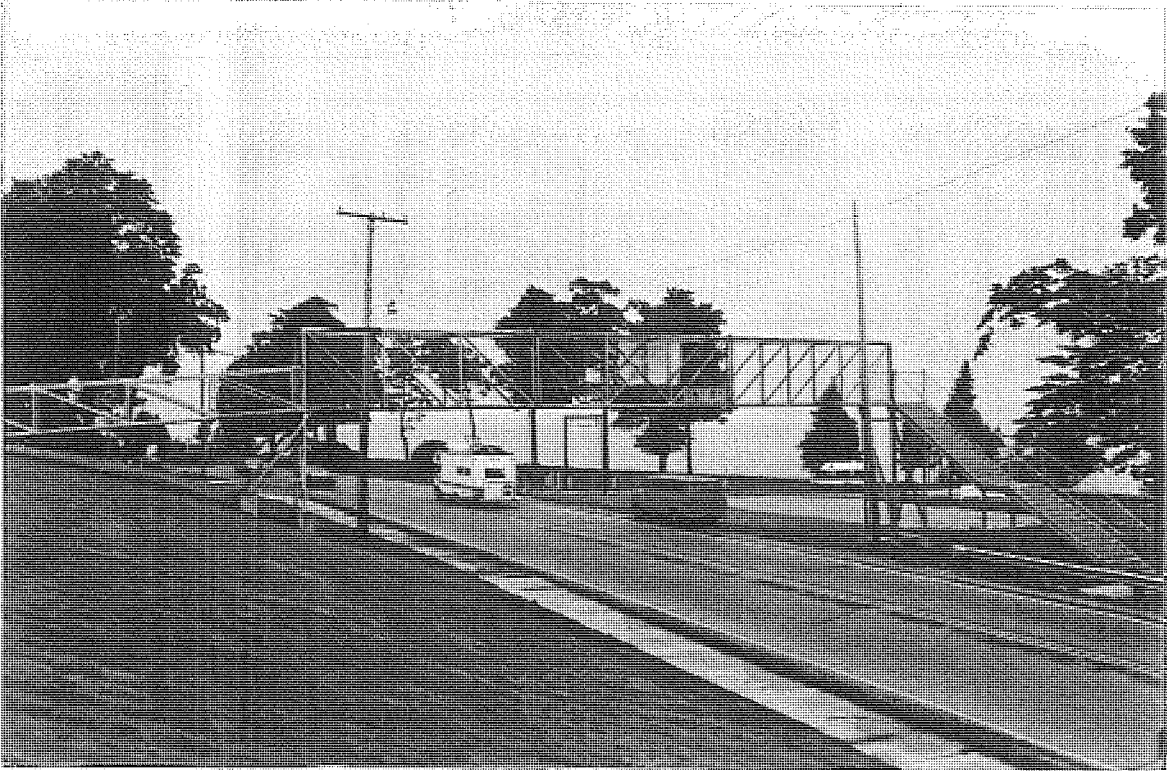
EAST ELEVATION

10. STRINGERS P.&H. #	0	7	10. 4"x4" Box sect. members some bolted conn. has some paint rust. (ONE TOP BAR SWELLING (CRACKS/TRAFFIC))
	11. PAINT	5	5	11. 10-15% overall rust.

12. SECTION LOSS	-	-	
SUB-STRUCTURE	13. ABUTMENTS	-	-	
	14. PIERS	8	4	14. 4"x4" Box Sect. members on CONC. BASE: N PIER BOTH E COLUMNS RUSTED THROUGH ON S FACE W/ (ANY WERE LOOSE (BRACKET SLIP DOWN))

21. CHANNEL PROTECT. #61	-	-	
	22. CULVERT (OVER 20') #62	-	-	
	SI & A # 67	7	5	
#58 (0)	7	7		
#59 (0)	7	7		
#60 (0)	7	5		
				RECOMMENDATIONS: <u>Clean & Repaint.</u> <u>FIX PIER SEE #14</u>

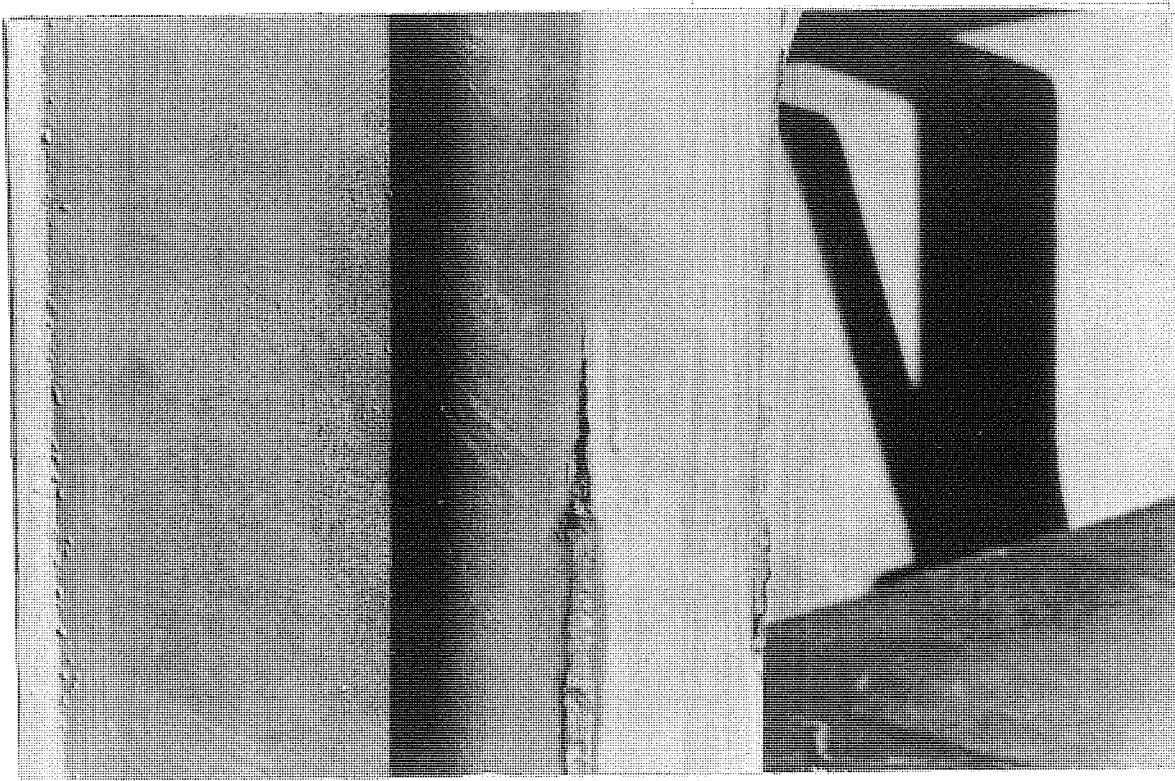
S.W. CORNER, WEST SUPPORT, SOUTH PIER

12. SECTION LOSS	<u>1</u>		
SUB-STRUCTURE	13. ABUTMENTS	-		
	14. PIERS	<u>6</u>		<u>14) W. Column of South Pier supporting main span is cracked along & extending into previous welded repair, 6" Above weld & 3" below @ SE corner & 3 1/2" Above SW corner South Ramp column N & S severe map cracking same tearing, North Ramp column 1F & 2E</u>

10. DRAINAGE SYSTEM	-	
	11. STRINGERS P. & H.	<u>88</u>	
	12. PAINT YEAR <u>Gray 1986</u>	<u>7/7</u>	
SUBSTRUCTURE	13. ABUTMENTS	-	
	14. PIERS	<u>66</u>	<u>14. W. Col of S. Pier supporting main span is cracked along and extending into previous weld repair 6" above weld and 3" below weld at SE corner 3 1/2" above at S.W. Corner</u>
