FROST HEAVE INVESTIGATION OF I 275

E. C. Novak, Jr.

Research Laboratory Section
Testing and Research Division
Research Project 79 TI-622
Research Report No. R-1194

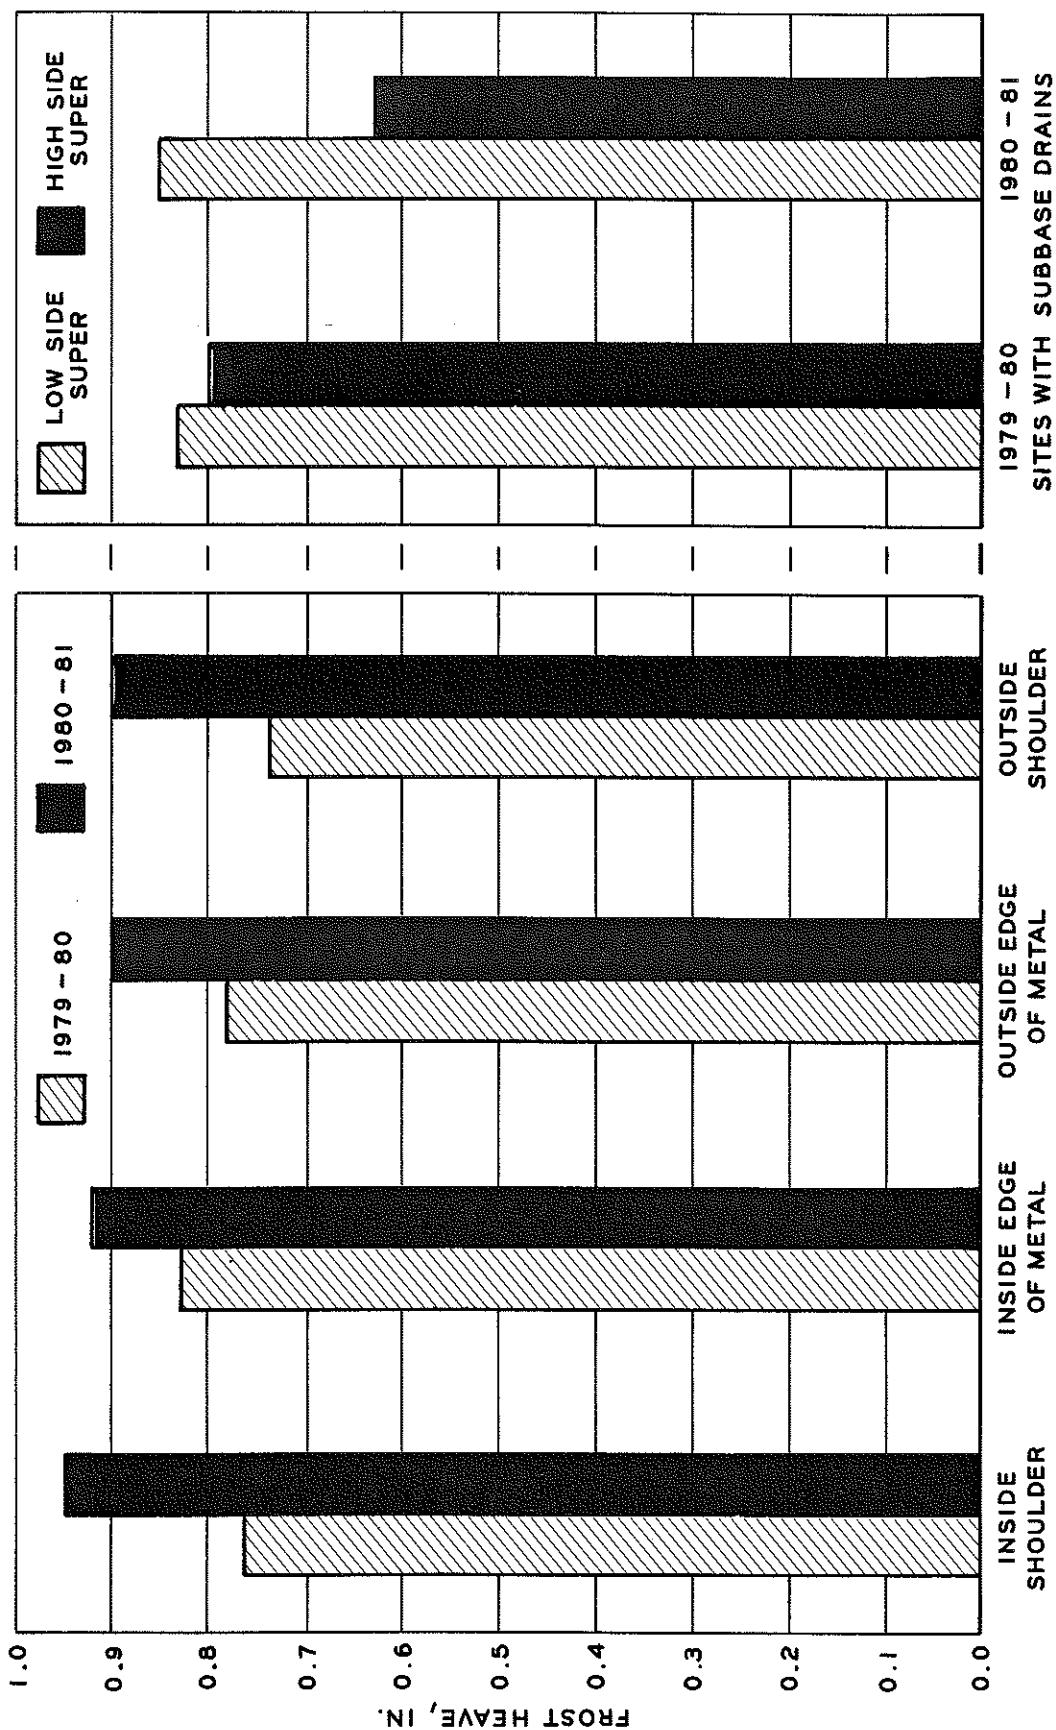
Figure 5. The average of the maximum frost heave measured at each site.

Figure 5 shows that the average of the maximum frost heave measured at both drained and undrained sites was greater for the 1980-81 season than it was for the previous season. These results show that the retrofit underdrains have had little, if any, influence on minimizing the frost heave potential of the pavement. However, as has previously been reported, the type of drain installed on I 275 does not reduce frost heave, rather it reduces the period of time that the pavement is in a weakened condition following spring thaws. The drains accomplish this by reducing the length of the drainage path which, in turn, increases the rate of consolidation of the subbase and, therefore, the base layers.

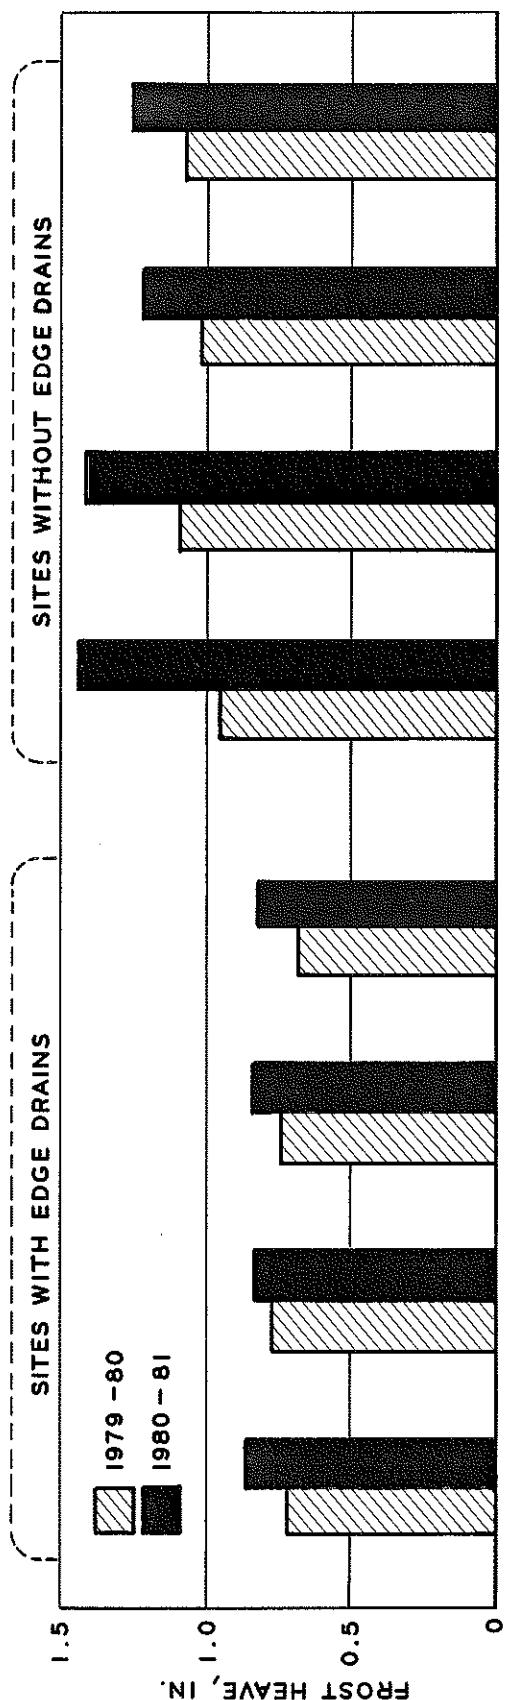
Figure 7. The average of the maximum frost heave measured at sites where retrofit underdrains were installed and sites where they were not installed.

Figure 7 compares the average of the maximum frost heave measured at sites with and without underdrains and before and after retrofitting underdrains. The results show that sites with underdrains heave about 1/2 in. less than those without underdrains. This figure also shows that the percent increase in frost heave from 1979-80 to 1980-81 freezing seasons was, 15 percent for drained sites compared to 30 percent for undrained sites. The indication is that retrofit underdrains are attenuating maximum frost heave. Of what value this may be in terms of increased pavement life requires long-term monitoring of longitudinal crack development of projects having retrofit underdrains compared to those without underdrains.

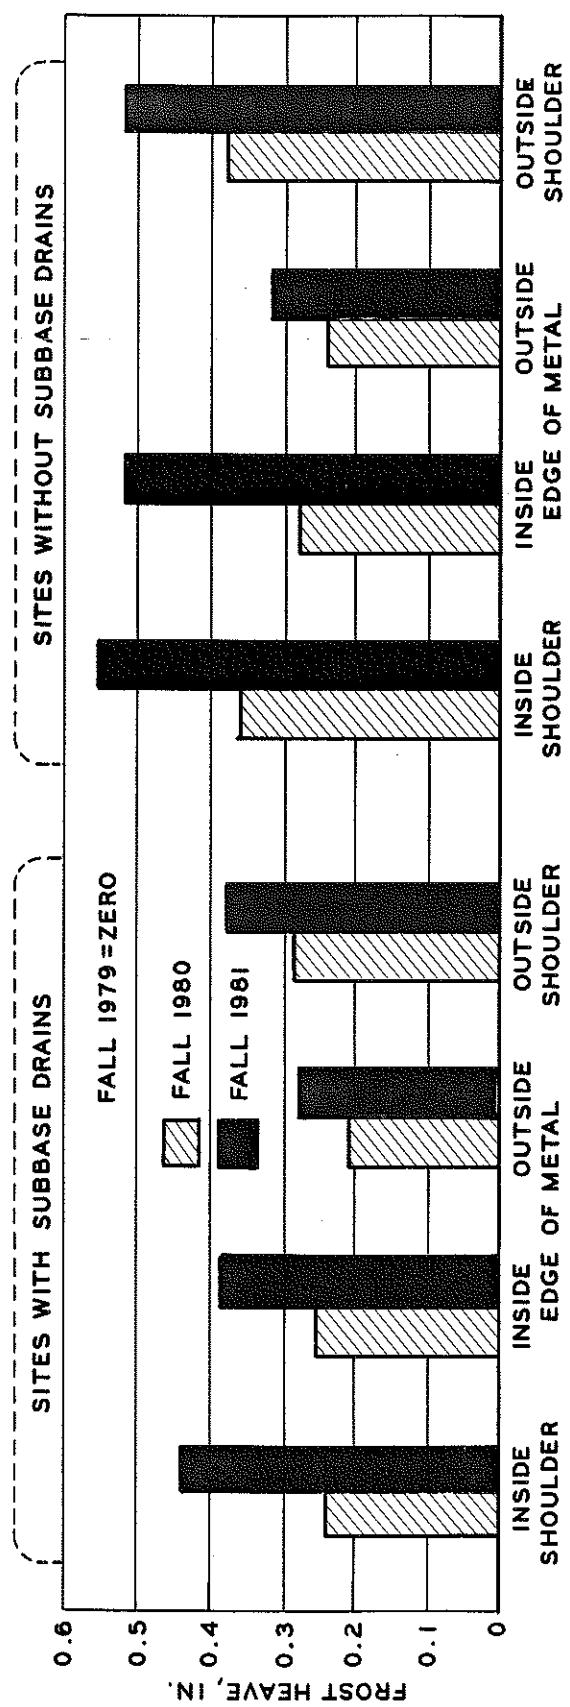
Figure 8. Average pavement elevation at the indicated locations, using 1979-80 elevations as data.

Figure 8 compares the average autumn pavement elevation for the 1979, 1980, and 1981 seasons. These data show that where less frost heave occurs there is less residual heave as a result of frost action. These data also show that recompactive effort and residual heave are inversely proportional. That is, in the traffic lane where compactive effort is greatest, permanent heave is smallest. These data also indicate the pavement sections studied are experiencing a reduction in the rate of accumulation of residual heave.

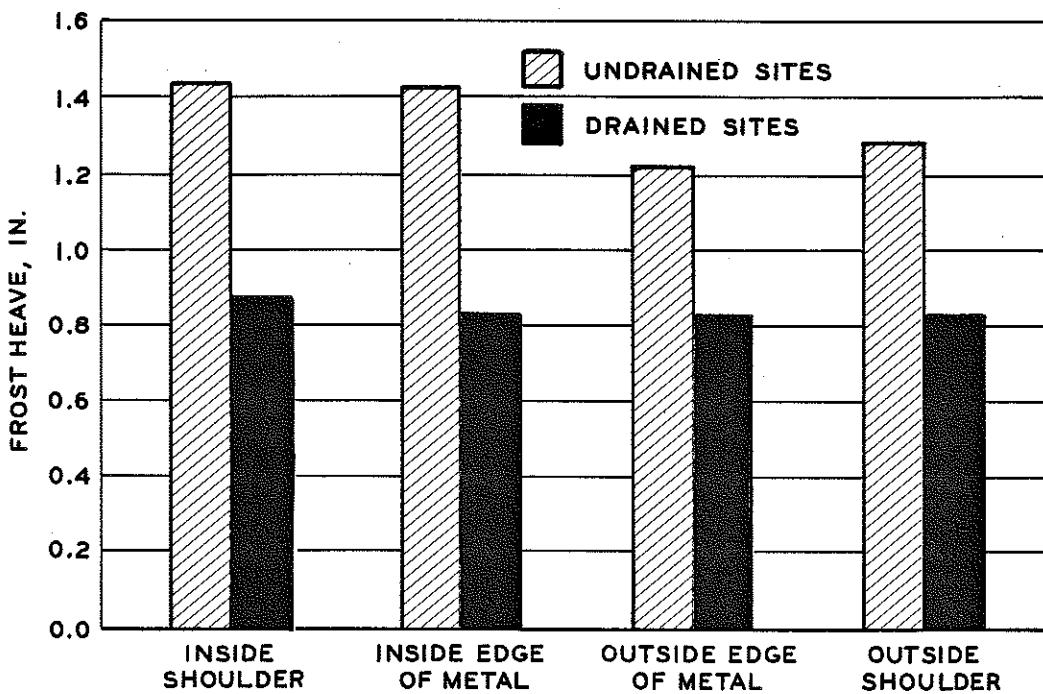
Figure 9. Average maximum frost heave of drained sites compared to undrained sites, 1980-81 data.

Figure 9 compares the maximum frost heave of undrained sites compared to drained sites (1980-81 data). These data show that considerably more frost heave occurs in section 3 where there are no retrofit underdrains compared to sections 4, 5, and 8 where drains were installed. Figure 7 shows this same relationship also existed before underdrains were installed. And, as Ref. (3) points out, section 3 has the poorest drained foundation of the sections compared. Ref. (3) also indicated that section 3 may not be subject to differential frost heave and this may explain why it has not longitudinally cracked. However, the large frost heave movements to which the pavement is subjected should, due to seasonal overstressing, shorten the life of the pavement. Plowed-in trenchless underdrains, of the type recommended by T. A. Coleman, may be beneficial in attenuating long-term deterioration of section 3.

- 1) Plowed-in trenchless underdrains should be installed in section 3 to minimize, as much as possible, overstressing of the pavement during thaw periods. The cost of those drains may be small compared to the possible long-term benefits. However, positive economical justification is not yet determinable. Frost heave measurements should be made on sections 6, 7, 9, 10, 11, 12, and 13 in order to determine the magnitude of heave they are subject to. If frost heave exceeds 1 in., such as occurs in section 3, these sections should also benefit from retrofit plowed-in under-drains.
