Research Record

Issue Number 102

September 2005

Box-Beam Concerns Found under the Bridge Expanding Inspector Handbook Promises Timely Bridge Care

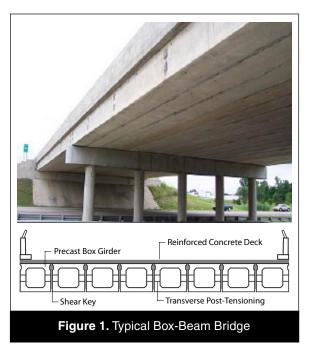
A side-by-side box-beam bridge under MDOT jurisdiction is constructed by placing precast prestressed box-beams adjacent to each other, grouting full depth shear-keys, applying transverse posttensioning, and casting a six-inch thick reinforced concrete deck (see Figure 1).
