# FINAL REPORT

REPORT ON THE RISK ASSESSMENT OF THE I-196  
INTERSTATE SECTION LOCATED OVER THE FORMER  
DOMTAR MINE, GRAND RAPIDS, MI

TESTING AND RESEARCH SECTION  
CONSTRUCTION AND TECHNOLOGY DIVISION  
RESEARCH REPORT NO. RC-1449

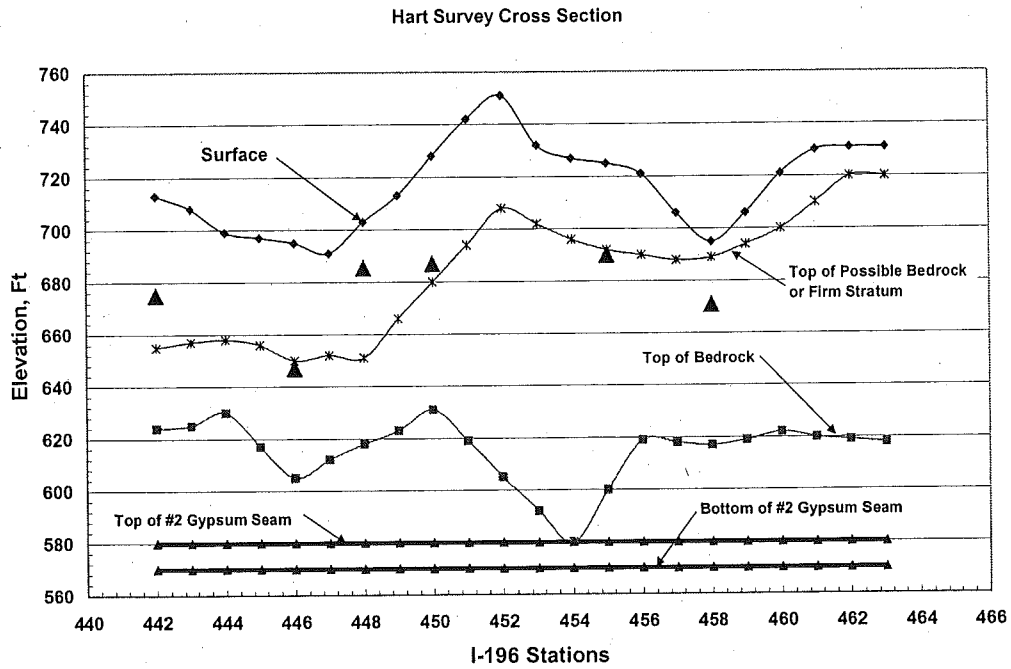
Based on Bell's velocities it is possible that that the layer above the "hard Shale" is likely shale as opposed to stiff clay. This would significantly increase the roof rock thickness above the #2 gypsum seam, which is indicated in Figures 4 and 5 as a "possible of possible bedrock or firm stratum."

Figure 4. Geologic cross-section along I-196 route based on Hart's seismic refraction study. The triangles indicate the depth where the flight auger hit refusal during the borehole exploration (Hart, 1962) conducted during the seismic refraction study.

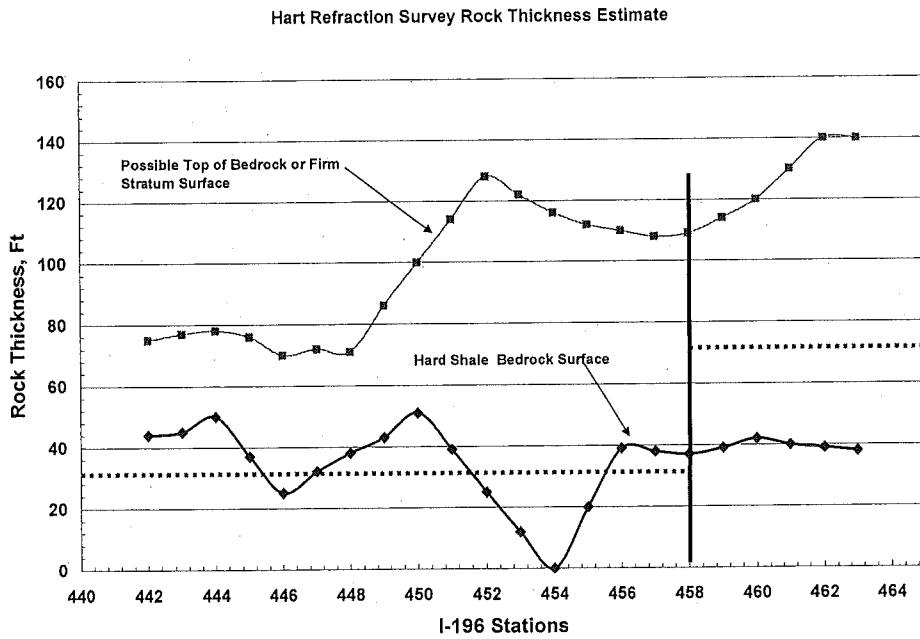
Figure 5. Rock thickness estimate above the #2 gypsum seam based on Hart's seismic refraction study.

- f) A MDOT seismic survey conducted in 1962 indicates, though, that the roof rock varies from 0 to 50 feet, with an average of about 35 feet. An underground inspection noted that the north end of the mine (Station 460 to 462) was accessible while the area below station 444 to 459 was not accessible and that significant cave-in had occurred. Also, the seismic survey indicated that no roof rock was present at Station 454. However, reviewing the seismic velocities provided in the Hart report it appears that this layer may be competent shale that is assisting the support of the mine structure.
