**GALVANIZED STEEL REINFORCED
CONCRETE BRIDGE DECKS**

Progress Report

**Progress Report on a Highway Planning and Research
Investigation Conducted in Cooperation with the
U. S. Department of Transportation,
Federal Highway Administration**

**Research Laboratory Section
Testing and Research Division
Research Project 68 F-103
Research Report No. R-1033**

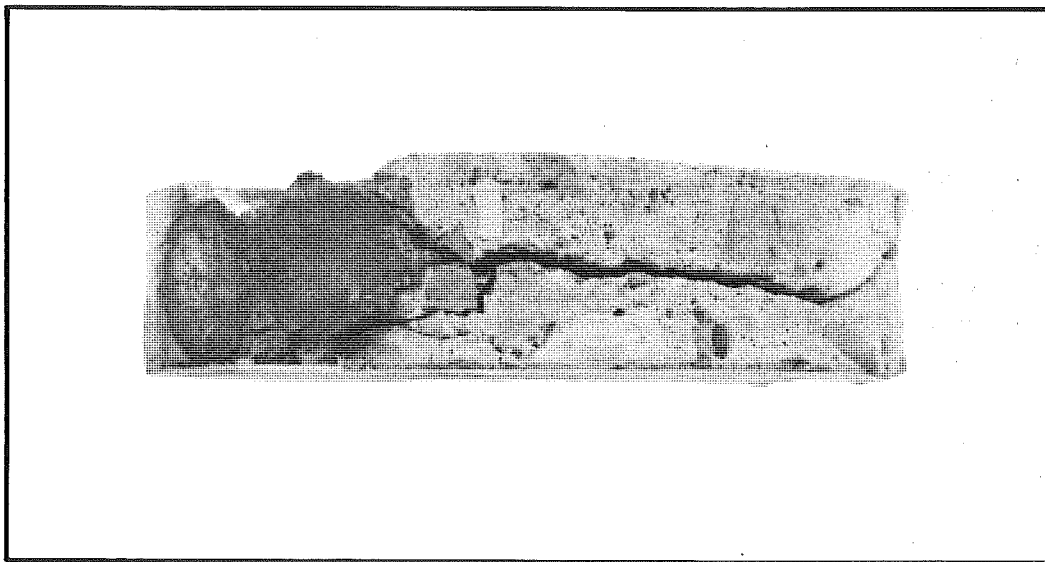
Figure 1. Core splice from block No. 5, showing delamination adjacent to spliced galvanized bars. Cover was 1/2-in. Hollow area was first noted during the 5-year inspection. It represents the worst deterioration to date of specimens with galvanizing. The top portion has not yet spalled away.

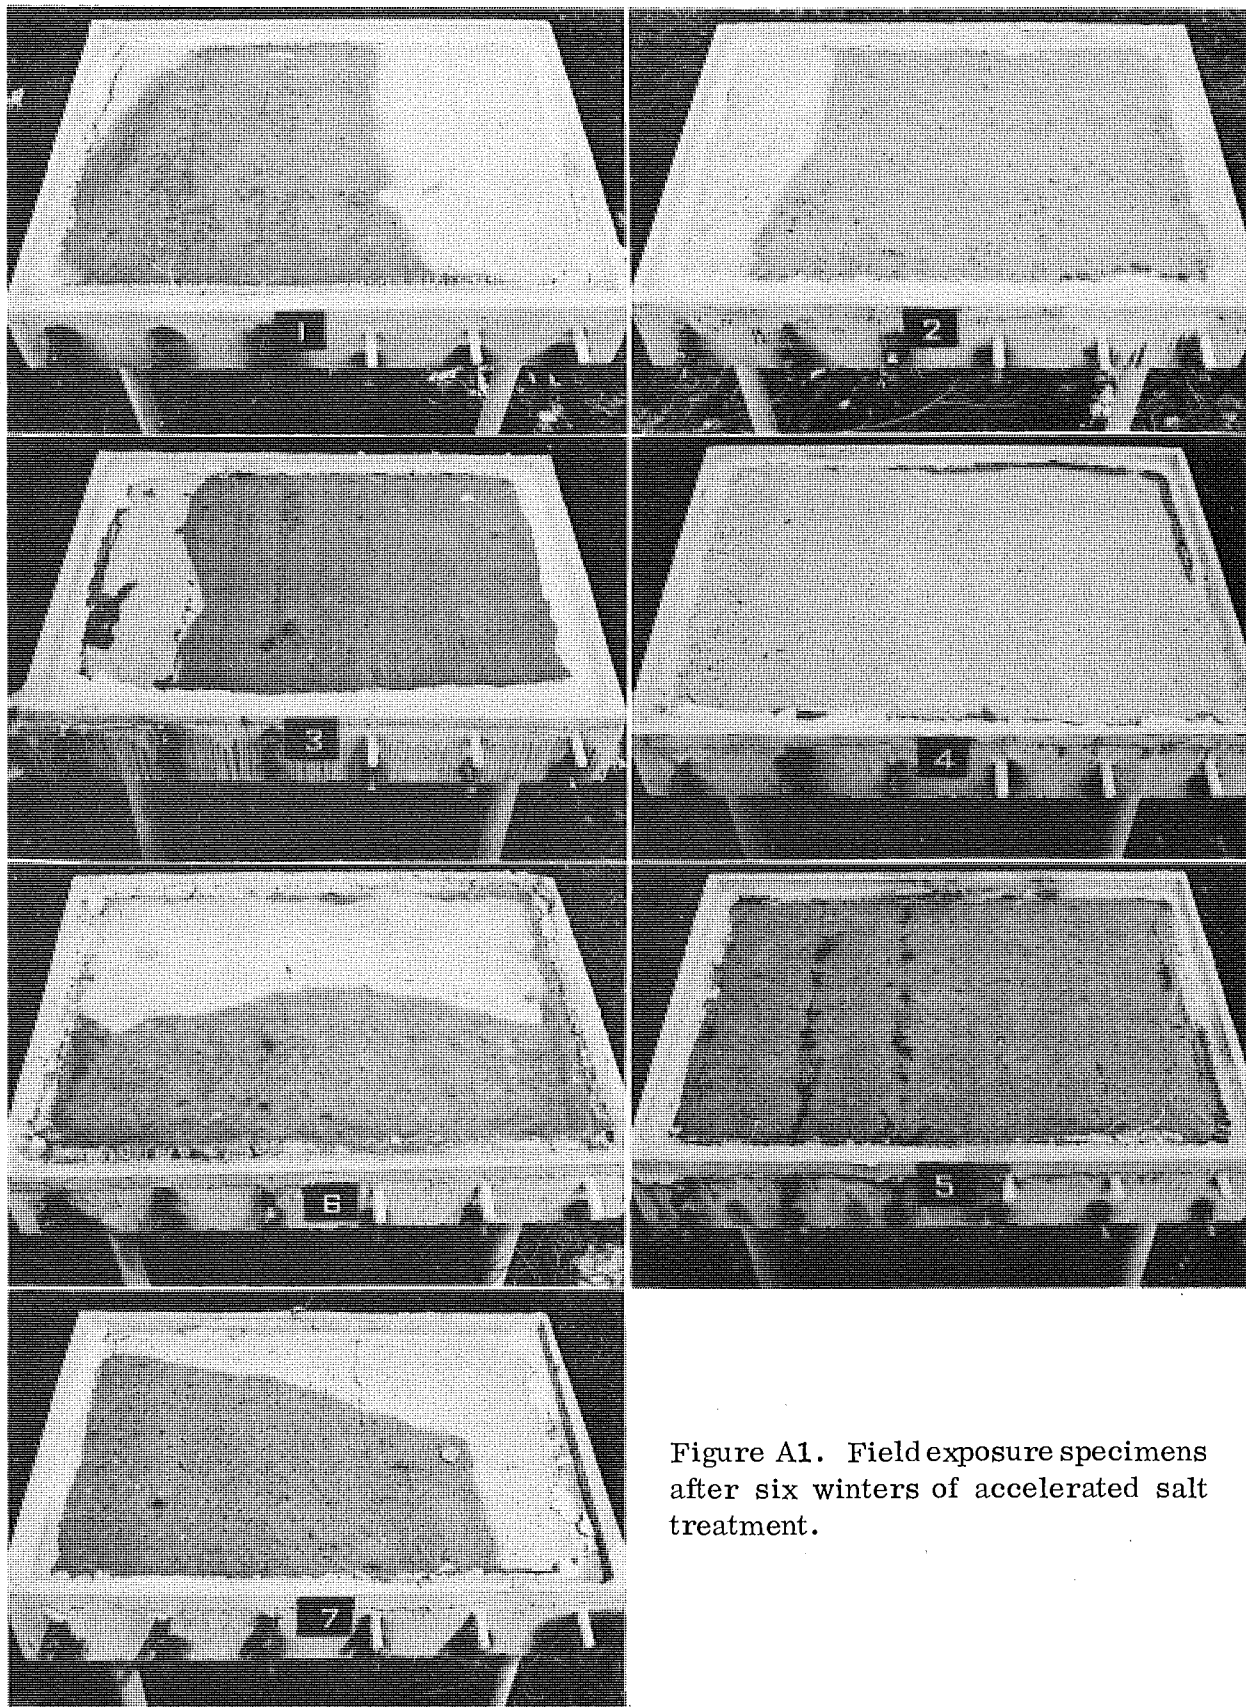
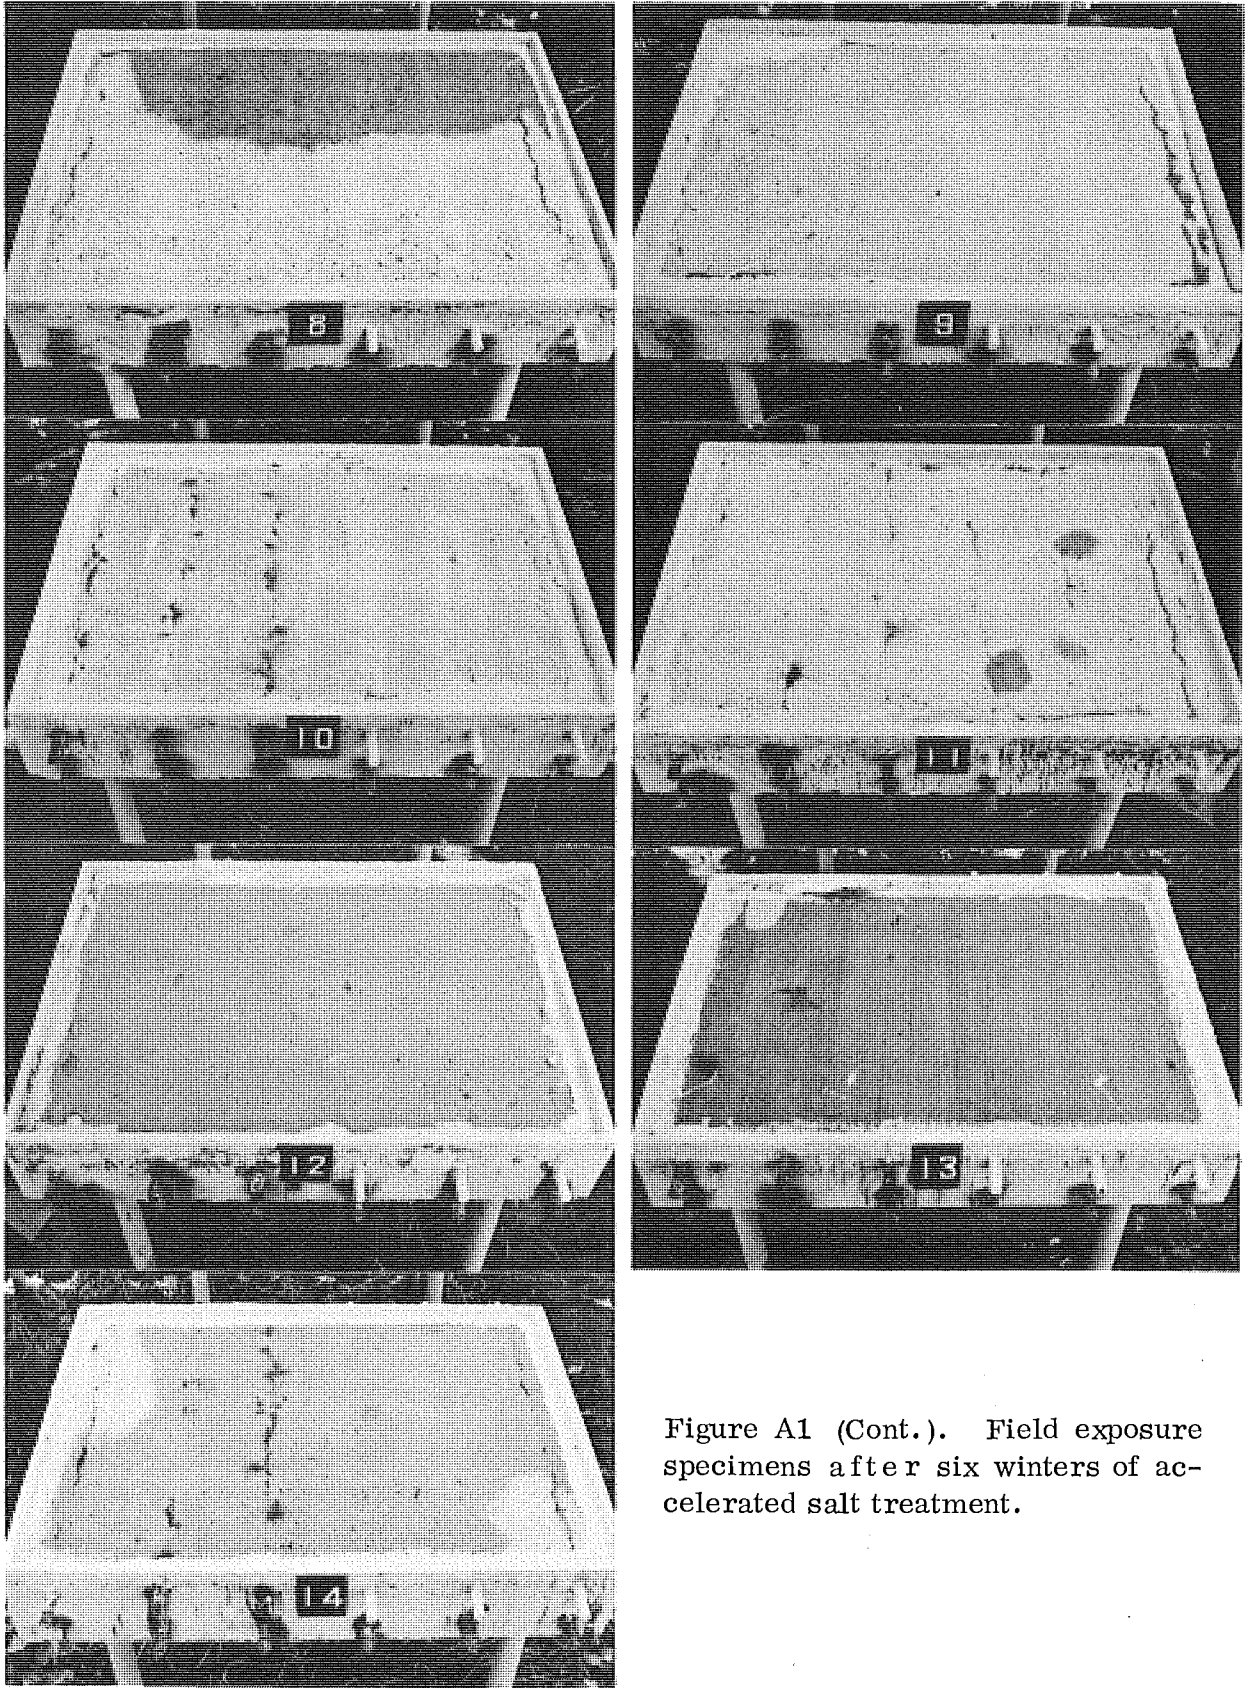
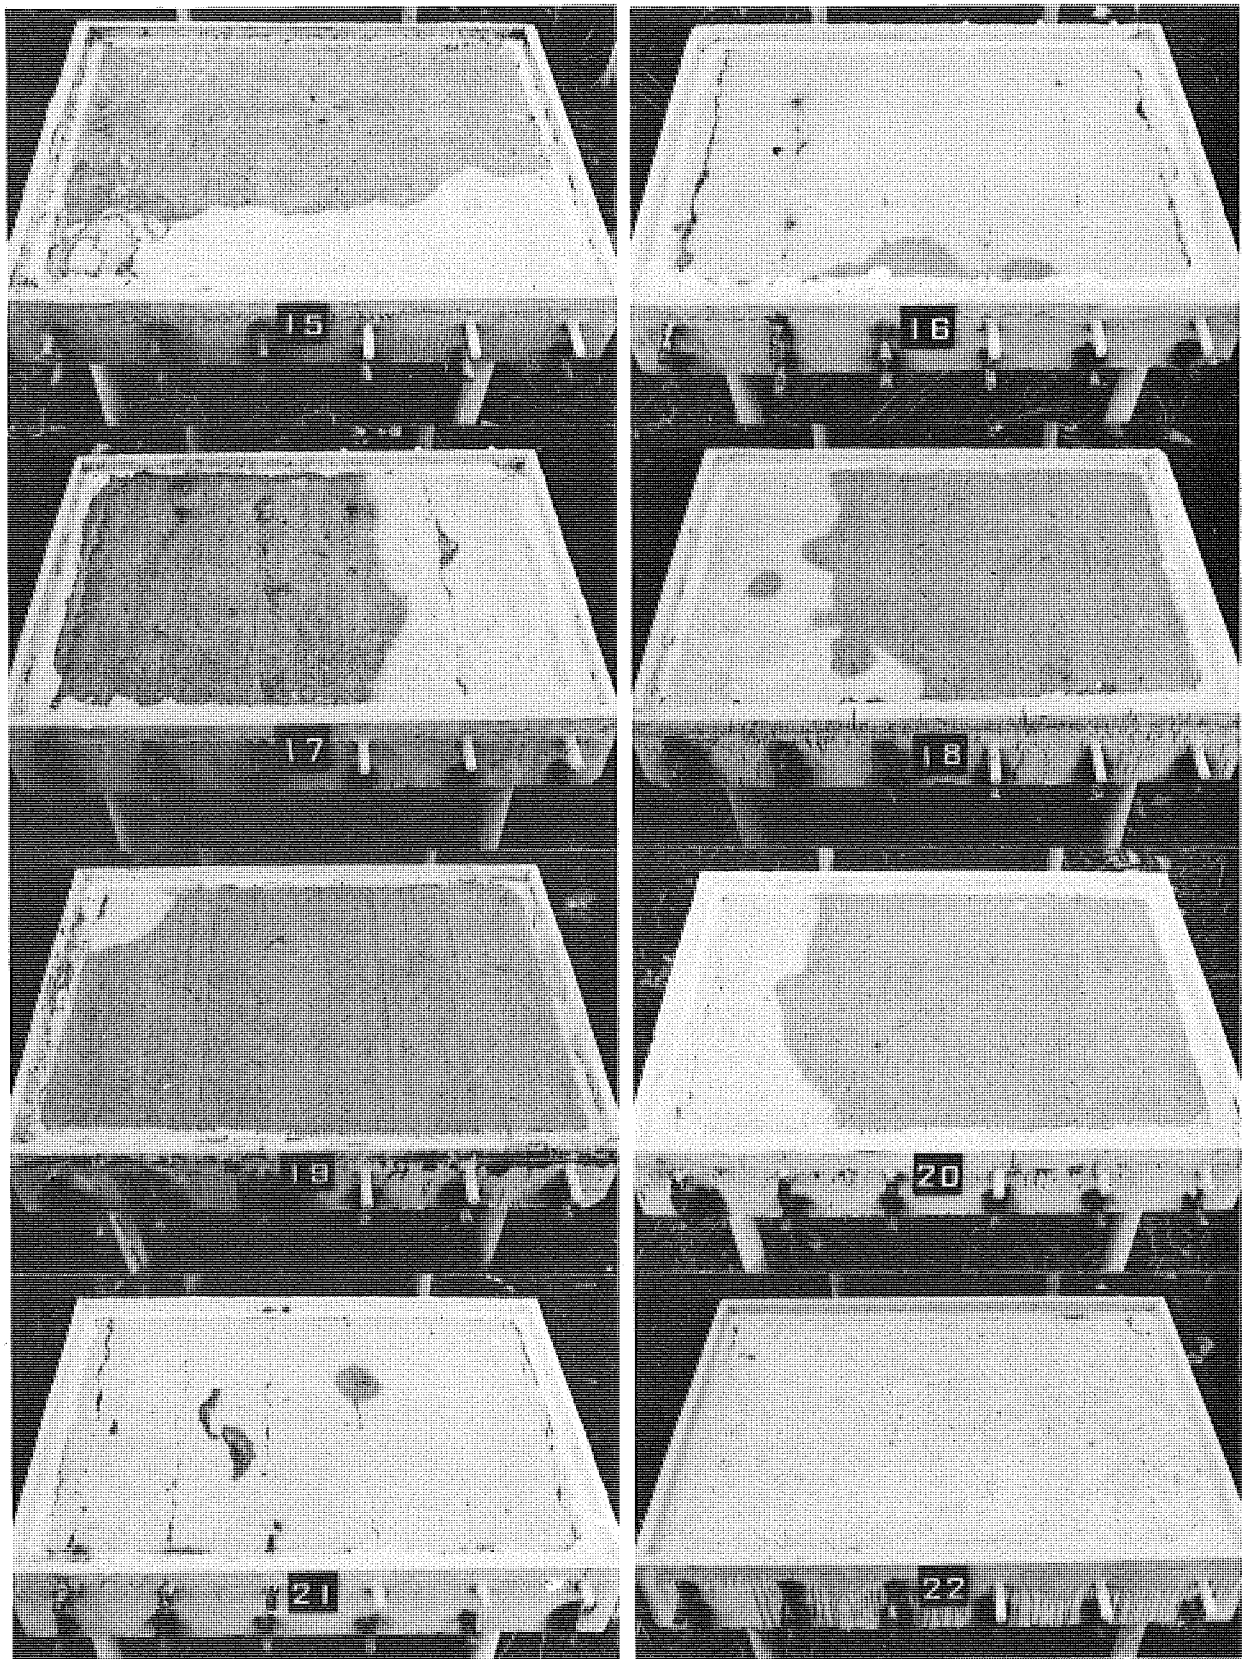
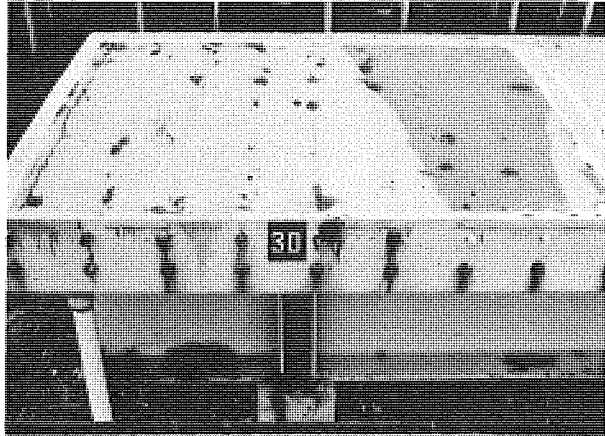
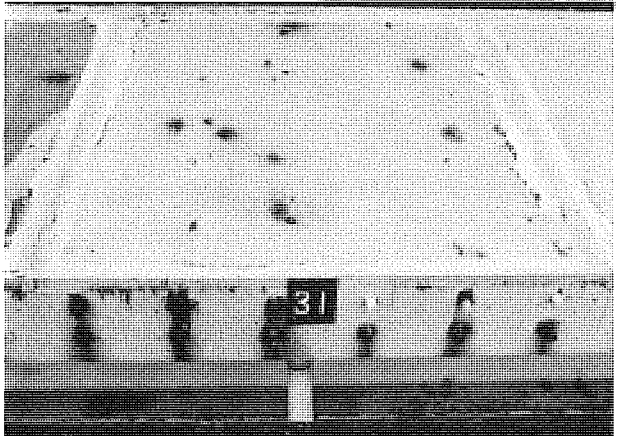
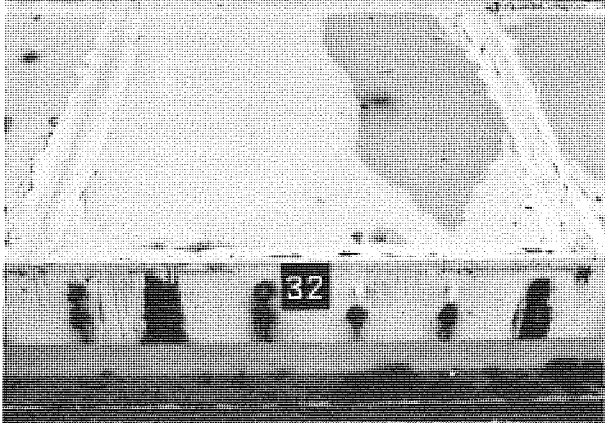
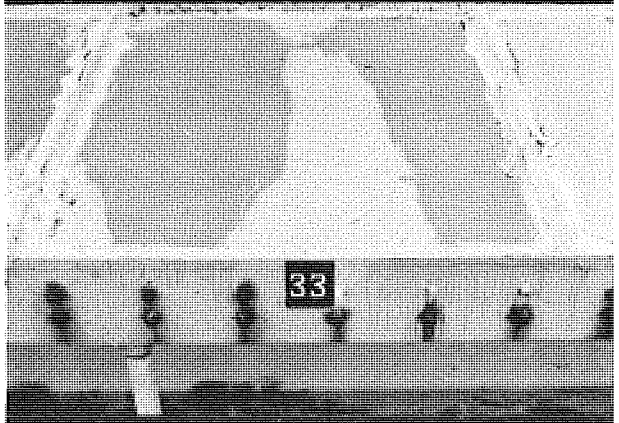
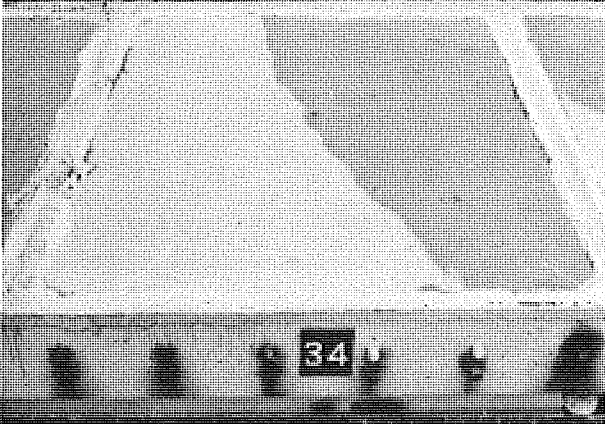
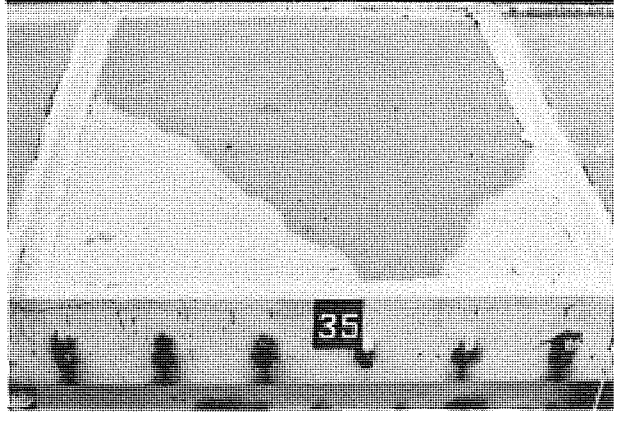
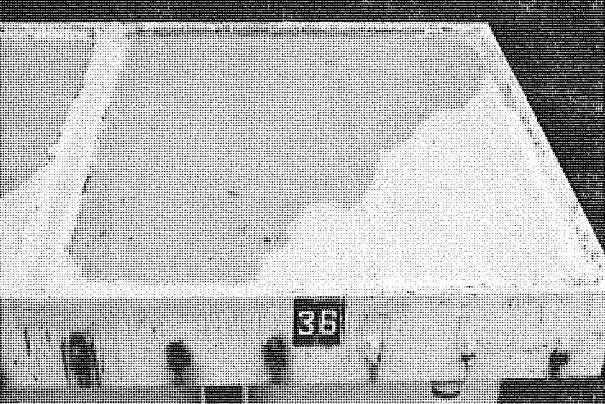
It has been noted that cracks seem to form most easily over the outermost bars, evidently because of the closer proximity to the end of the block. These blocks have 4 in. of clearance from the centerline of the bar to the block end. Greater end clearance would seem to be desirable for future installations.

Figure A1. Field exposure specimens after six winters of accelerated salt treatment.

Figure A1 (Cont.). Field exposure specimens after six winters of accelerated salt treatment.

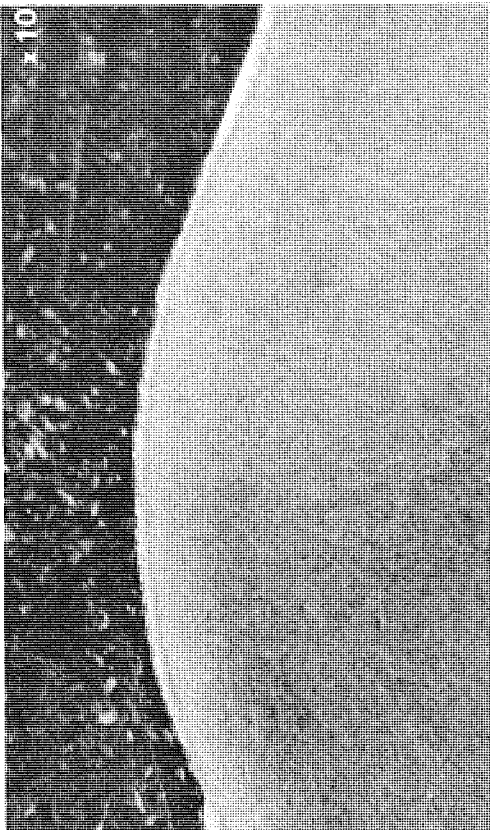
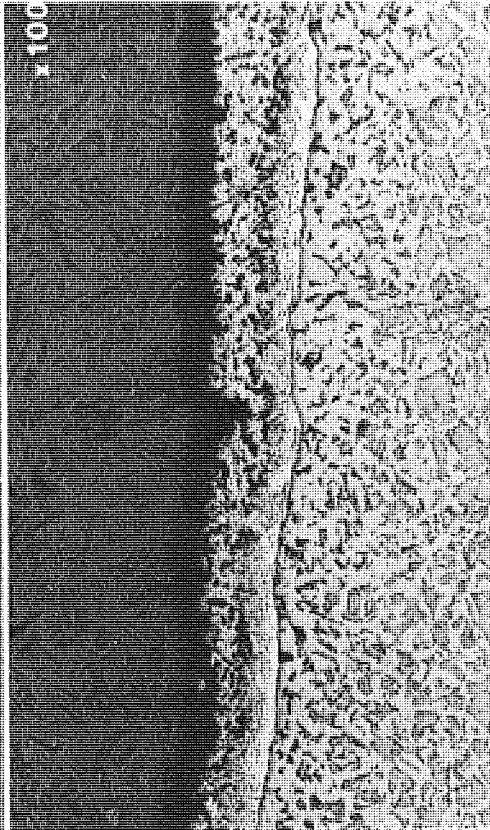
Figure A2. Section of stained galvanized bar from Specimen No. 1. Pictures taken at location of thinner coating. Other side of bar had heavier coating. (Concrete still in good condition: 1-1/4-in. cover; 7-1/2 sack, 4-1/2 gal/sack mix.) The comparable uncoated bar had scattered light rusting on one side.

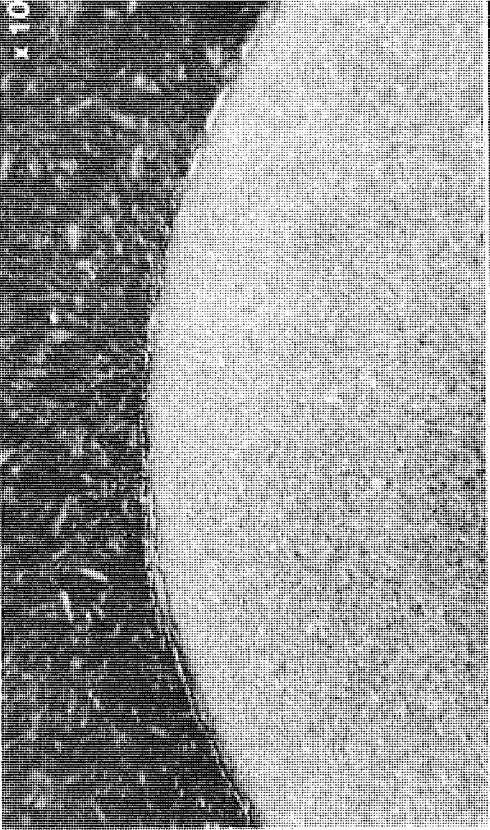
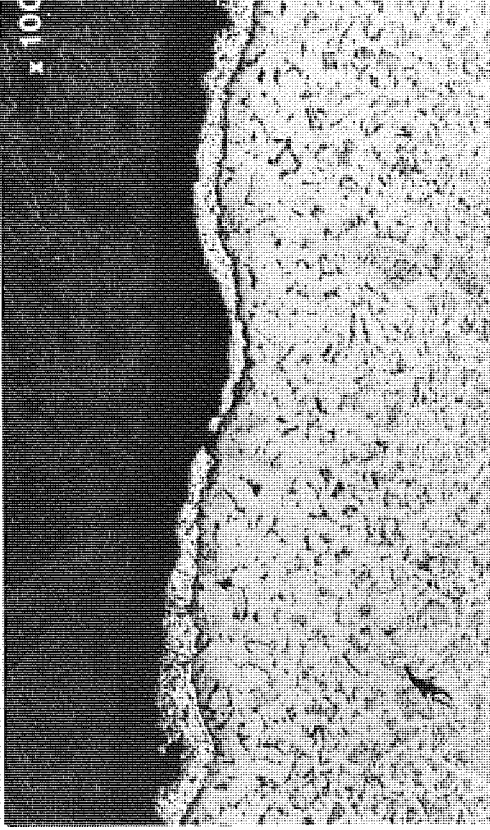
Figure A3. Galvanized bar from Specimen No. 2. Much of the coating gone, but bar protected from attack. (Concrete still in good condition: 2-in. concrete cover, 6 sack, 5-1/4 gal/sack mix.) The comparable uncoated bar had moderate corrosion on one side and heavy corrosion with pitting over most of the other side.

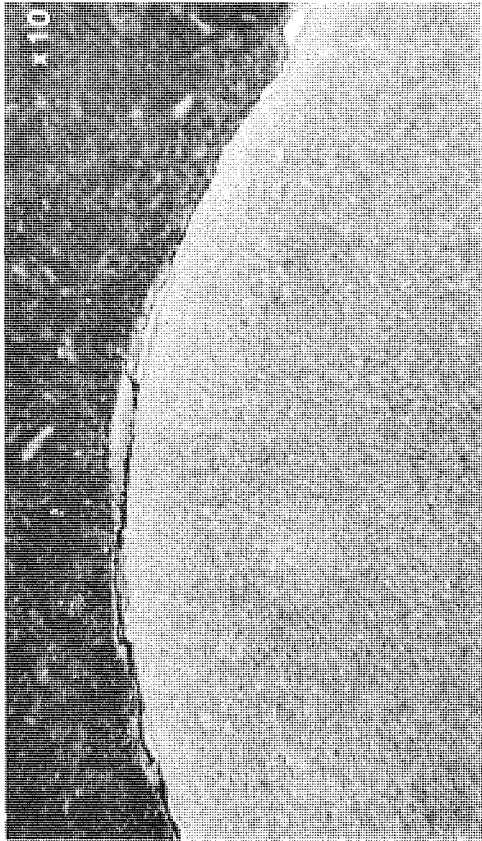
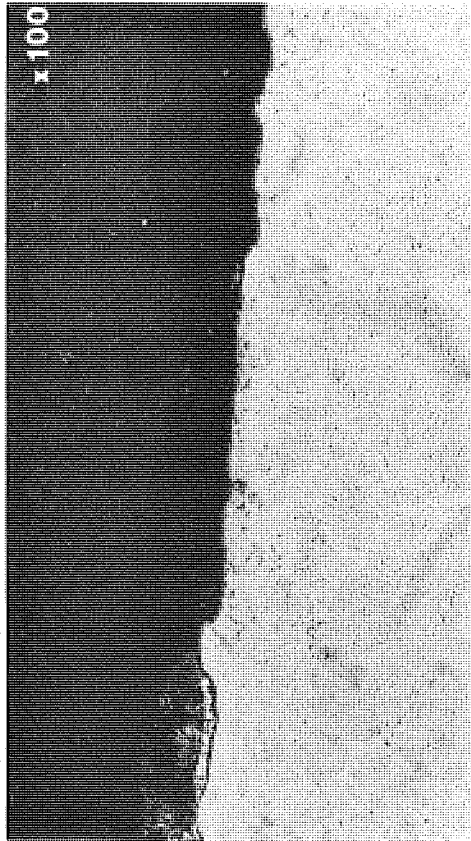
Figure A4. Galvanized bars from Specimen No. 3. Much of coating gone, but only scattered and slight rusting on the bar. (Concrete in good condition above galvanized bars, but showing distress over uncoated bars: 1/2-in. cover, 7-1/2 sack, 4-1/2 gal/sack mix.) The comparable uncoated bar had scattered light rusting on one side and heavy corrosion with pitting over most of the other side.

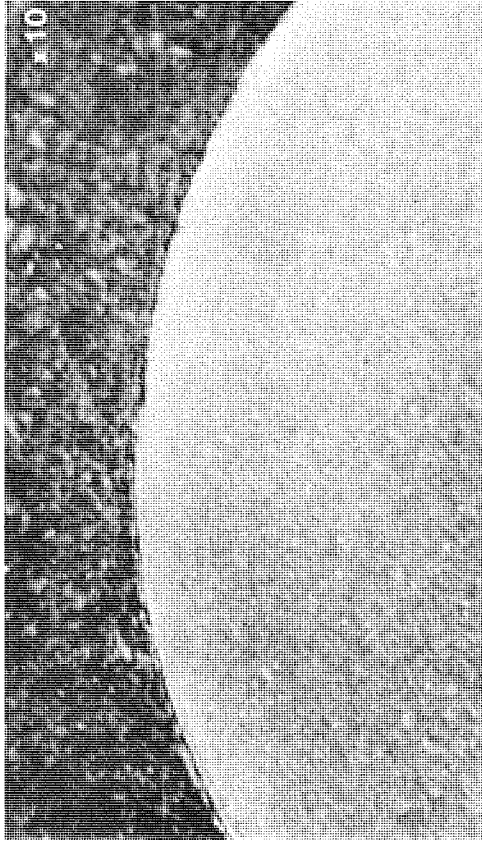
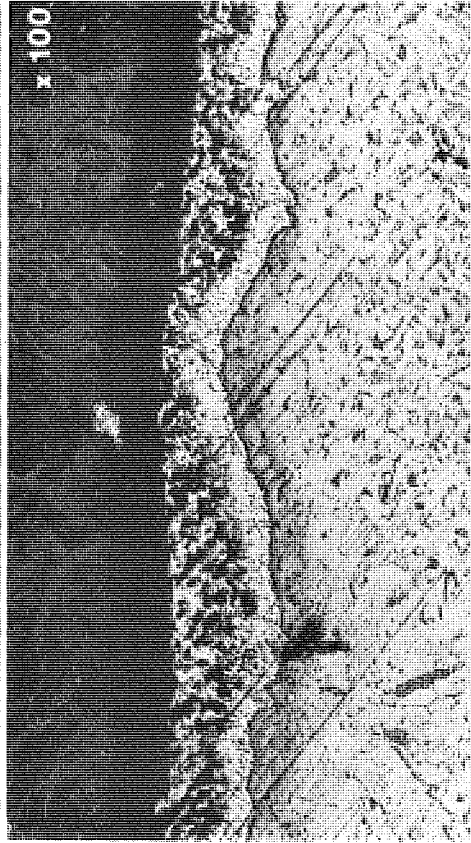
Figure A5. Galvanized bar from Specimen No. 4. Slight attack on coating. (Concrete still in good condition: 2-in. cover, 6 sack, 5-1/4 gal/sack mix). The comparable uncoated bar had moderate corrosion on one side, and heavy corrosion with pitting over most of the other side.

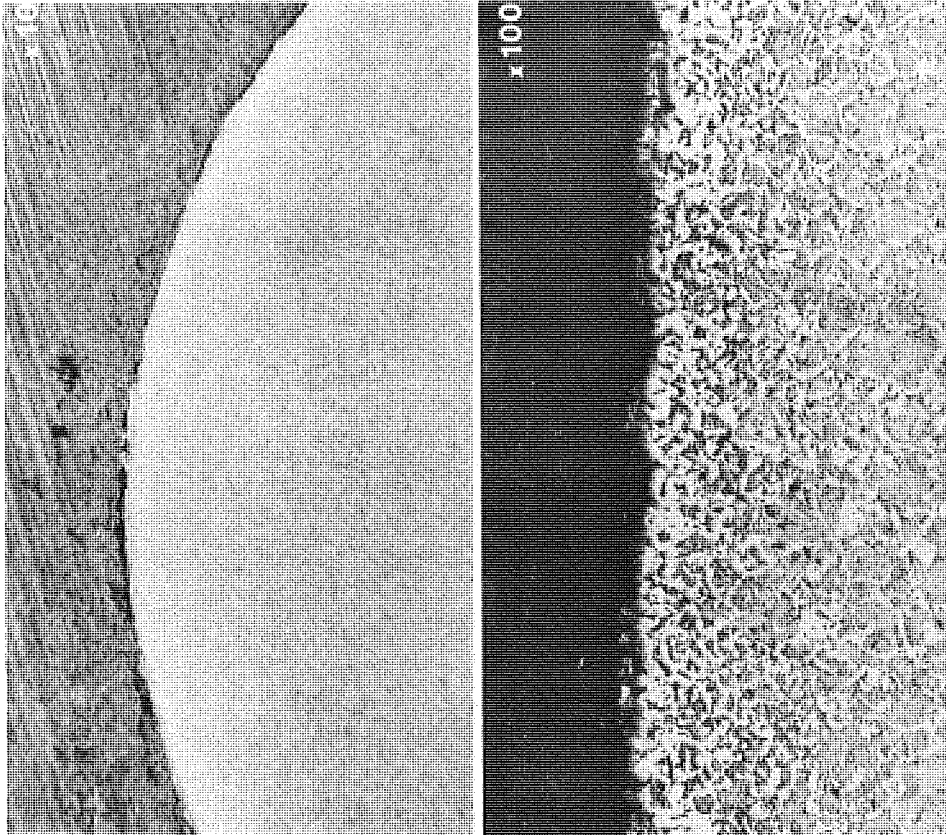
Figure A6(a). Galvanized bar from hollow area on Specimen No. 5. Most of coating gone from some parts on this side of bar. Moderate spotty corrosion of bar. Other side of bar in better condition and adjacent (splice) bar was also in relatively good condition. (Concrete showing signs of distress above uncoated bars, looked good but had hollow area in galvanized section: 1/2-in. cover, 6 sack, 5-1/4 gal/sack mix.)

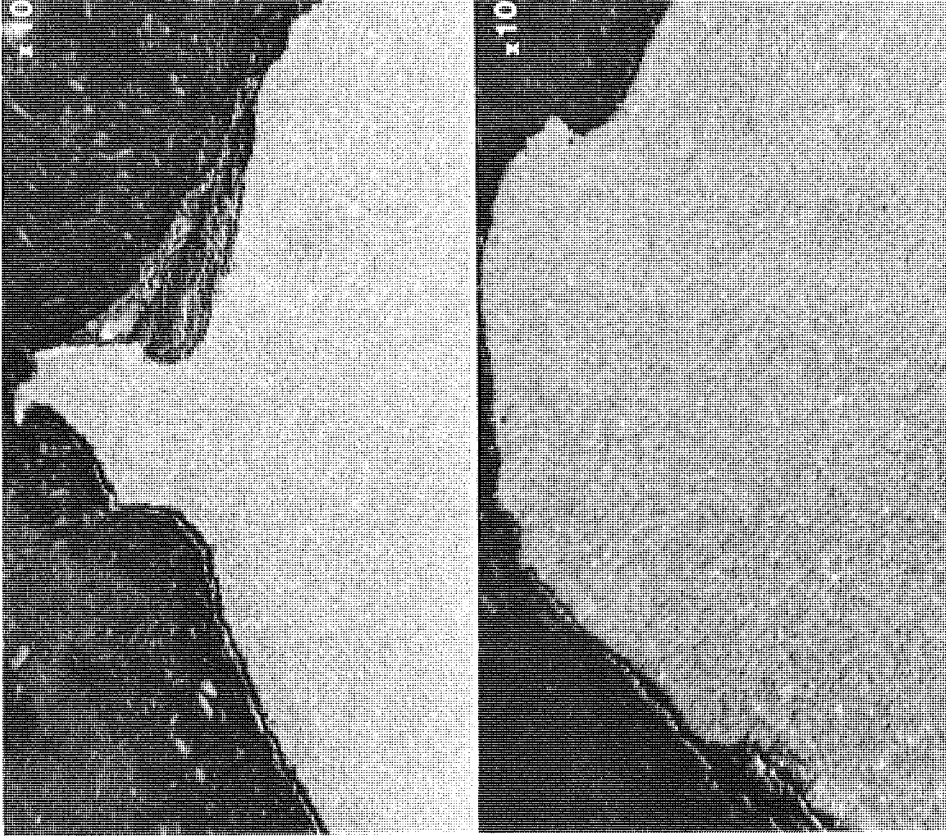
Figure A6(b). Cross-sections of uncoated bars from Specimen No. 5 showing deterioration of rib (above) and general corrosion (below). The uncoated bars varied from light corrosion on one side of one bar, to heavy corrosion over most of the remainder of that bar and both sides of the adjacent (splice) bar.

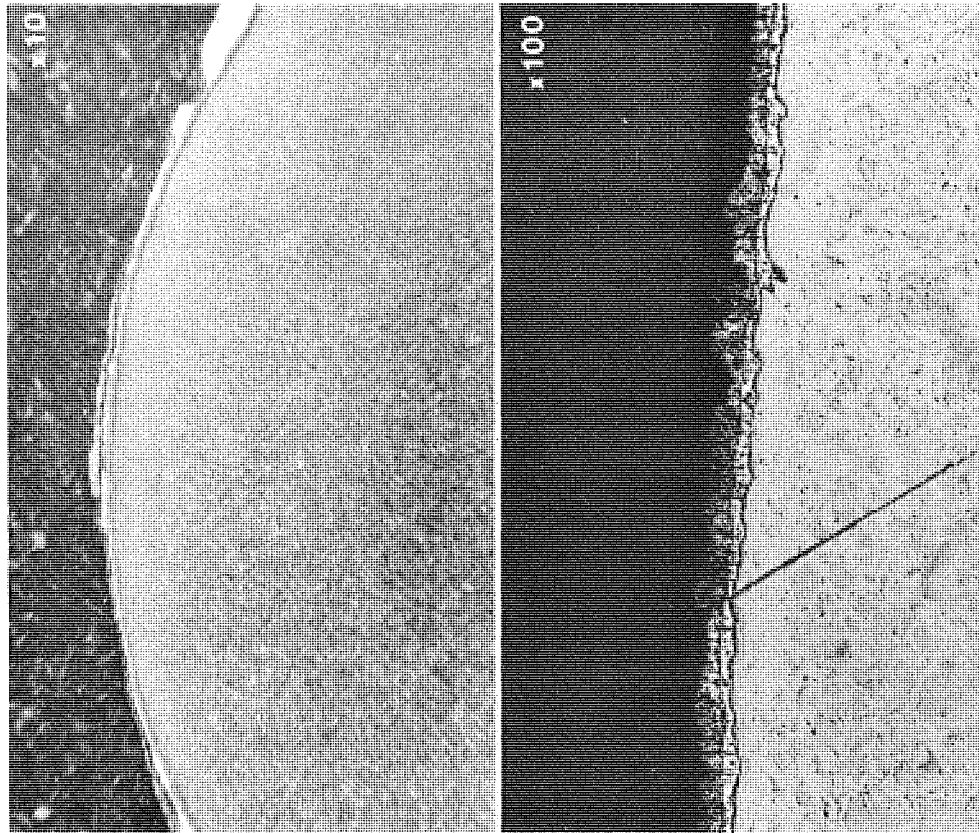
Figure A7. Galvanized bar from Specimen No. 8. Some corrosion of coating evident, but no penetration of the coating. Uncoated bar had light to moderate corrosion (2-in. cover, 6 sack, 5-1/4 gal/sack mix, spliced bars).

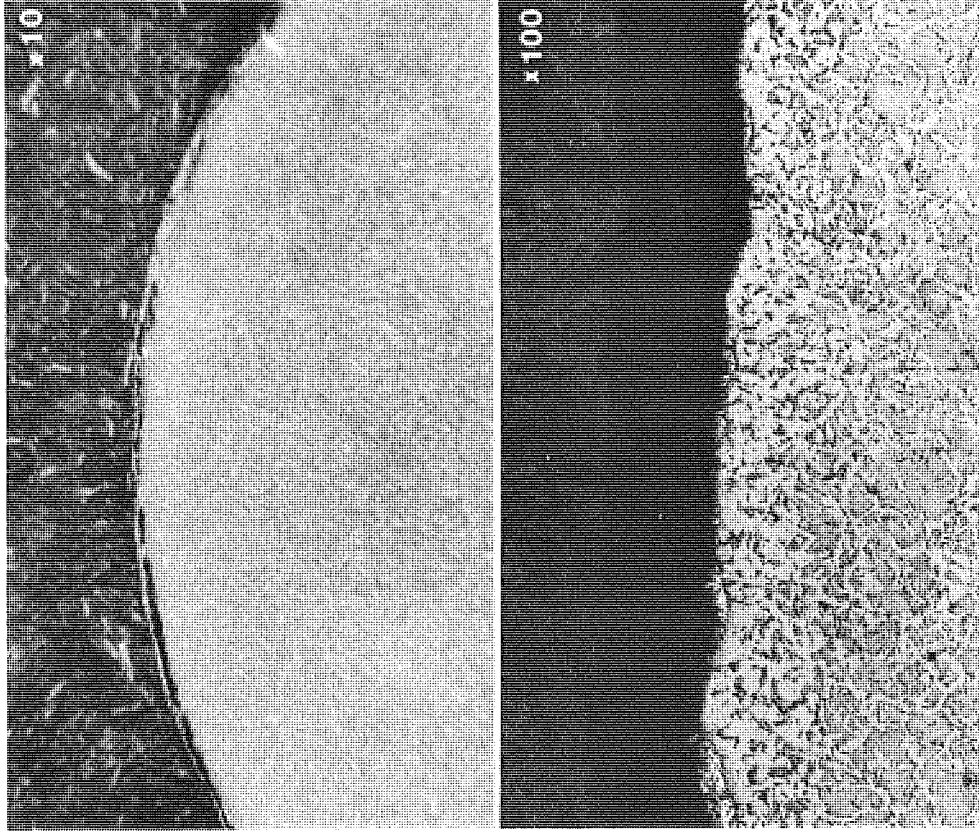
Figure A8. Galvanized bar from Specimen No. 10. Coating is nearly gone, and the concrete above the coated bars has begun to crack, but is still in better condition than the concrete over the uncoated bars (1/2-in. cover, 6 sack, 5-1/4 gal/sack mix). The comparable uncoated bar had moderate corrosion over most of one side and heavy corrosion with pitting on most of the other side.

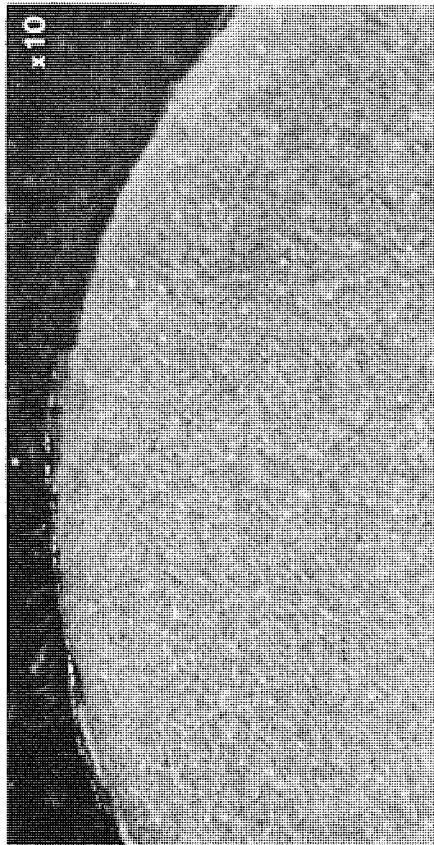
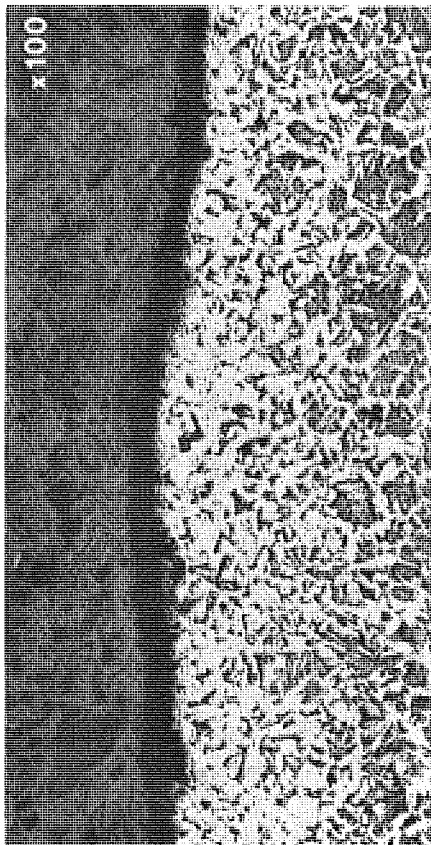
Figure A9. Galvanized bar from Specimen No. 11, which has a considerable amount of cracking on both the galvanized and uncoated sections. (The photo of Specimen No. 11 exaggerates the severity of cracking on the galvanized side, because that side was not yet quite as dry as the other side: 1-1/4-in. cover, 6 sack, 5-1/4 gal/sack mix). The other (splice) galvanized bar was in better condition. One of the comparable uncoated bars had scattered light rusting on both sides and the other had heavy corrosion and pitting on part of one side and most of the opposite side.

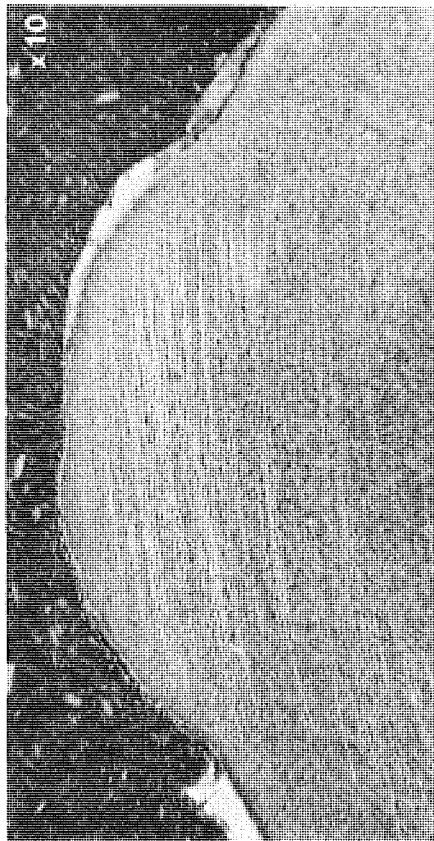
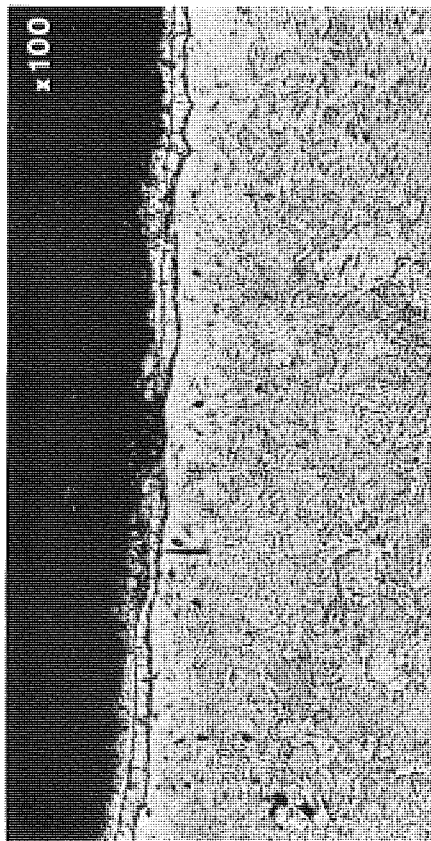
Figure A10. Galvanized bar from Specimen No. 12. Much of the coating is gone from the bar and light corrosion is evident on both sides of the bar. Bar has been protected by the coating (2-in. cover, 6 sack, 6 gal/sack mix). Comparable uncoated bar had moderate corrosion on part of one side and heavy corrosion on part of the other side.

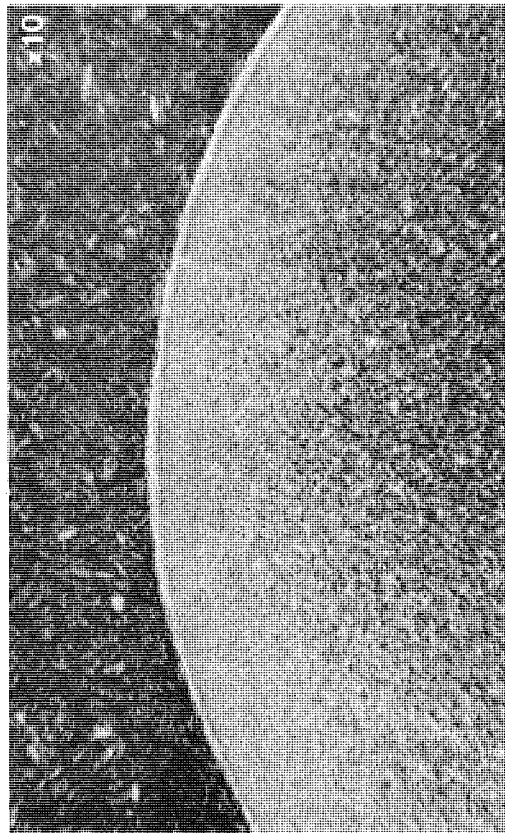
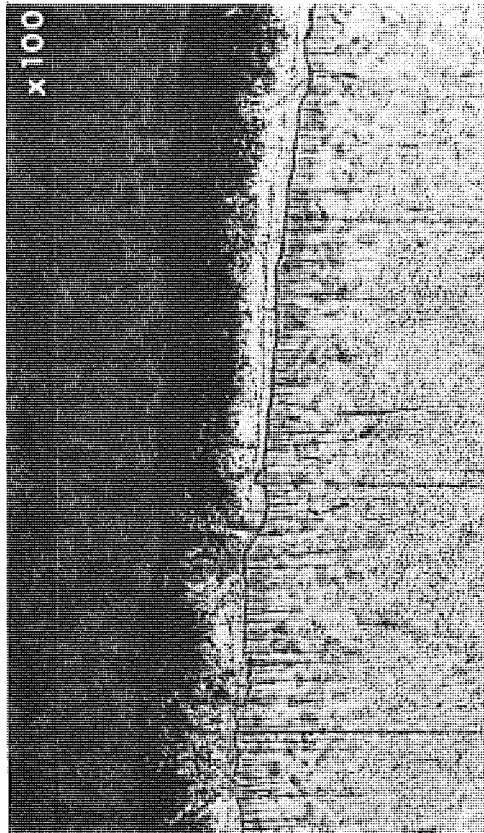
Figure A11. Galvanized bar from Specimen No. 15. Coating stained, but in good condition on both sides of bar. Concrete in good condition over entire specimen (1-1/4-in. cover, 6 sack, 5-1/4 gal/sack mix). Comparable uncoated bar had moderate corrosion on part of one side and heavy corrosion on most of the other side.

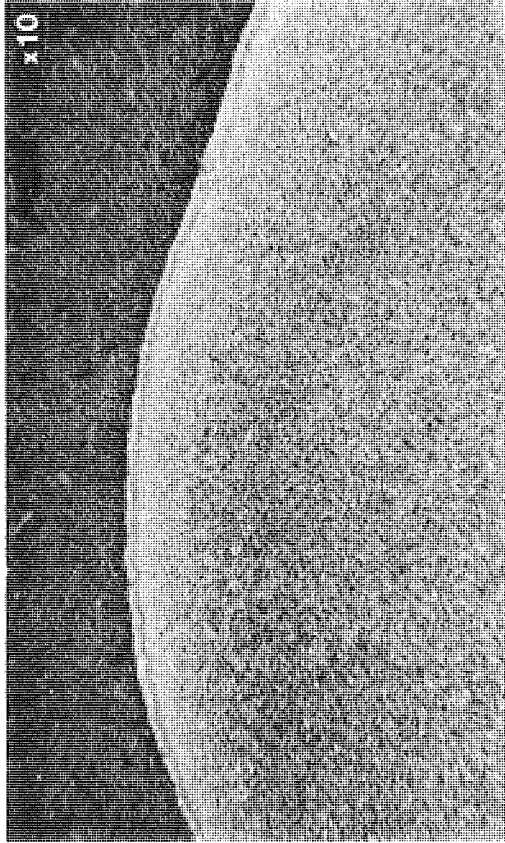
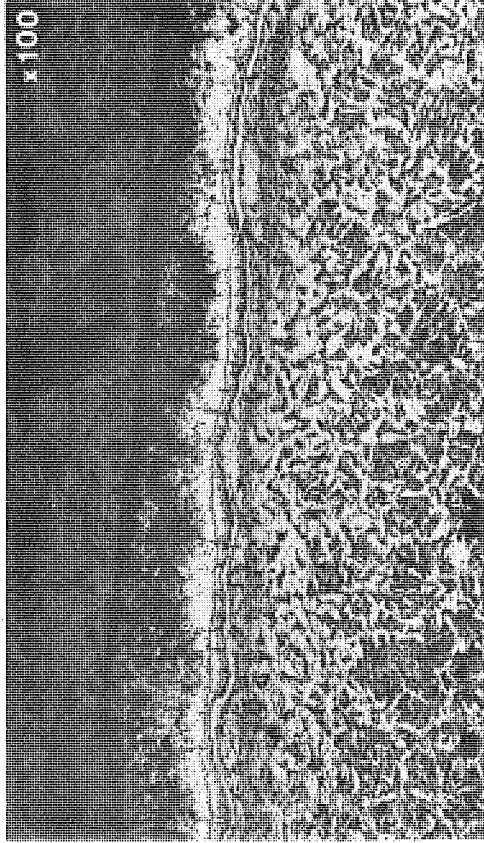
Figure A12. Galvanized bar from Specimen No. 18. Coating and concrete both in very good condition (2-in. cover, 6 sack, 5-1/4 gal/sack mix). Comparable uncoated bar also was uncorroded.

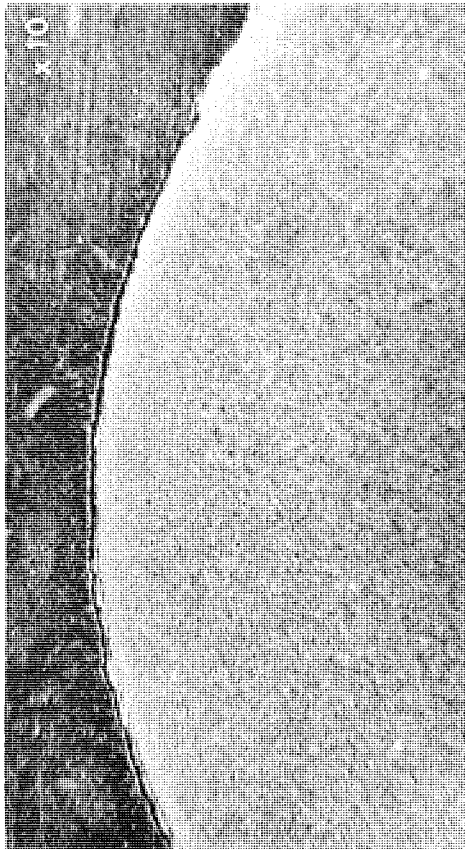
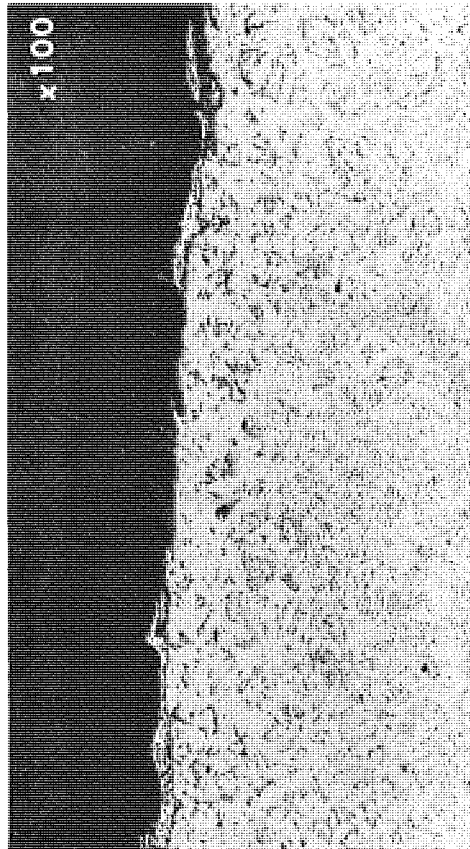
Figure A13. Galvanized bar from Specimen No. 19. Much of the coating is gone from this side of the bar but bar was protected. The other side is still very good and looks much like Figure 12. Concrete still in good condition (1-1/4 in. cover, 6 sack, 6 gal/sack, mix). Comparable uncoated bar had heavy corrosion over most of both sides.

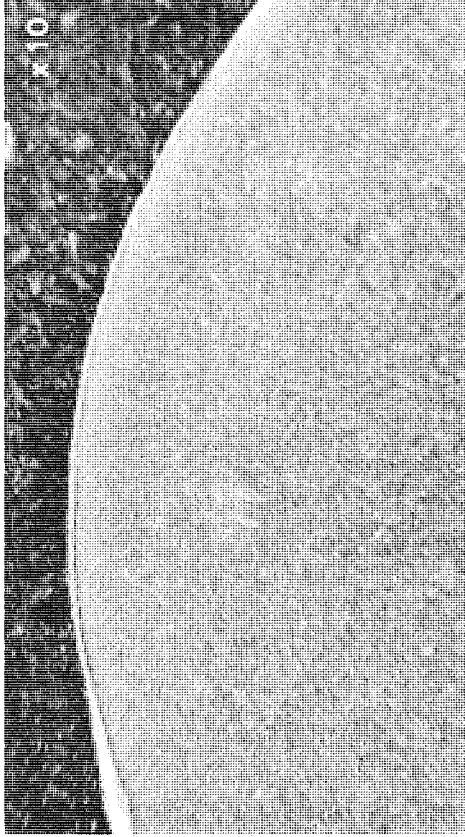
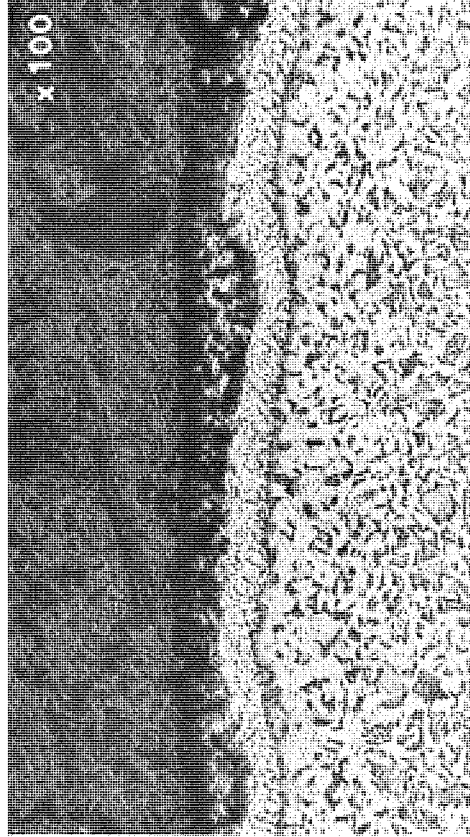
Figure A14. Galvanized bar from Specimen No. 35. Coating in virtually new condition. Only those at these maximum cover depths have maintained the shiny galvanized appearance. (There, as in some other cases, the corner of the coating has been rounded by the polishing and etching procedures.) Concrete in very good condition (3-in. cover, 6 sack, 5+ gal/sack mix). Comparable uncoated bars also were in excellent condition.
