**CORROSION OF PAINTED STEEL RIGHT-OF-WAY FENCE POSTS**

**Research Laboratory Division  
Office of Testing and Research  
Research Project R-61 NM-34  
Research Report No. R-419**

**Michigan State Highway Department  
John C. Mackie, Commissioner  
Lansing, April 1963**

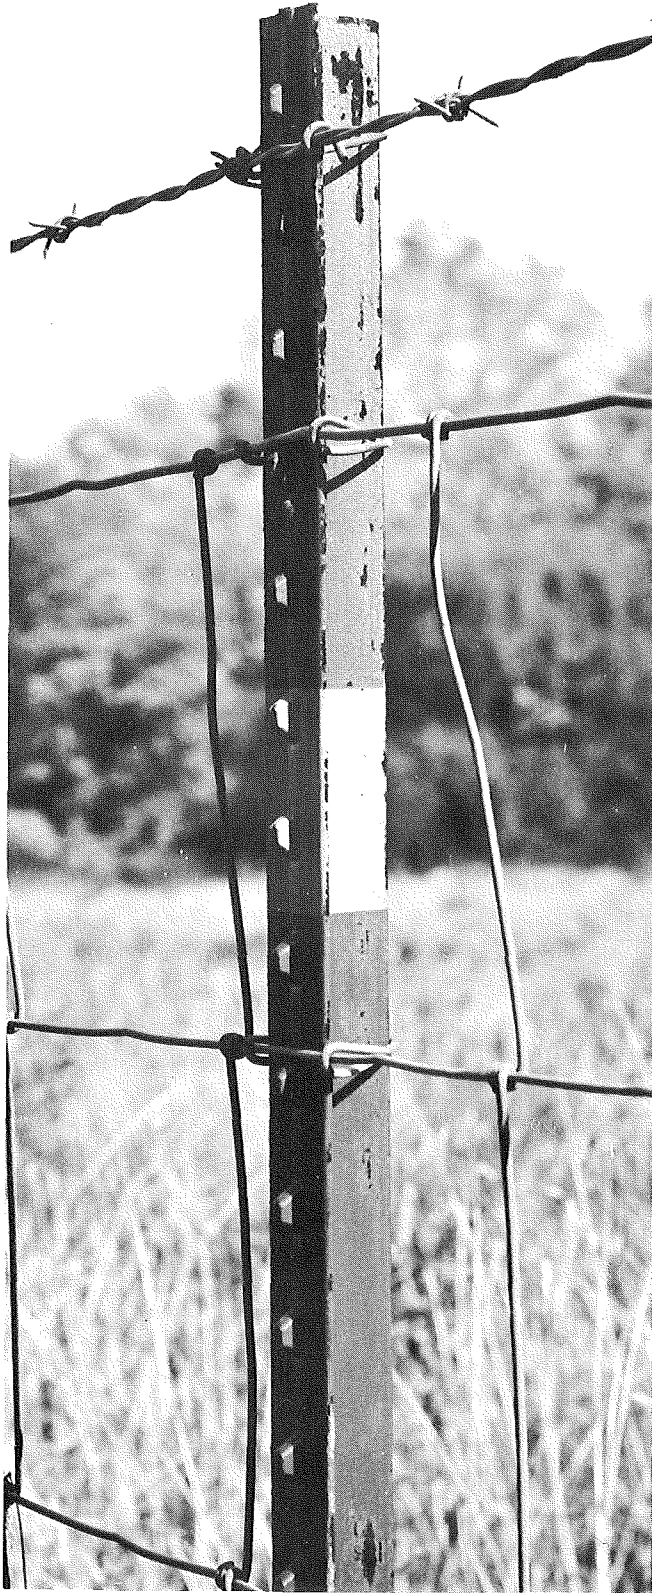
Figure 1. Age: 1 year. East side of I 94 about 2 to 3 miles north of Bridgman at 19-mile sign post marker. Red-yellow-red paint. Localized beginning corrosion.

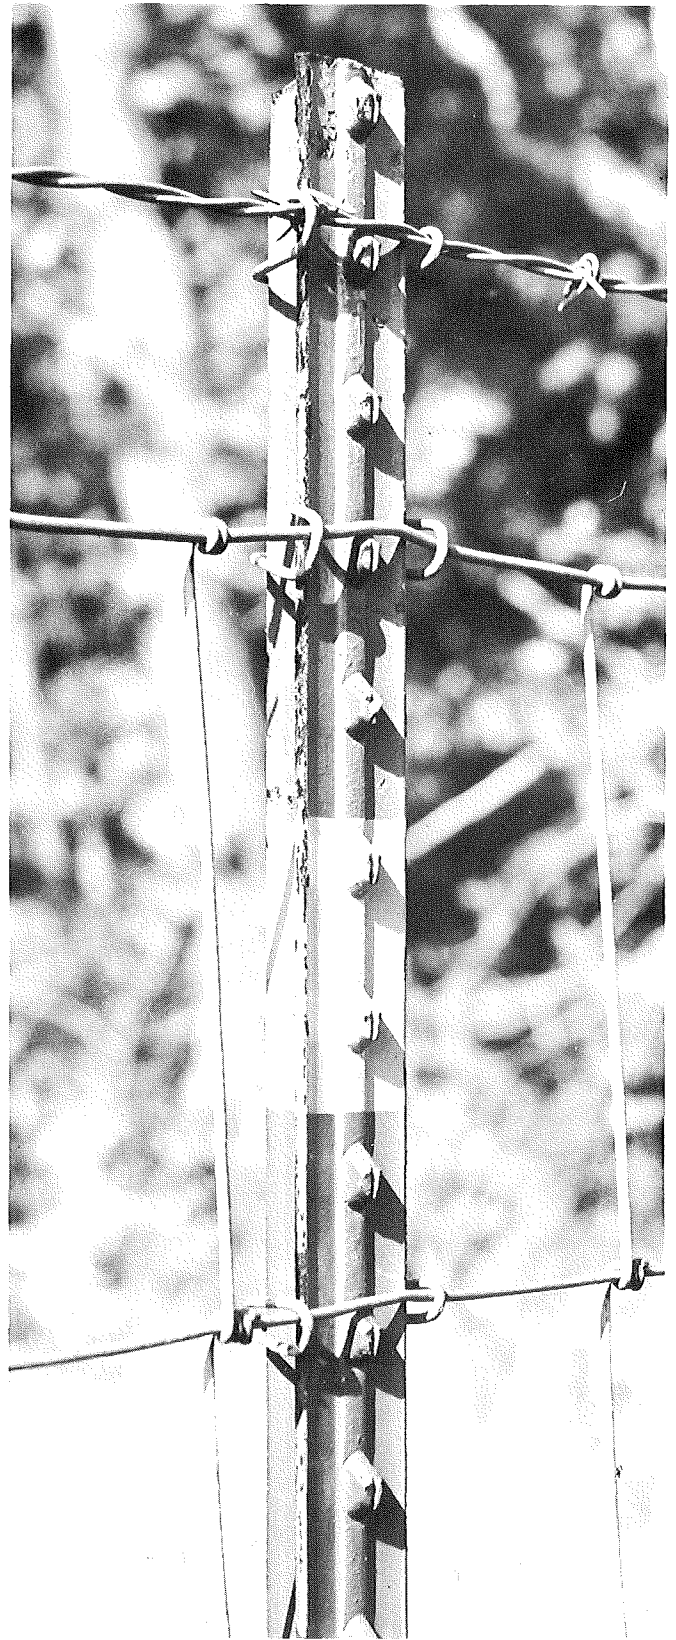
Figure 2. Age: 1 year. West side of I 94 just north of Bridgman exit. Red-yellow-red paint. Localized beginning corrosion.

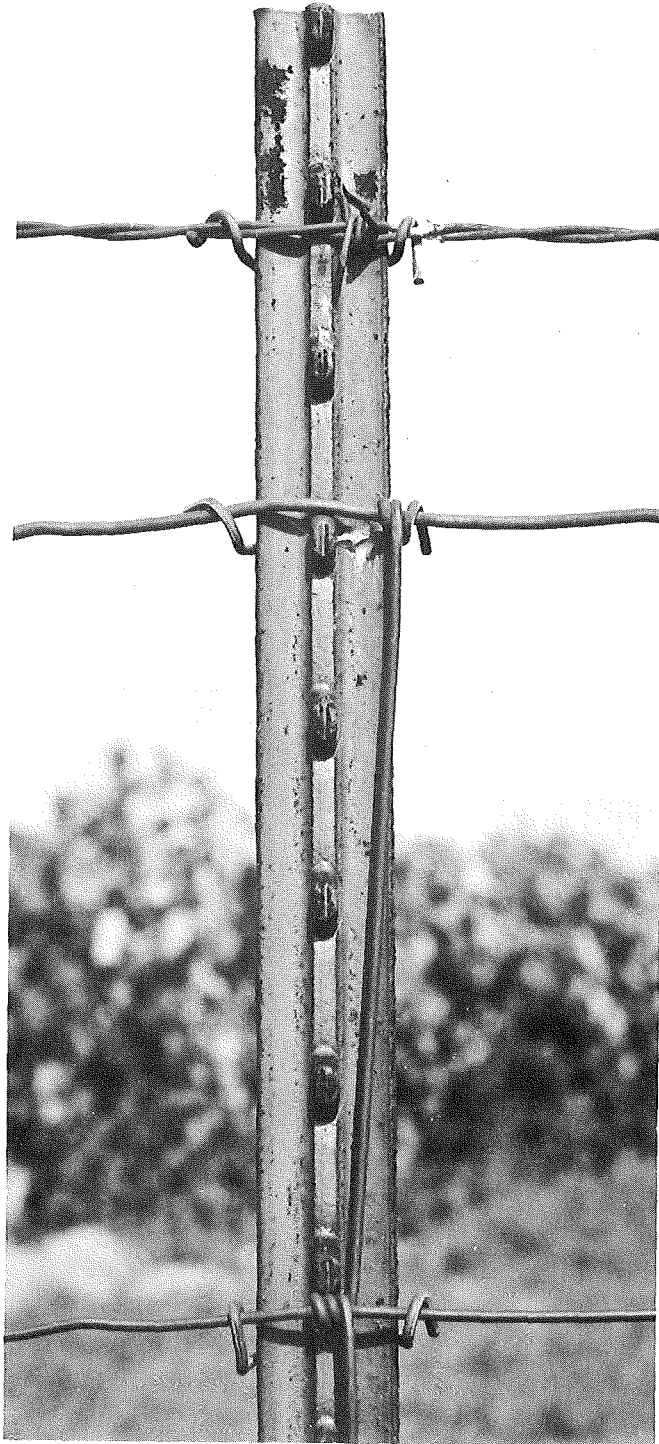
Figure 3. Age: 2 years. East side of I 94 about 2 to 3 miles north of Bridgman at 19-mile sign post marker. Red paint. Localized beginning corrosion.

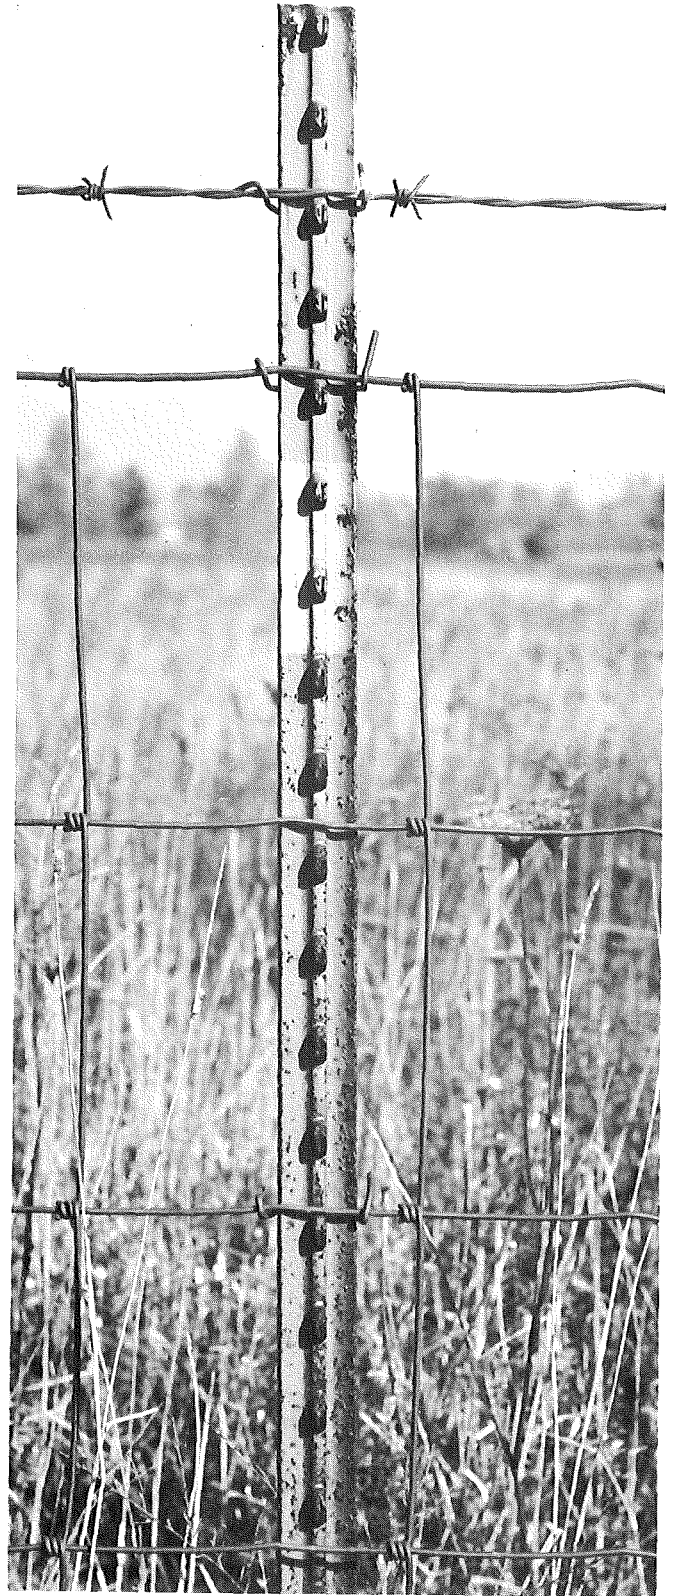
Figure 4. Age: 3 years. North side of I 94 just west of Kalamazoo, east of Oshtemo exit. Red paint. Localized beginning corrosion.

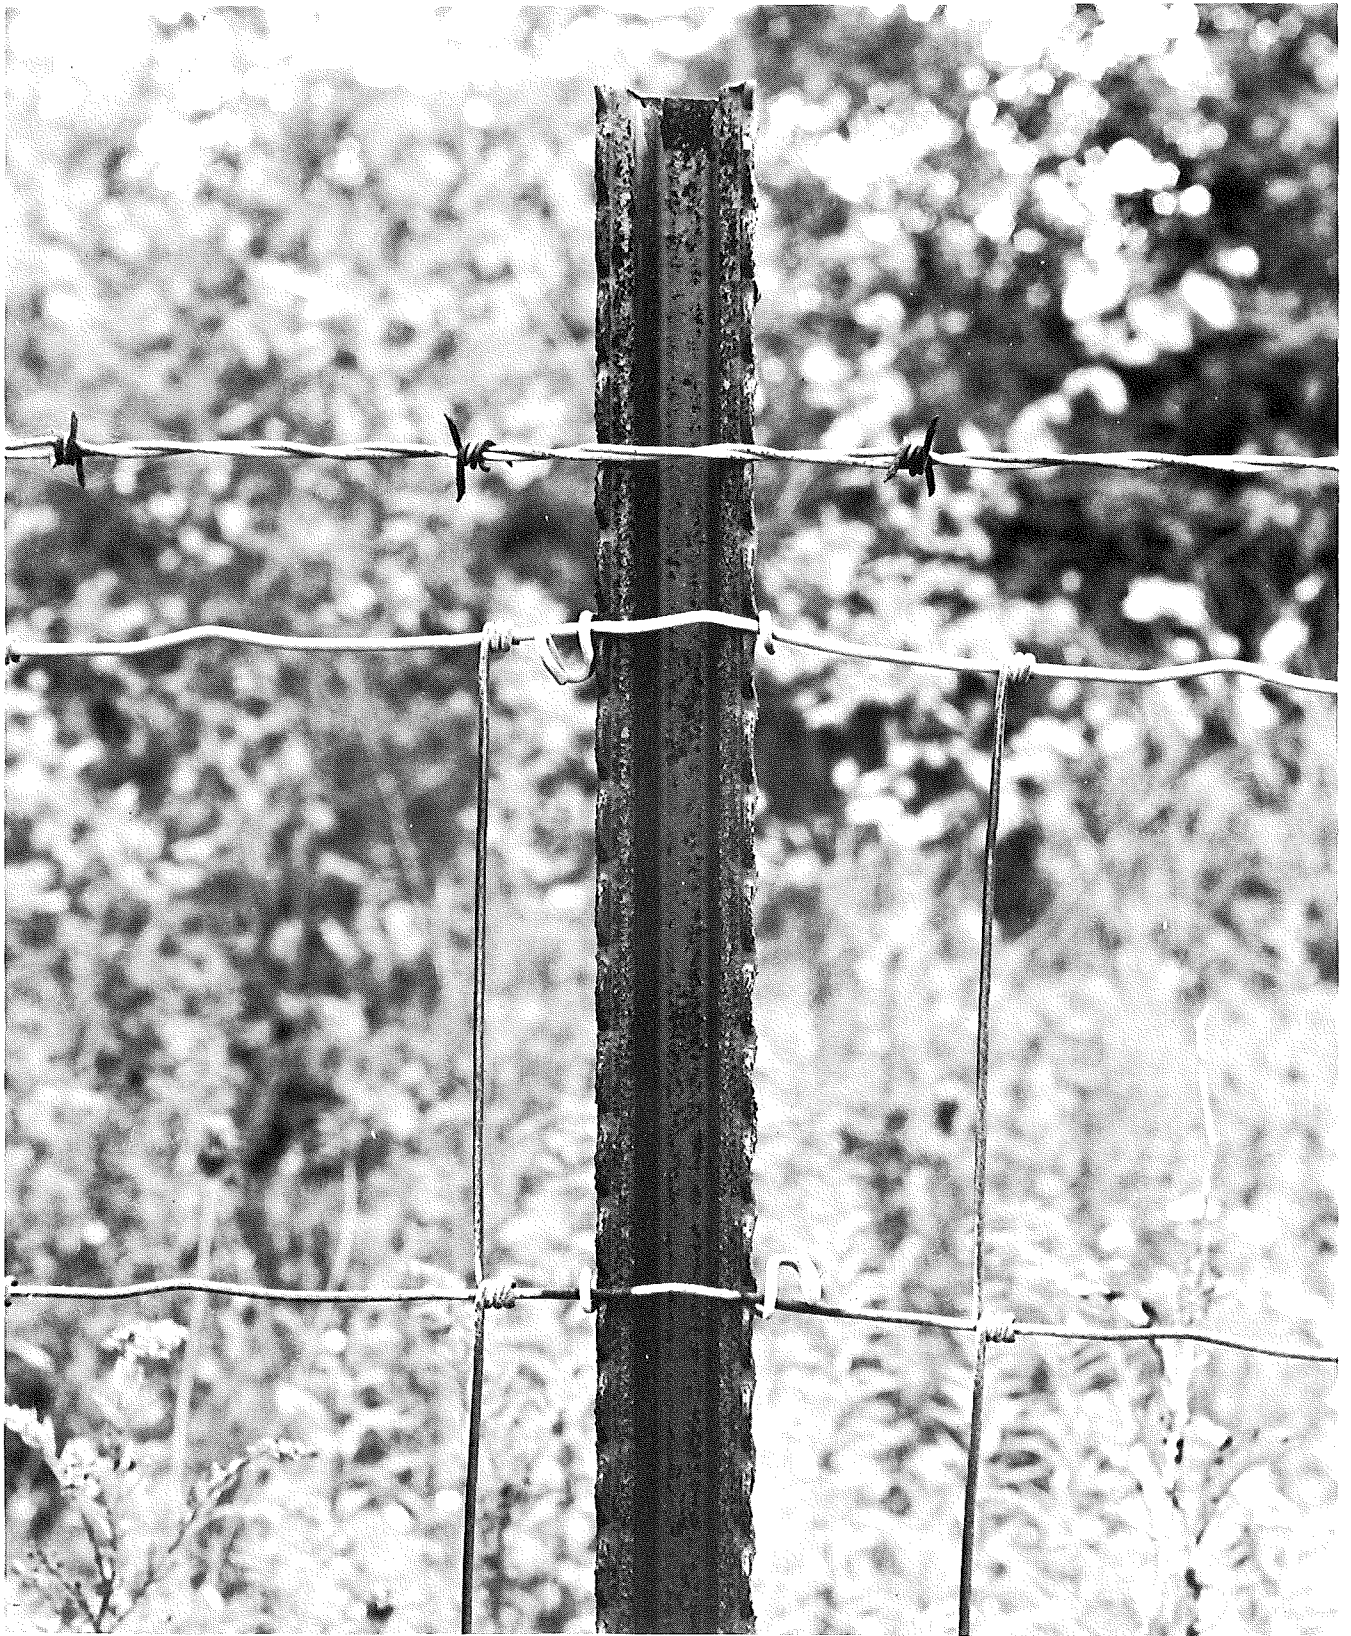
Figure 5. Age: 4 years. East side of I 75 at Station 1099+90, south of M 57. Severe corrosion. Note apparent galvanic corrosion of horizontal wire near bottom of figure at clip area where wire is in contact with post.

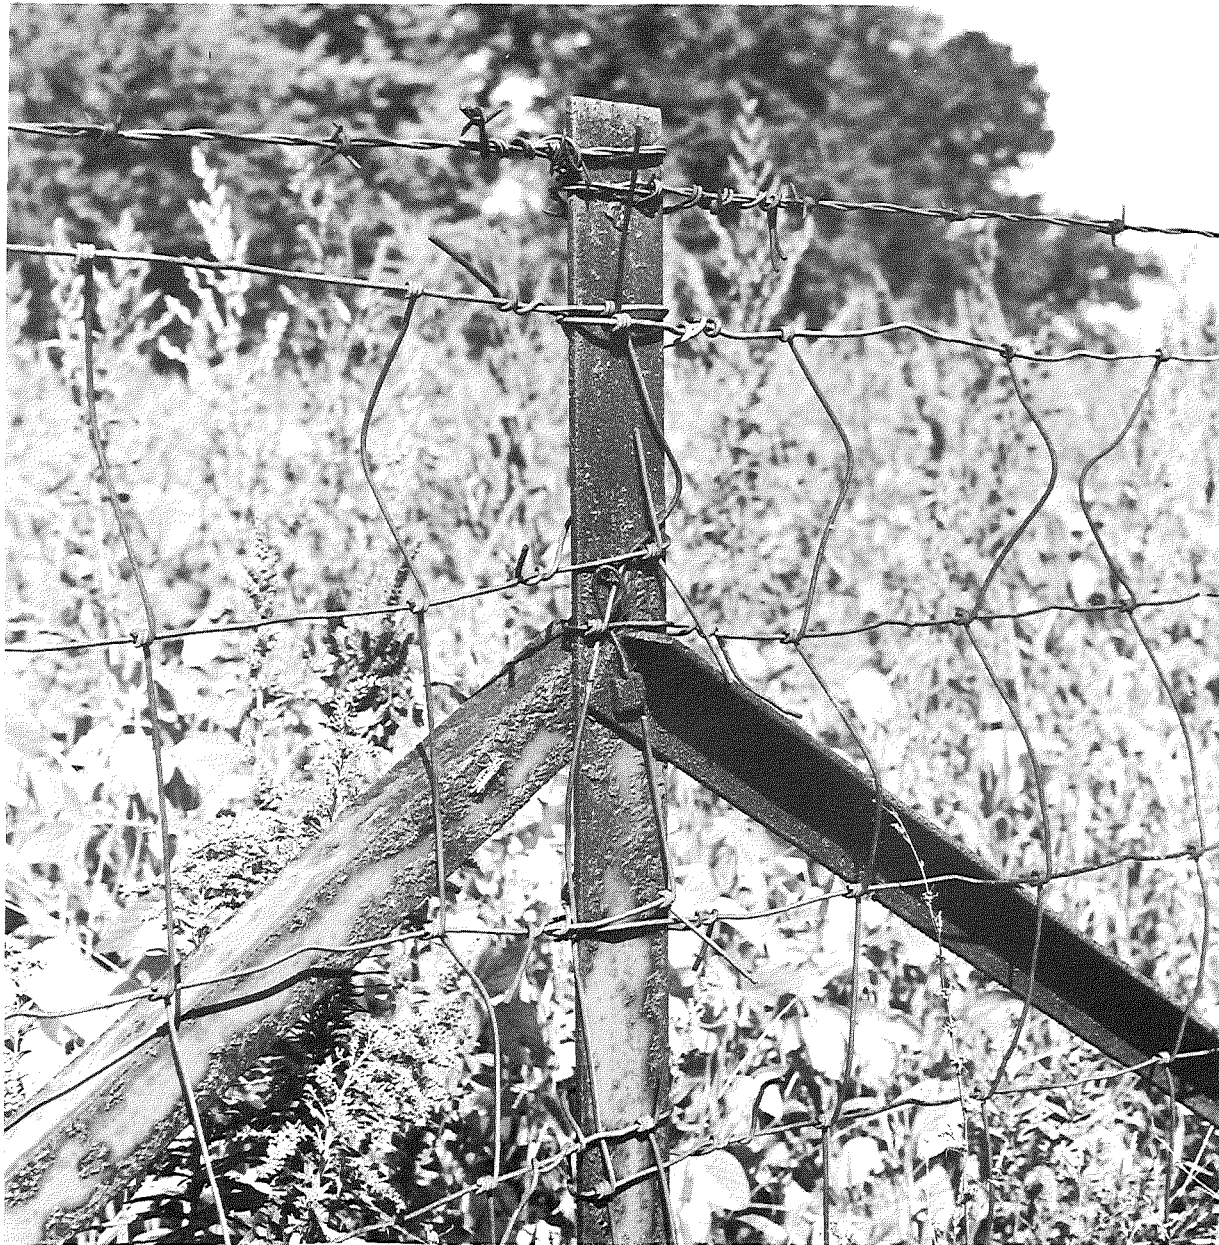
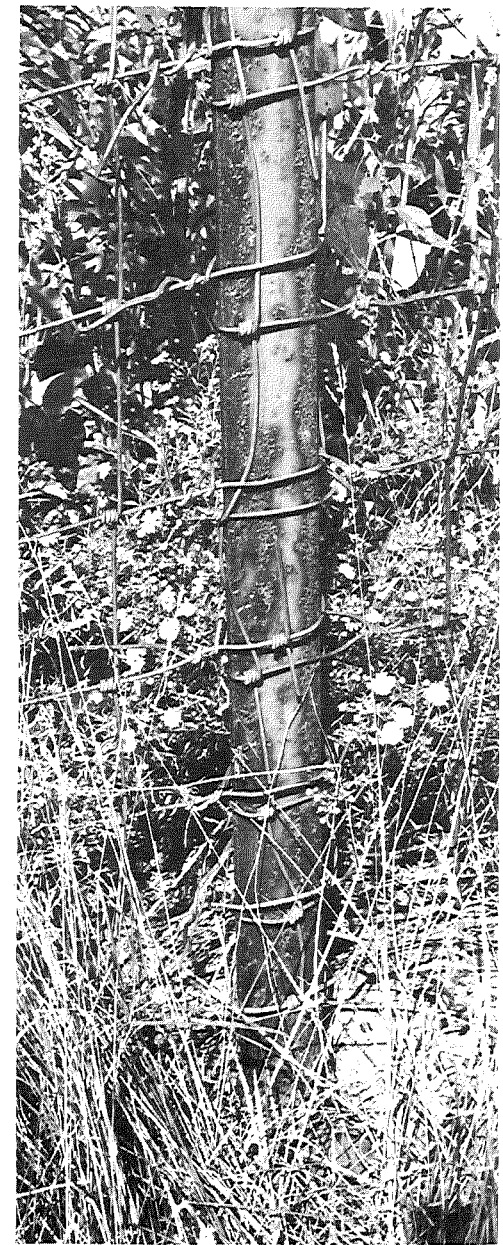
Figure 6. Age: 5 years. West side of I 75 at Station 1357+00 south of Vreeland Road between Detroit and Monroe. Two views of severe corrosion of intermediate braced post with several instances of galvanic corrosion of fencing wire.

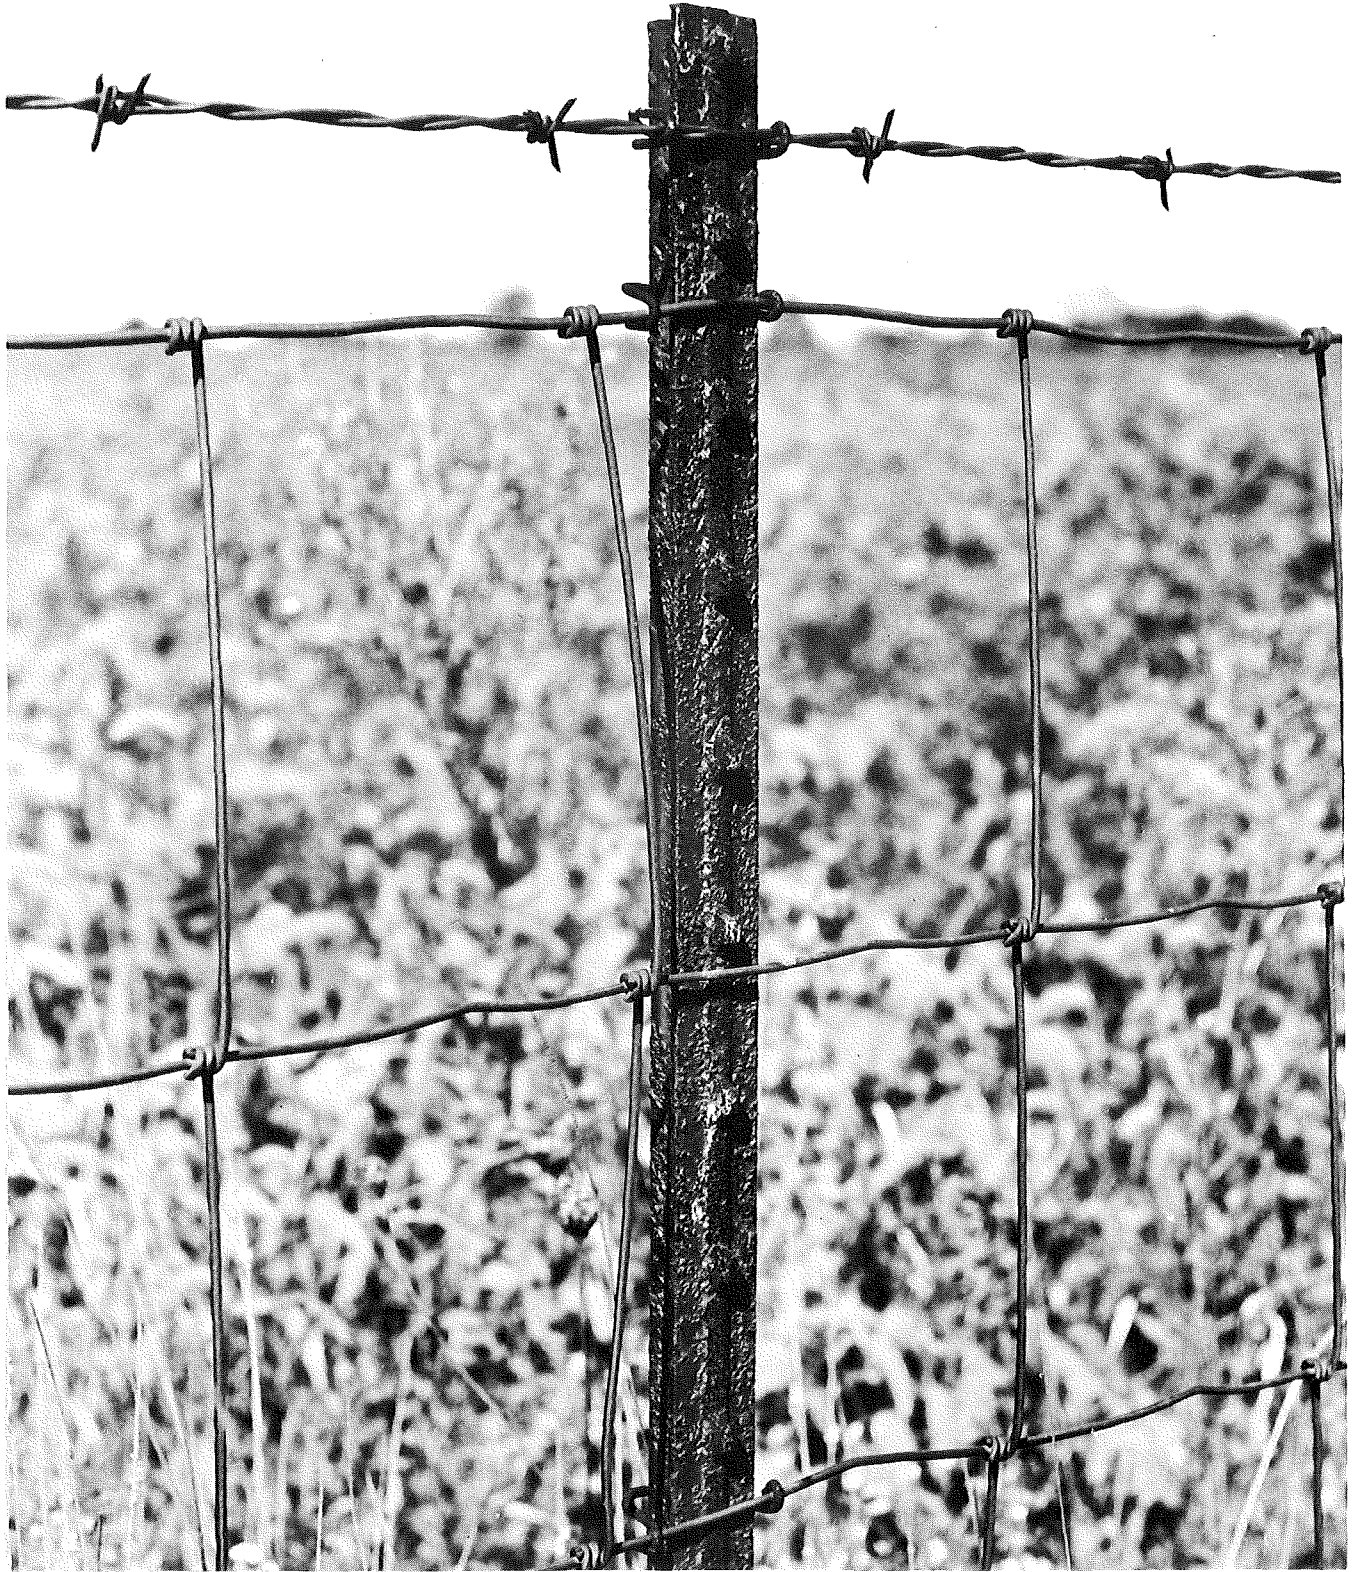
Figure 7. Age: 5 years. West side of I 75 at Vreeland Road between Detroit and Monroe. Excessive, severe corrosion, typical of posts in this area. Post is still structurally sound, but wobbly.

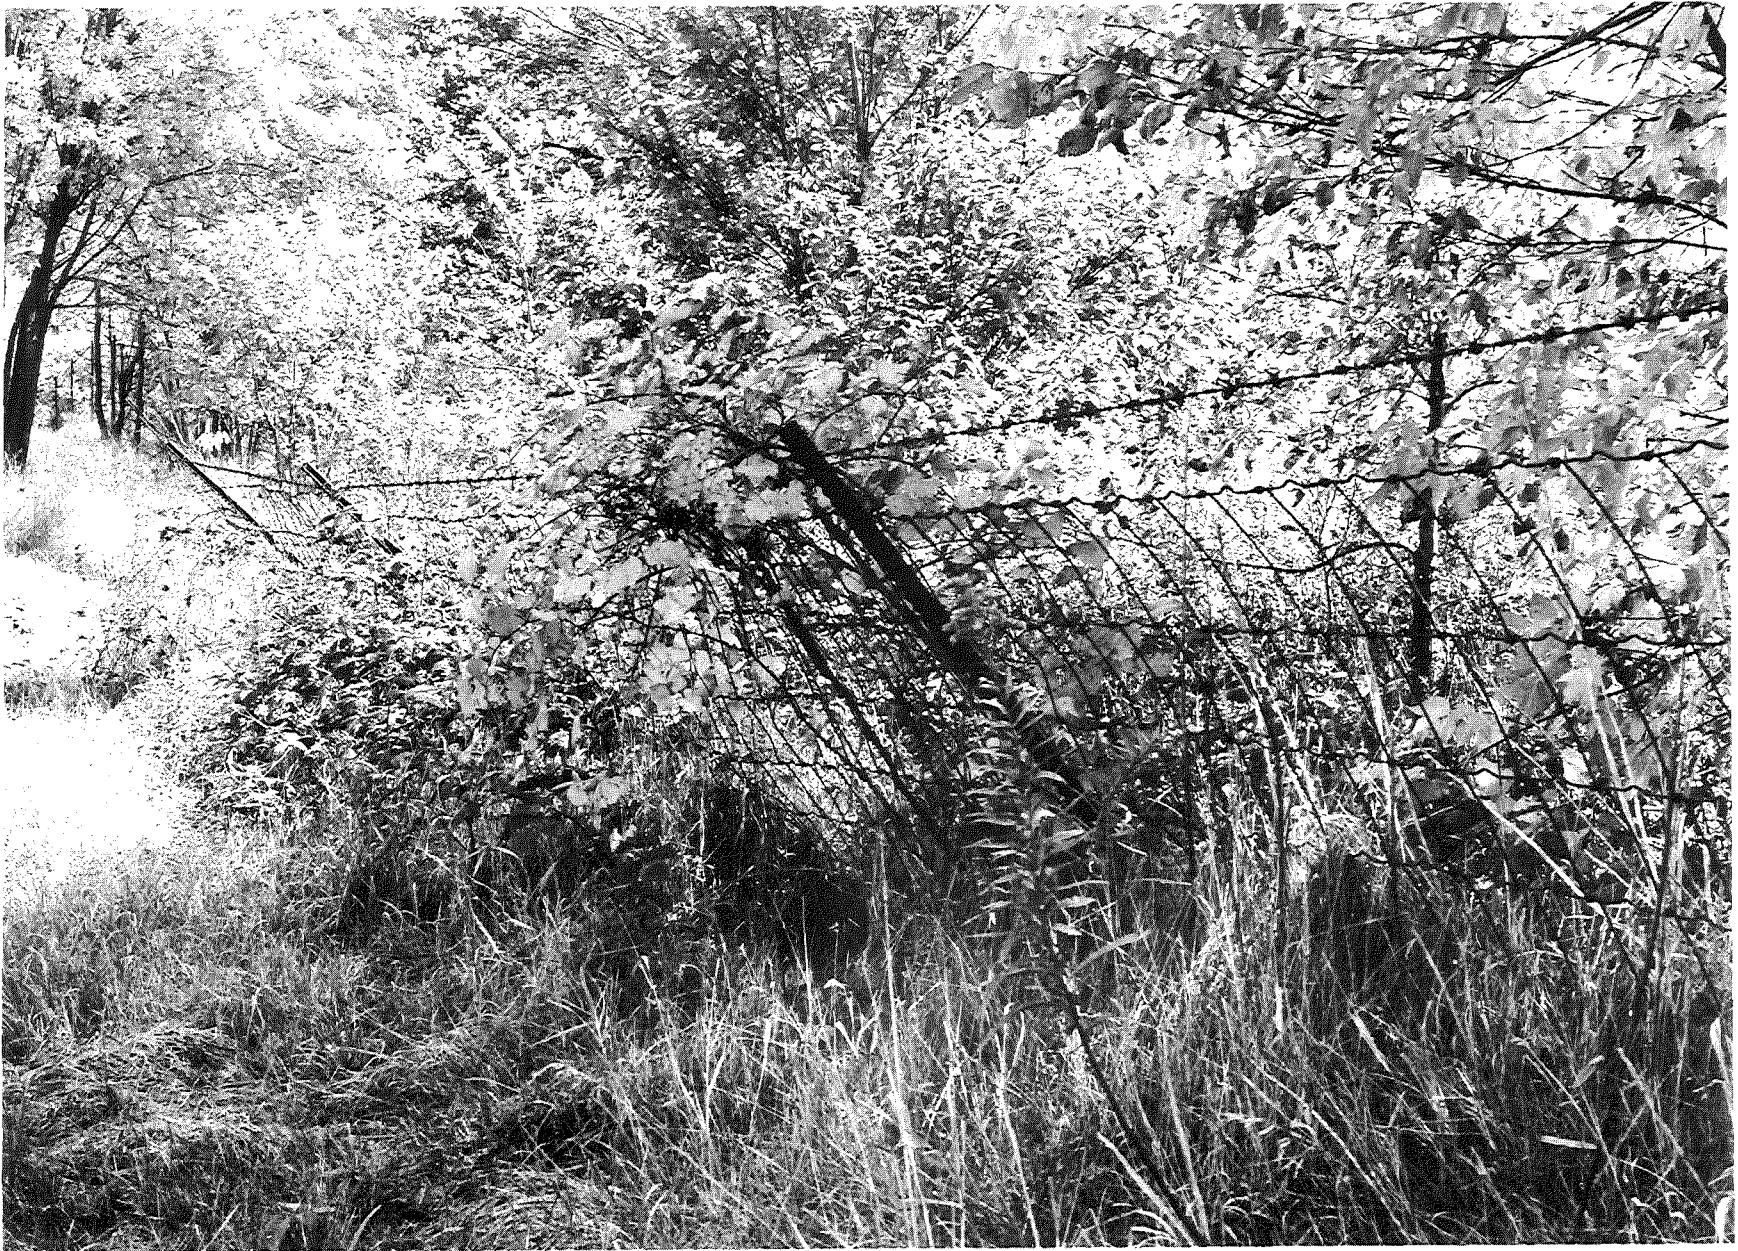
Figure 8. Age: 13 years. South side of I 94, 1/2 mile east of Cooper Street exit, Jackson area. Large section corroded through at ground level, with fence lying on ground. One post (see Figure 9) taken to laboratory for study. Wire fencing badly corroded.

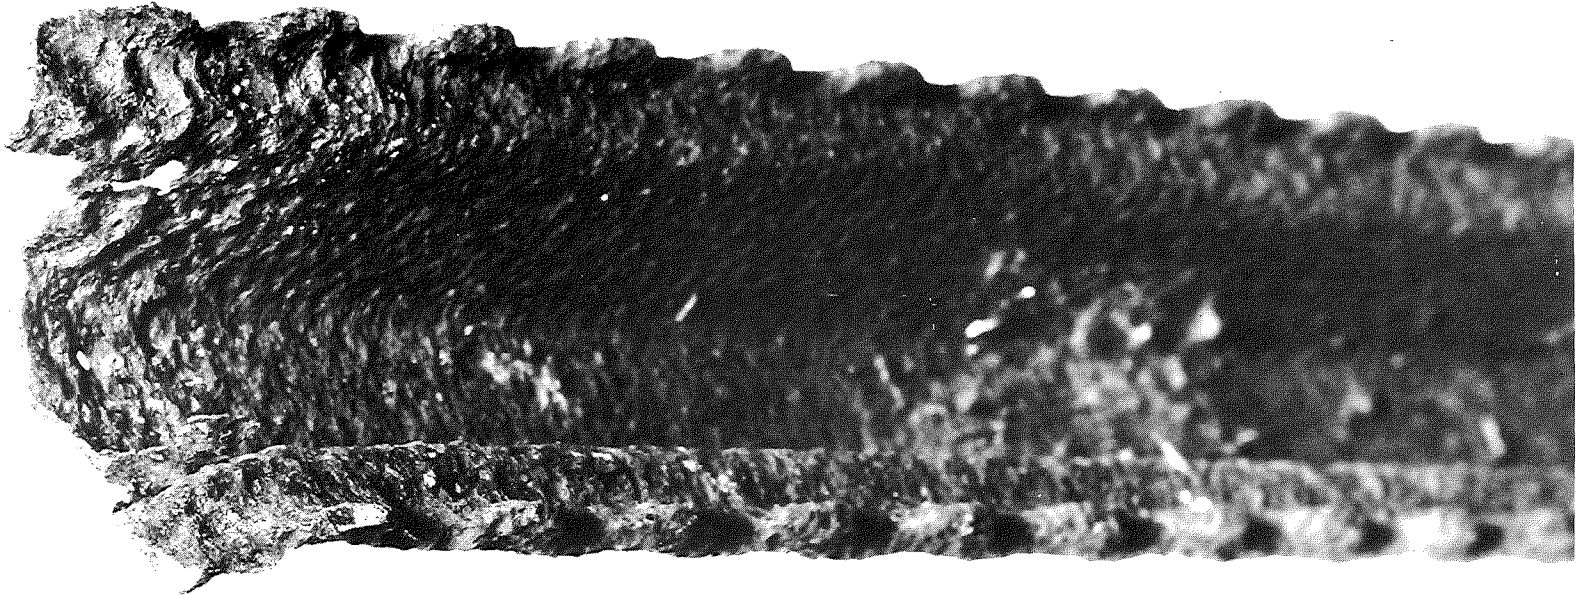
Figure 9. Age: 13 years. Post from fence section shown in Figure 8 taken to laboratory for study. Shows end of part above ground corroded through at ground level, with very severe corrosion above.

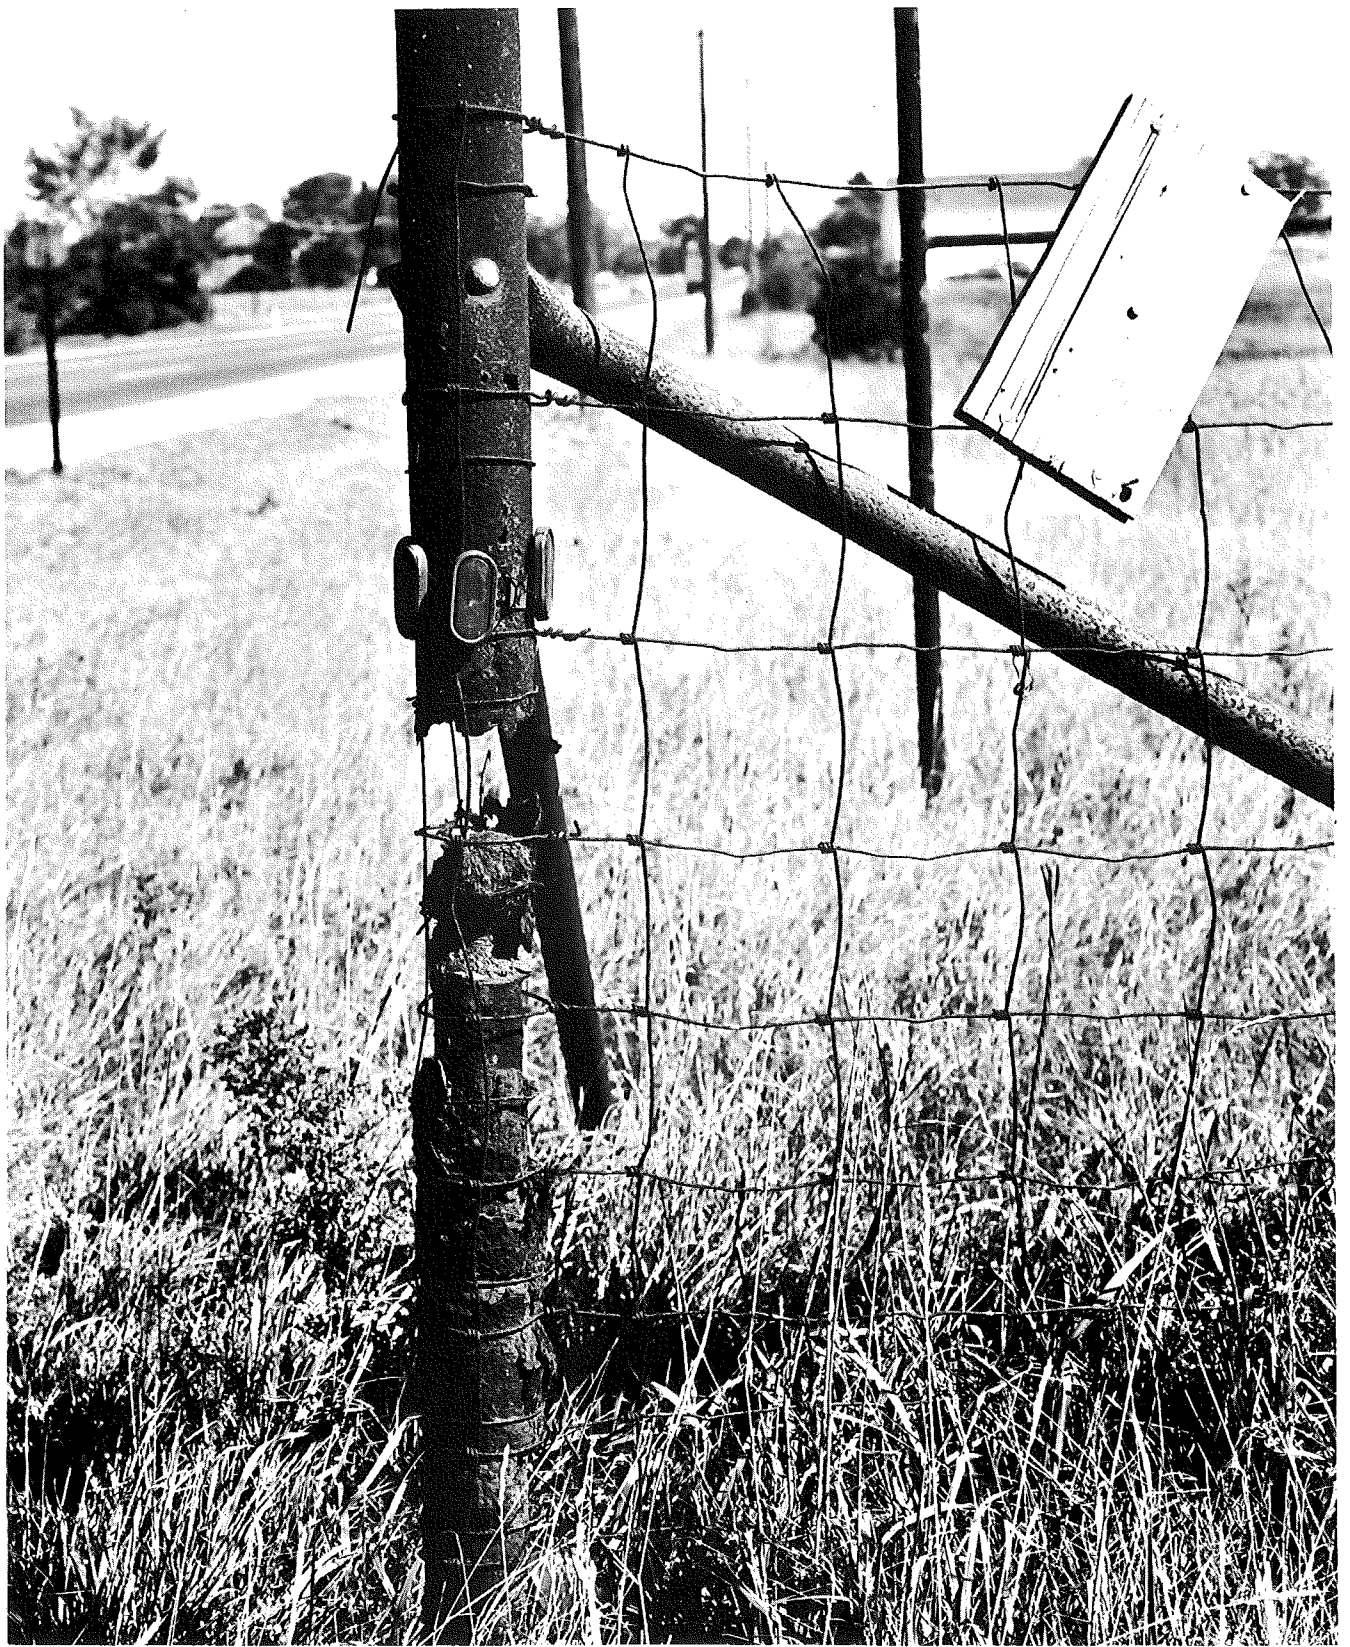
Figure 10. Age: 24 years. South-east corner of East Grand River Road (formerly US 16) and Bauer Road between Brighton and Howell. Corner pipe post corroded through about 2-1/2 ft above ground level, upper portion held up by brace posts.

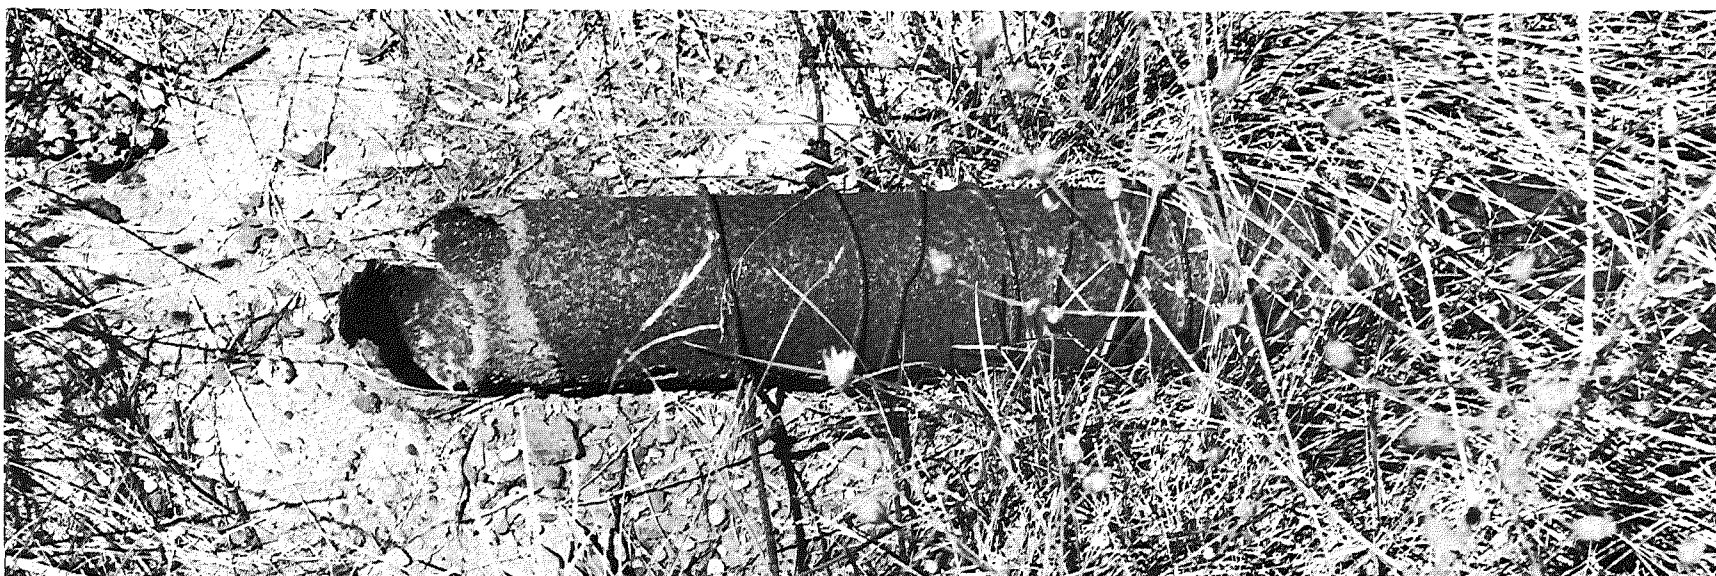
Figure 11. Age: 24 years. West side of US 16, north edge of Brighton. Pipe post corroded through at ground level, fence lying on ground.

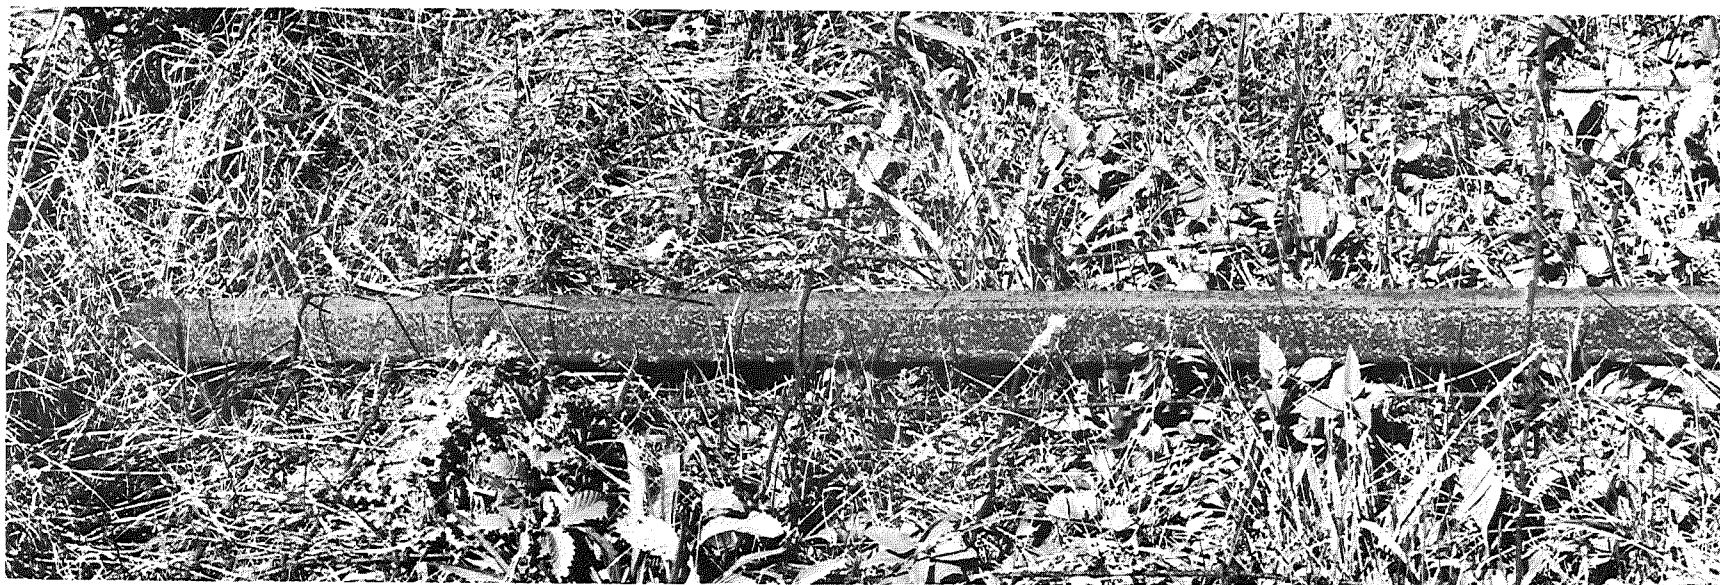
Figure 12. Age: 24 years. West side of US 23 just south of M 59 at Camp Tamarack. Fence post corroded through at ground level, fence lying on ground.

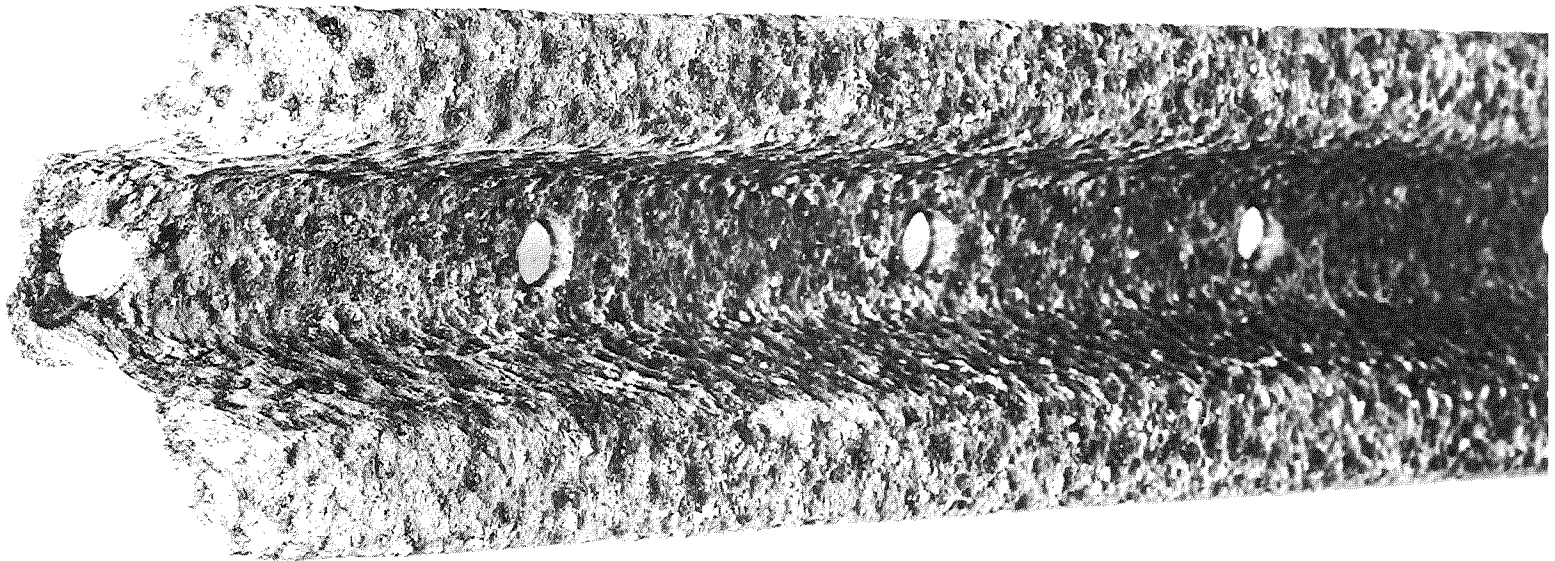
Figure 13. Age: 37 years. Southeast corner of Grand River and Stowe Road on US 16 east of Webberville. Post corroded through and lying loose on ground taken to laboratory for examination. Advanced corrosion above ground.

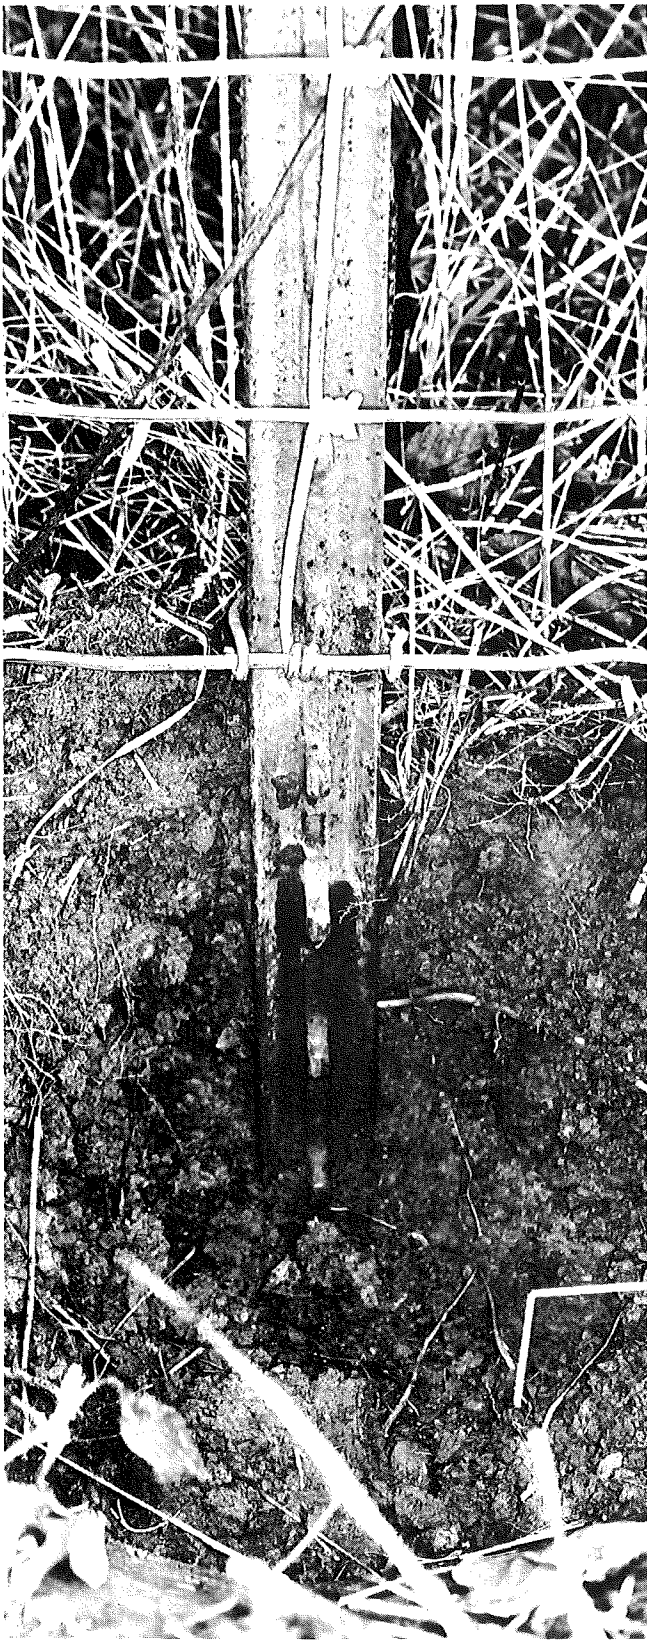
Figure 14. Age: 4 years. East side of I 75 just north of Flint. Clay soil. Original green paint still very good below ground level. Severe attack at ground line.

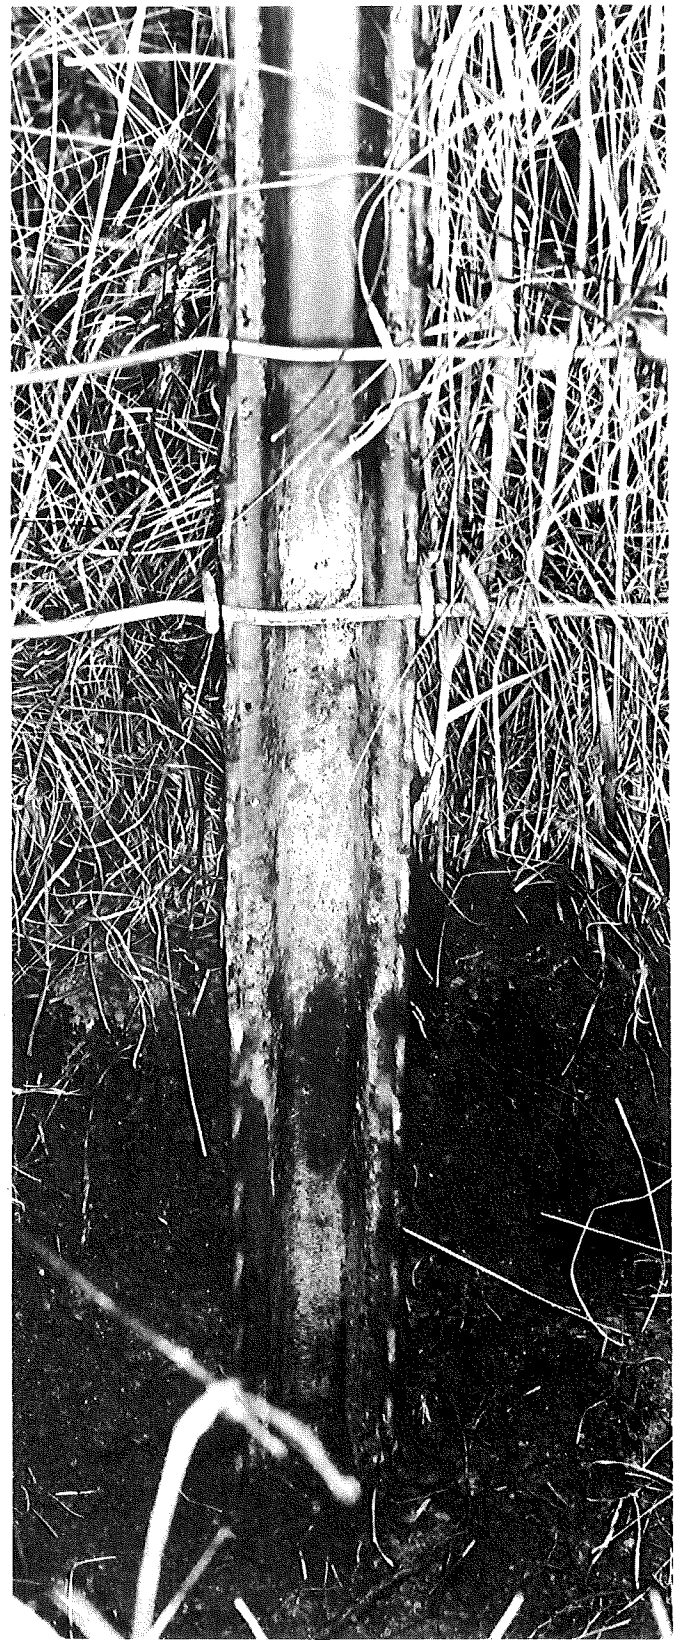
Figure 15. Age: 4 years. East side of I 75 south of M 57. Dark, rich soil. Green paint still satisfactory below ground but corrosion is severe at ground level.

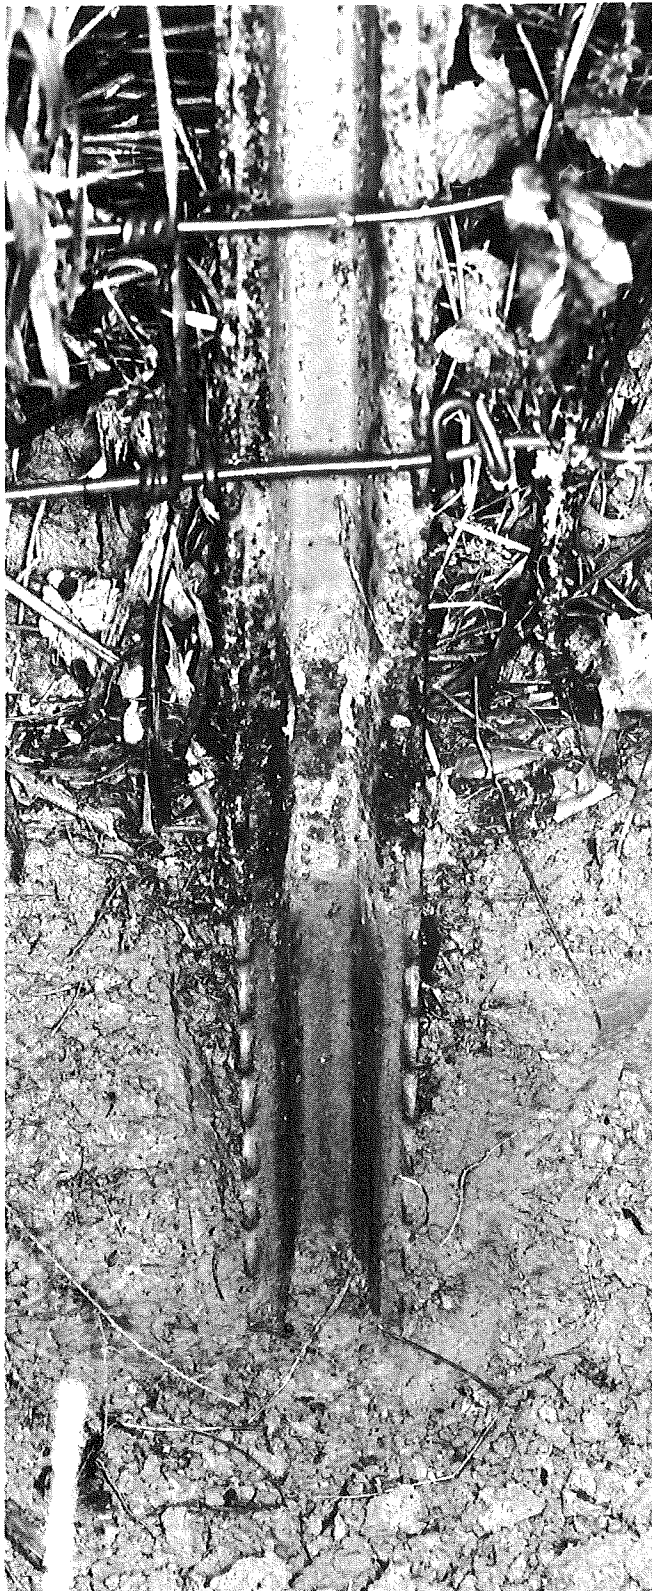
Figure 16. Age: 5 years. West side of I 75 at 1357+00. Clay loam soil. Green paint excellent below ground level with no apparent corrosion. Severe corrosion at ground line, less severe above ground.
