**CORROSION OF PAINTED STEEL RIGHT-OF-WAY FENCE POSTS**

**Research Laboratory Division  
Office of Testing and Research  
Research Project R-61 NM-34  
Research Report No. R-419**

**Michigan State Highway Department  
John C. Mackie, Commissioner  
Lansing, April 1963**

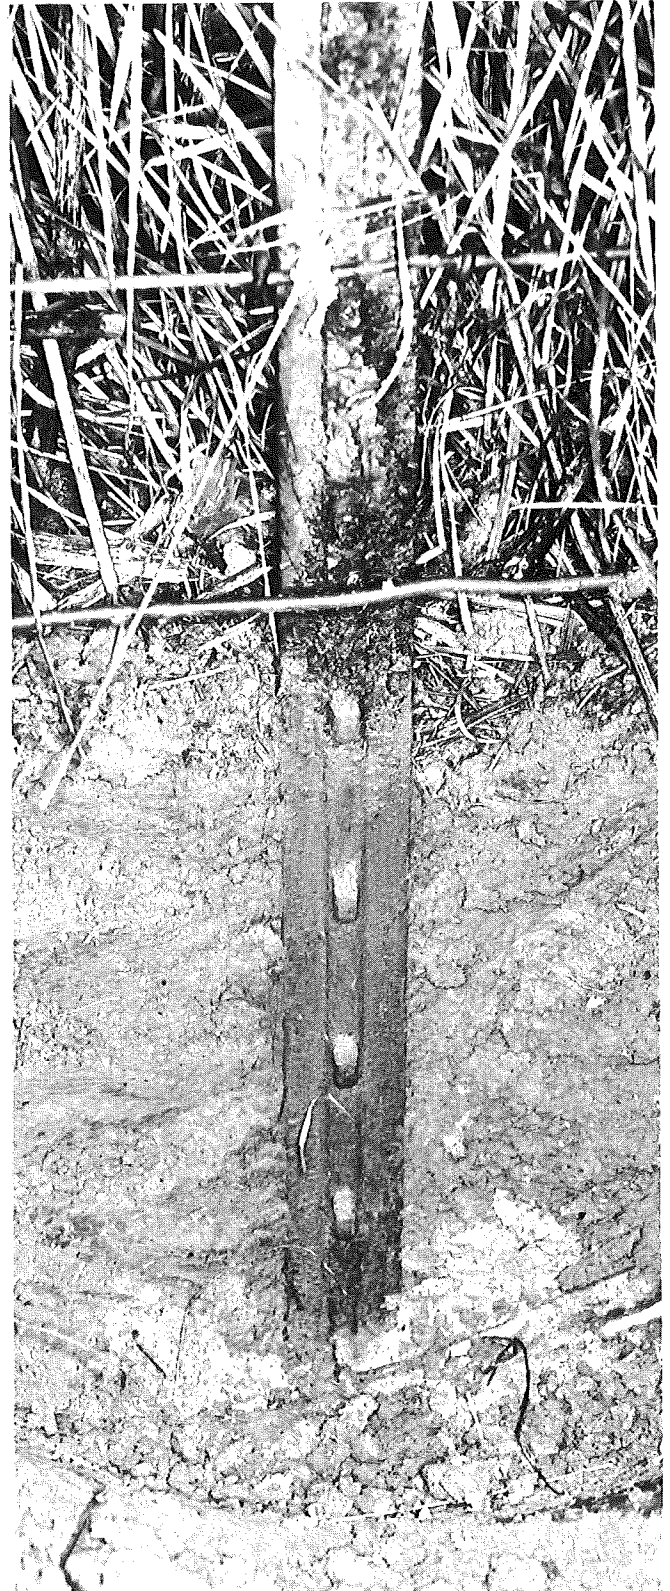
Figure 17. Age: 5 years. West side of I 75 at Vreeland Road overpass. Clay loam soil. Green paint excellent below ground level with practically no apparent corrosion. Severe corrosion at ground line, less severe above ground.

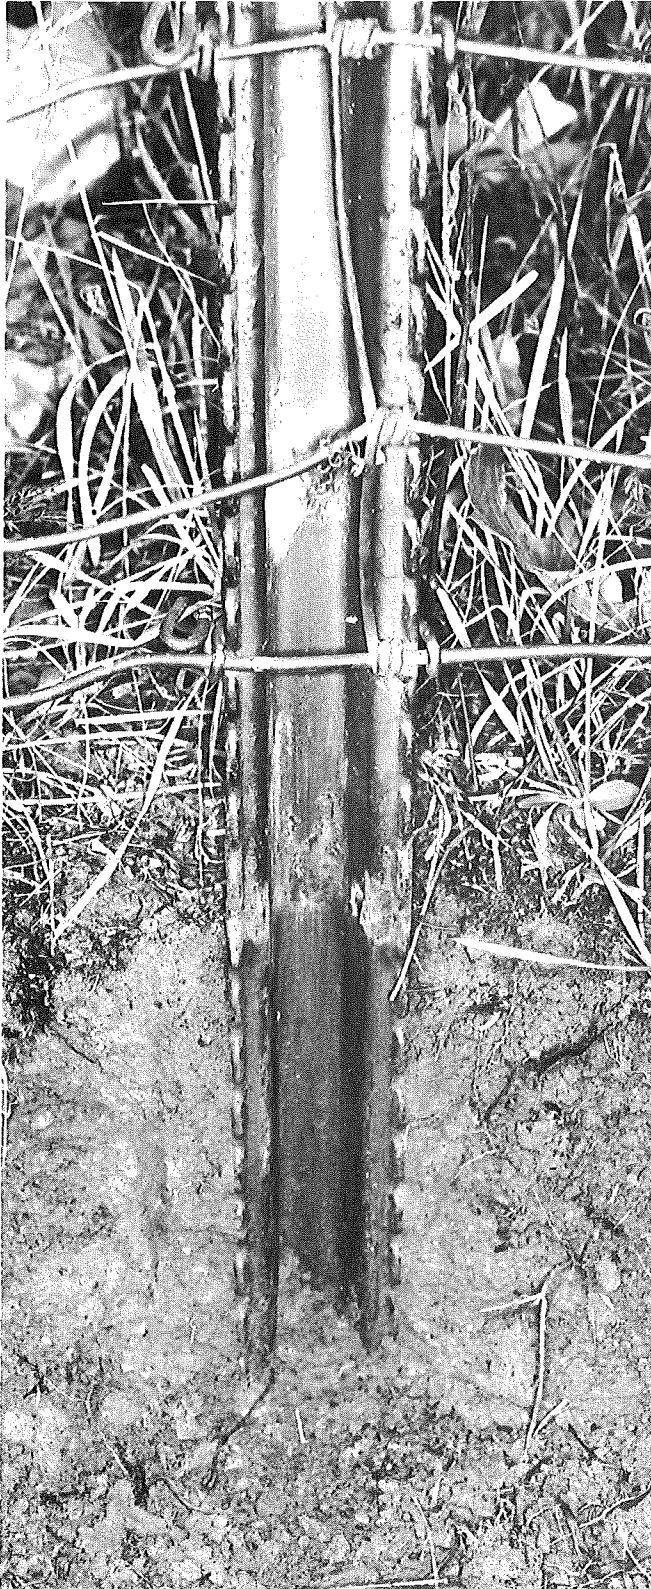
Figure 18. Age: 5 years. West side of I 75 at Mount Morris exit. Sandy loam soil. Green paint excellent below ground level with little apparent corrosion. Severe corrosion at ground line, less severe above ground. White area is caterpillar's nest.

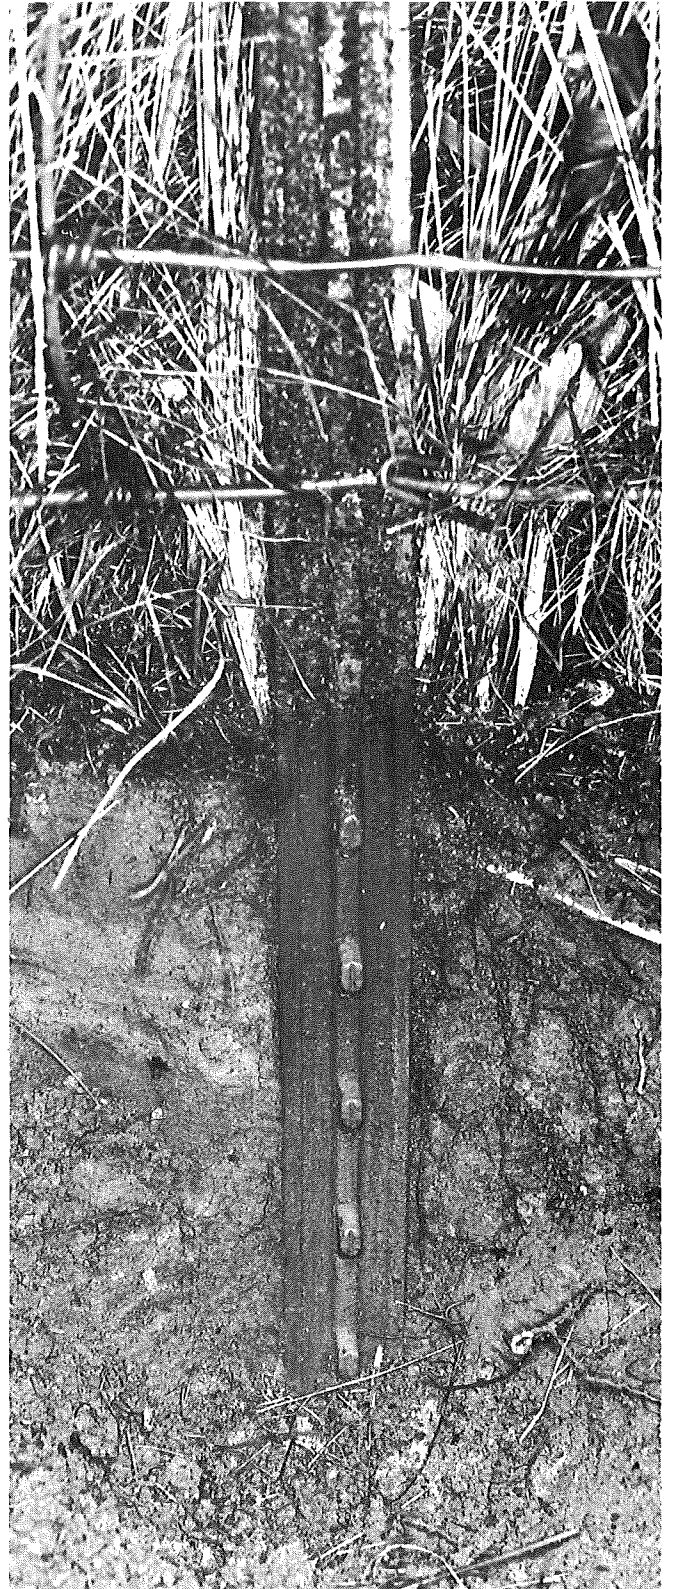
Figure 19. Age: 5 years. West side of I 75 at 1305+00. Sandy loam soil. Green paint in good condition below ground level with little apparent corrosion. Severe corrosion starting at ground line and extending above ground.

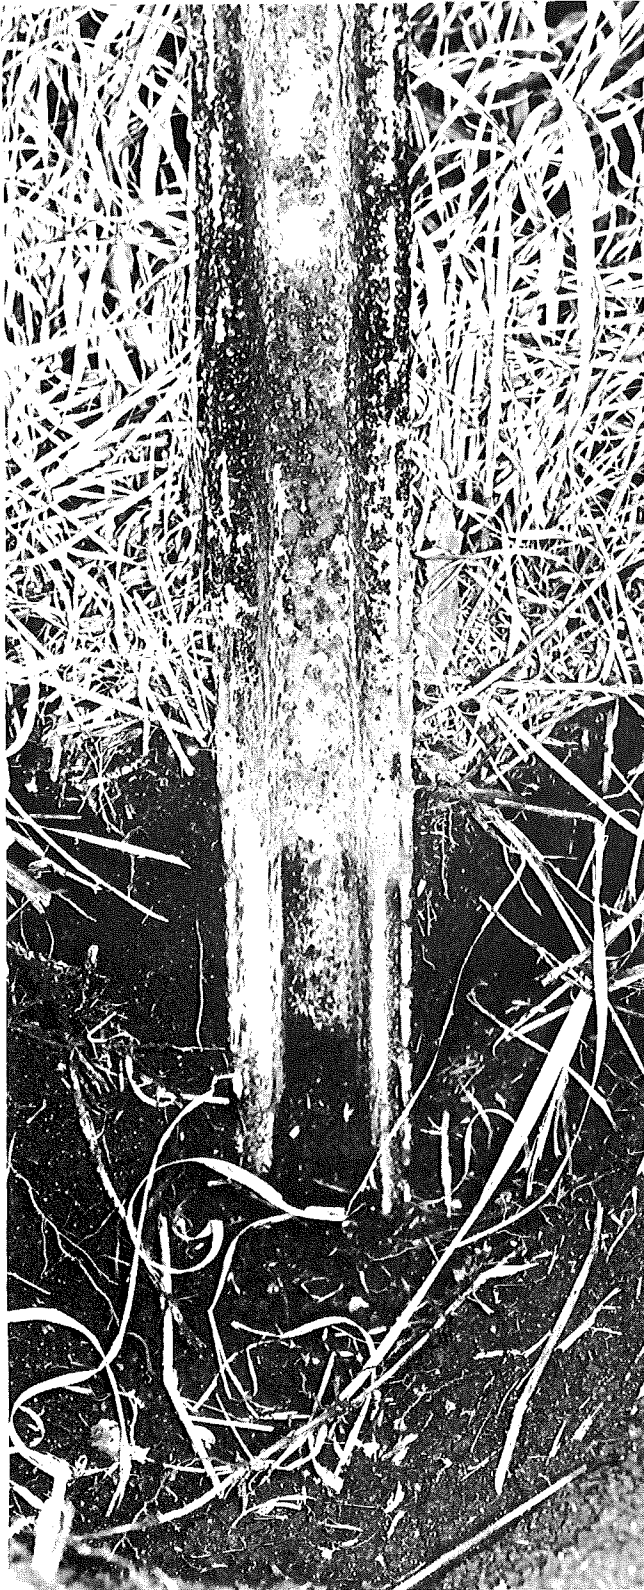
Figure 20. Age: 8 years. North side of I 94 just west of US 127. Black dirt. Yellow paint still in good condition below ground level, with little corrosion. Intense corrosion at ground line with severe corrosion above ground.

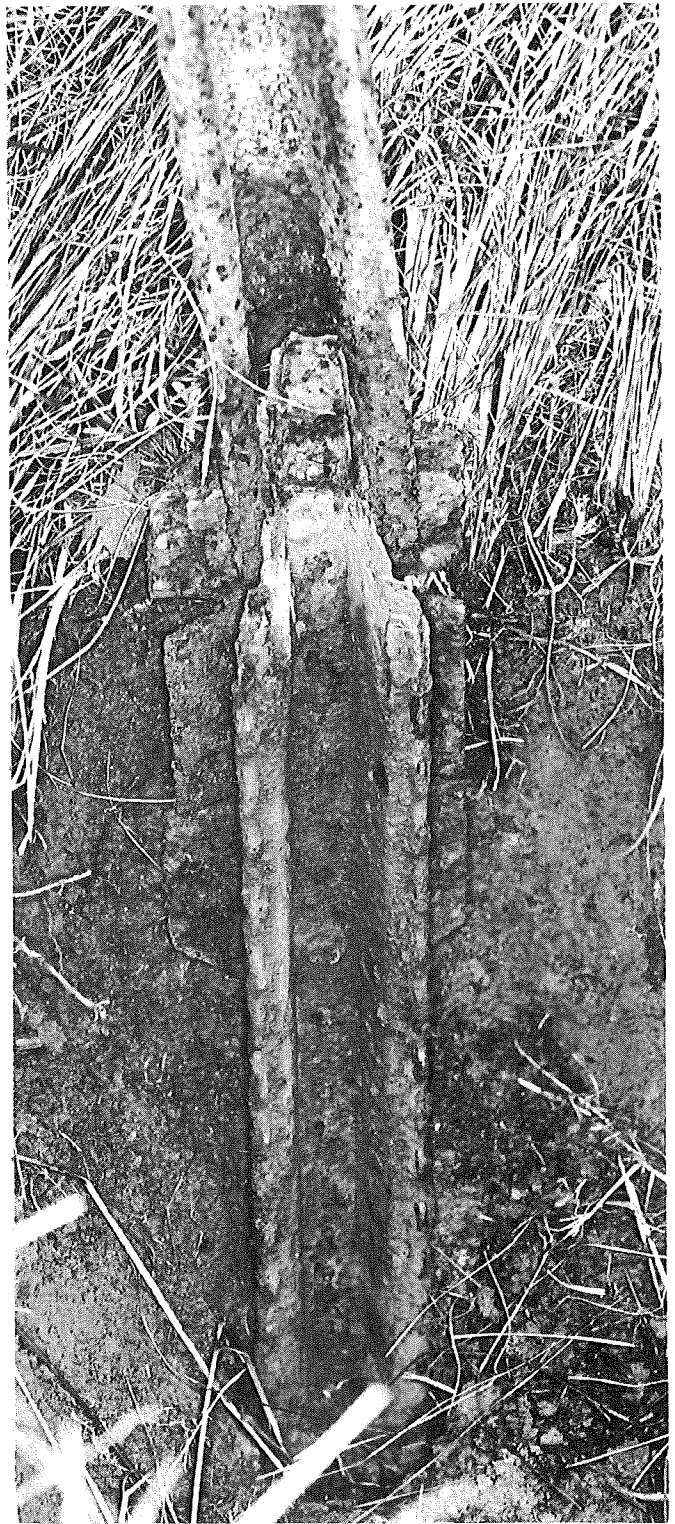
Figure 21. Age: 28 years. North side of US 16 about 4 miles east of Hogback Road and 1 mile west of M 59 intersection. Clay soil with some loam. Corroded completely through at ground line with severe corrosion above ground. Yellow paint still present below ground level. Three or four spots where paint has come off show shiny black metallic surface. Some corrosion under ground.

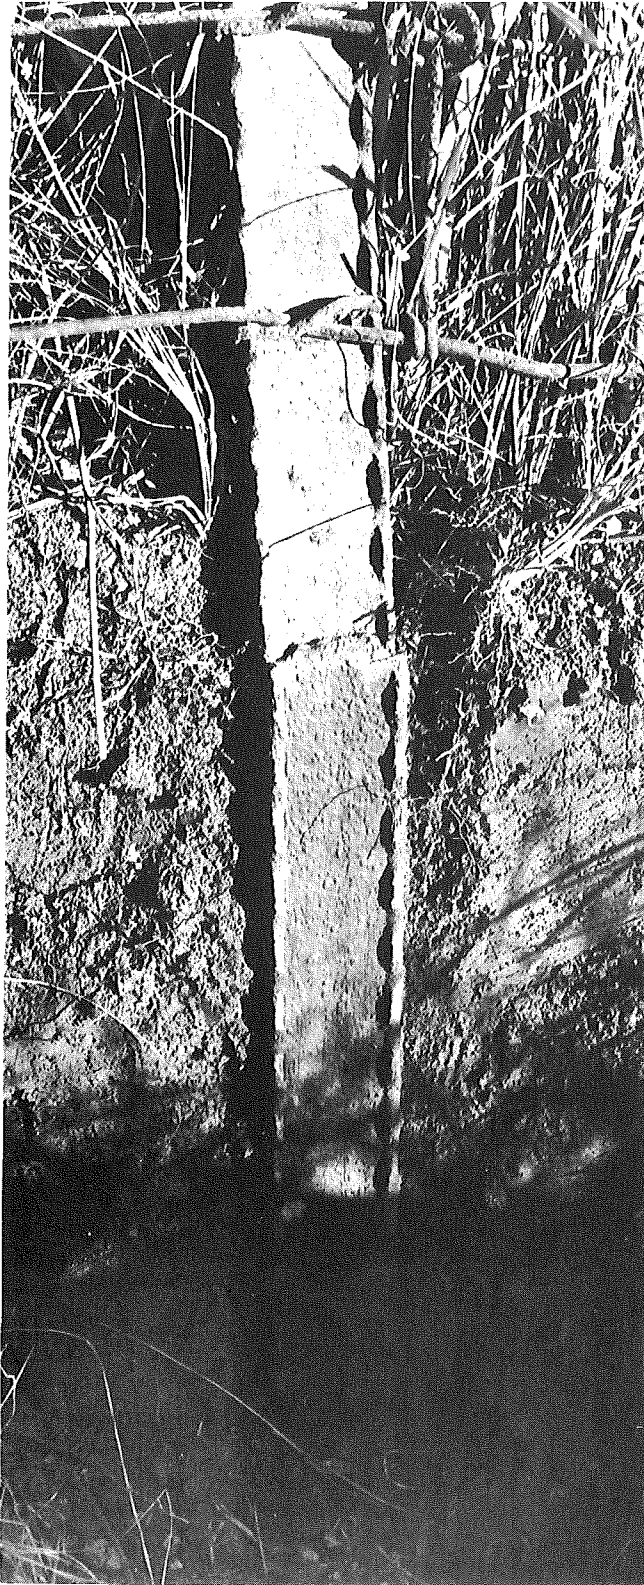
Figure 22. Age: 38 years. North side of US 16 just east of I 96 entrance west of Lansing. Sandy loam soil. Surface corrosion below ground level, otherwise sound. Corroded completely through at ground line, extensive corrosion above ground.

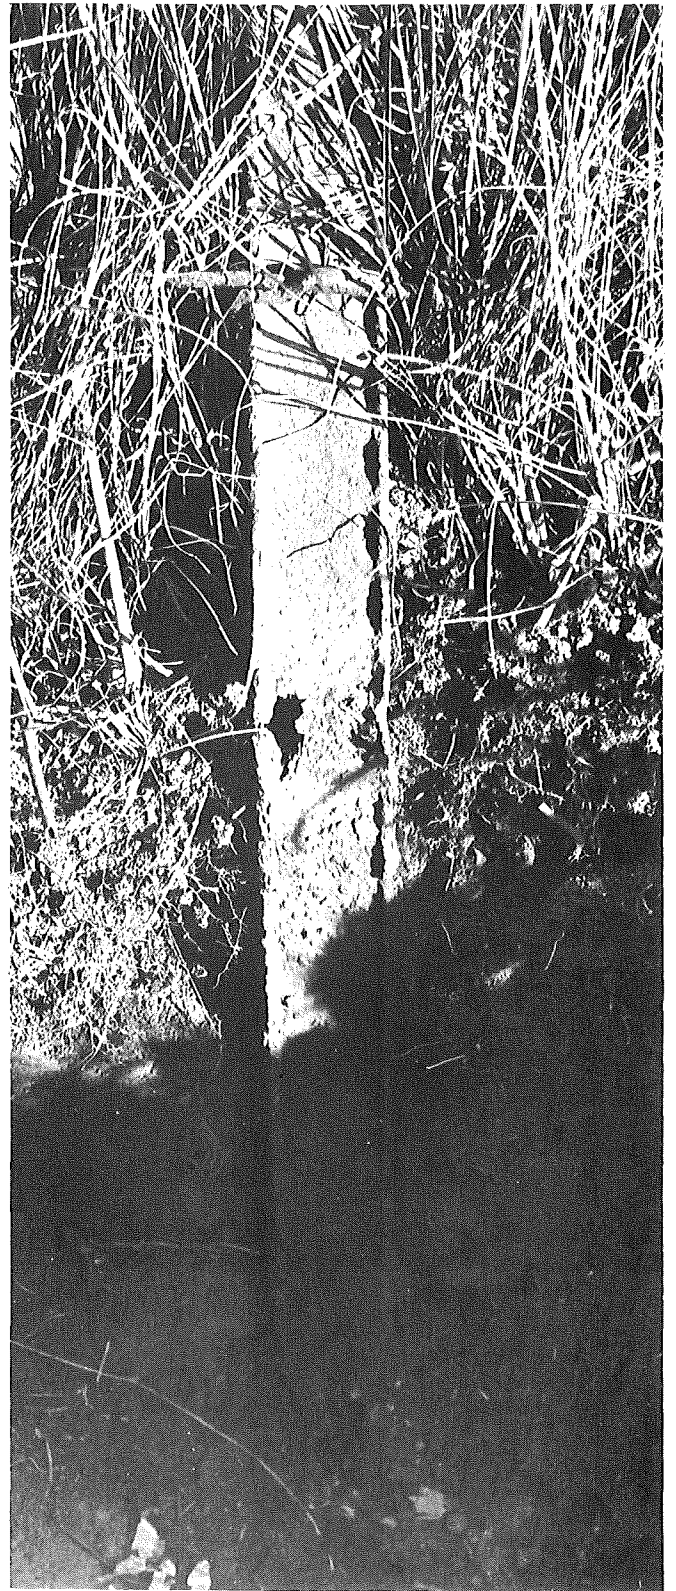
Figure 23. Age: 38 years. Another post in same location as that shown on left. More metal appears to be present below ground than above.

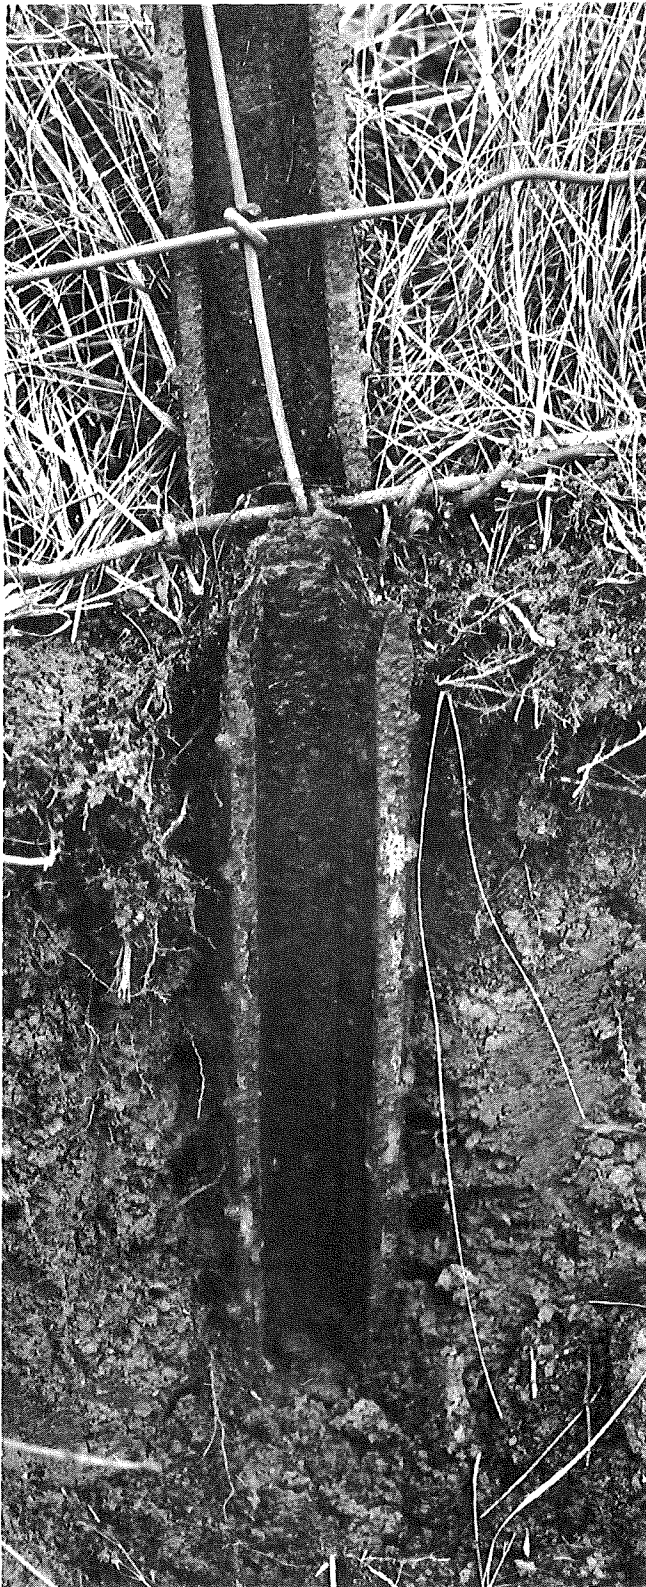
Figure 24. Age: 39 years. North side of US 16 just east of Fowlerville. Clay and loam soil, stony. Corroded entirely through at ground level. Apparently protective rust has formed below grade. Corrosion severe above ground.

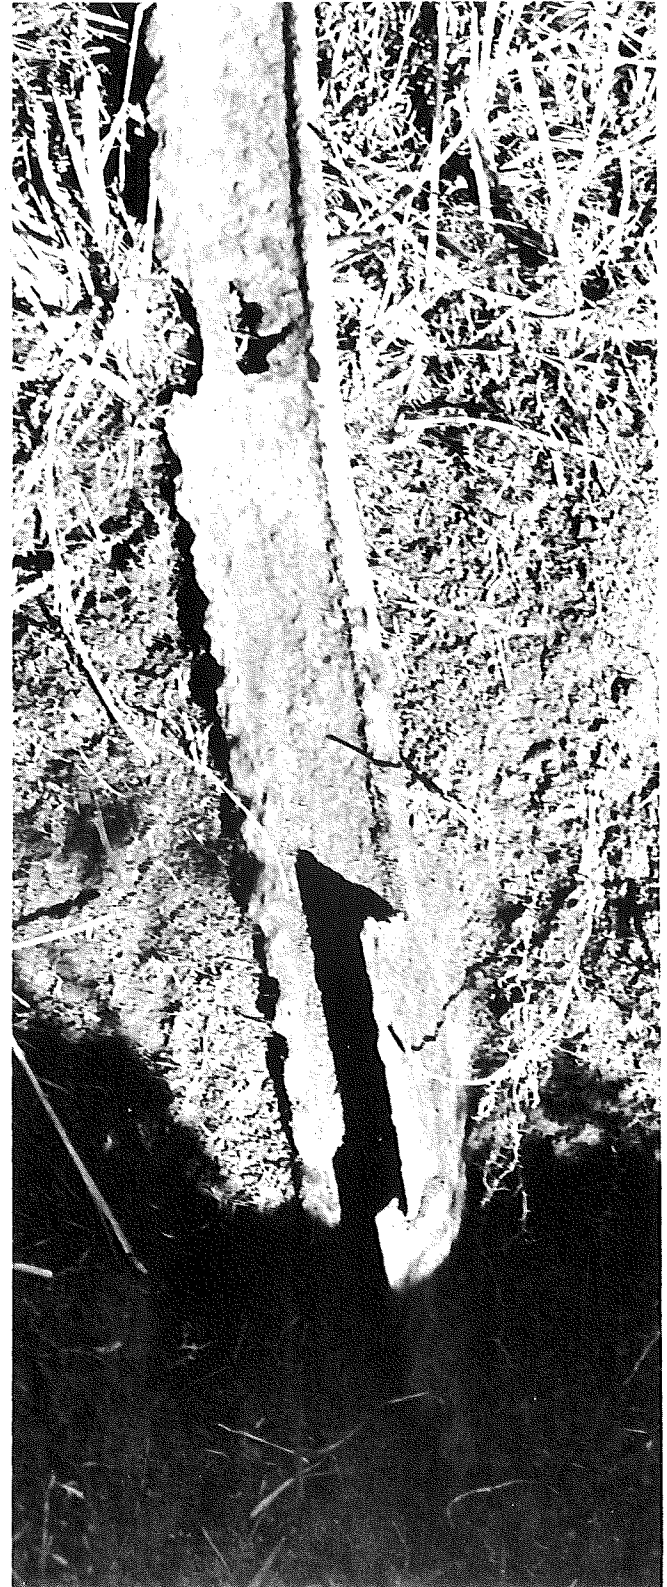
Figure 25. Age: 41 years. South side of US 16 just west of M 59 intersection. Sandy loam soil. Sound below grade with surface rusting. Almost completely severed at ground line by corrosion.
