CONDITION STUDY OF
MENOMINEE TOURIST LODGE

Highway Research Project 49 G-48

Research Laboratory
Testing and Research Division
Report No. 138
November 7, 1949

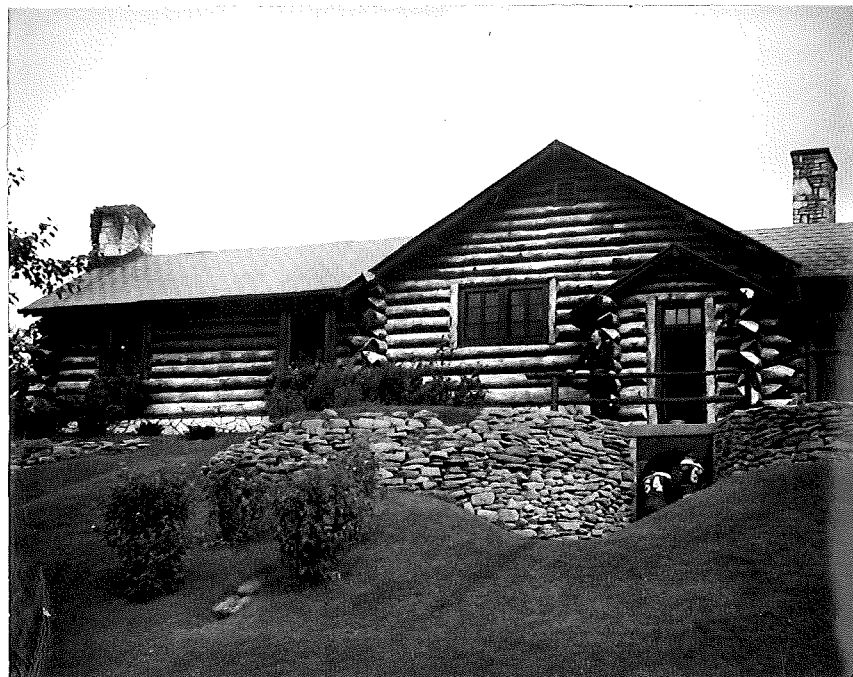
Further reference to Figure 2 shows a whitish discoloration of the logs on the south side. This condition became a corollary to the main study, as the discoloration undoubtedly detracted from the appearance of the lodge, and Mr. J. C. Jenkins, Lodge Supervisor, particularly asked the Research Laboratory for a recommendation on restoring the south wall to a more normal rustic appearance.

Figure 2. Rear view, south wall.

2. The use of varnish or other special seal materials which impede the evaporation of moisture from rain or snow should be discontinued.
3. The whitish surface coatings on the south, east, and west walls, caused by the bleaching action of the sun's rays on resins in varnish materials, can be removed by wire brushing and scraping after preliminary softening with trichlorethylene.

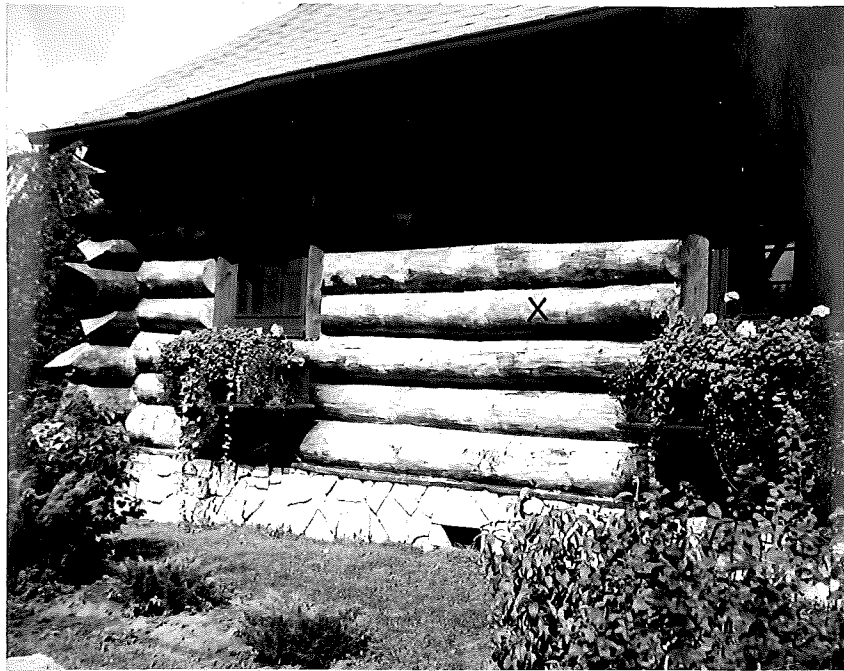
Accordingly, through the cooperation of Mr. R. F. Rosatti, District Maintenance Engineer, and members of his maintenance crew, arrangements were made for a surface sample to be removed at the point marked "X" in Figure 3. Figures 4 and 5 show the extent of the sample.

Figure 3. Portion of south wall. Sample removed at point marked "X".

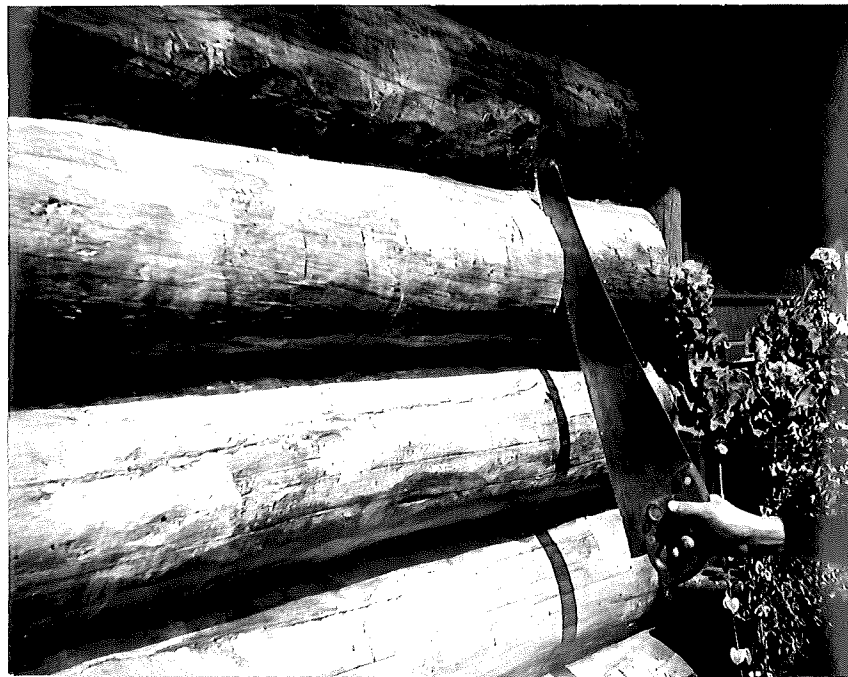
Figure 4. Removing sample at point shown in Figure 3.

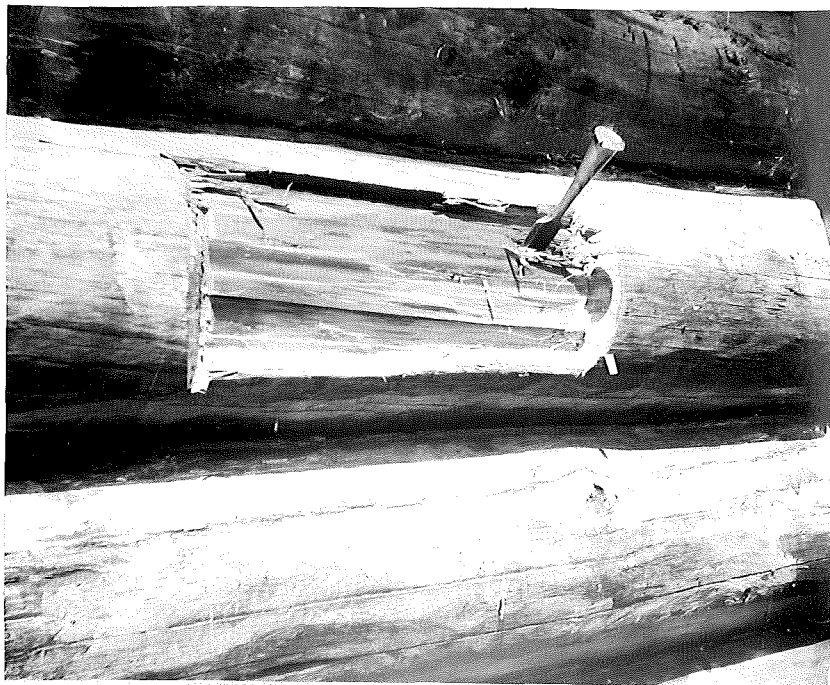
Although the surface sample was removed primarily to serve as a laboratory specimen for further study of the whitish discoloration, examination of the residual log under the 1-inch layer removed showed that the interior of the log was rotted to a considerable depth. Figure 5 shows the extent to which a 1-inch wood chisel was pushed into the log with the bare hands.

It is worthy of note at this point that there was no outward indication that this particular log had deteriorated, both it and adjacent logs being hard, firm, and apparently sound from the outside.

Figure 5. Condition of log after removal of 1-inch thick surface sample. Interior of log rotted to unknown depth.

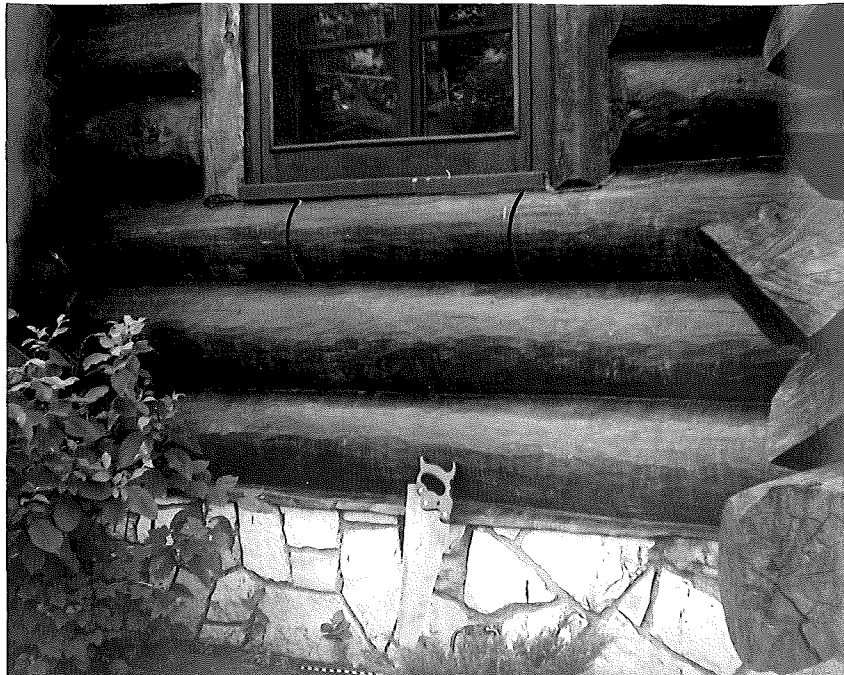
There were, however, several logs whose outer layers were definitely yielding on pressure, possessing apparently hollow spaces near the surface "skin", and sounding "dead", "flat", or "hollow" on percussion. One such log was that located directly under the window sill in Figure 6, and this was typical of several of the worst logs in this respect. The same log seemed sound when examined from the interior of the building, as was true of every log in the structure.

It was decided to remove an approximately 3-foot section of this log between the points shown in Figure 6 and to submit the entire section to the Forestry, Entomology, and Botany Departments of Michigan State College for study and appraisal.

Figure 6. Portion of north wall showing point at which section of log was removed for study at Michigan State College.

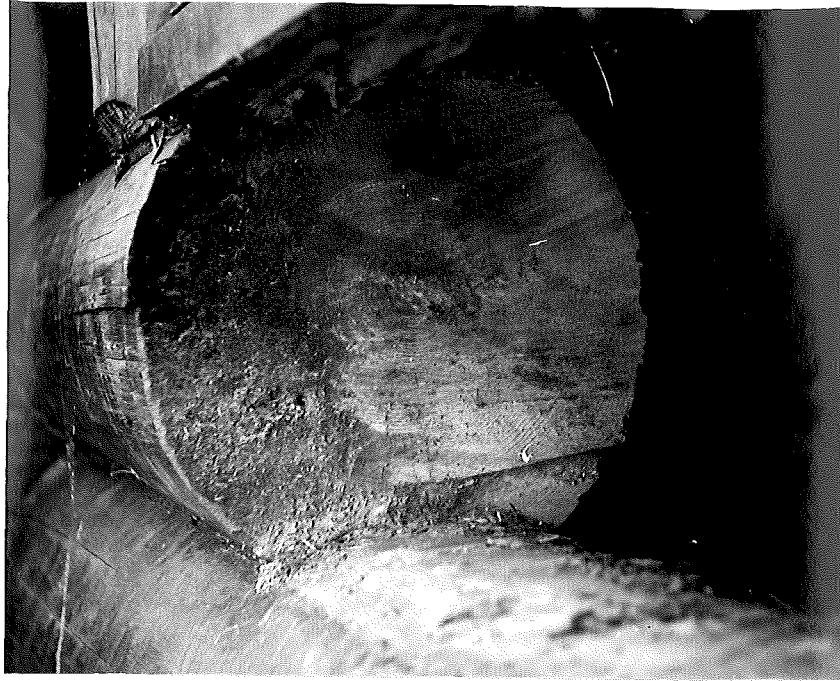
main of disintegrated punk, held together loosely by an outer 1/4-inch layer or skin, this skin being all that maintained the original contour of the log. Figures 7 and 8 show the cross-section of the log adjacent to the section removed.

As shown in the photographs, the central third of the log, and the third facing the interior of the building were in relatively sound condition.

Figure 7. Log adjacent to east end of section removed.

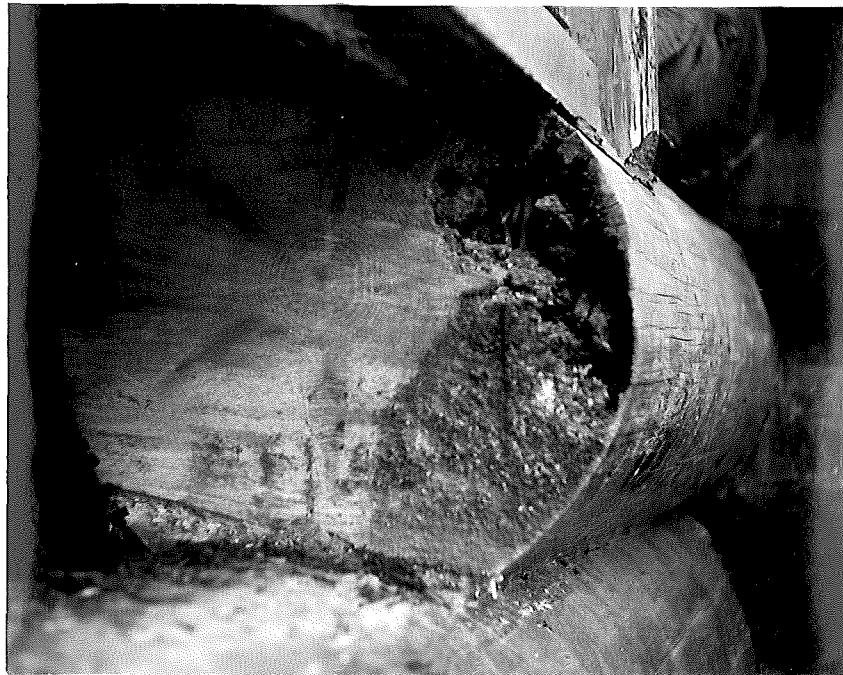
Figure 8. Log adjacent to west end of section removed.

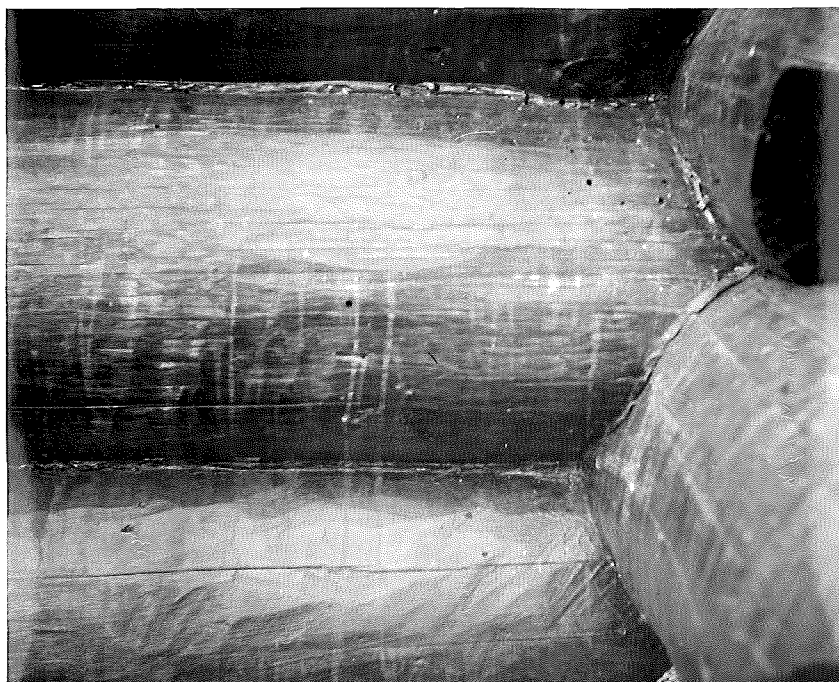
As already mentioned, the logs facing the inside of the lodge were apparently all sound. There were scattered areas showing insect holes, as in Figure 9, but the logs themselves were hard and sound on percussion. Except for these few insect borings, no sign of deterioration could be found anywhere in the building.

Figure 9. View of inside wall showing insect borings, sole evidence of any deterioration within the lodge.

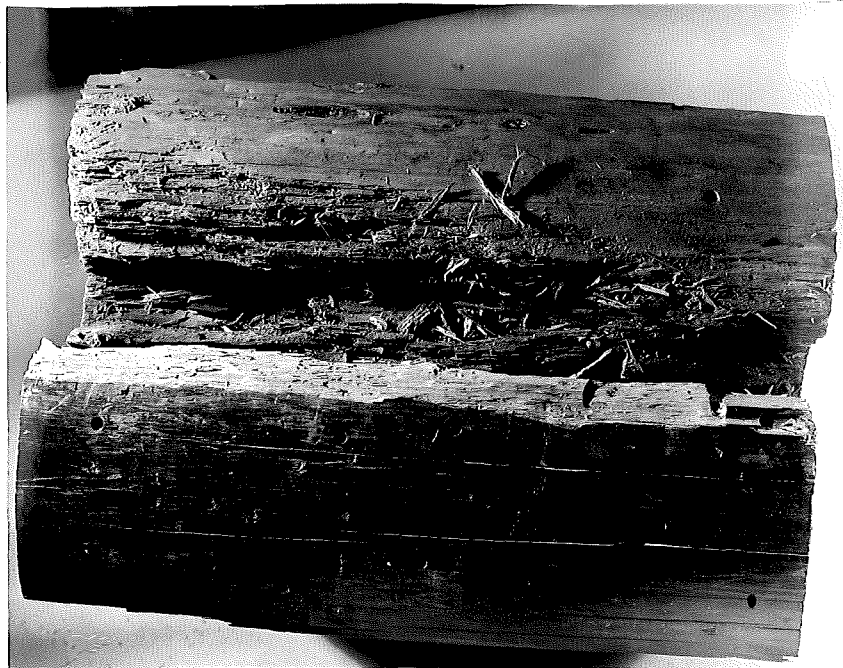
Insect borings of the same type, however were visible with much greater frequency along the surfaces of logs composing the outside walls of the structure. Figure 10, taken later in the laboratory of a portion of the section removed for study, shows several such holes.

Figure 10. Portion of section removed for study showing insect borings in exterior wall surface.

Entomology Department experts diagnosed the problem as being not one of insects, but rather one of fungus rot, stating that in recent years invasion of the timbers and logs by insects had been secondary to infestation by fungus organisms.
