***INVESTIGATION OF EARLY
CRACKING ON SELECTED
JPCP PROJECTS***

1. Report No. RC-1501	2. Government Accession No.	3. MDOT Project Manager David Smiley	
4. Title and Subtitle Investigation of Early Cracking on Selected JPCP Projects		5. Report Date December 2007

**Investigation of Early Cracking on
Selected JPCP Projects**

**Pavement Research Unit
Construction and Technology Division
Research Report RC-1501**

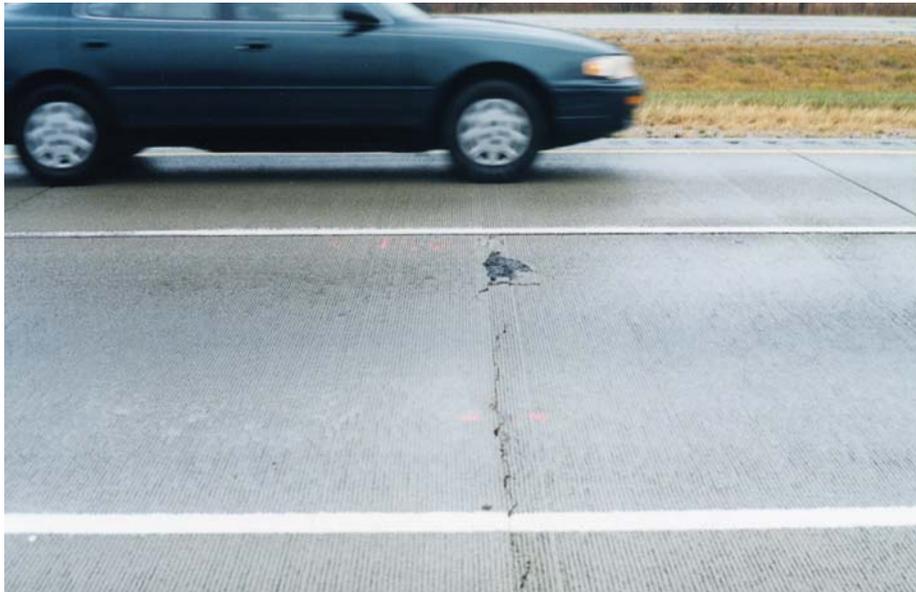
Figure 3.30 Typical Mid-Panel Transverse Crack

Of the 15 JPCP projects constructed through 2000, five¹⁰ are cracked in some manner. Low severity, mid-panel transverse cracks are the norm. A typical mid-panel transverse crack is shown in Figure 3.30. Spalling exists only along cracks and is highly sporadic among projects in extent and severity. Very limited crack faulting exists. The pavement joints, regardless of the slab's level of cracking, exhibit excellent condition.

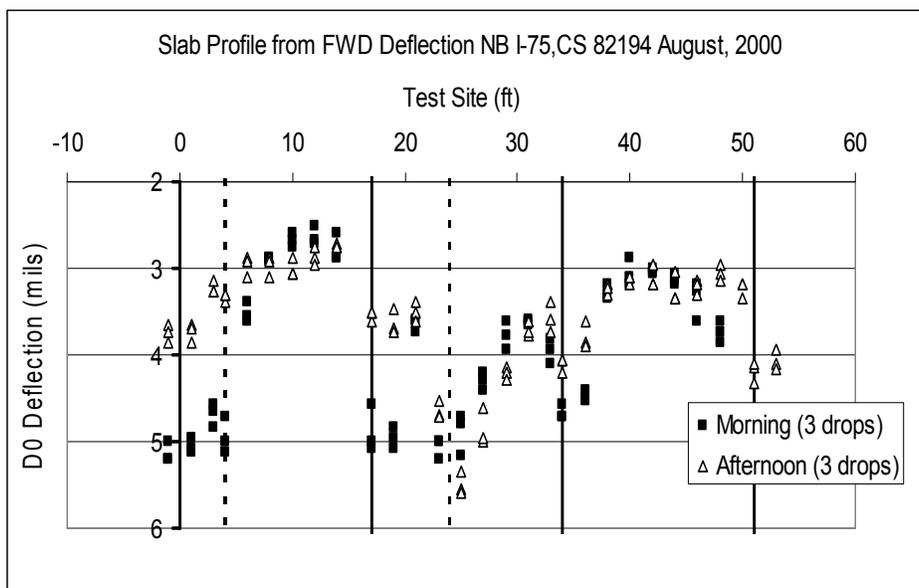
Figure 4.30 Effect of Time of Day on Slab Profile From FWD Deflection Along Outer Wheel Path

Deflection testing and profile measurements were made over the entire 460 ft. length. In the morning there was a noticeable slab “rocking”¹⁴ sensation at the TCs, which would indicate a loss of slab-base contact near the crack. The “rocking” sensation also was felt across a joint, but was much less apparent where there was no slab cracking. The “rocking” sensation gradually went away during the afternoon as the pavement surface warmed. The previous nighttime temperature was in the 70s following daytime highs in the high 80s. Even without a significant air temperature change, the deflection testing still indicated that early morning slab curling¹⁵ was present, as depicted in Figure 4.30. Deflection values are higher at the joints because of the upward curled effect. The curling gradually went away as the surface temperature increased during the afternoon and the deflections reduced in magnitude. Figure 4.31 compares the variation in joint LTE for morning and afternoon. The afternoon LTEs improved significantly, as the joint deflections (d0) reduced in magnitude.

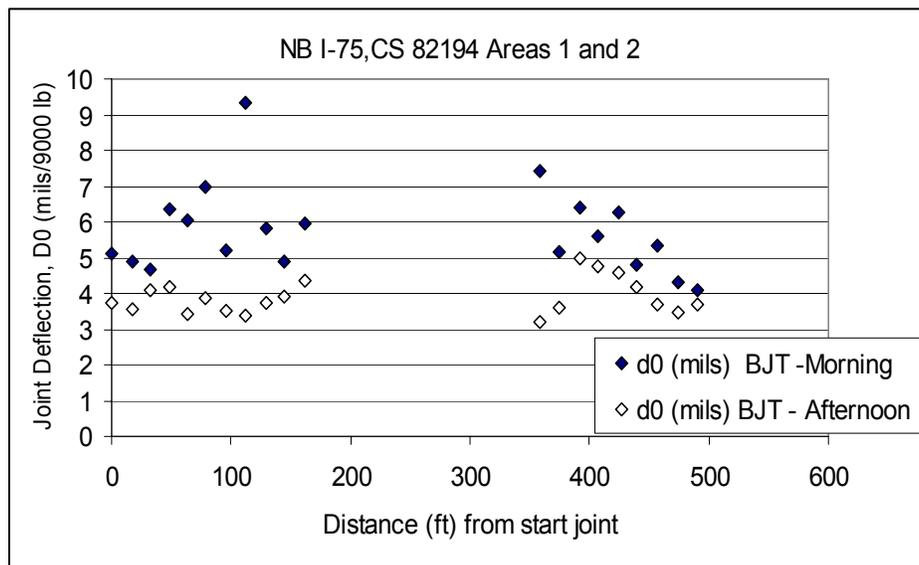
Figure 4.32 Comparison of Joint Deflections for Areas 1 and 2

Figure 4.32 compares the relative joint deflections (d0) for the morning and afternoon for both area 1 and area 2. Some curling was present, but joint load transfer (BJT) remained very adequate (80-90+% LTE – PM hours) with typical joint deflection values of 3.5 to 5.0 mils at d0 (9000 lb). The afternoon values are much more consistent than the morning scatter as the effects from curling are reduced. Later analysis of the FWD data found no indication that a permanent built-in curling condition is present.

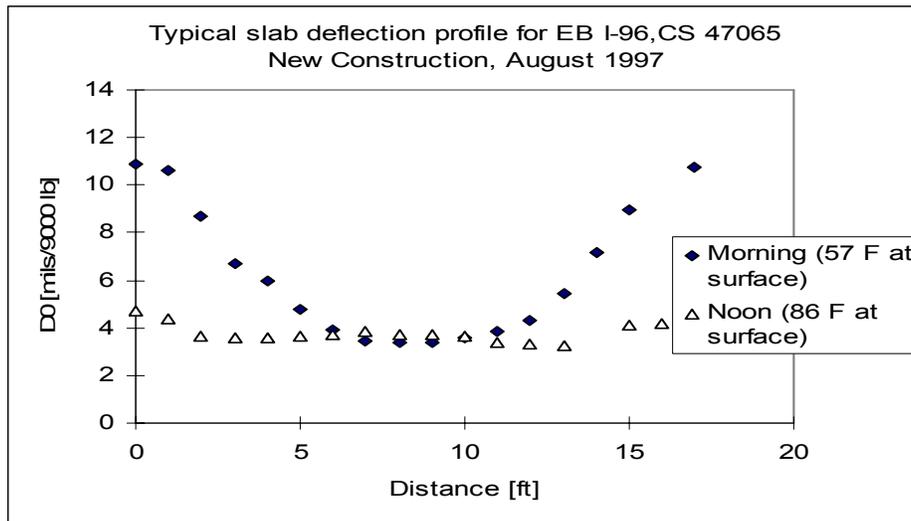
Figure 4.42 Variation in Slab Deflections Along Outer Wheel Path

Figure 4.42 clearly shows from joint deflections (outer wheel path) for a typical slab that concave curling exists in the morning hours, which declines significantly in magnitude (11 to 5 mils) by noon as the slab's surface temperature increased about 30 degrees. Figure 4.43 compares the high variability in LTE (BJT) values in the morning and afternoon in the outer wheel path. The majority of the LTEs are remarkably (disturbing) low (< 90 percent) for new construction which questions the effectiveness of the dowel bar installation. Infrared measurements showed the pavement's surface temperature increased to about 95°F later in the afternoon. Figure 4.44 depicts the same joint deflection values versus pavement surface temperature suggesting when the temperature increase is sufficient for the slab to resume contact with the base, which is somewhere above 70 degrees.

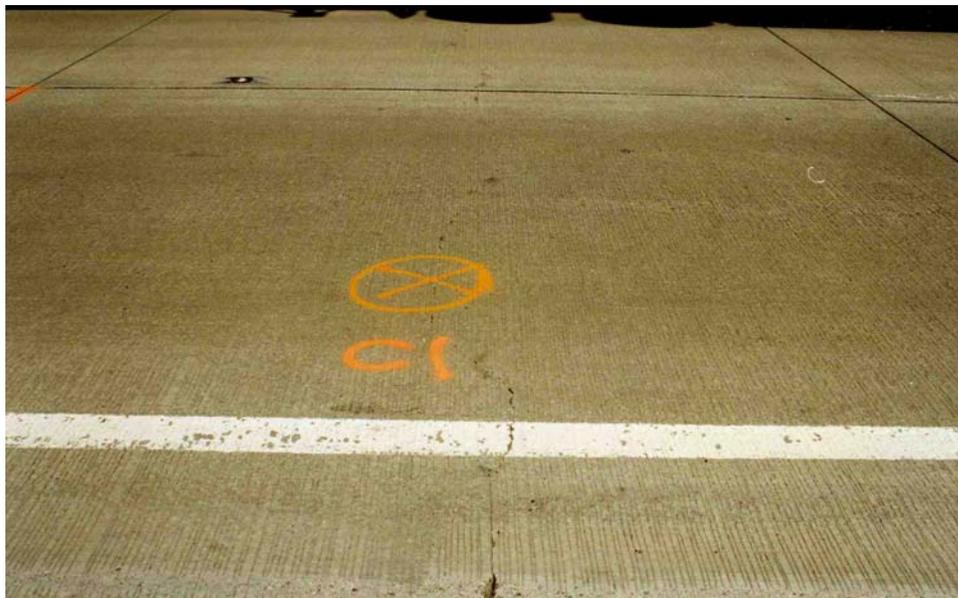
Figure 5.20 Typical JPCP Mid-Panel Crack

Figure 5.20 is a picture of a typical mid-slab, full-width crack on EB in December 1996. The partial-width cracks originated from either edge of the slab. In many cases, a single slab had more than one partial crack. The survey noted that cracking was more prevalent and clustered in areas where morning paving had occurred. Previously in June, pins had been set in three random segments of section B to monitor movement of the contraction joints and the hinge joints. December measurements found that the contraction joints were moving freely and the hinge joints were fixed, as they were designed. Pins had also been randomly set in three 200 ft. segments of WB (sta 1700 to 1767) to measure joint movement. December measurements also found those joints to be moving freely.

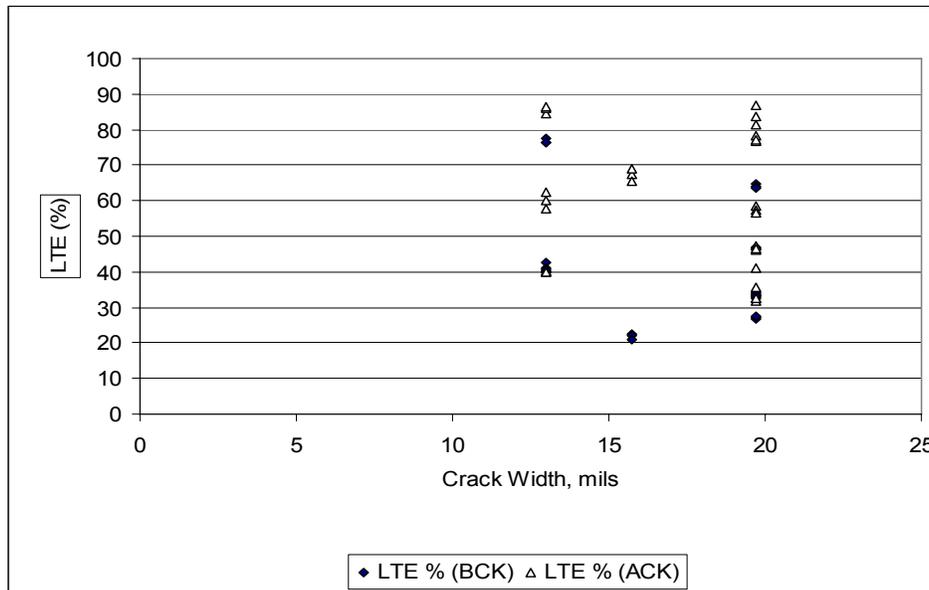
Figure 5.31 Crack Width Versus LTE – Section A EB I-94 Watervliet

The LTE of mid-slab cracks, as related to surface crack width, are shown in Figure 5.31. The results do not show an expected pattern, so other factors are affecting results. Testing was performed with the load plate (d0) on both sides of the crack. The LTEs on the leave (before) side (BCK) of a crack tend to be lower than the approach (after) side (ACK) of a crack.

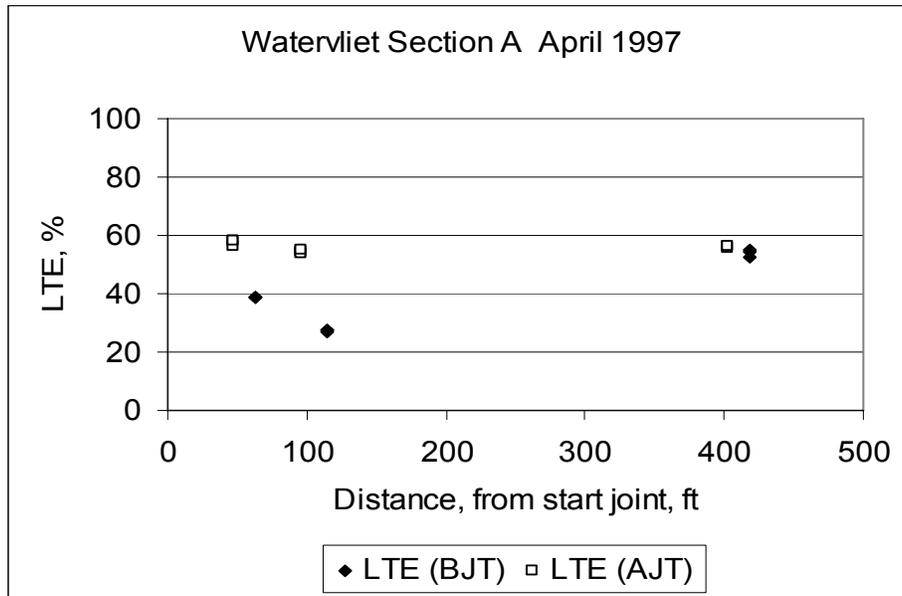
Figure 5.32 Load Transfer at Joints

The LTE of the transverse joints was measured similar to the cracks with the load plate placed on both sides of the joint. The joint LTE results are shown in Figure 5.32, which are low. The LTEs before the joint (BJT) are somewhat less than those after the joint (AJT). Data points are

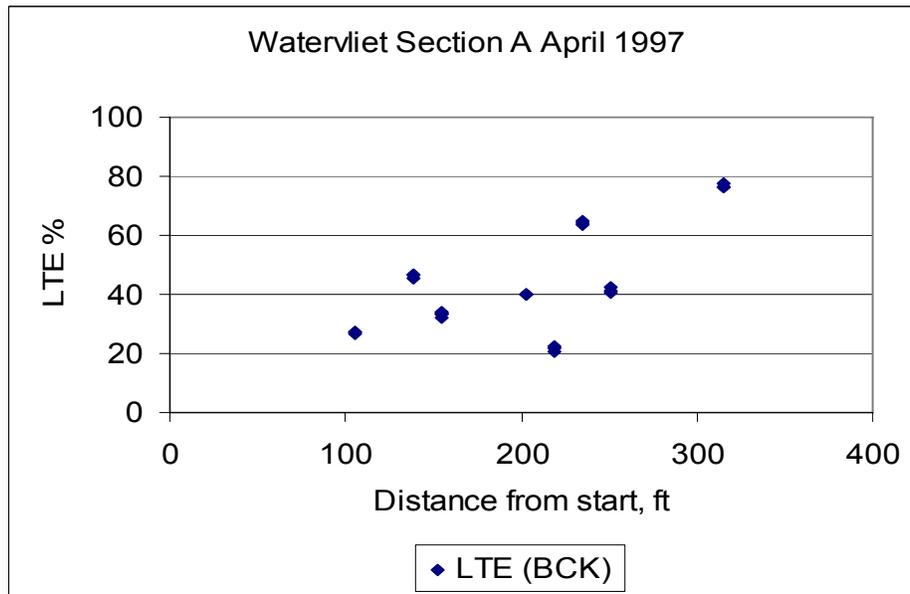
Figure 5.33 Load Transfer Efficiency of Mid-Slab Cracks

limited as only uncrack slabs were tested. Figure 5.33 shows LTE (BCK) for all the mid-slab cracks tested sequentially. Overall, the LTE of cracks and joints are similar.

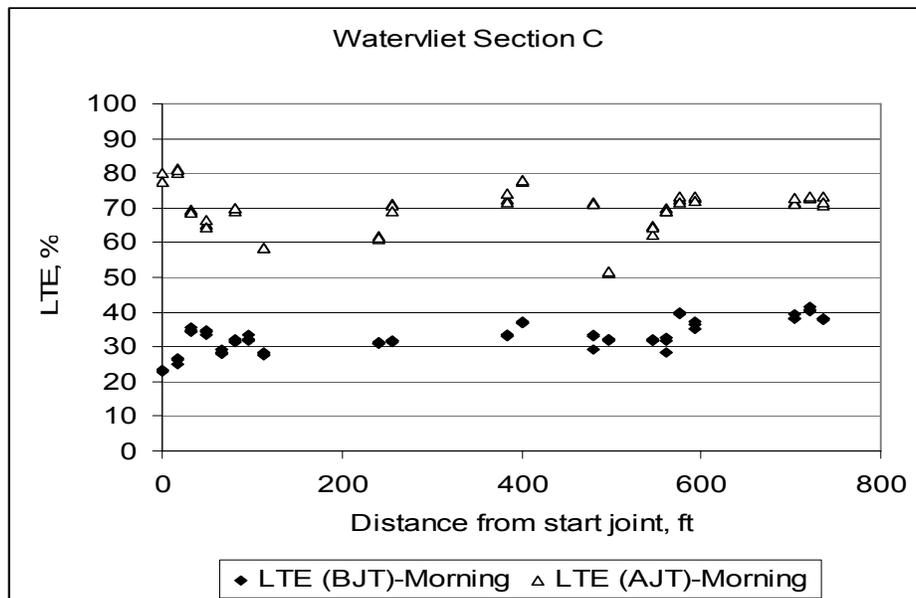
Figure 5.34 Morning Joint Load Transfer Efficiency – Section C Watervliet

The joint LTEs for section C are shown in Figure 5.34, which are all morning values. The BJT values are much lower than the AJT values which indicates permanent slippage at the relief crack has occurred. This indicates the dowels during initial loading have become ineffective with time.

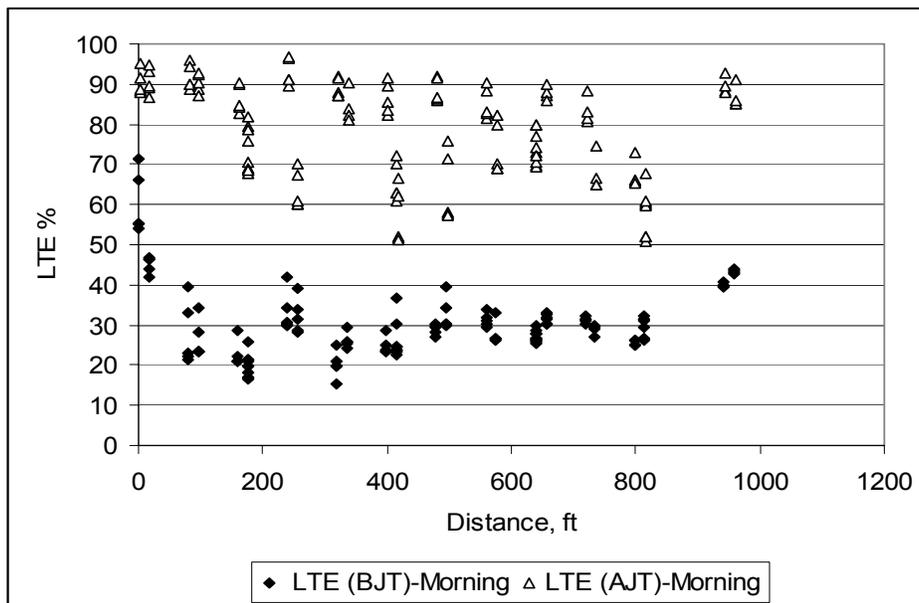
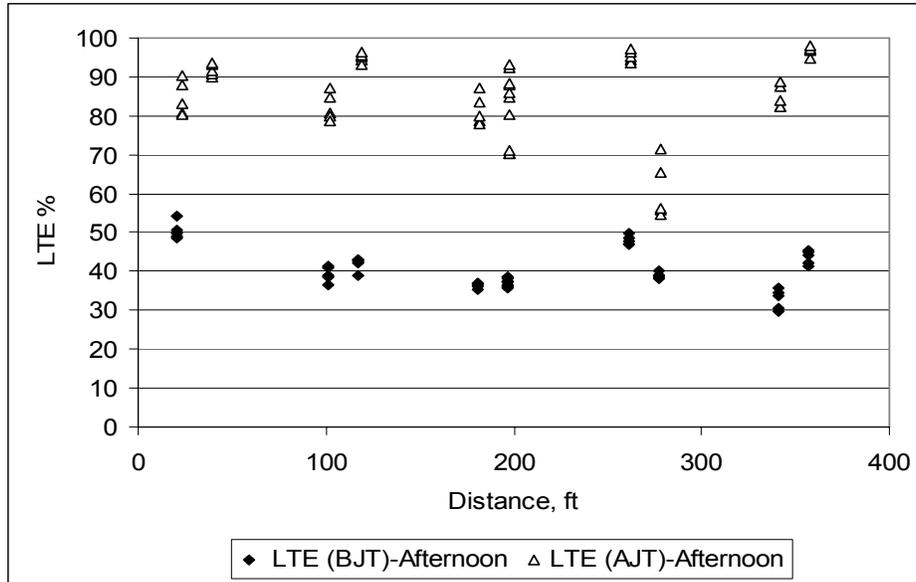
Figures 5.35 and 5.36 compare the joint LTEs for morning and afternoon, respectively. Overall, the LTEs did not significantly change from morning to afternoon. Morning BJT's averaged 30 percent, while AJTs averaged 79 percent. Afternoon BJT's averaged 41 percent and AJTs averaged 85 percent. However, there was much less variation in deflection values (d0) for the afternoon tests. AJT deflections ranged from 4-8 mils for the morning to 4-6 mils for the afternoon. BJT deflections went from 5-12 mils to 4-6 mils, respectively.

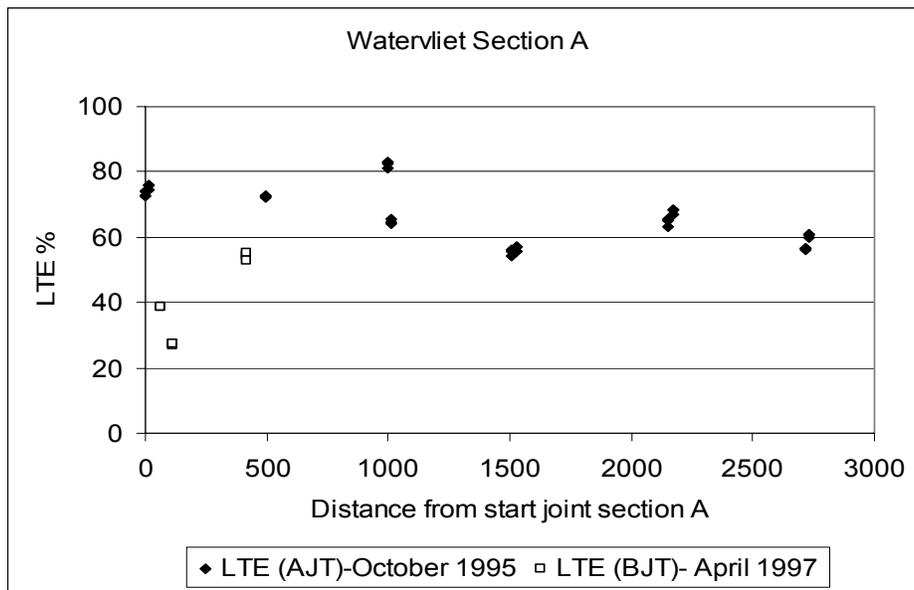
Figure 6.23 LTE After Two Years From Construction – I 94 Watervliet

Unfortunately, section B was not tested during the 1997 site investigation. However, when the original LTEs for section A are compared to the 1997 test site values (Figure 6.23), overall LTE has likely reduced. Since the comparison is between BJT and AJT values, which have shown to differ for reasons previously given, whether a significant reduction has occurred is not certain. Still, a change, as shown, is dramatic for a two-year old pavement. A rapid reduction in LTE helps to explain why the cracking on EB I-94 is accelerating geometrically, both in extent and severity.

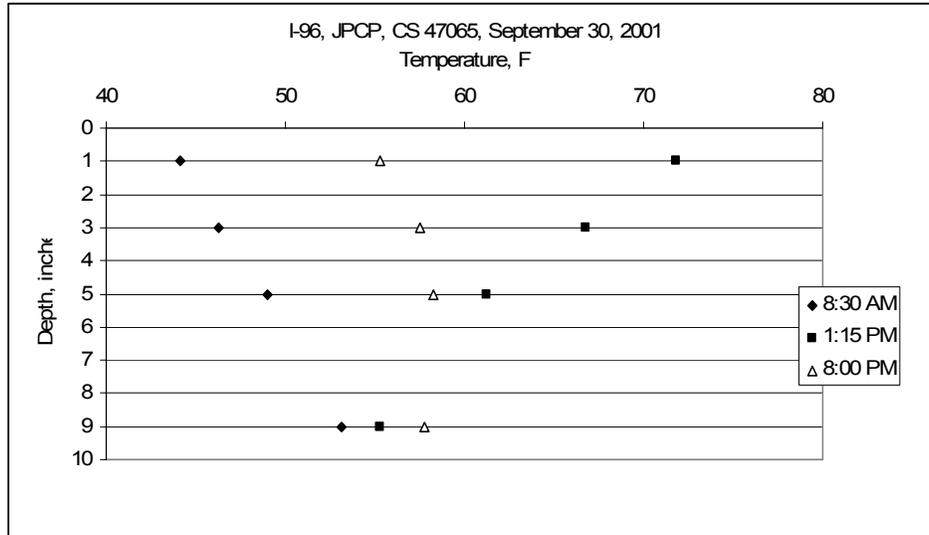
Figure 6.24 Cross Section Temperature Gradient From Morning to Evening

During the September 2001 testing for EB I-96, the temperature gradient of a slab was measured using thermistor probes in drilled holes filled with oil. The slab's temperature was measured in ten minutes intervals at 1 in., 3 in., 5 in., and 9 in. depths during the morning, afternoon and evening. Figure 6.24 shows the representative gradients that occurred through the day, which are not linear with depth.

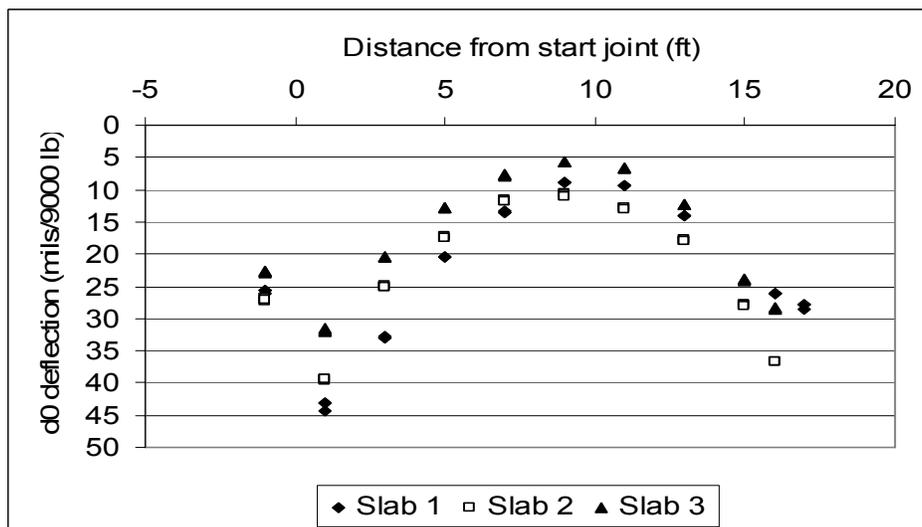
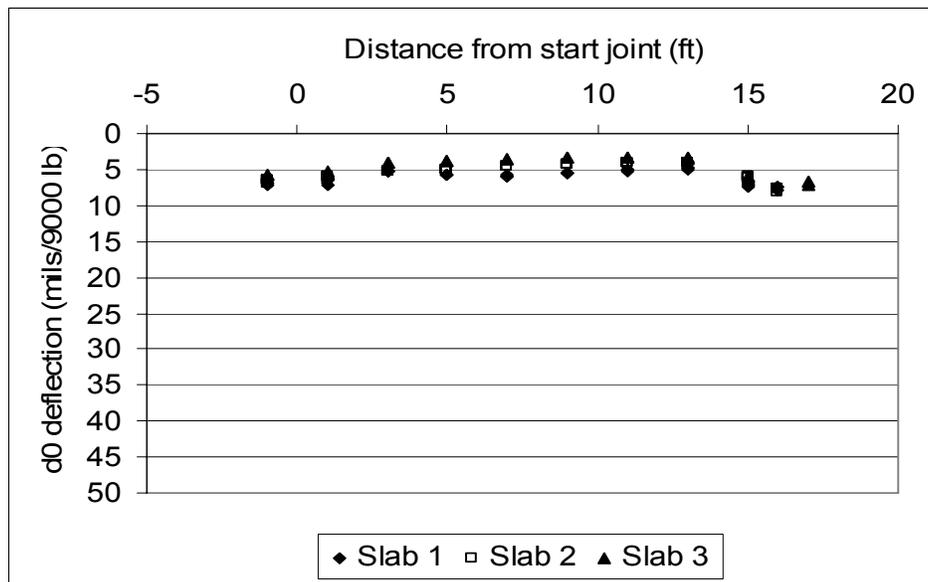
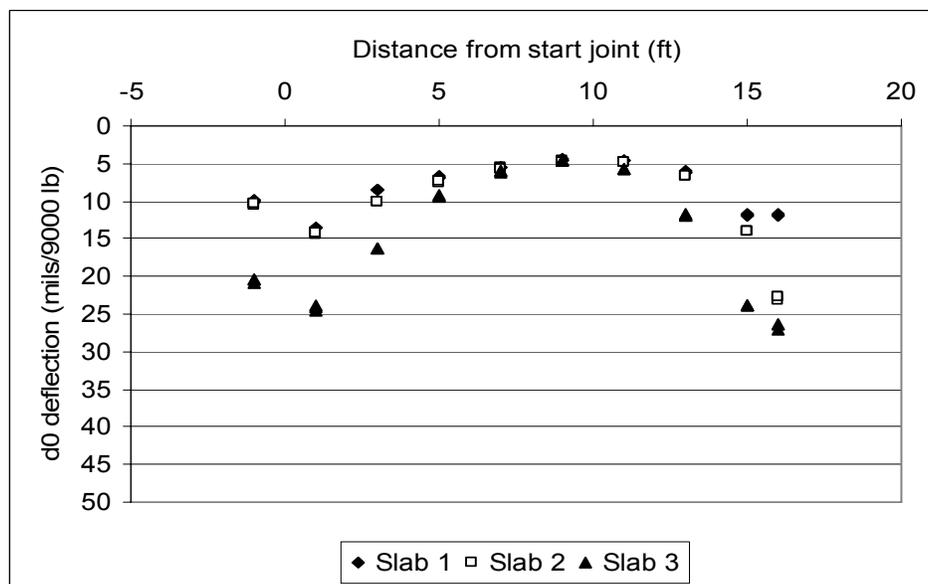
The daily change in deflection for three consecutive slabs is shown in Figures 6.25a, b, and c. The figures reveal that a slab is subjected to upward curling for most of the day and a corresponding loss of joint support. As the temperature differential (ΔT) increases, the magnitude of the loss (gap) at the joint becomes greater. This analysis supports the conclusion from the previous 1997 testing that suspected a built-in curling condition formed during construction for much of EB I-96.

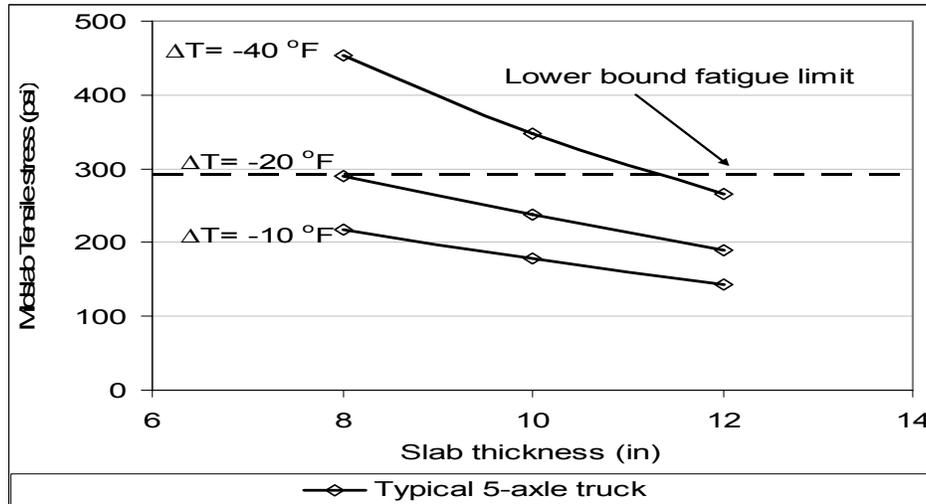
Figure 6.40 Mid-Slab Tensile Stress Prediction (ISLAB 2000) at Top of Slab 15 ft. JPCP, CTE of 5.6×10^{-6} in/in/ F, k value of 250 psi/in

The predicted stress values indicate that very large negative gradients combined with high CTE concrete are needed to initiate fatigue cracking. These large gradients are not typical of Michigan’s environmental condition. So, additional uplift from built-in curl and likely moisture warping (not confirmed) are likely contributors.
