**A COMPARISON OF THE CORROSION PERFORMANCE
OF UNCOATED, GALVANIZED, AND EPOXY COATED
REINFORCING STEEL IN CONCRETE BRIDGE DECKS**

**MICHIGAN DEPARTMENT OF TRANSPORTATION
M•DOT**

Research and Technology Section
Materials and Technology Division
Research Projects 68 F-103 and 73 F-131
Research Report No. R-1321

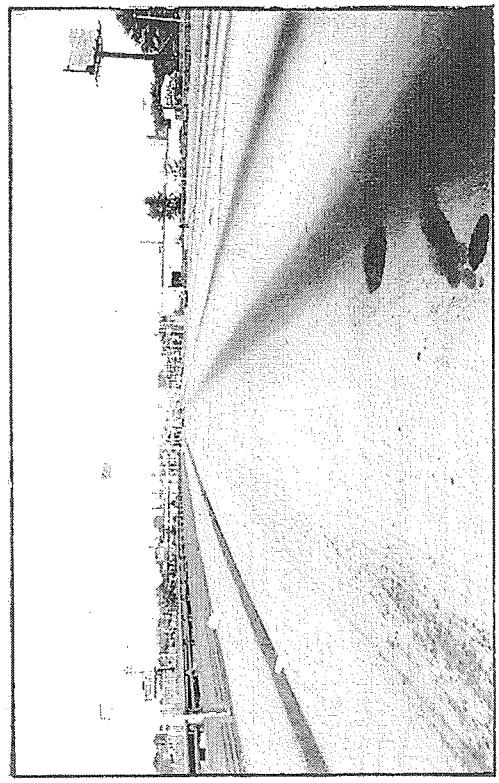
This structure has the highest traffic volumes of all of the structures comparing uncoated and galvanized reinforcement and has roughly the worst ratings for spalls and delaminations. The galvanized and uncoated reinforcement spans have roughly comparable ratings for spalls and delaminations, however.

A. Looking North--Spans 1 and 2 (Galvanized Reinforcement--Top Mat Only) in Foreground.

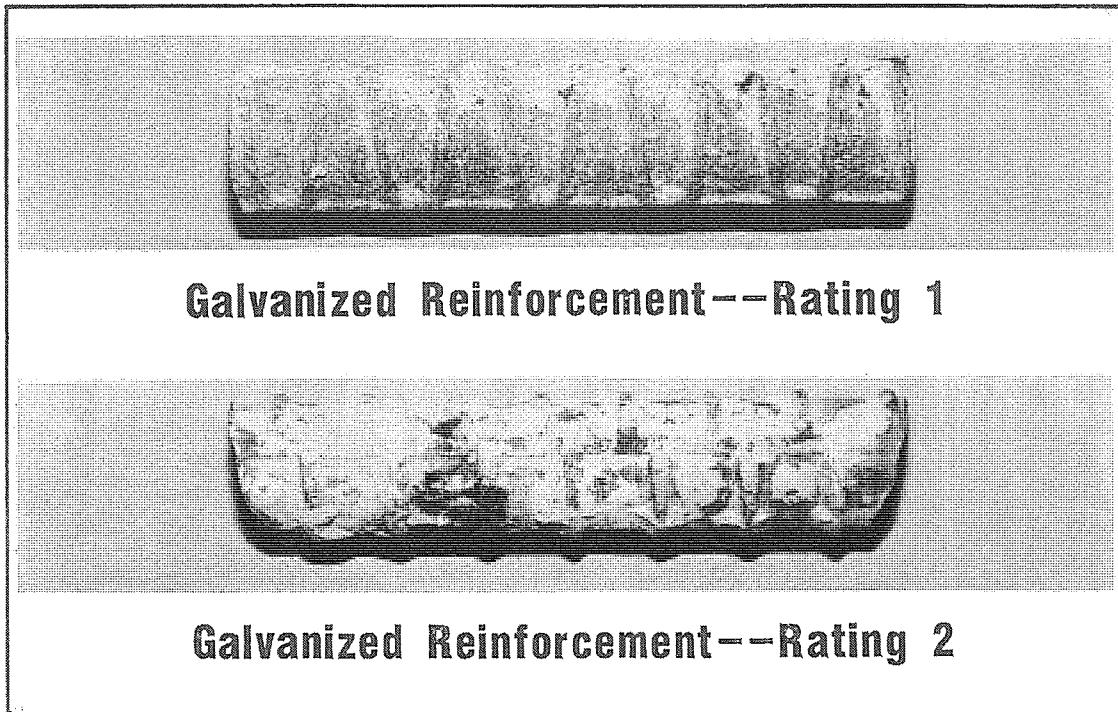
Galvanized Reinforcement--Rating 3

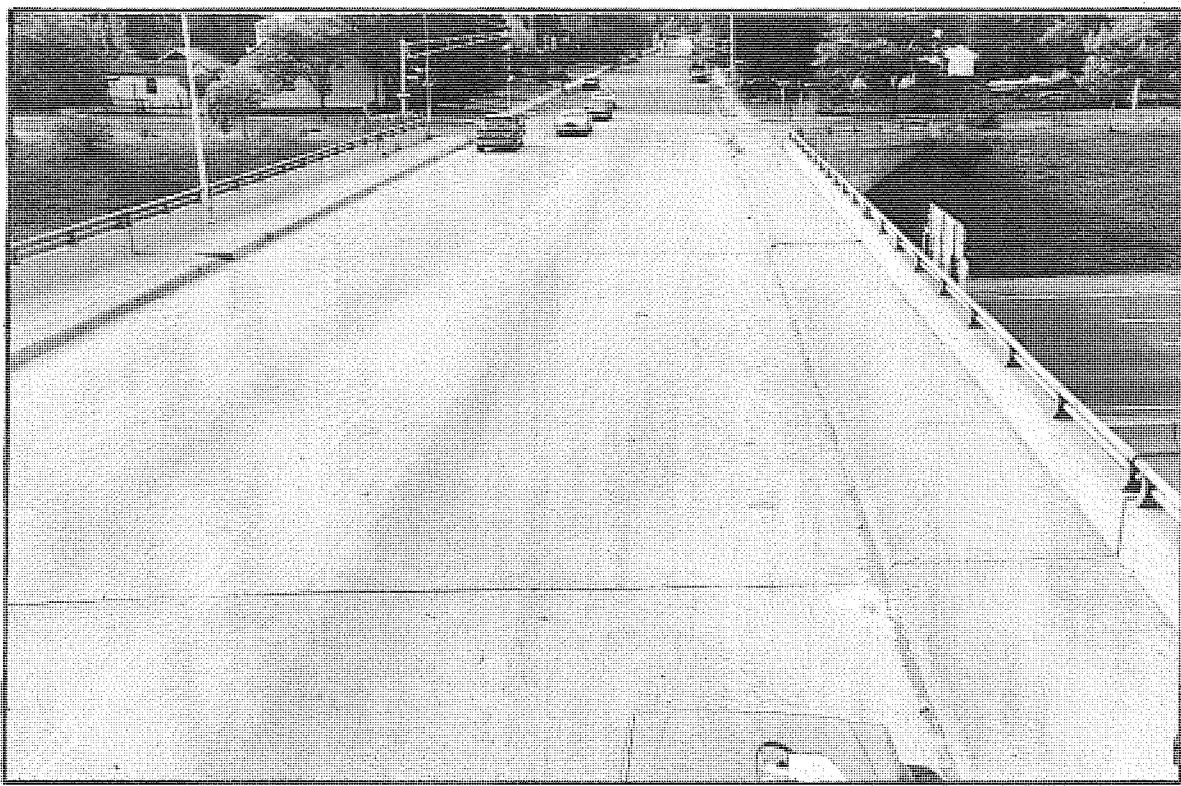
Figure 13 S17 of 82123--Meyers Avenue over I-96 (Jeffries Freeway). Pictures Taken in 1991.

A. Looking South--Part of Span 4 and Span 3
(Uncoated Reinforcement) in Foreground and
Spans 2 and 1 (Galvanized Reinforcement-
-Top Mat Only) in Background.

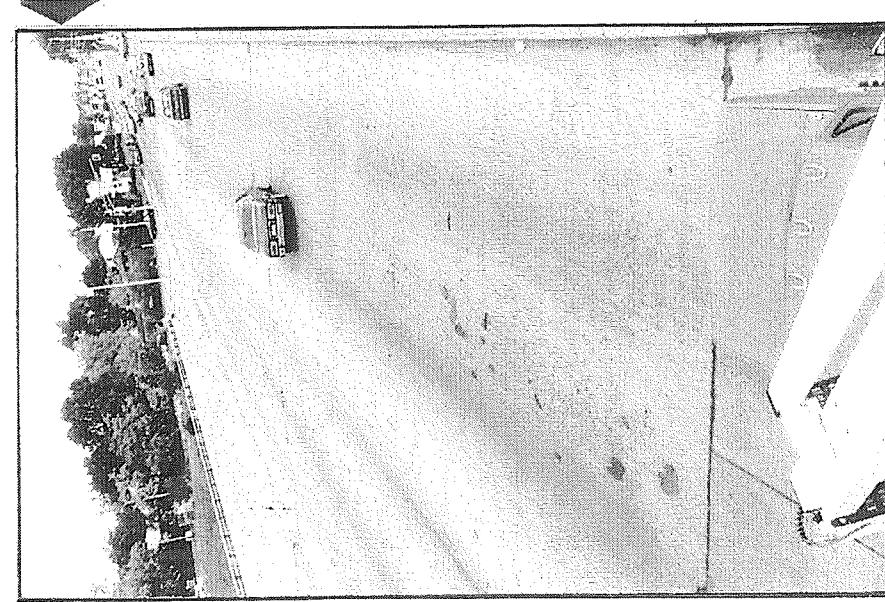
A. Looking North--Part of span 1 (Uncoated Reinforcement) in Foreground and Spans 2 and 3 (Galvanized Reinforcement--Top Mat Only) and Span 4 (Uncoated Reinforcement) in Background.

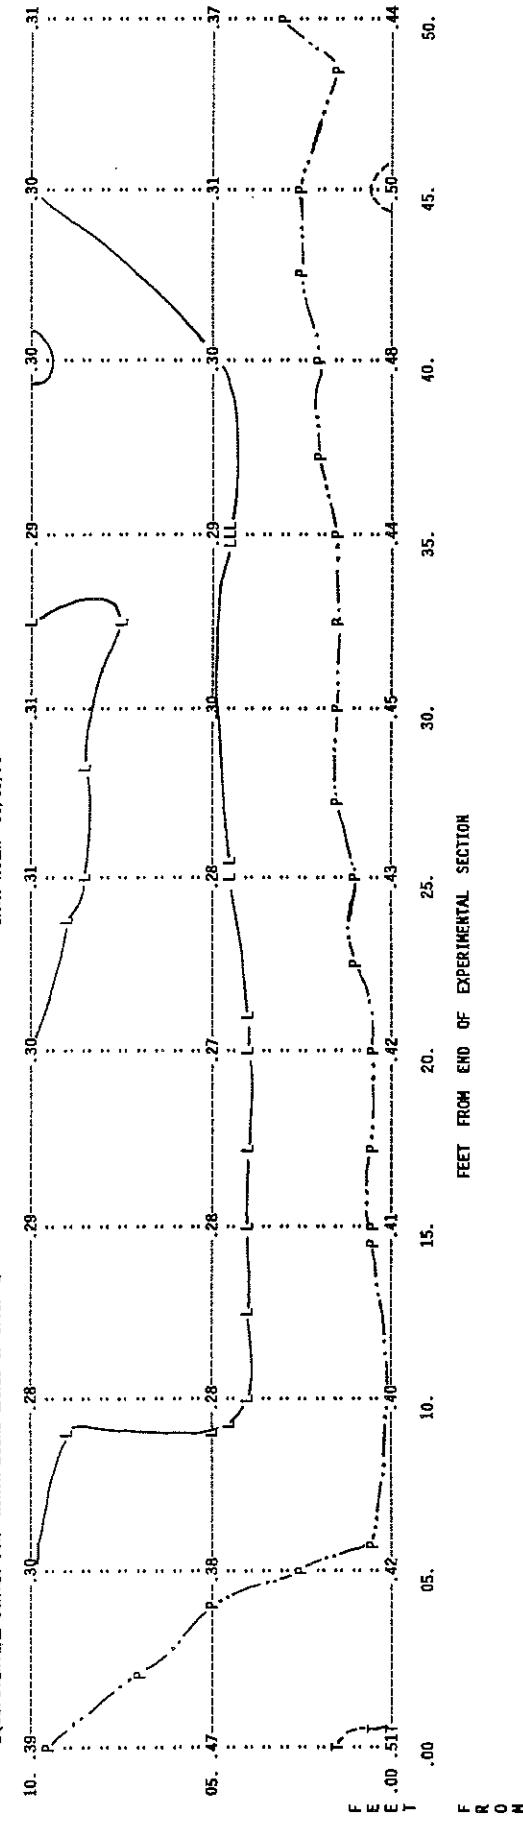
STRUCTURE S16 OF 82123-BR RIVER AVENUE OVER JEFFRIES FREEMAY (I 96)
 STATISTICS FOR NORTH BOUND LANES OF SPAN 2
 D.0 PERCENT OF DATA POINTS ARE BELOW .20 VOLTS. 57.9 PERCENT OF DATA POINTS ARE ABOVE .35 VOLTS.

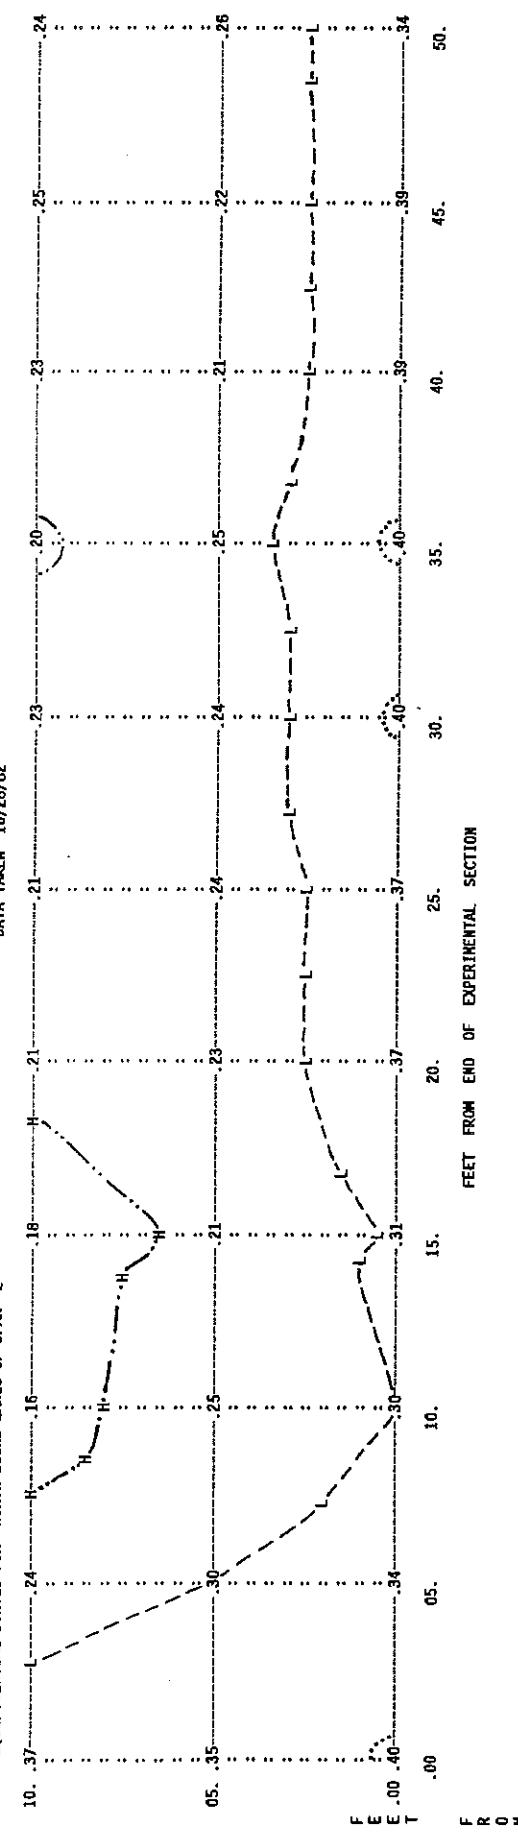
STRUCTURE S16 OF 82123--GRID RIVER AVENUE OVER JEFFRIES FREEMAY (I 96)
 STATISTICS FOR NORTH BOUND LANES OF SPAN 2
 3.5 PERCENT OF DATA POINTS ARE BELOW .20 VOLTS 38.6 PERCENT OF DATA POINTS ARE ABOVE .35 VOLTS.

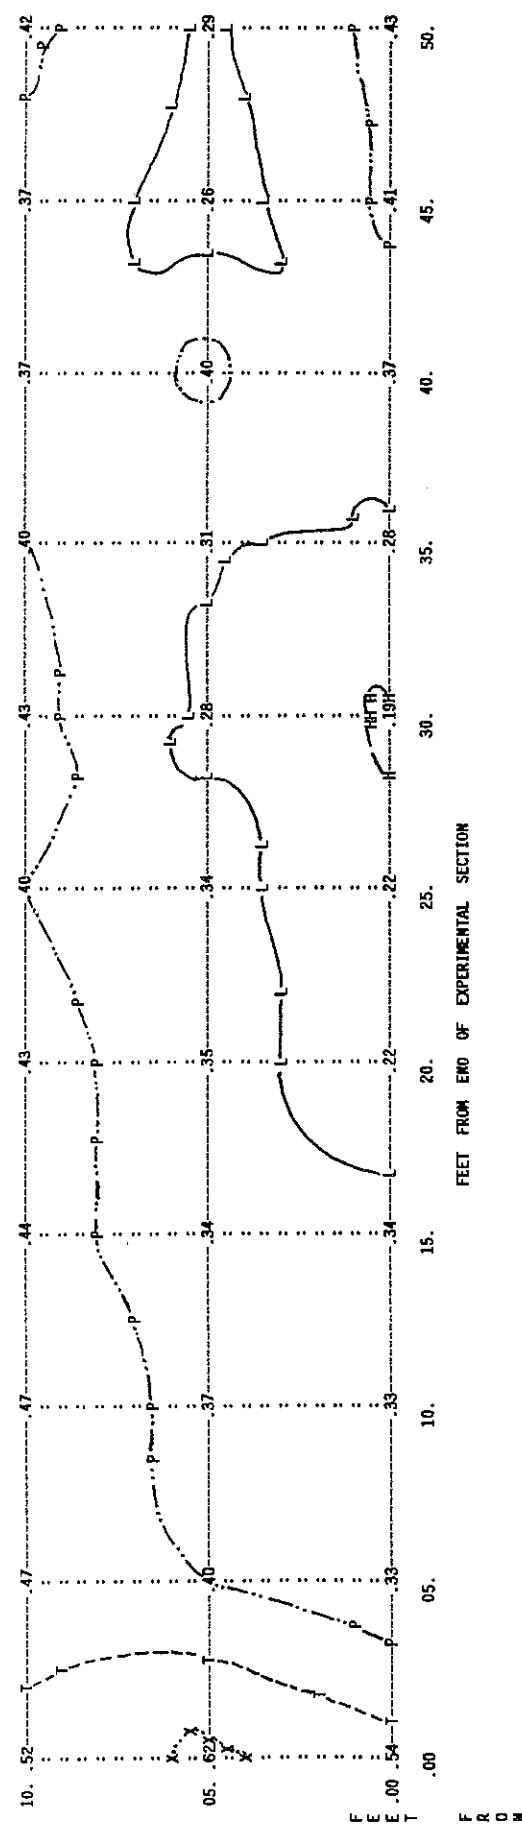
STRUCTURE S16 OF B2123--GRD RIVER AVENUE OVER JEFFRIES FREEWAY (I 96)
 STATISTICS FOR NORTH BOUND LANES OF SPAN 2
 1.8 PERCENT OF DATA POINTS ARE BELOW .20 VOLTS 70.2 PERCENT OF DATA POINTS ARE ABOVE .35 VOLTS.

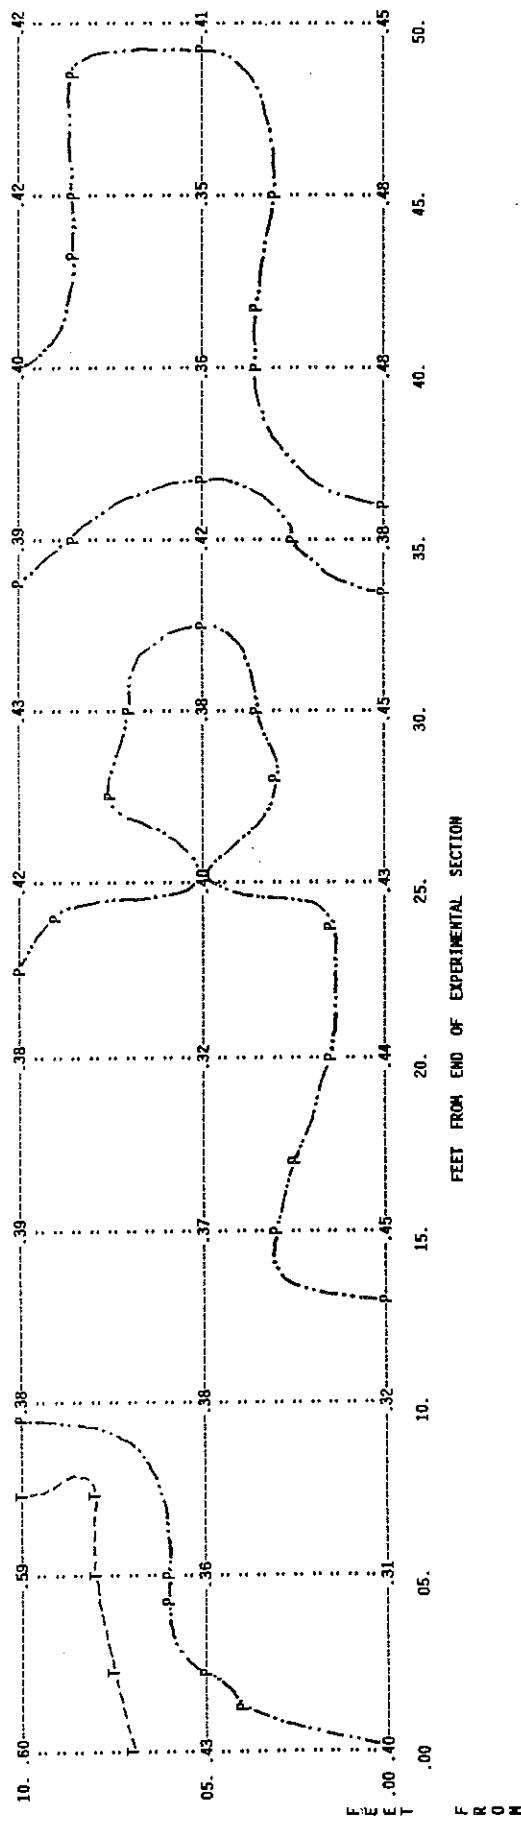
STRUCTURE \$16 OF 82123--GRD RIVER AVENUE OVER JEFFRIES FREEWAY (I 96)
 STATISTICS FOR NORTH BOUND LANES OF SPAN 2
 0.0 PERCENT OF DATA POINTS ARE BELOW .20 VOLTS 93.0 PERCENT OF DATA POINTS ARE ABOVE .35 VOLTS.

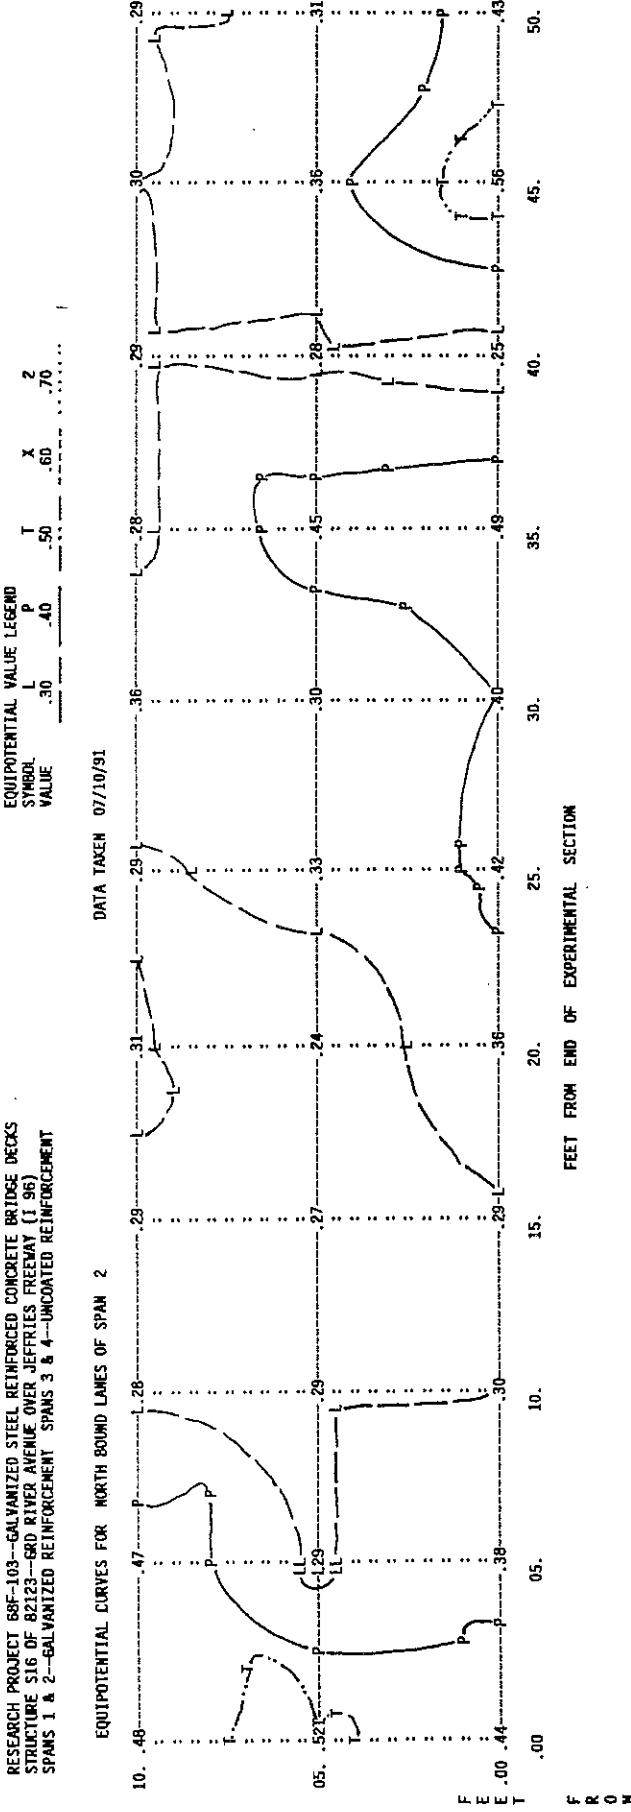
STRUCTURE S16 OF 82123--GRD RIVER AVENUE OVER JEFFRIES FREWAY (I-96)
 STATISTICS FOR NORTH BOUND LANES OF SPAN 2
 61.7 PERCENT OF DATA POINTS ARE ABOVE .35 VOLTS.
 0.0 PERCENT OF DATA POINTS ARE BELOW .20 VOLTS.

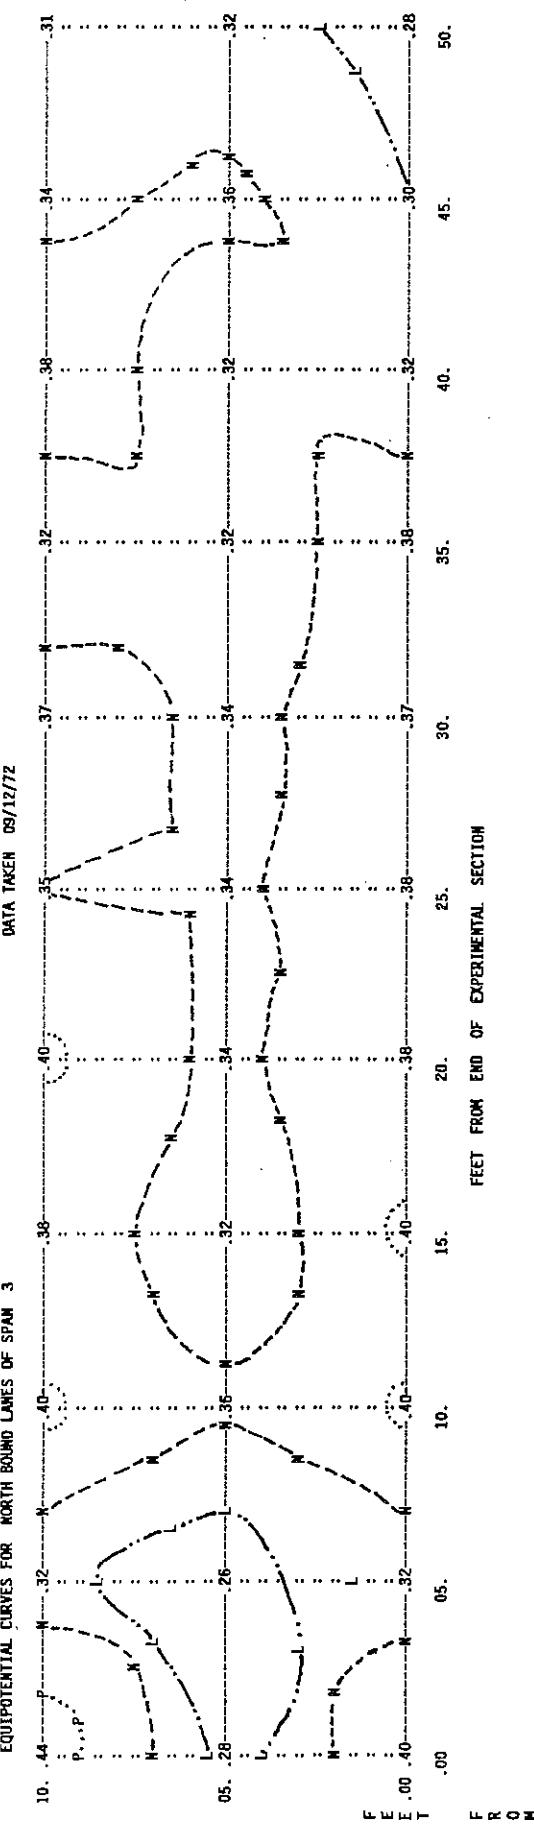
STRUCTURE S16 OF 82123—GRD RIVER AVENUE OVER JEFFRIES FREEWAY (I 96)
 STATISTICS FOR NORTH BOUND LANES OF SPAN 3
 0.0 PERCENT OF DATA POINTS ARE BELOW .20 VOLTS 29.8 PERCENT OF DATA POINTS ARE ABOVE .35 VOLTS.

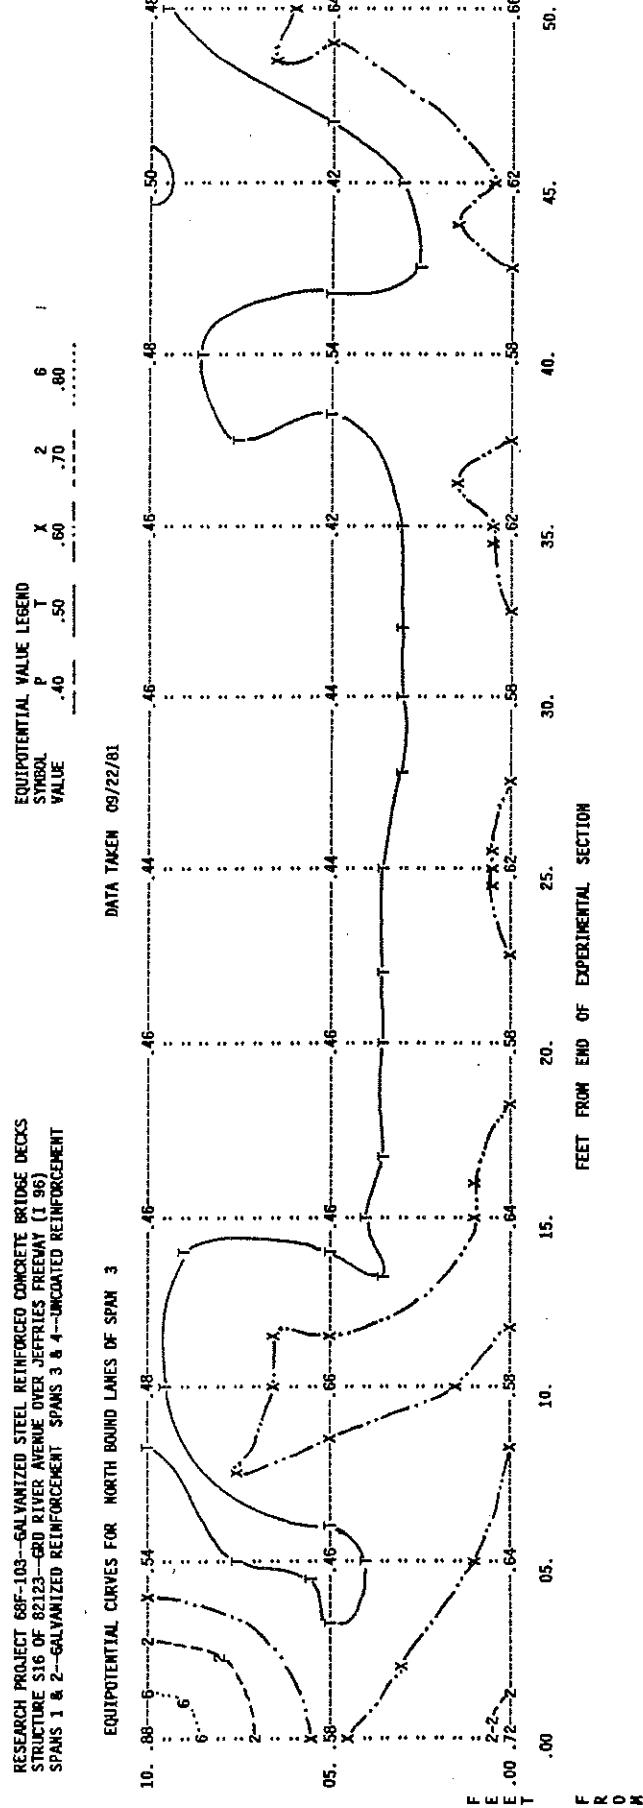
STRUCTURE S16 OF 82123—GRD RIVER AVENUE OVER JEFFRIES FREWAY (I 96)
 STATISTICS FOR NORTH BOUND LANES OF SPAN 3
 0.0 PERCENT OF DATA POINTS ARE BELOW .20 VOLTS 100.0 PERCENT OF DATA POINTS ARE ABOVE .35 VOLTS

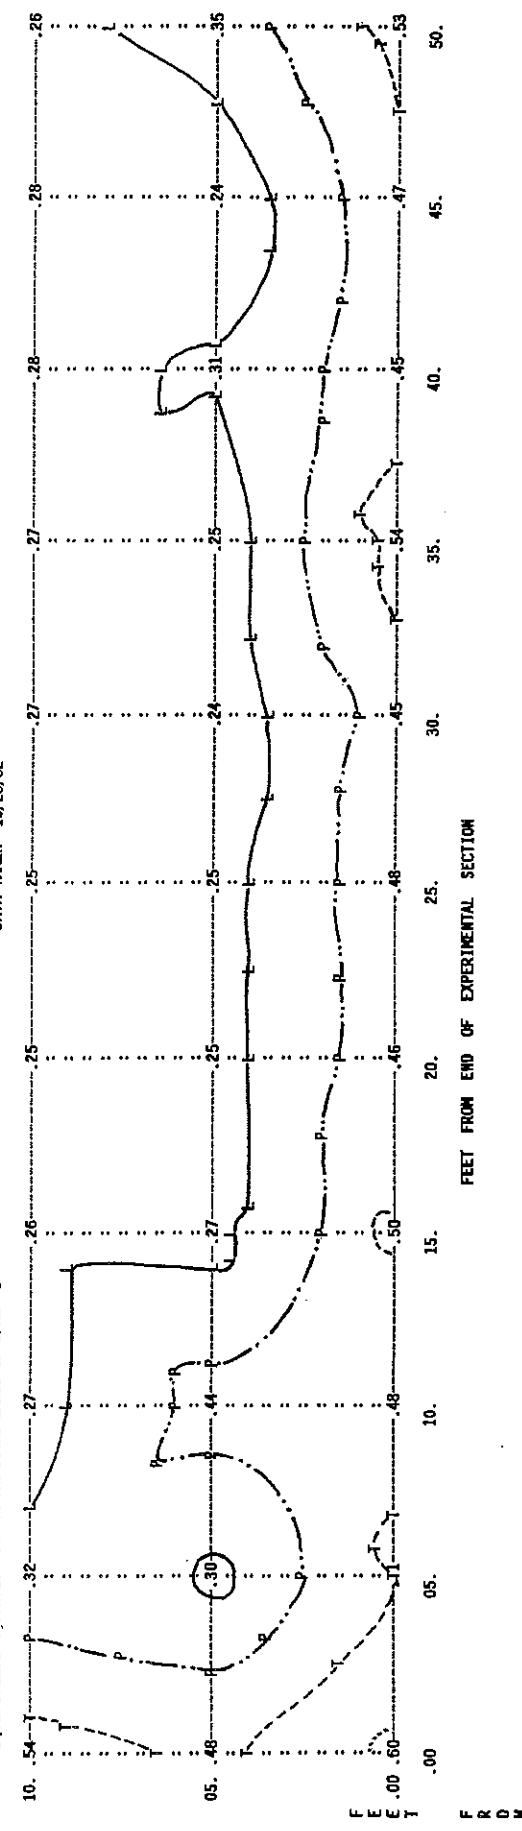
STRUCTURE S16 OF 82123--RD RIVER AVENUE OVER JEFFRIES FREWAY (I 96)
 STATISTICS FOR NORTH BOUND LANES OF SPAN 3
 0.0 PERCENT OF DATA POINTS ARE BELOW .20 VOLTS 40.4 PERCENT OF DATA POINTS ARE ABOVE .35 VOLTS.

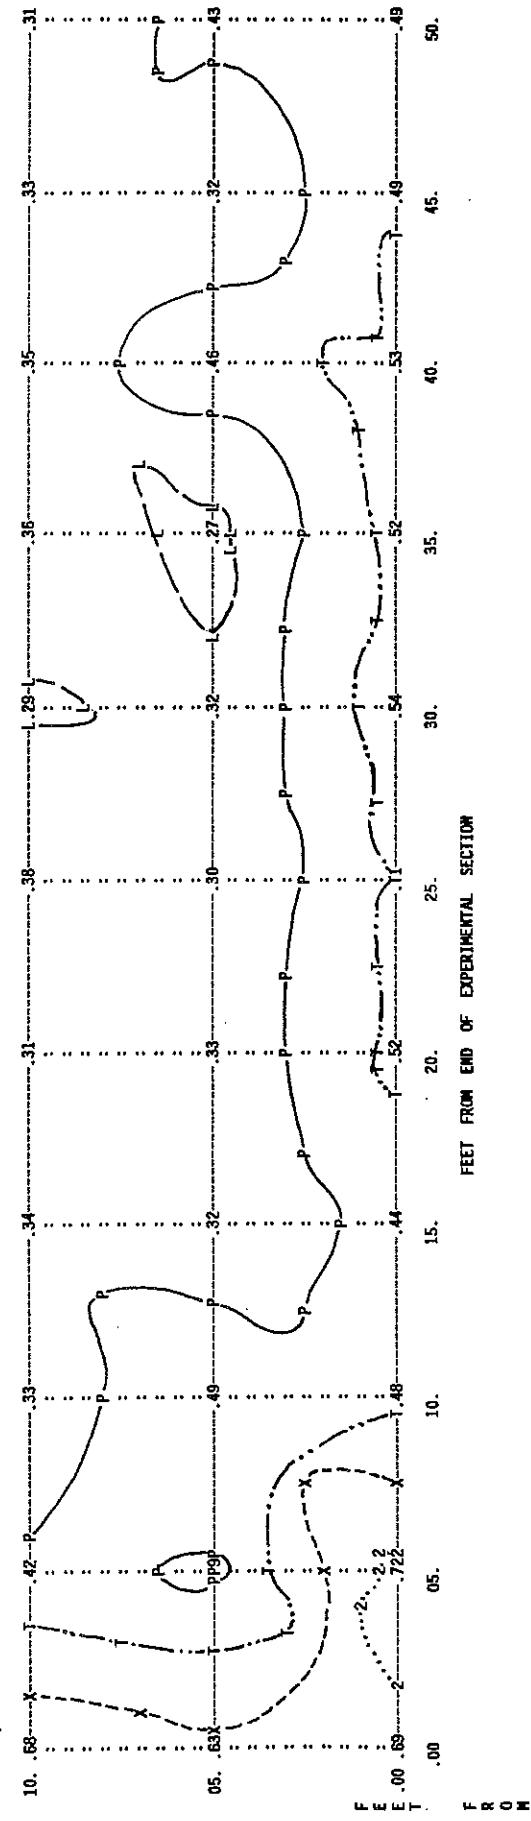
STRUCTURE S16 OF 82123--GRD RIVER AVENUE OVER JEFFRIES FREEWAY (I-96)
 STATISTICS FOR NORTH BOUND LANES OF SPAN 3
 0.0 PERCENT OF DATA POINTS ARE BELOW .20 VOLTS 53.3 PERCENT OF DATA POINTS ARE ABOVE .35 VOLTS.
