Evaluation of Bridge Decks Using Non-Destructive Evaluation (NDE) at Near Highway Speeds for Effective Asset Management – Implementation for Routine Inspection (Phase III)

**Element Level Condition State Assessment,
Comparison to Traditional Methods, and Cost and
Time Comparison Analysis mini reports**

October 09, 2018

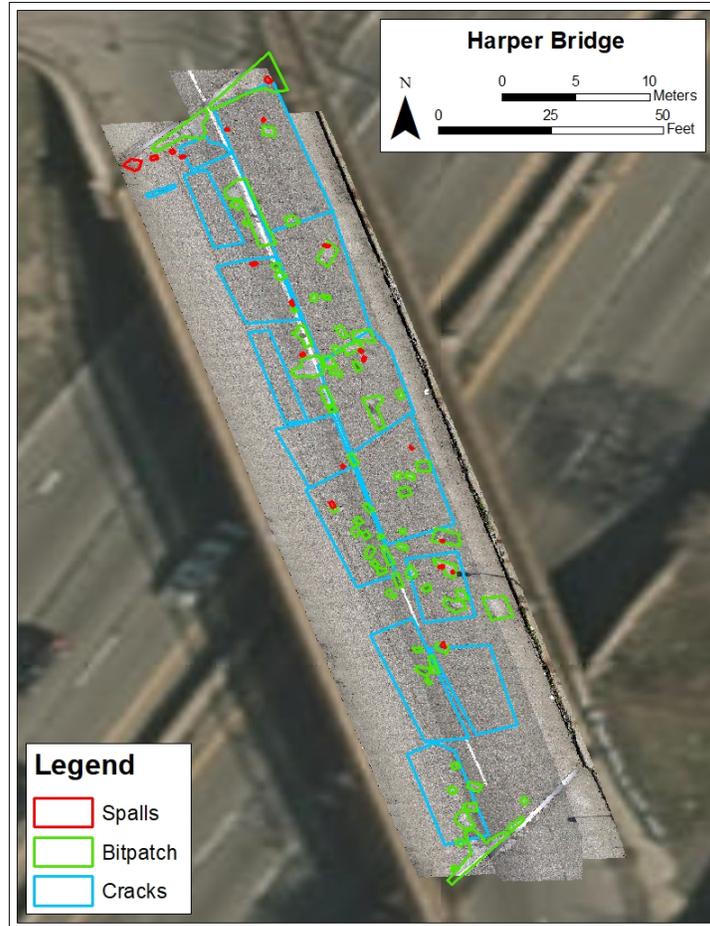
Figure 2. Identified distresses on the Harper Road bridge.

The Harper Road bridge (Str 11223) is located in Detroit, Michigan and passes over Interstate 94. The total area of the bridge deck is approximately 6,836 sq. ft. and has two spans. After processing the optical imagery, analysts were able to identify spalls, bitpatch, and cracks (Figure 2). The total area of the distresses are as follows:

- Spalls - 11 sq. ft
- Bitpatch - 379 sq. ft
- Concrete Patching - 0 sq. ft
- Cracks - 2,454 sq. ft

Since a DEM could not be created for the Harper Road bridge, visual inspection of the merged output was conducted to determine if any rebar could be detected within each of the spalls. If there was rebar, the spall was classified as “Condition State 3 - Poor”. However, if rebar could not be detected and the spall was smaller than six inches in diameter, the spall was classified as “Condition State 2 - Fair”.

Table 1 shows the results from processing the distresses through the BDCS algorithm. For Elem. Key 1080 (spalls and bitpatch), there was one spall that had visible rebar, placing it into the “poor” category. Otherwise, the other spalls were classified as “fair”. Bitpatch distresses were also classified as “poor” condition. For Elem. Key 1130 (cracks), some of the crack detected regions were classified as “insignificant” and therefore rated as “good”. The cracked regions that were classified as “unsealed - moderate” were rated as “fair” and lastly, those classified as “unsealed - wide/heavy” were rated as “poor”. Overall, the condition of the bridge deck was rated “Good” at 67%, “Fair” at 11%, and “Poor” at 23%.

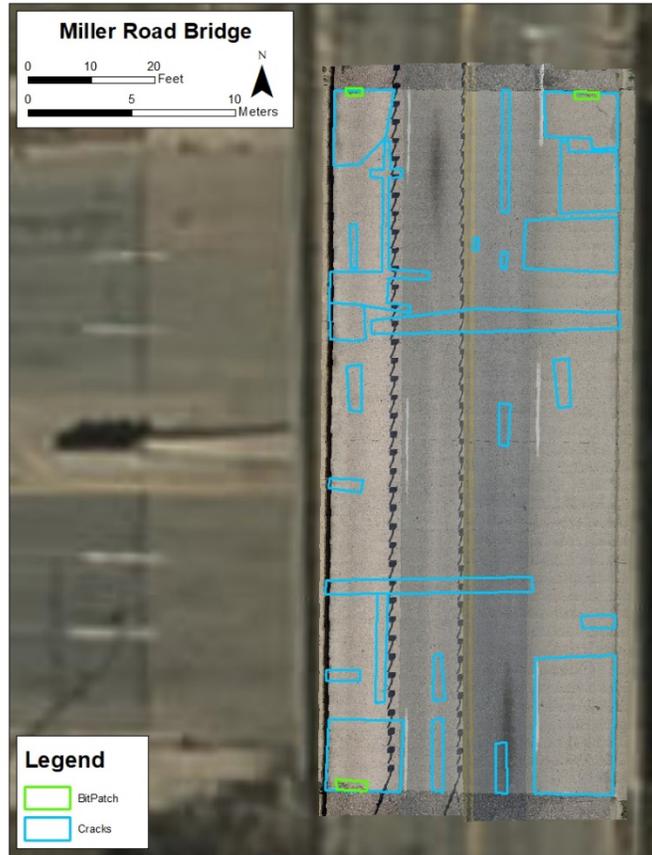
Figure 3. Identified distresses on the Miller Road bridge.

The Miller Road bridge (Str 11334) is located in Dearborn, Michigan and passes over M-153 (Ford Road). The total area of the bridge deck is approximately 6,000 sq. ft. and has two spans. After processing the optical imagery, analysts were able to identify bitpatch and cracks (Figure 3). The total area of the distresses are as follows:

- Spalls - 0 sq. ft
- Bitpatch - 14 sq. ft
- Concrete Patching - 0 sq. ft
- Cracks - 1,286 sq. ft

Table 2 shows the results from processing the distresses through the BDCS algorithm. For Elem. Key 1080 (bitpatch), the bitpatch areas were all placed into the “poor” category. All of the identified cracks were classified as “unsealed - moderate”, which were placed in condition state “fair”. Although there is a large area of the bridge deck that is cracked, none of the cracks appear to be in a “poor” condition. Overall, the condition of the bridge deck was rated “Good” at 78% and “Fair” at 21%.

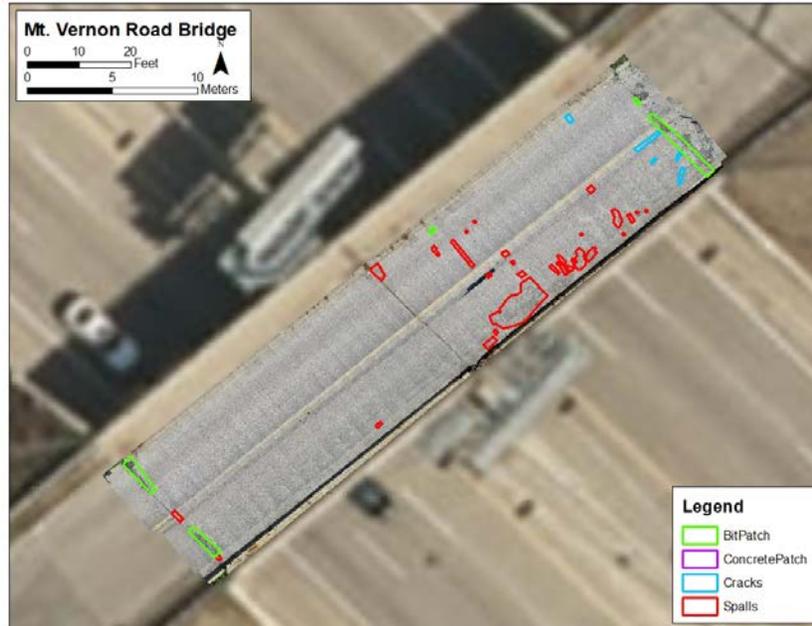
Figure 4. Identified distresses on the Mt. Vernon Road bridge.

The Mt. Vernon bridge (Str 7882) is located in Southfield, Michigan and passes over M-10, the Lodge. The total area of the bridge deck is approximately 4,685 sq. ft. and has two spans. After processing the optical imagery, analysts were able to identify spalls, bitpatch, and cracks (Figure 4). The total area of the distresses are as follows:

- Spalls - 94 sq. ft
- Bitpatch - 51 sq. ft
- Concrete Patching - 0 sq. ft
- Cracks - 9 sq. ft

Table 3 shows the results from processing the distresses through the BDCS algorithm. None of the identified spalls had rebar showing, placing each of the spalls into a “fair” category. All of the bitpatch distresses were classified as “poor” condition. Lastly, the cracks on the deck were all rated as “insignificant”, resulting in a classification of “fair”. Overall, the condition of the bridge deck was rated “Good” at 97%, “Fair” at 2%, and “Poor” at 1%

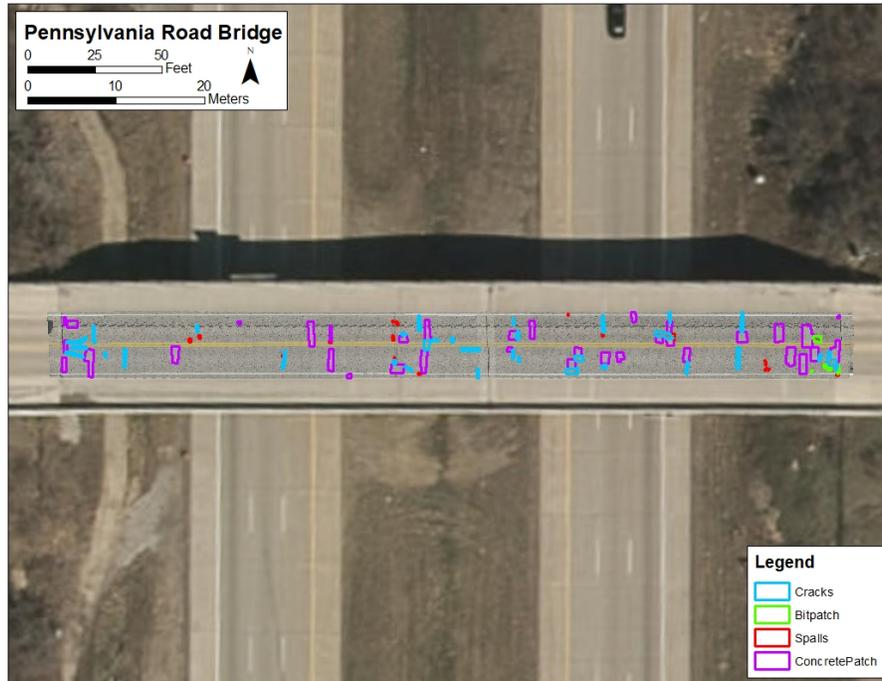
Figure 5. Identified distresses on the Pennsylvania Road bridge.

The Pennsylvania bridge (Str 11902) is located in Romulus, Michigan and passes over I-275. The total area of the bridge deck is approximately 13,939 sq. ft. and has two spans. After processing the optical imagery, analysts were able to identify spalls, bitpatch, concrete patches, and cracks (Figure 5). The total area of the distresses are as follows:

- Spalls - 11 sq. ft
- Bitpatch - 11 sq. ft
- Concrete Patching - 402 sq. ft
- Cracks - 135 sq. ft

Table 4 shows the results from processing the distresses through the BDCS algorithm. For Elem. Key 1080 (spalls, bitpatch, and concrete patches), the bitpatch areas were all placed into the “poor” category. None of the identified spalls had rebar showing, placing each of the spalls into a “fair” category. All concrete patches were assigned a “fair” category. For Elem. Key 1130 (cracks), most of the cracked areas were determined to be insignificant / “good”. However, some cracks were moderate or heavy, resulting in ratings of “fair” or “poor”. Overall, the condition of the bridge deck was rated “Good” at 97% and “Fair” at 3%.

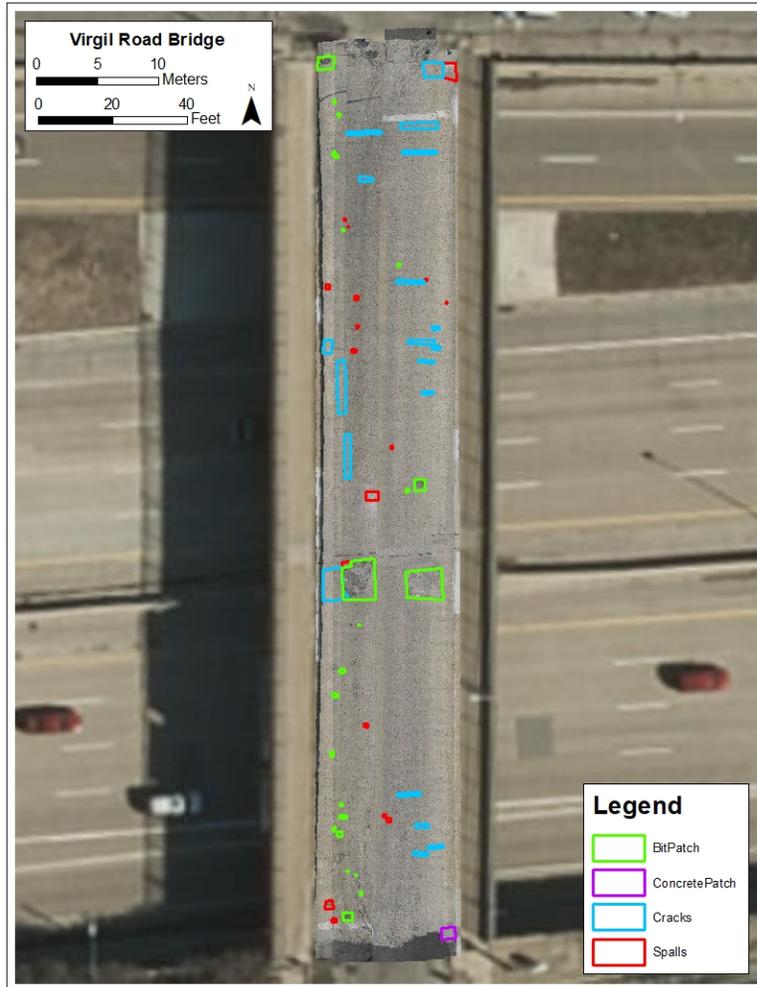
Figure 6. Identified distresses on the Virgil Road bridge.

The Virgil Road bridge (Str 11508) is located in Detroit, Michigan and passes over I-96. The total area of the bridge deck is approximately 14,185 sq. ft. and has two spans. After processing the optical imagery, analysts were able to identify spalls, bitpatch, concrete patches, and cracks (Figure 6). The total area of the distresses are as follows:

- Spalls - 38 sq. ft
- Bitpatch - 201 sq. ft
- Concrete Patching - 11 sq. ft
- Cracks - 193 sq. ft

Table 5 shows the results from processing the distresses through the BDCS algorithm. For Elem. Key 1080 (spalls, bitpatch, and concrete patches), the bitpatch areas were all placed into the “poor” category. None of the identified spalls had rebar showing, placing each of the spalls into a “fair” category. All of the concrete patches were assigned a category of “fair”. For Elem. Key 1130 (cracks), most of the cracked areas were determined to be insignificant / “good”. However, some cracks were moderate or heavy, resulting in ratings of “fair” or “poor”. Overall, the condition of the bridge deck was rated “Good” at 97%, “Fair” at 1%, and “Poor” at 2%.

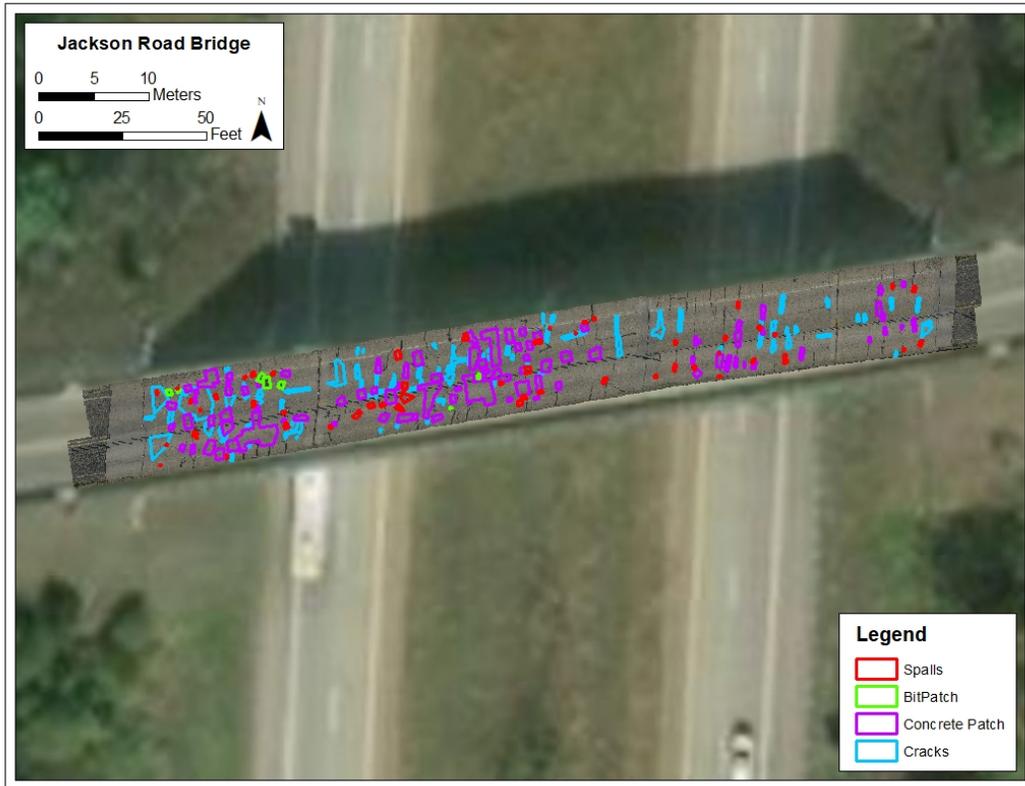
Figure 7. Identified distresses on the Jackson Road bridge.

The Jackson bridge (Str 1224) is located in Tekonsha, Michigan and passes over I-69. The total area of the bridge deck is approximately 8,261 sq. ft. and has four spans. After processing the optical imagery, analysts were able to identify spalls, bitpatch, concrete patches, and cracks (Figure 7). The total area of the distresses are as follows:

- Spalls - 66 sq. ft
- Bitpatch - 18 sq. ft
- Concrete Patching - 574 sq. ft
- Cracks - 318 sq. ft

Table 6 shows the results from processing the distresses through the BDCS algorithm. For Elem. Key 1080 (spalls, bitpatch, and concrete patches), the bitpatch areas were all placed into the “poor” category. Two spalls had rebar showing and were therefore assigned a “poor” condition. The remaining spalls were assigned a “fair” condition. All concrete patches were assigned a “fair” category. For Elem. Key 1130 (cracks), most of the cracked areas were determined to be insignificant / in “good” condition. However, some cracks were moderate or heavy, resulting in a “fair” category. Overall, the condition of the bridge deck was rated “Good” at 92% and “Fair” at 8%.

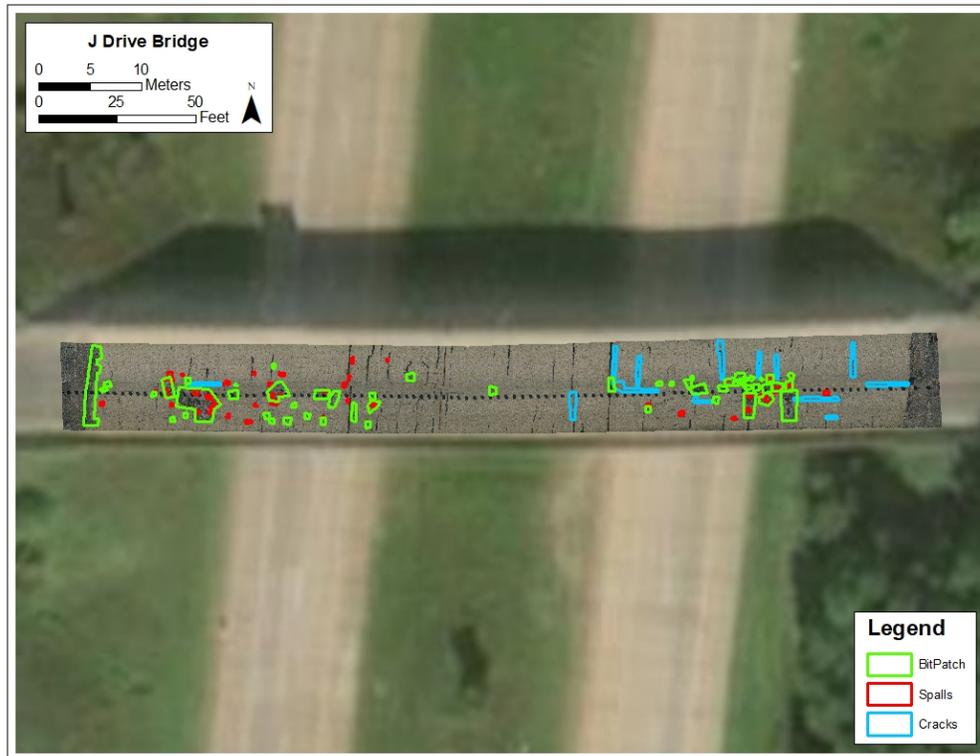
Figure 8. Identified distresses on the J Drive Road bridge.

The J-Drive bridge (Str 1241) is located in Marshall, Michigan and passes over I-69. The total area of the bridge deck is approximately 10,127 sq. ft. and has two spans. After processing the optical imagery, analysts were able to identify spalls and bitpatch (Figure 8). The total area of the distresses are as follows:

- Spalls - 38 sq. ft
- Bitpatch - 500 sq. ft
- Concrete Patching - 0 sq. ft
- Cracks – 146 sq. ft

Table 7 shows the results from processing the distresses through the BDCS algorithm. For Elem. Key 1080 (spalls and bitpatch), the bitpatch areas were all placed into the “poor” category. Four spalls had rebar showing and were therefore placed assigned a “poor” condition. The remaining spalls were assigned a “fair” condition. For Elem. Key 1130 (cracks), most of the cracked areas were determined to be insignificant / in “good” condition. However, some cracks were moderate or heavy, resulting in a “fair” category. Overall, the condition of the bridge deck was rated “Good” at 94%, “Fair” at 1%, and “Poor” at 5%.

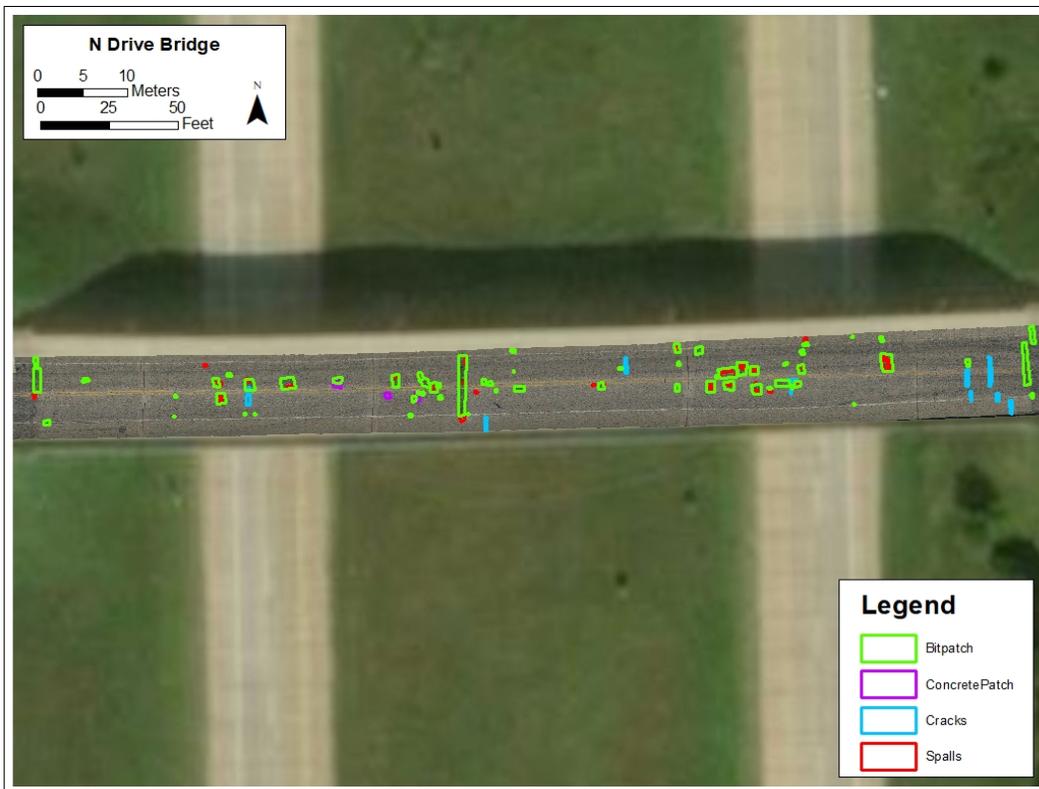
Figure 9. Identified distresses on the N Drive Road bridge.

The N-Drive bridge (Str 1243) is located in Marshall, Michigan and passes over I-69. The total area of the bridge deck is approximately 15,441 sq. ft. and has five spans. After processing the optical imagery, analysts were able to identify spalls, bitpatch, concrete patching, and cracks (Figure 9). The total area of the distresses are as follows:

- Spalls - 56 sq. ft
- Bitpatch - 413 sq. ft
- Concrete Patching - 17 sq. ft
- Cracks - 46 sq. ft

Table 8 shows the results from processing the distresses through the BDCS algorithm. For Elem. Key 1080 (spalls, bitpatch, and concrete patches), the bitpatch areas were all placed into the “poor” category. None of the spalls had any rebar showing and were therefore assigned a “fair” condition. Since concrete patches were identified on the bridge, all were assigned a “fair” rating. For Elem. Key 1130 (cracks), half the cracked areas were determined to be insignificant / in “good” condition. However, the other half of the cracked areas were moderate or heavy, resulting in both “fair” and “poor” ratings. Overall, the condition of the bridge deck was rated “Good” at 97% and “Poor” at 3%.

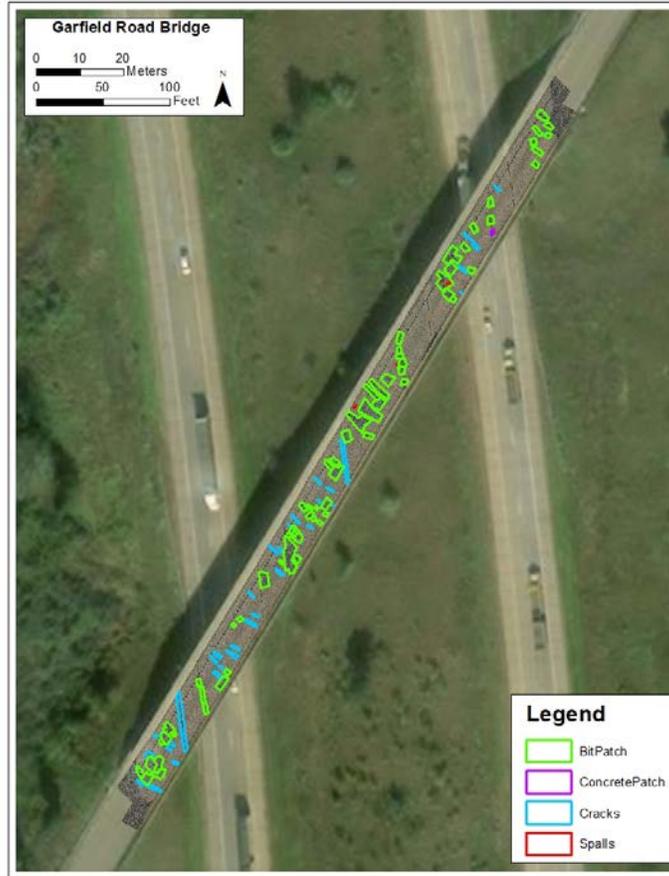
Figure 10. Identified distresses on the Garfield Road bridge.

The Garfield bridge (Str 1244) is located in Marshall, Michigan and passes over I-69. The total area of the bridge deck is approximately 23,129 sq. ft. and has six spans. After processing the optical imagery, analysts were able to identify spalls, bitpatch, concrete patching, and cracks (Figure 10). The total area of the distresses are as follows:

- Spalls - 10 sq. ft
- Bitpatch - 2,341 sq. ft
- Concrete Patching - 6 sq. ft
- Cracks - 438 sq. ft

Table 9 shows the results from processing the distresses through the BDCS algorithm. For Elem. Key 1080 (spalls, bitpatch, and concrete patches), the bitpatch areas were all placed into the “poor” category. One spall had rebar showing and were therefore placed assigned a “poor” condition. The remaining spalls were assigned a “fair” condition. All of the concrete patches were assigned a “fair” category. For Elem. Key 1130 (cracking), most of the cracked areas were determined to be insignificant / in “good” condition. However, some cracks were moderate, resulting in ratings of “fair”. Overall, the condition of the bridge deck was rated “Good” at 89%, “Fair” at 1%, and “Poor” at 10%.

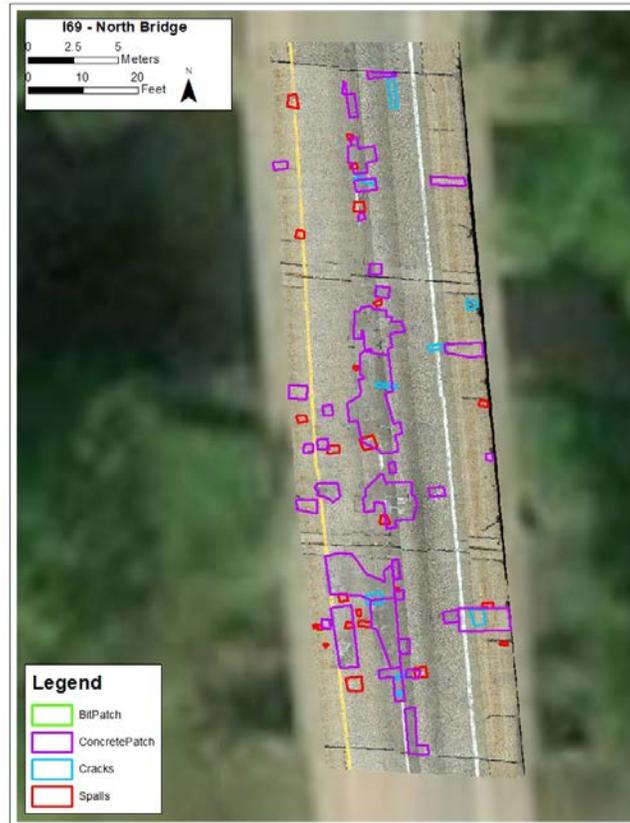
Figure 11. Identified distresses on the I-69 North bridge.

The I-69 North bridge (Str 1215) is located in Tekonsha, Michigan and passes over the St. Joseph River. The total area of the bridge deck is approximately 5,494 sq. ft. and has three spans. After processing the optical imagery, analysts were able to identify spalls, concrete patching, and cracks (Figure 11). The total area of the distresses are as follows:

- Spalls - 48 sq. ft
- Bitpatch - 0 sq. ft
- Concrete Patching - 585 sq. ft
- Cracks - 16 sq. ft

Table 10 shows the results from processing the distresses through the BDCS algorithm. For Elem. Key 1080 (spalls and concrete patches), two spalls had rebar showing and were therefore placed assigned a “poor” condition. The remaining spalls were assigned a “fair” condition. All concrete patches were assigned a “fair” condition. For Elem. Key 1130 (cracking), most of the cracked areas were determined to be insignificant / in “good” condition. However, one area of cracking was moderate, resulting in a rating of “fair”. Overall, the condition of the bridge deck was rated “Good” at 89% and “Fair” at 11%.

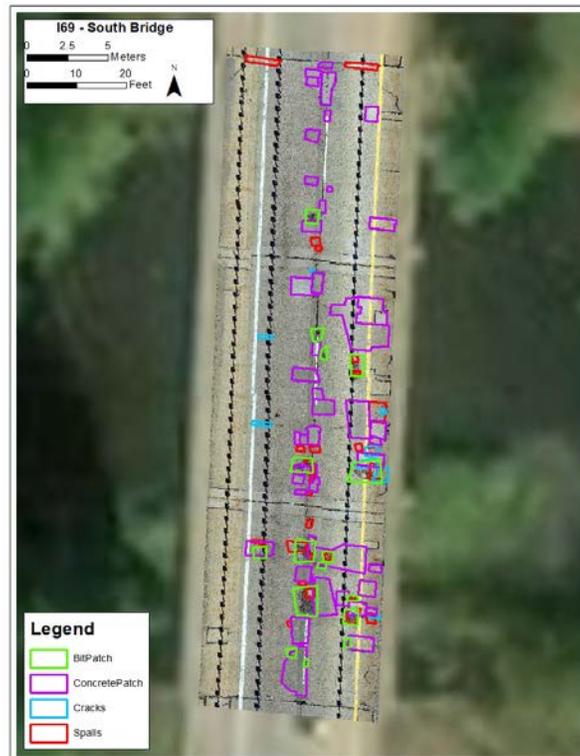
Figure 12. Identified distresses on the I-69 South bridge.

The I-69 South bridge (Str 1213) is located in Tekonsha, Michigan and passes over the St. Joseph River. The total area of the bridge deck is approximately 5,625 sq. ft. and has three spans. After processing the optical imagery, analysts were able to identify spalls, bitpatch, concrete patching, and cracks (Figure 12). The total area of the distresses are as follows:

- Spalls - 63 sq. ft
- Bitpatch - 125 sq. ft
- Concrete Patching - 488 sq. ft
- Cracks - 18 sq. ft

Table 11 shows the results from processing the distresses through the BDCS algorithm. For Elem. Key 1080 (spalls, bitpatch, and cracking), the bitpatch areas were all placed into the “poor” category. Three spalls had rebar showing and were therefore placed assigned a “poor” condition. The remaining spalls were assigned a “fair” condition. All concrete patches were assigned a rating of “fair”. For Elem. Key 1130 (cracking), half of the cracked areas were determined to be insignificant / in “good” condition. However, some cracks were moderate or heavy, resulting in “poor” and “fair” ratings. Overall, the condition of the bridge deck was rated “Good” at 88%, “Fair” at 10%, and “Poor” at 3%.
