# OFFICE MEMORANDUM

MICHIGAN  
STATE HIGHWAY DEPARTMENT  
JOHN C. MACKIE, COMMISSIONER

March 20, 1964

Subject: Decayed Dimension Guard Rail Posts near Farmington.  
Research Project R-63 G-131. Research Report No. R-454.

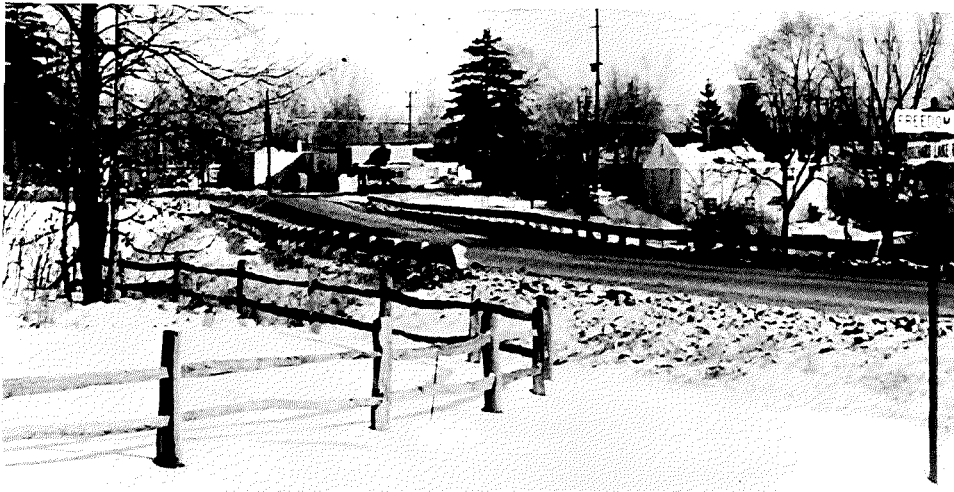
An investigation of decayed wood guard rail posts on Orchard Lake Road just north of I 96 has been conducted as authorized by W. W. McLaughlin in a memorandum to H. J. Rathfoot dated December 3, 1963. This installation of approximately 1133 lin ft of guard rail (Fig. 1) was included as part of Construction Project IN 63-29, C12, built in 1957. The contract proposal specified wood posts (pressure treated with creosote) or steel posts to support the guard rail. This project was originally planned with cable guard rail, but before construction Departmental policy was changed to provide for steel beam guard rail on expressways. A supplementary sheet attached to the proposal for this project indicated that brush treatment with Osmosalts was an approved alternate for treating round posts for cable guard rail.

Figure 1. View looking north on Orchard Lake Road, showing guard rail from which decayed posts were removed.

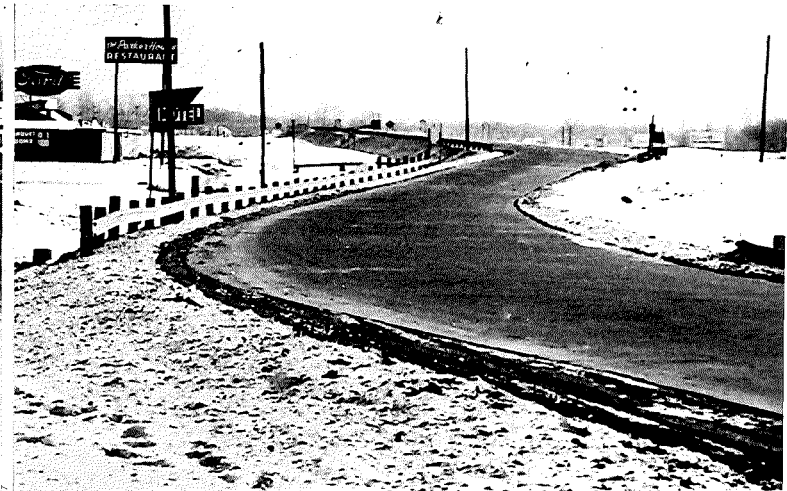
A sample post (63 MR-287) was delivered by J. Murphy, Materials Inspector, on December 6, 1963. It was determined later that this sample post was not from the area in question but was removed from permanent guard rail on the north side of I 96 about 300 yd east of Orchard Lake Road during a culvert installation (I 63022C, C20), involving two culverts carrying the Rouge River under Orchard Lake Road and I 96. Fig. 2 shows the I 96 construction area with remaining permanent guard rail at the left center from which the sample was taken. This post was in excellent condition. Chemical testing and examination of sawed sections established that it had been pressure treated with creosote.

Figure 2. View looking east at I 96 culvert construction area. Sample 63 MR-287 was obtained when permanent guard rail from ramp in background was partially relocated as temporary rail in foreground.

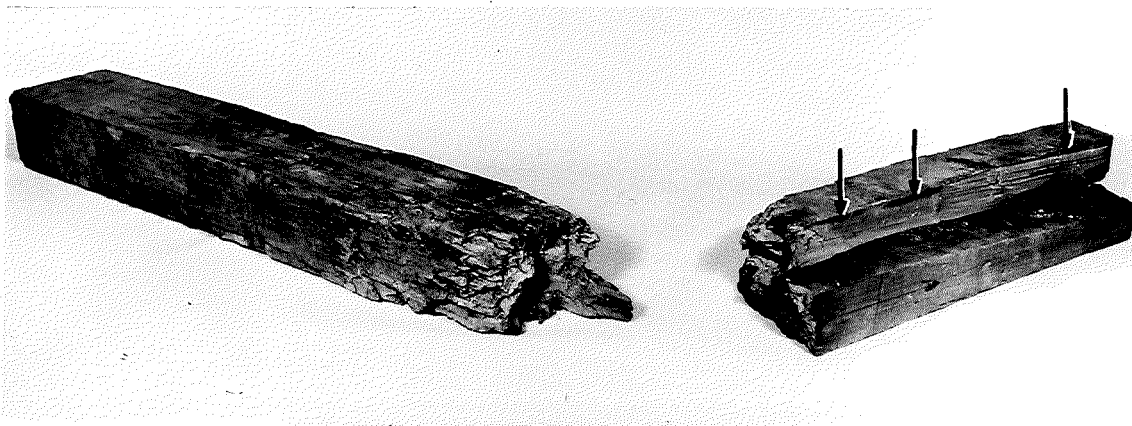
Later, a second sample post (63 MR-288) was obtained by M. H. Janson and W. L. Frederick from H. J. Rathfoot, Jr. of the Garavaglia Construction Co., at the Orchard Lake Road-I 96 overpass on December 16, 1963. Posts at this location scaled badly when pulled, leaving a circular cross-section according to contractor's personnel, and were subsequently used for firewood. The guard rail was re-installed on new posts. This second post (63 MR-288) had broken off at ground level when a grader bumped the guard rail north of the culvert, during grading at the close of construction. It did not scale since it had to be substantially dug out. Fig. 3 shows the rotted sample post. The darker

areas (green) at the top of the broken area indicate that the post had received some chemical treatment; the top portion of the post was sound. At the ground level, however, about 3 in. of the post was completely decayed. Below this area, condition gradually improved until the bottom of the post was sound except for some peripheral decay.

Chemical tests on the sound top wood proved that creosote and pentachlorophenol were absent. A positive test for chromate, an ingredient of Osmosalts, was obtained, however. Subsequent contact with the original project engineers, D. L. Wickham and R. G. Johnson, confirmed that Osmosalts had been used to an unknown extent on guard rail posts. Accordingly, a survey was made to determine the location of other Osmosalt-treated posts. The attached line drawing of I 96 (Fig. 5) shows the location of various types of guard rail posts installed in the project area. It was not possible to determine the type of preservative used on painted cable guard rail posts visually, but chemical tests on wood removed from a post near the southeast corner of the Haggerty Road overpass indicated Osmosalt-treatment at that location. Frozen ground prevented inspection of any posts below ground level, where decay would be expected. Several Osmosalt-treated posts had splintered where guard rail had been bumped by a vehicle. Fig. 4 shows two splintered posts. None of the creosote-treated posts inspected had splintered in this manner.

The deterioration of these guard rail posts is due to an ineffective original treatment with Osmosalts which resulted in low penetration and insufficient retention of the preservative.

Figure 3 (below). Two parts of decayed post (Sample 63 MR-288); arrows indicate darker areas which show very little penetration of preservative into the wood.

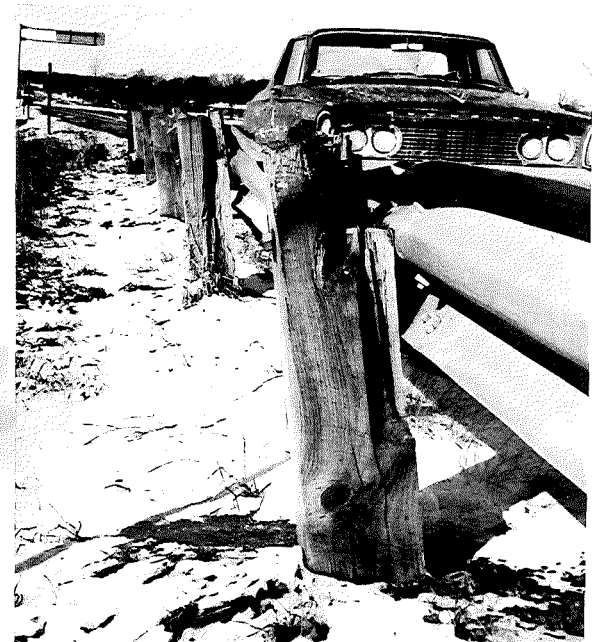
Figure 4 (right). Osmosalt-treated posts which splintered when a vehicle bumped the guard rail.

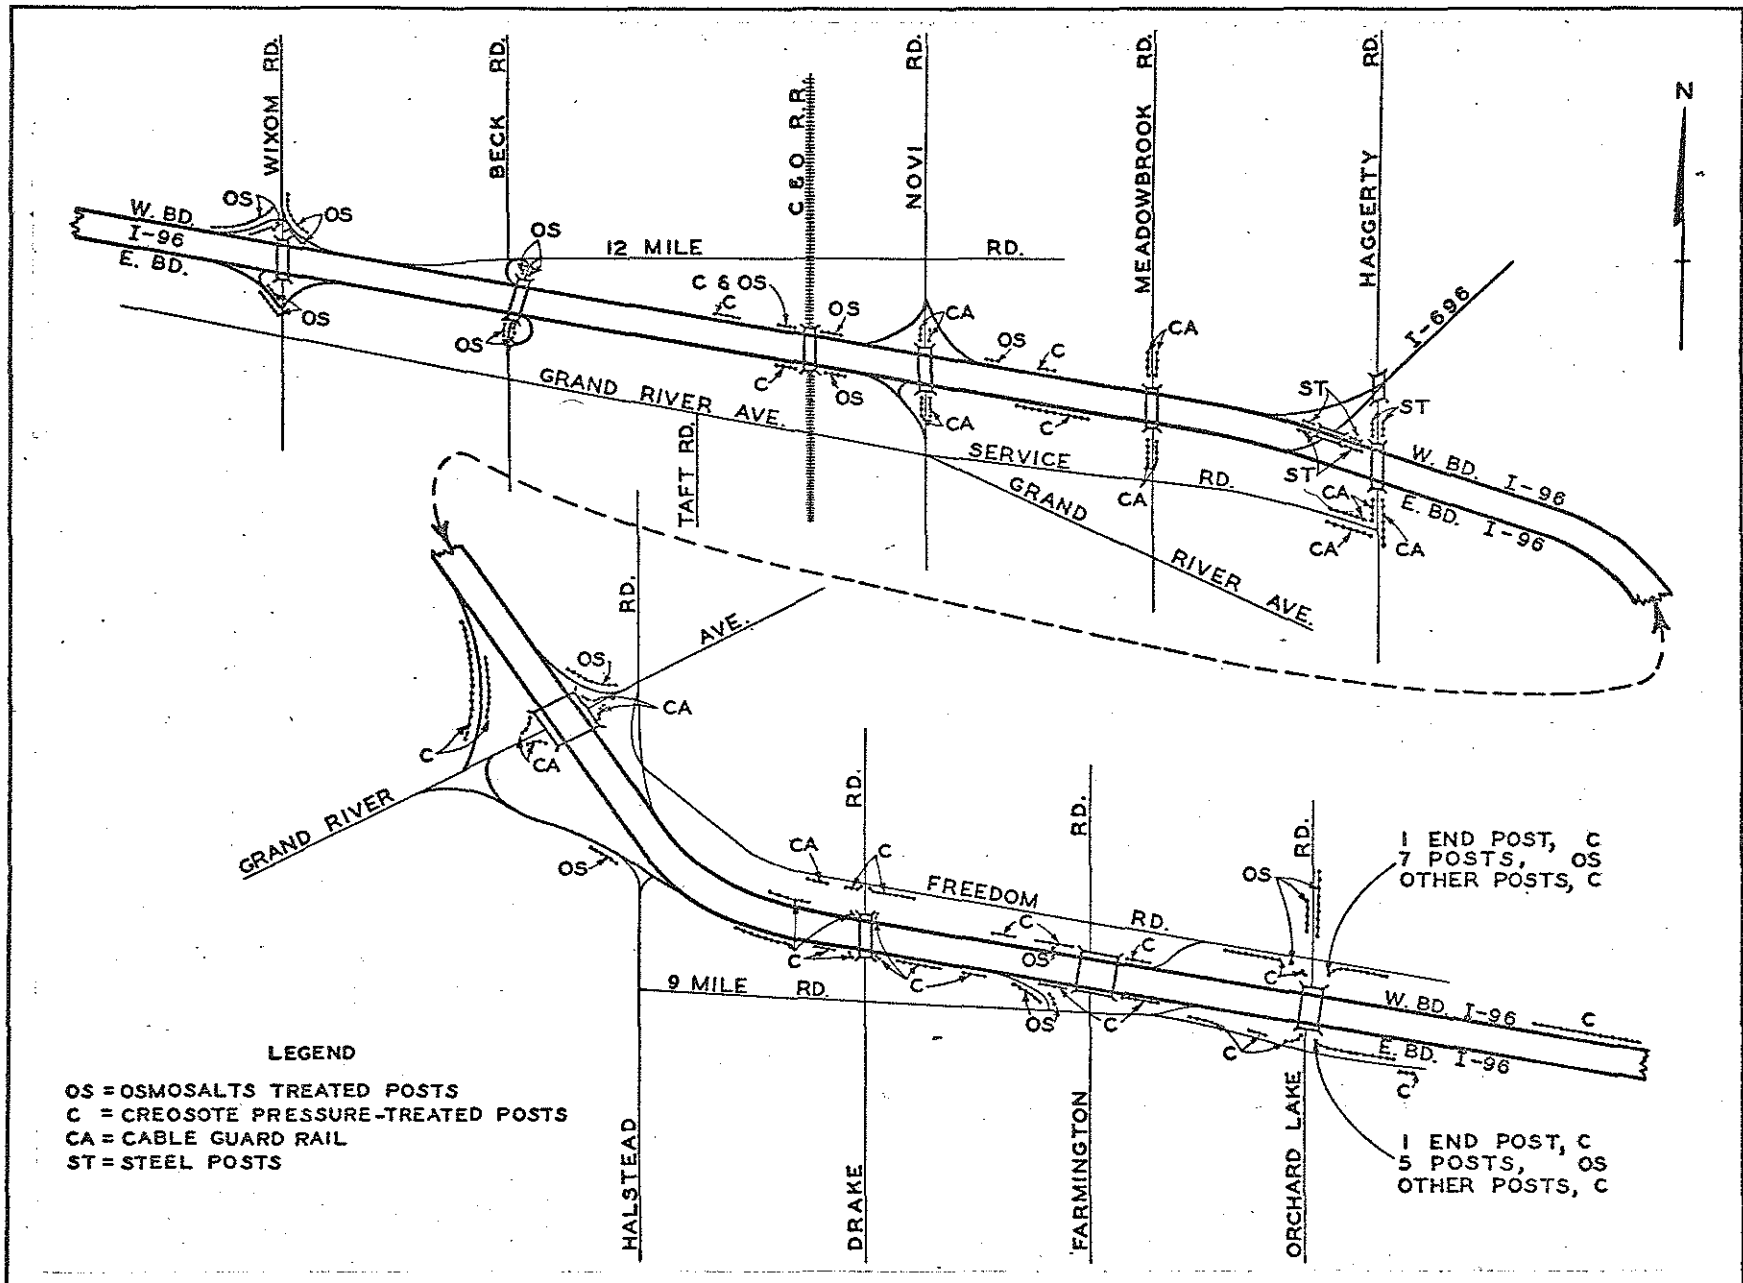
Figure 5. Schematic drawing showing I 96 installations of guard posts having various preservative treatments; note Orchard Lake Road overpass at extreme right.
