**Evaluation of Bridge Decks Using
Non-Destructive Evaluation (NDE)
at Near Highway Speeds
for Effective Asset Management**

FINAL REPORT

Michigan Department of Transportation

Michigan Technological University
1400 Townsend Drive
Houghton, MI 49931

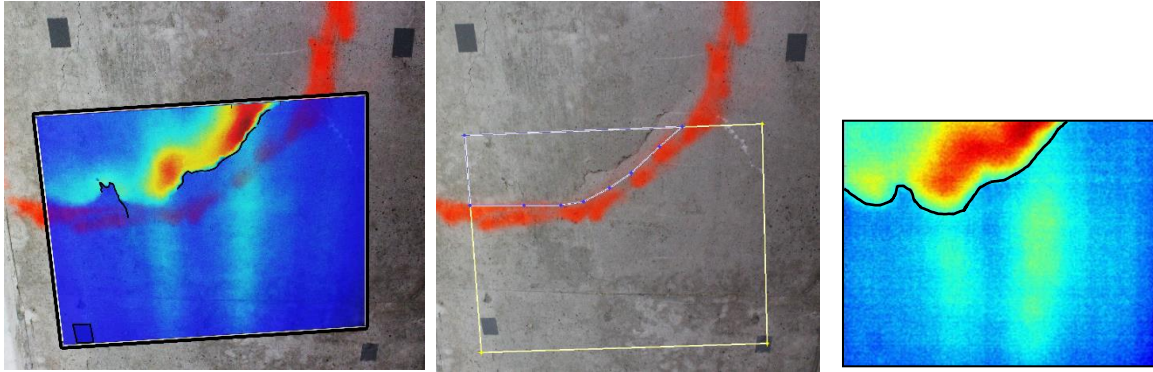
Results indicate that this remote sensing technology is acceptable for detecting and quantifying delaminations. A simple polygon method for analysis was developed to quantify delamination areas for comparison to MDOT ground truth. In all cases, the current MDOT hammer sounding method of inspection for estimating the area of delamination was conservative relative to active thermography results.

Figure ES-3: Results of active thermography testing on the underside of a concrete bridge deck

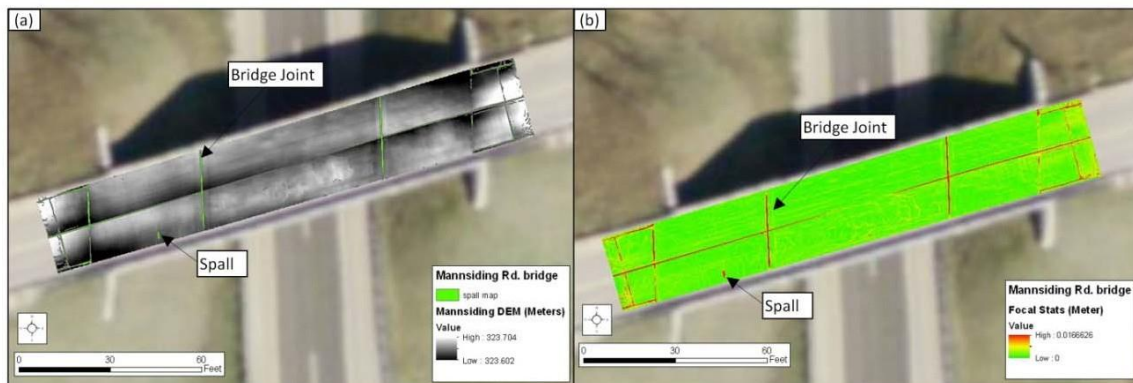
3DOBS and infrared thermography results for this bridge were imported in ArcGIS and are shown Figure 2-8 and Figure 2-9, respectively. The total spalled area on Mannsiding Road bridge was 1.73 m² (18.62 ft²) which is 0.47% of the entire bridge deck surface. Chain drag results showed 127.3 ft² (3.63% of the total bridge deck area) total delaminated areas on the bridge deck, while the total delaminated area calculated from thermal infrared imagery survey was 136.13 ft² (3.88% of the total bridge deck area).

Figure 2-8: A) Mannsiding Road Bridge Digital Elevation Model (DEM) and Spall Map Layer on ArcGIS, B) Mannsiding Road Bridge Spall Map Generated with Spall Detection Algorithm.

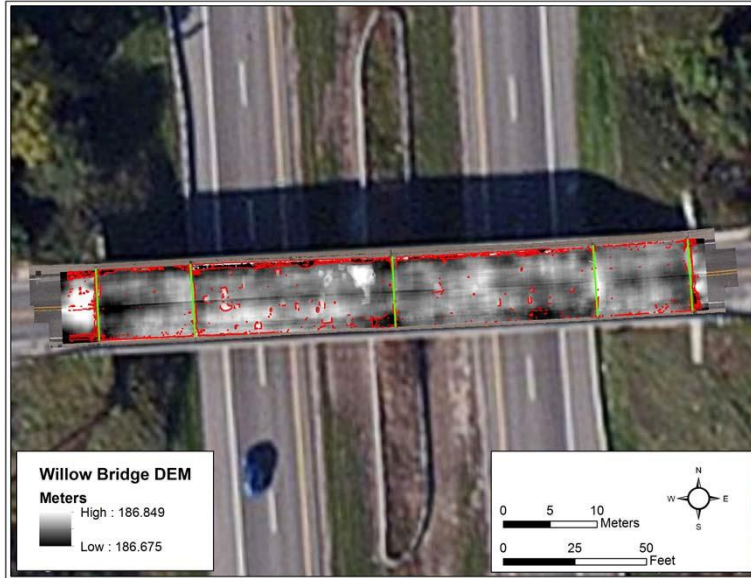
Figure 2-10 and Figure 2-11 shows the results of 3DOBS and infrared thermography of Willow Rd. bridge, respectively. Total area of spalls on this bridge was 27.3 m² (293.7 ft²) which was 5.15% of the entire bridge deck surface. Hammer sounding results showed 159.5 ft² (3.05 % of the total bridge deck area) total delaminated areas on the bridge deck, while the total delaminated area calculated from thermal infrared imagery survey was 157.83 ft² (3.02 % of the total bridge deck area).

Figure 2-10: Willow Road Bridge Digital Elevation Model (DEM) and Spall Map Layer on ArcGIS.

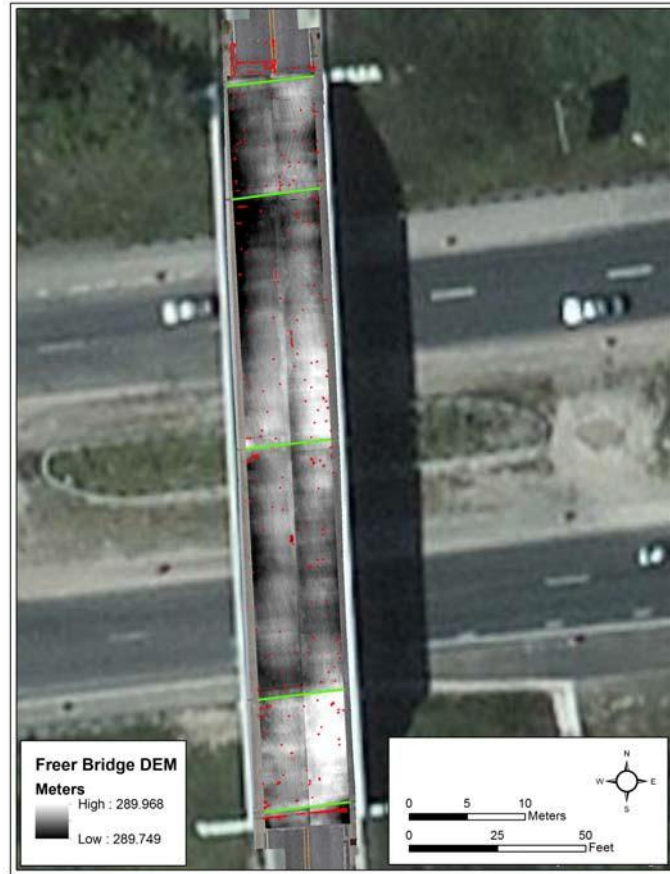
Figure 2-12 and Figure 2-13 shows the results of 3DOBS and infrared thermography of Freer Rd. bridge. Total area of spalls on this bridge was 3.8 m² (40.1 ft²) which is 0.67% of the entire bridge deck surface. Hammer sound results showed 101.74 ft² (1.8 % of the total bridge deck area) total delaminated areas on the bridge deck, while the total delaminated area calculated from thermal infrared imagery survey was 29.25 ft² (0.52 % of the total bridge deck area). The main cause of variation between the results of the hammer sounding and infrared thermography surveys on the Freer Road bridge is that most of the delaminations on this bridge were around the construction joint and overlapped with the painted centerline on the bridge deck. Reflective paint on the bridge deck has lower emissivity than concrete; therefore, it will appear on the thermal IR image with lower temperature and cause some difficulties in detecting delaminations in those areas.

Figure 2-12: Freer Road Bridge Digital Elevation Model (DEM) and Spall Map Layer on ArcGIS.

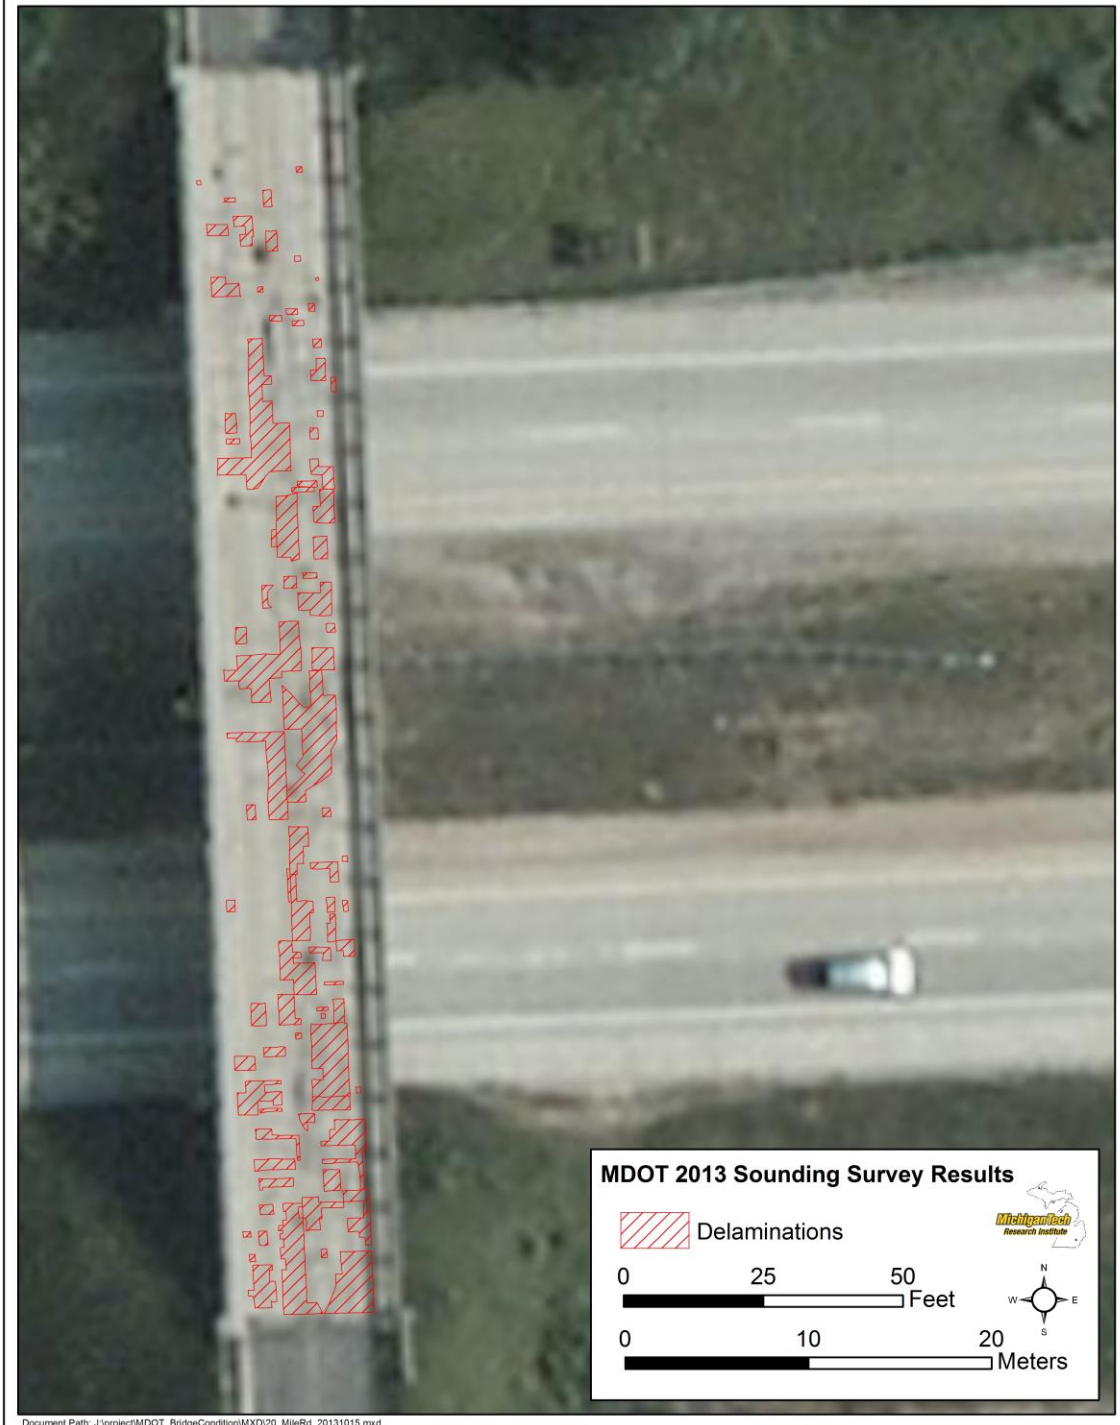
Figure 4-3: Georeferenced Sketch of the Results of the Deck Sounding Showing the Locations of Delaminations. The Total Area Delaminated is 1,276 ft².

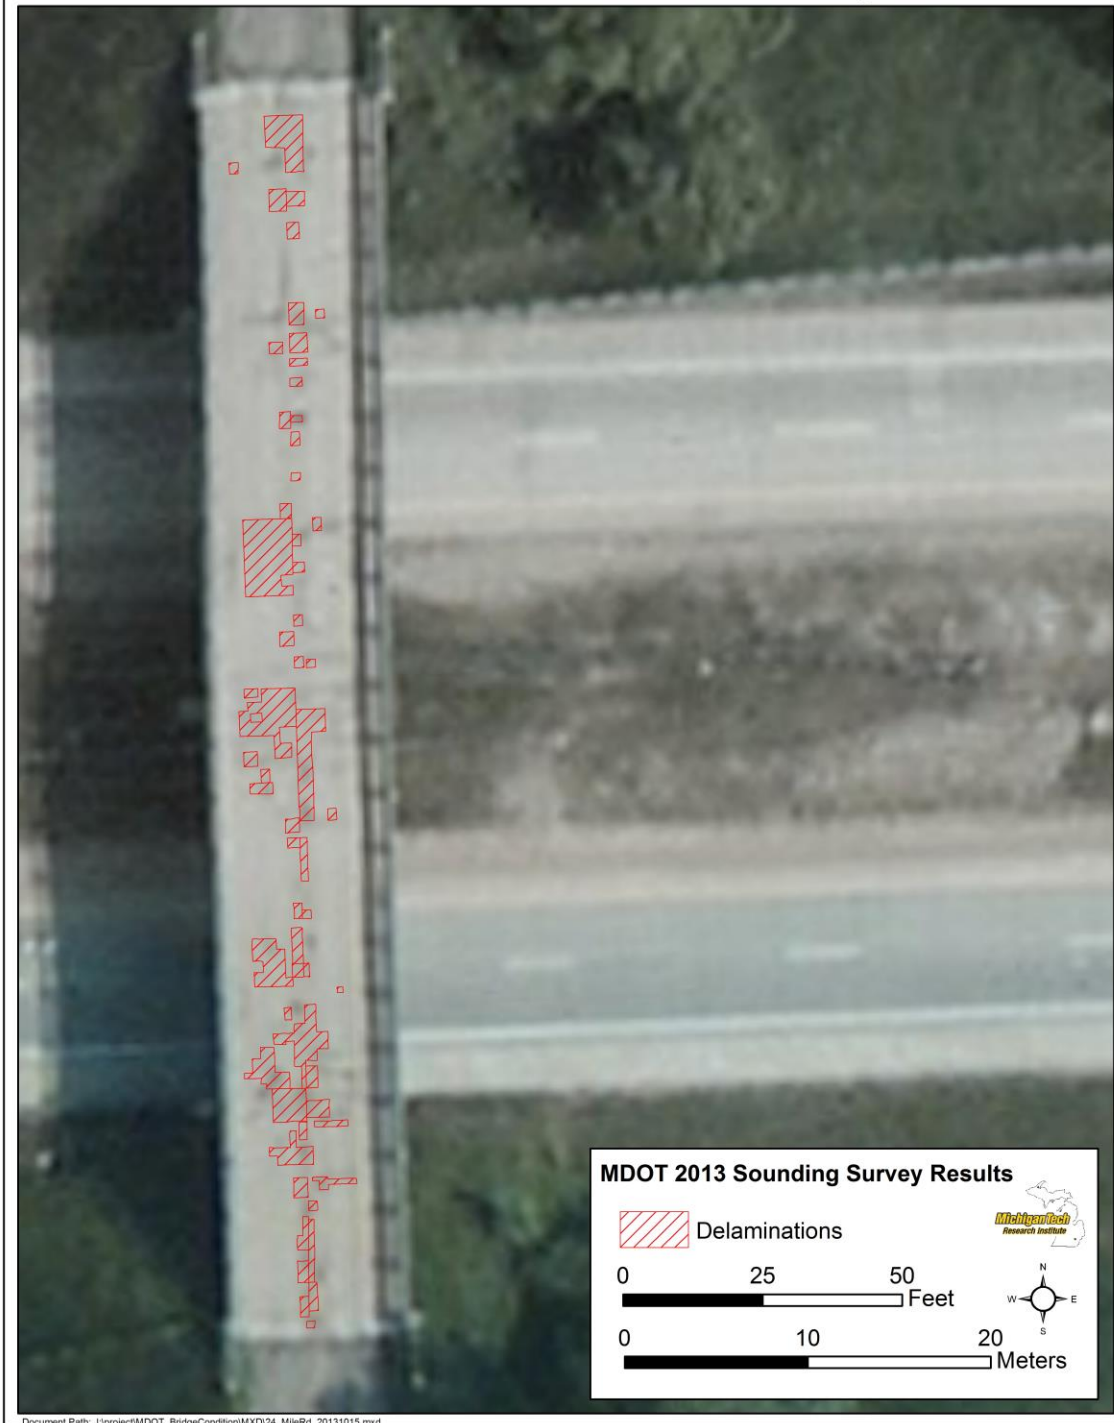
Figure 4-6: Georeferenced Sketch of the Results of the Deck Sounding of 24 Mile Rd Showing the Locations of Delaminations. The Total Area Delaminated is 762 ft²

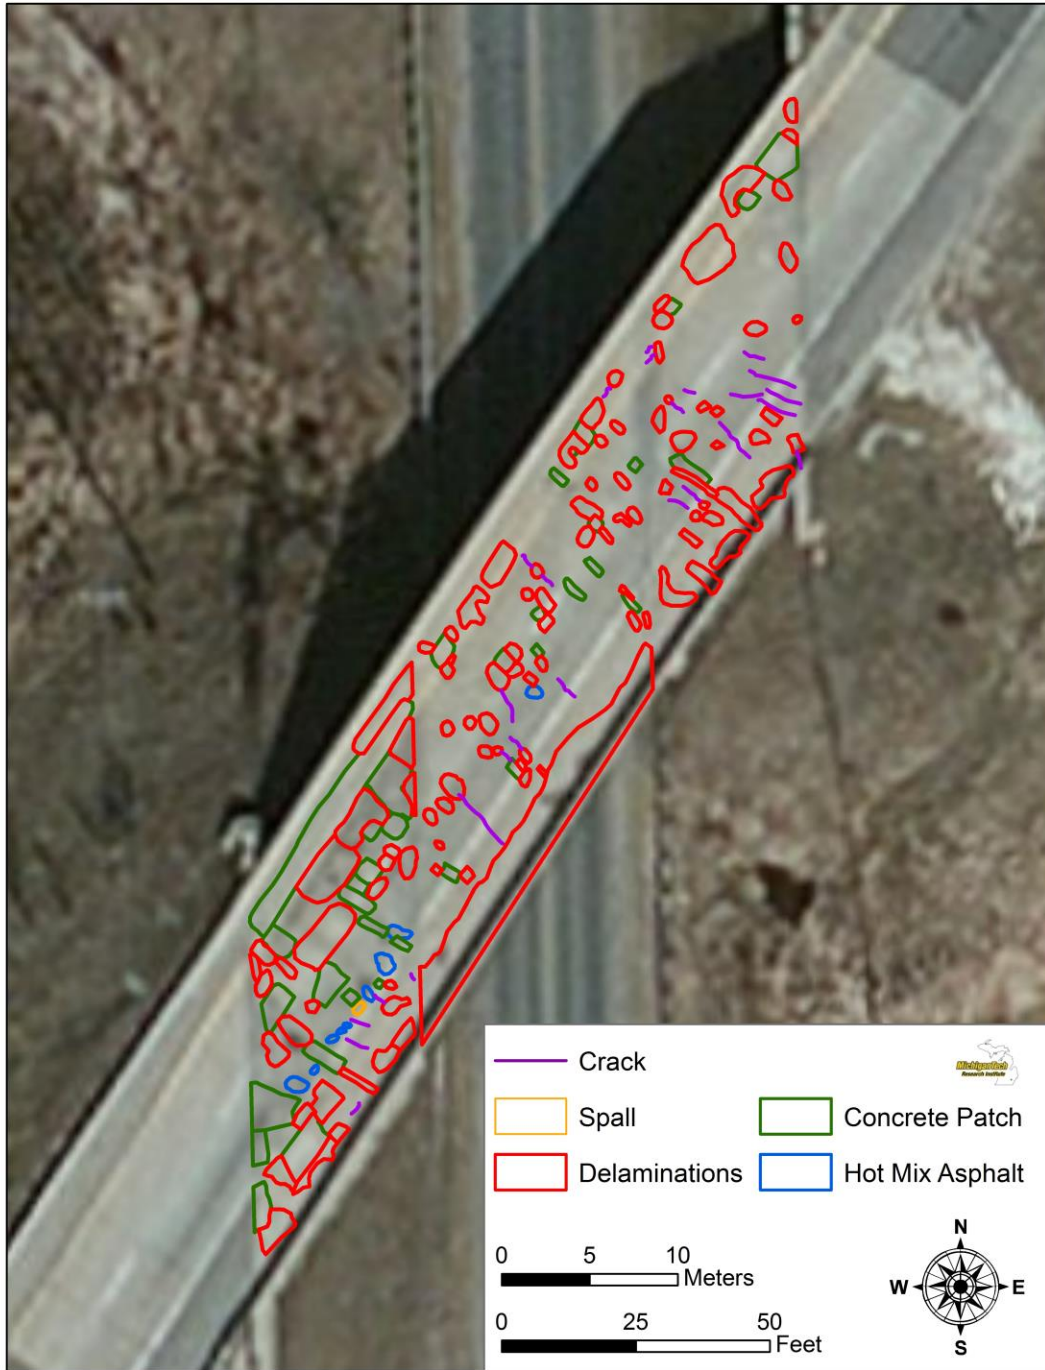
Figure 4-10: Georeferenced Sketch of the Results of the Deck Sounding of the North Bound Bridge of US-131 Showing the Locations of Delaminations, Cracking and Spalls.

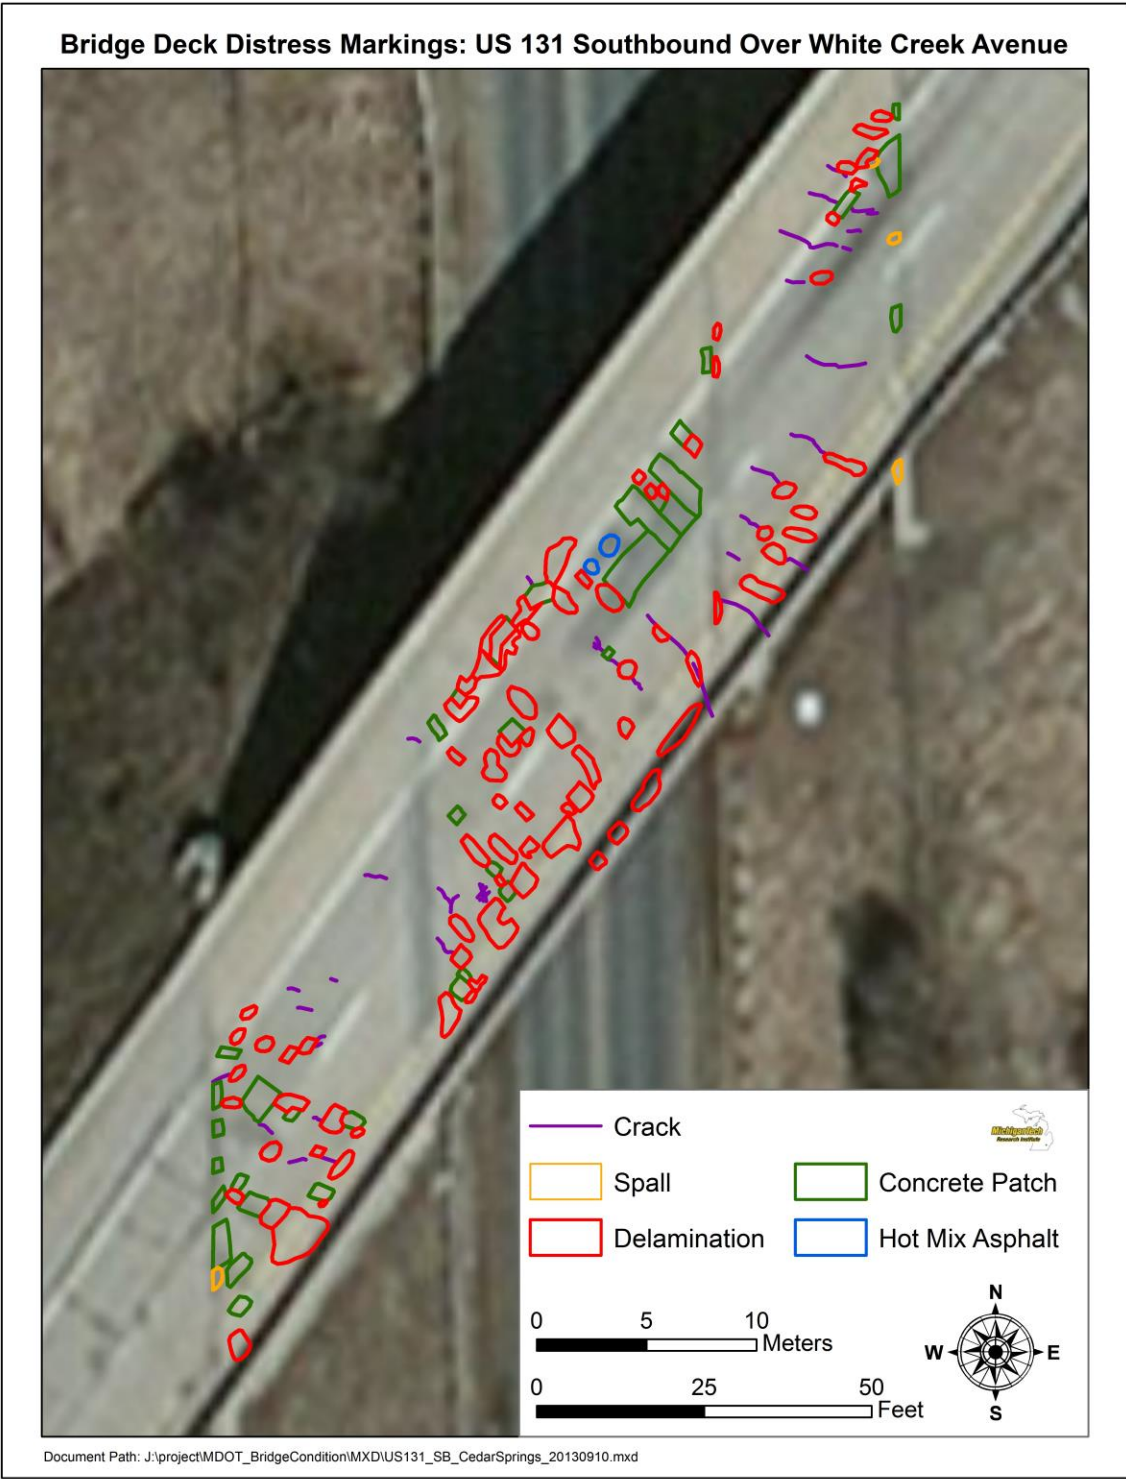
Figure 4-11: Georeferenced Sketch of the Results of the Deck Sounding of the South Bound Bridge of US-131 Showing the Locations of Delaminations, Cracking and Spalls.

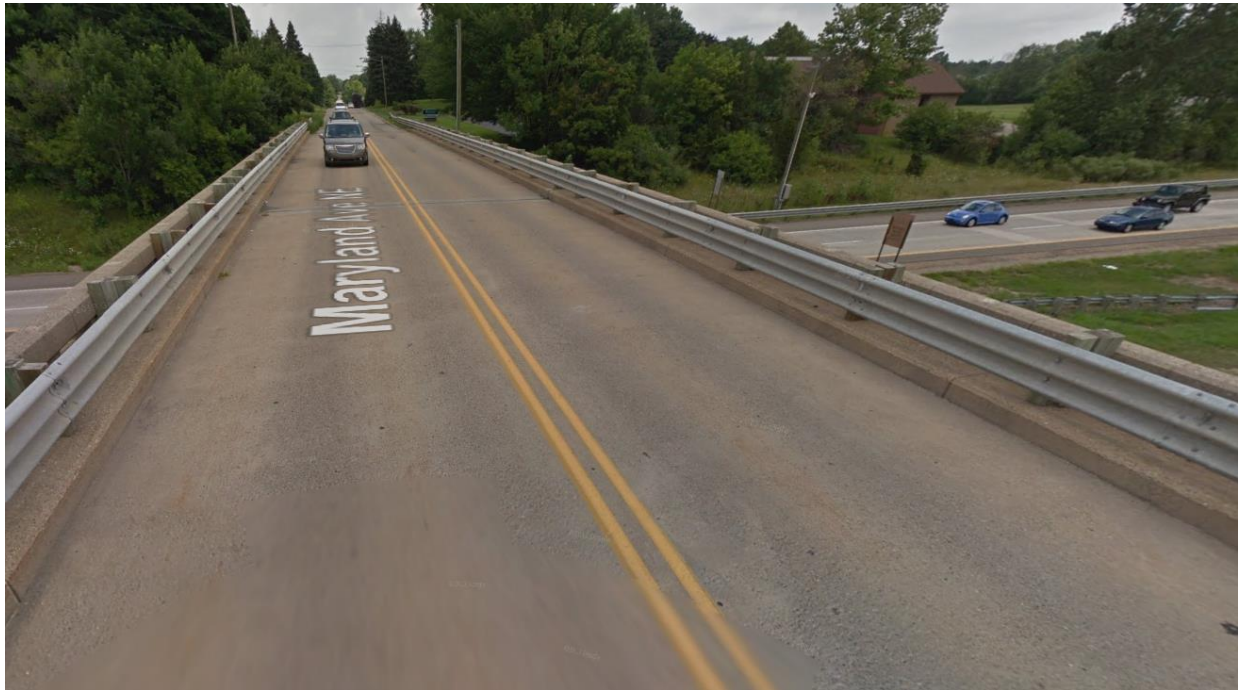
Figure 4-13: Current Condition of the Maryland Avenue Bridge Deck

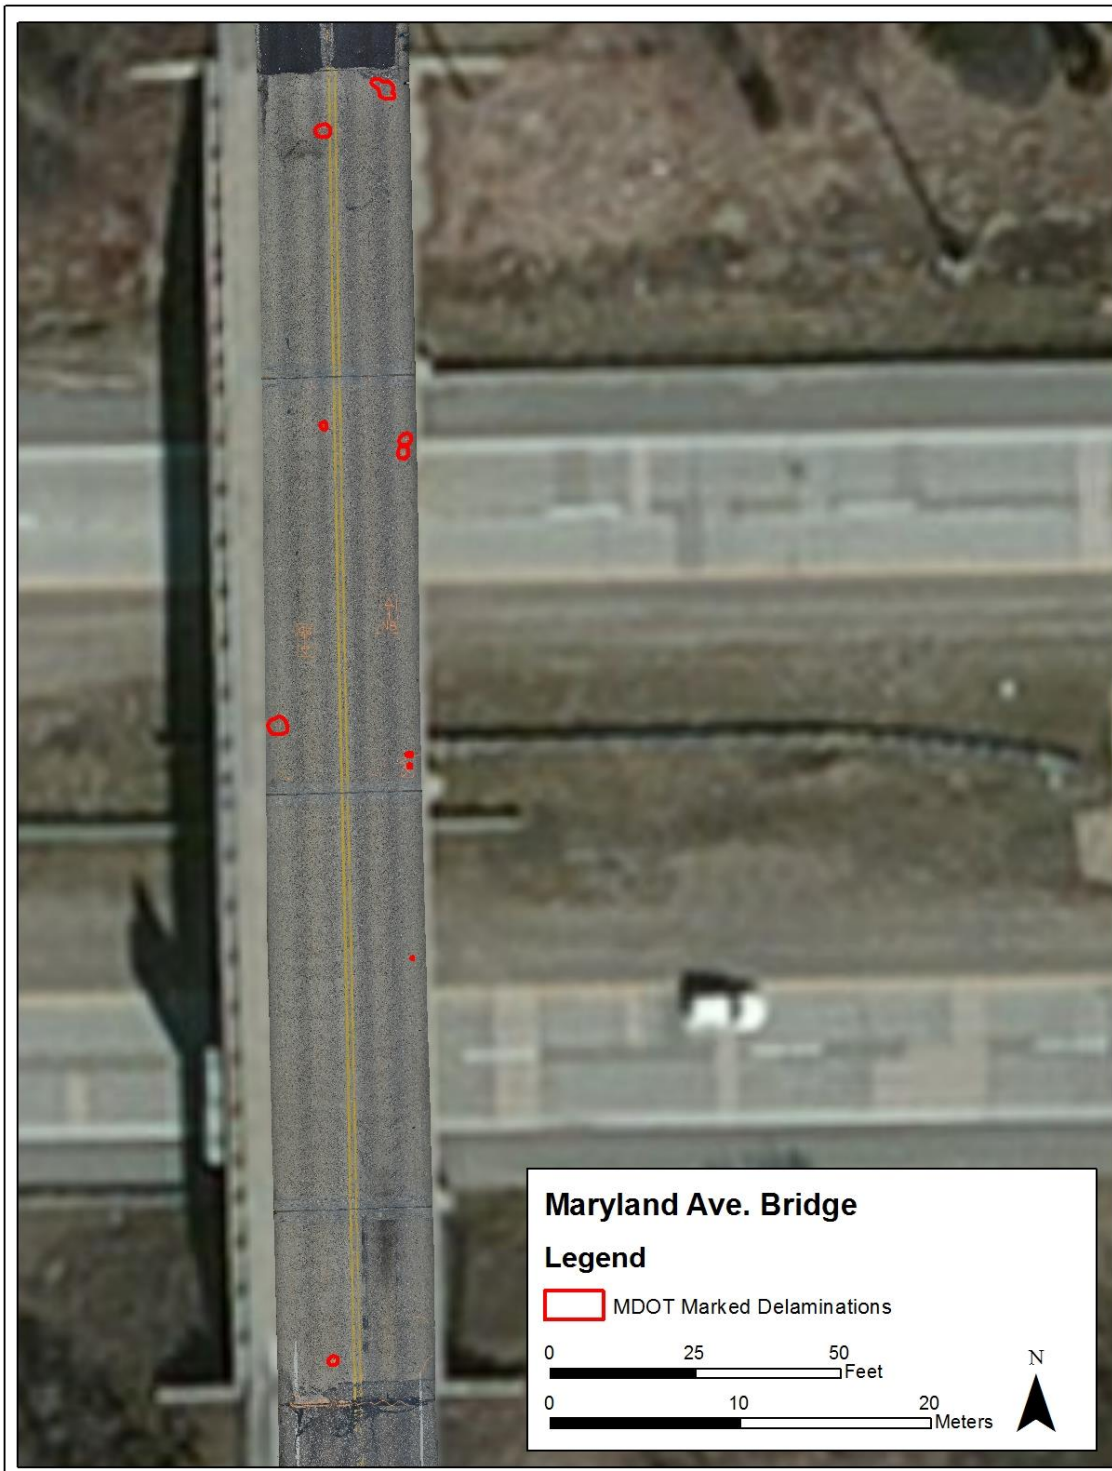
Figure 4-14: Georeferenced Sketch of the Results of the Deck Sounding of Maryland Ave. Showing the Locations of Delaminations.

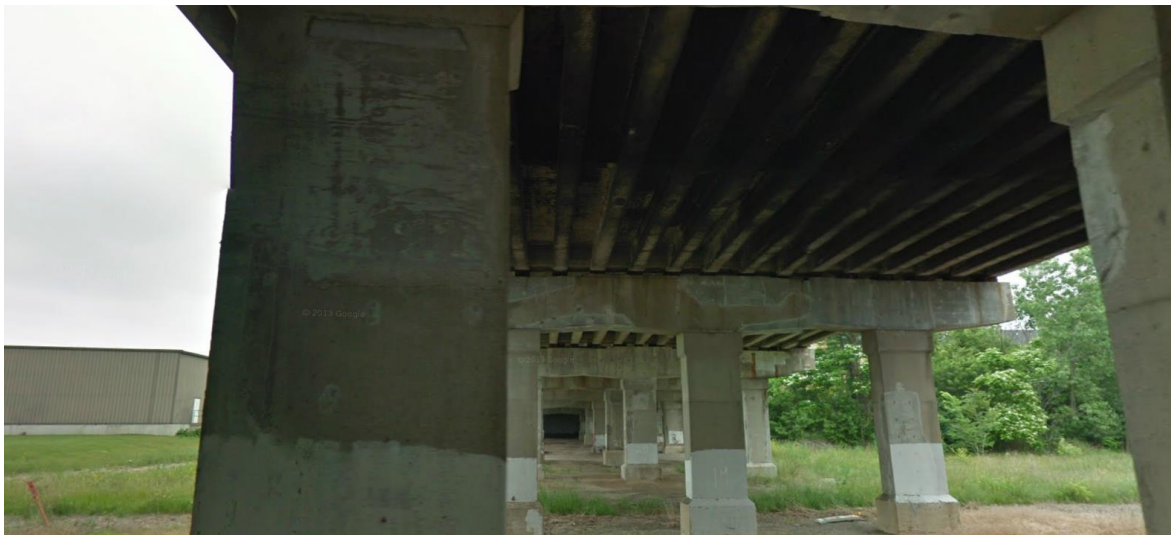
Figure 4-19: Current Condition of Bottom Deck Surface of Franklin Street Bridge.

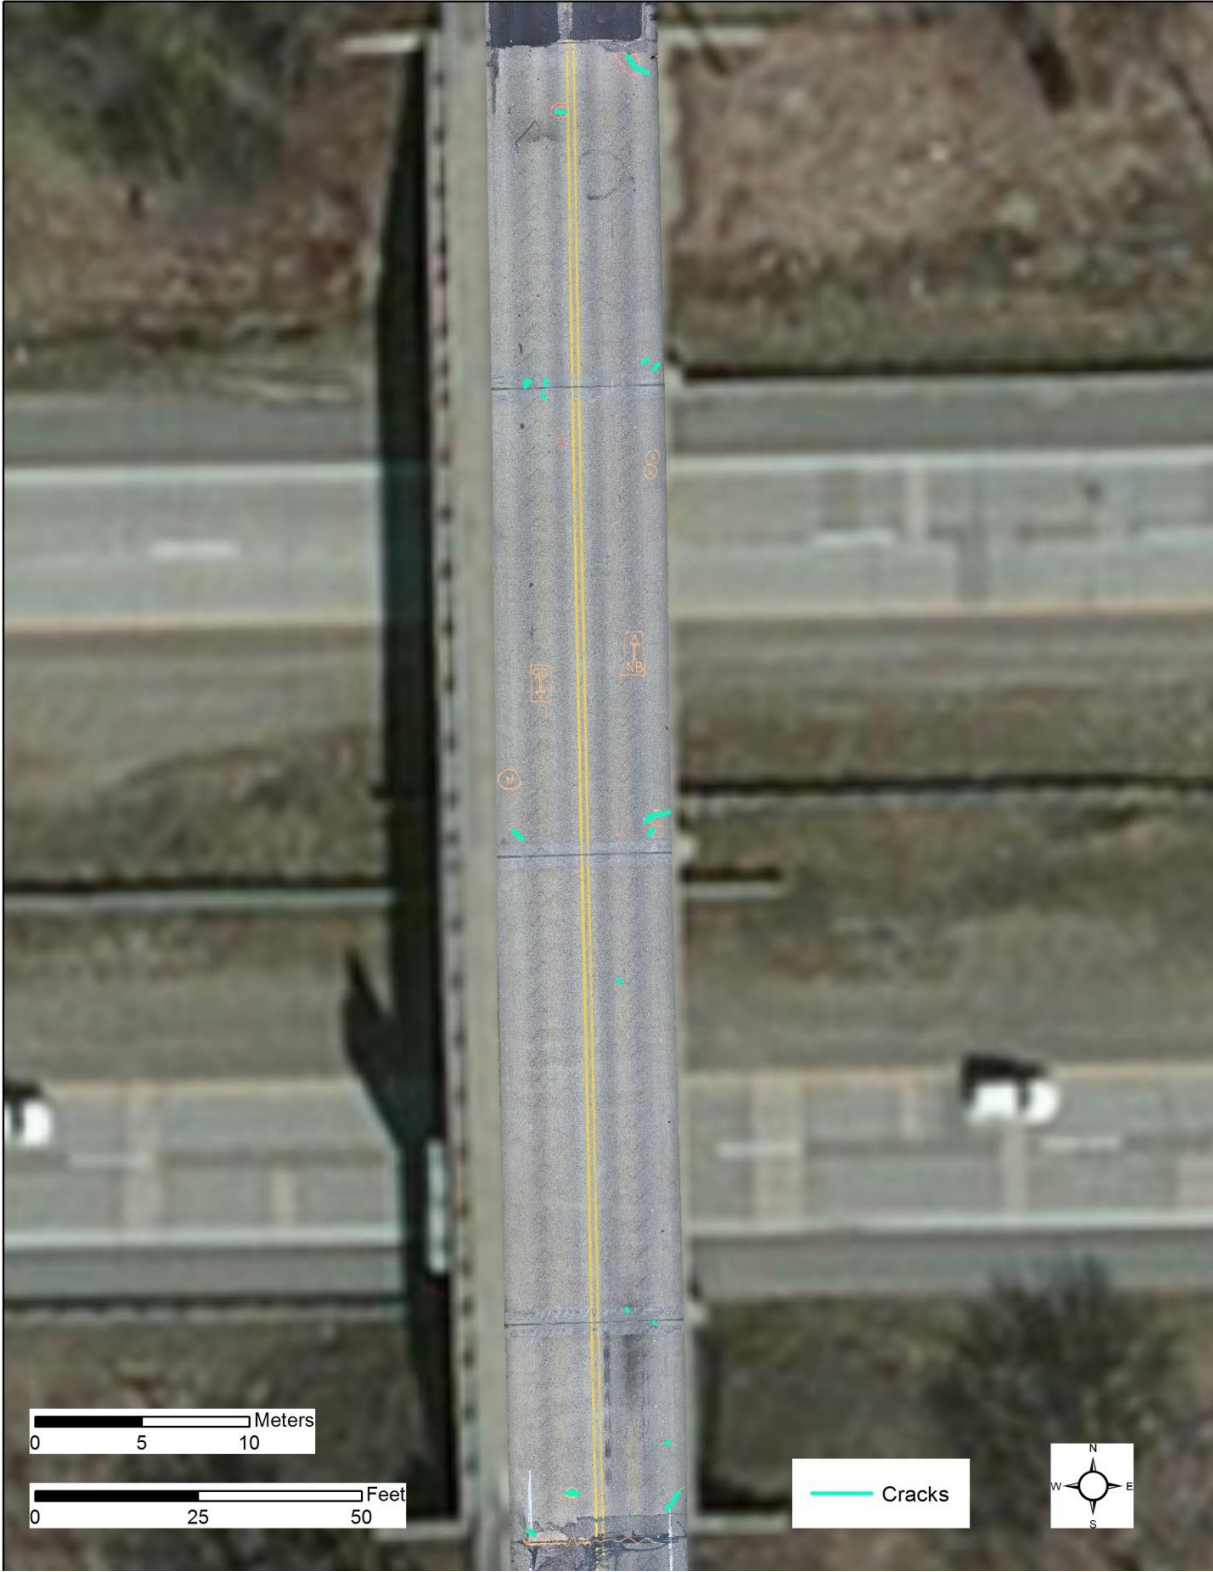
Figure 5-7: Detected Cracks on Maryland Ave.

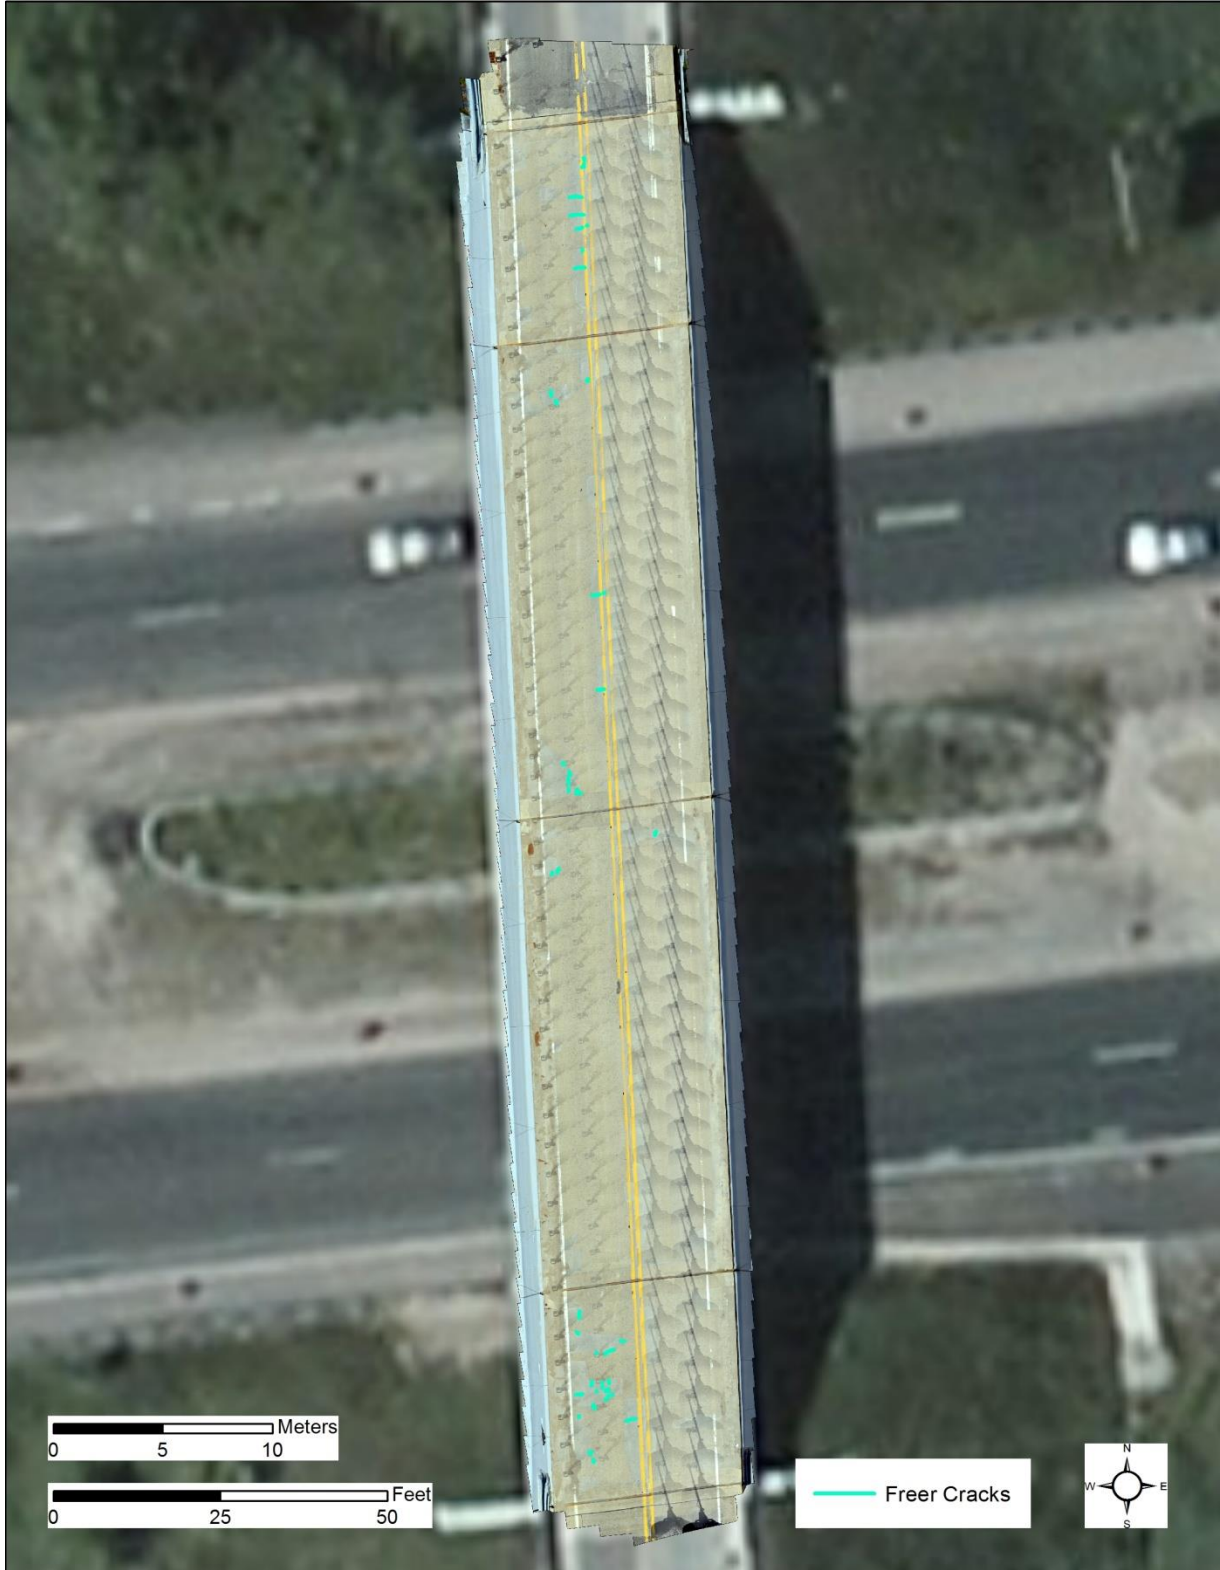
Figure 5-8: Detected Cracks on Freer Rd.

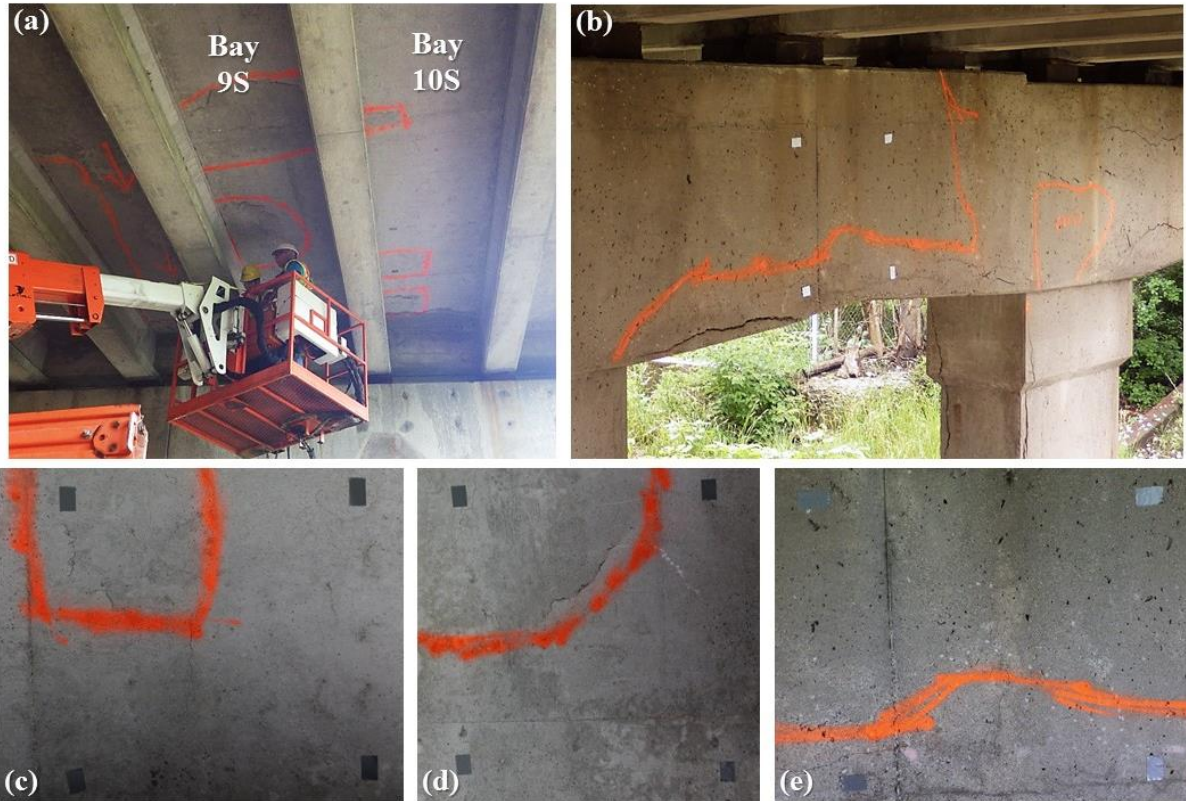
Figure 6-16: (a) Underside of the Franklin Street Bridge Deck. (b) Delamination on Pier 22. (c) Test Location A: Underside of Bridge Deck in Bay 10S. (d) Test Location B: Underside of Bridge Deck in Bay 9S. (e) Test Location C: Pier Cap of Pier 22.

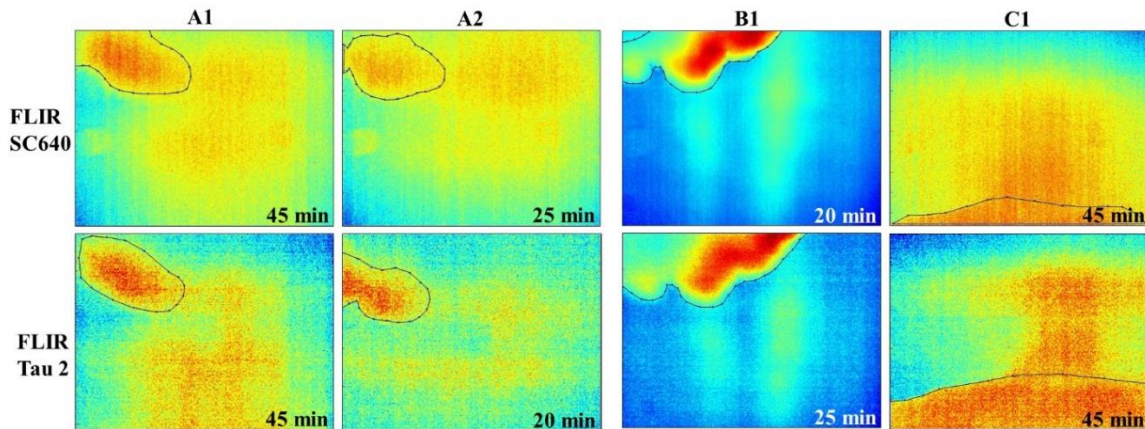
Figure 6-21: Maximum Delamination Areas using Simple Polygon Method for Thermal Image Processing.
