RAISED PAVEMENT MARKERS

**Research Laboratory Section
Testing and Research Division
Research Project 76 TI-377
Research Report No. R-1066**

**Michigan State Highway Department
Peter B. Fletcher, Chairman; Carl V. Pellonpaa,
Vice-Chairman, Hannes Meyers, Jr., Weston E. Vivian
John P. Woodford, Director
Lansing, July 1977**

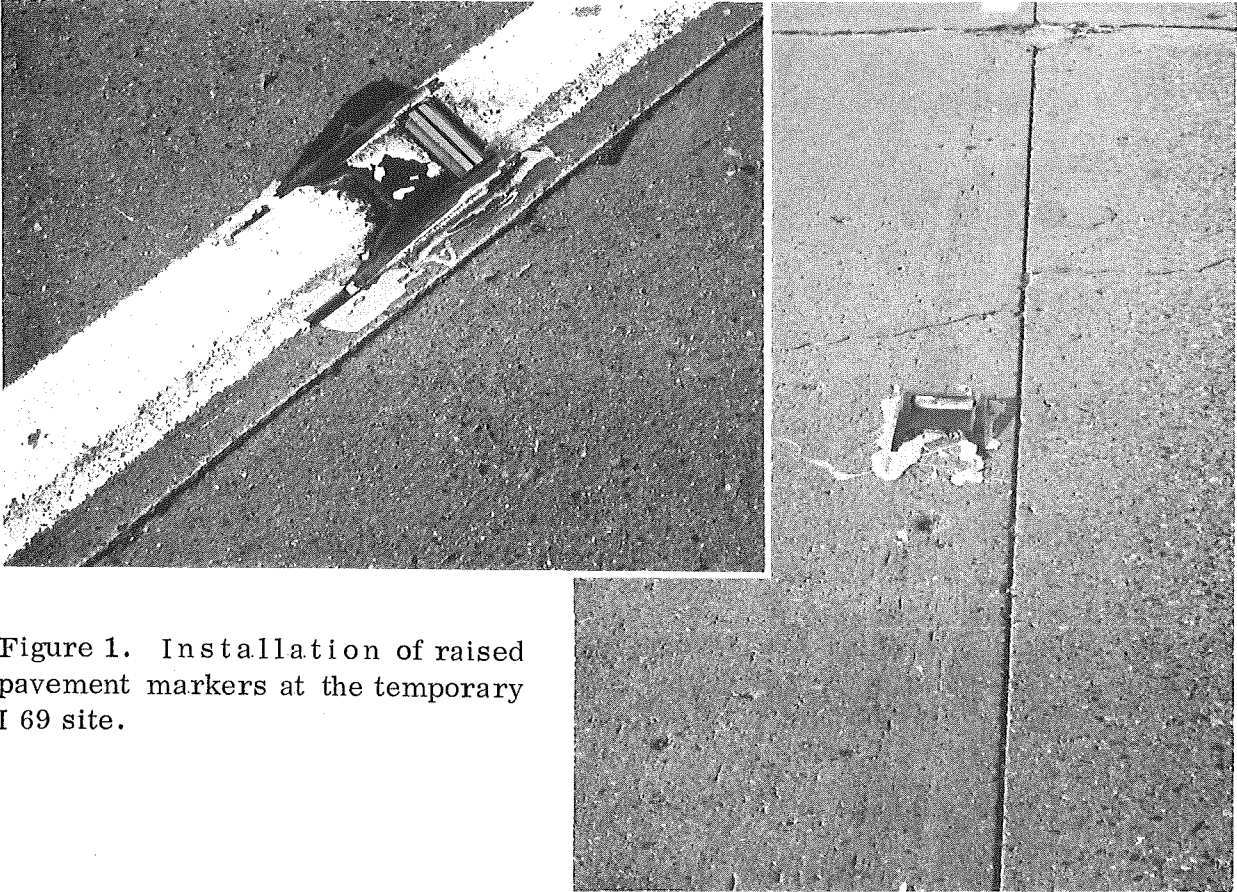
Figure 1. Installation of raised pavement markers at the temporary I 69 site.

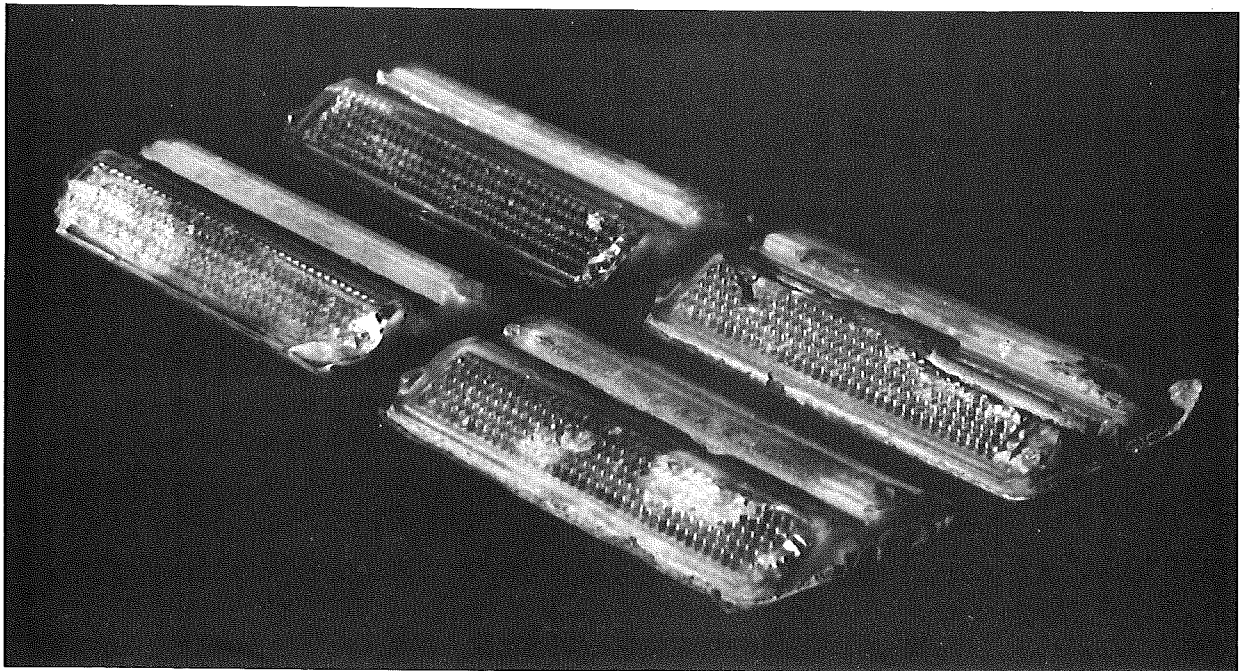
The reflectors lost 80 to 90 percent of their specific luminance after 5 months, and 95 to 99 percent after 12 months depending on the testing geometry. In a new condition the reflector was approximately 20 times brighter than a newly painted centerline stripe, but after 12 months both were approximately equal in brightness. This comparison is valid only under dry pavement or dry paint stripe conditions.

Figure 2. Raised pavement marker reflectors at various stages of service; new reflector (top), 5-month old reflector (left), 12-month old reflector (right), and 18-month old reflector (bottom). Light spots indicate damaged cube corners.

The effective area of the reflectors varied with time in service because of damage to the reflector (Fig. 2). The values of reflective area employed in the computation of specific luminance are listed in Table 2.
