SAFETY PERFORMANCE EVALUATION OF MICHIGAN'S 4X5 PORTABLE SIGN SUPPORT

Michigan Department of Transportation

MwRSF Research Report No. TRP-03-135-03

**TESTING AND RESEARCH SECTION
CONSTRUCTION AND TECHNOLOGY DIVISION
RESEARCH REPORT NO. RC-1446**

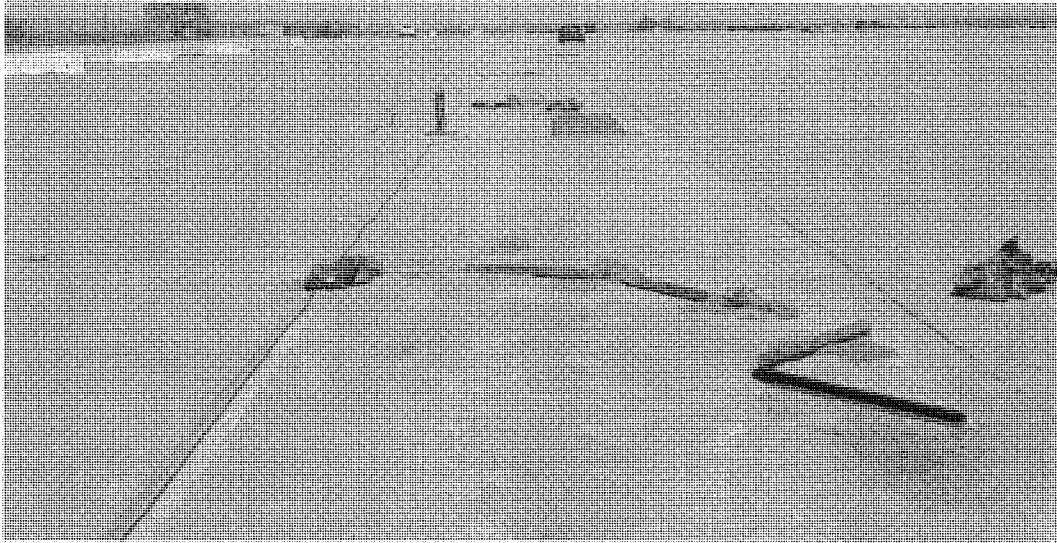
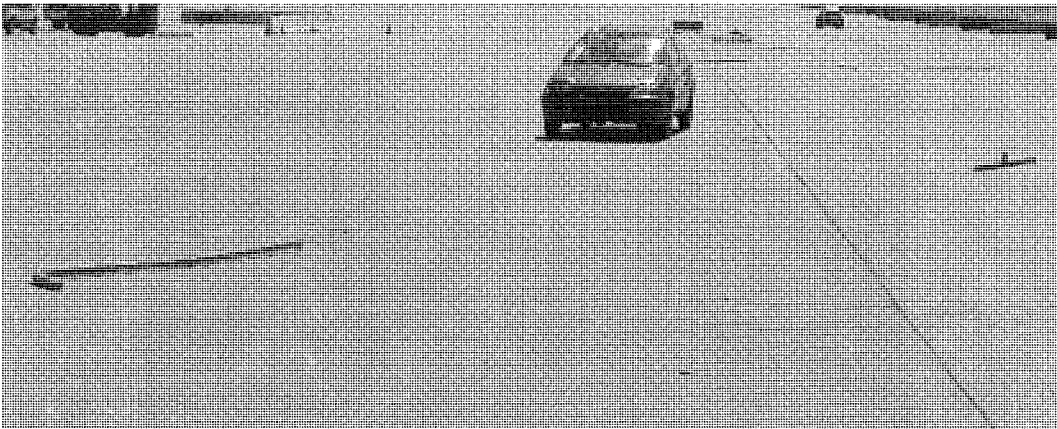
Figure 17. Overall Damage and Final Positions, Test MI-4

Damage to System Nos. 7 and 8 is shown in Figures 17 through 22. System No. 7 encountered moderate damage. Both legs disengaged from the masts. The impacted leg's vertical upright tube disengaged from the angle portion due to fracture of the welds. The disengaged vertical upright tube was deformed on the non-impacted side. Both legs' angles were deformed near their center points. The impacted outer tube and mast were deformed at bumper height and near the lower panel bolts and also fractured near bumper height. The non-impacted outer tube and mast were deformed near the lower panel bolts. The sign panel disengaged from both masts and the panel bolts

System No. 8 encountered moderate damage. The right mast, outer tube, and leg remained attached, and the mast and outer tube encountered minor deformations. The left leg disengaged from the mast and was undamaged. The left mast and outer tube were deformed near the center of the outer tube. The sign panel disengaged from both masts and the panel bolts remained attached to the masts. The sign panel encountered moderate deformations on all edges. The sign panel also deformed at each of the four panel bolt holes and was slightly torn at the bottom right hole. All eight of the sandbags were torn open with the sand scattered along the path of the vehicle, starting at the initial position of the second sign support.

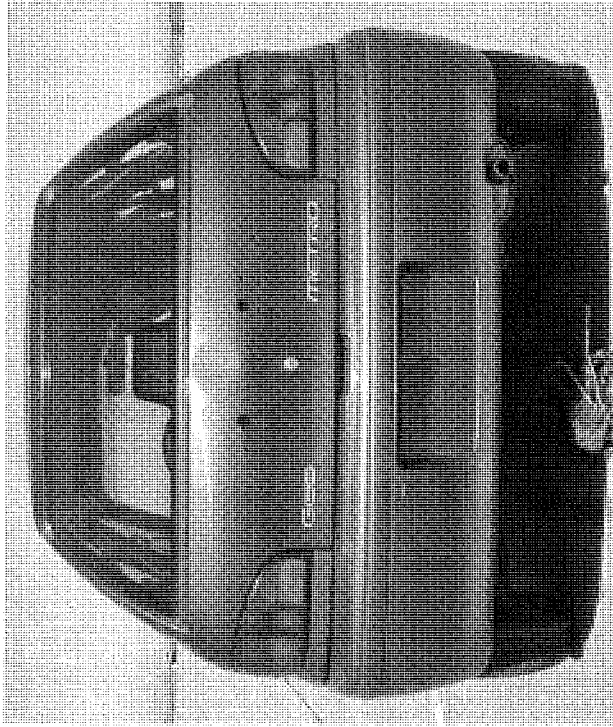
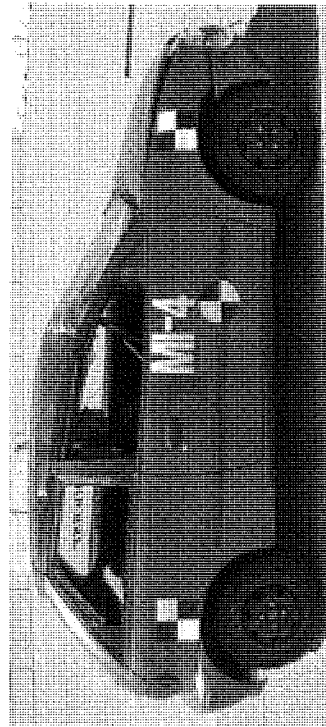
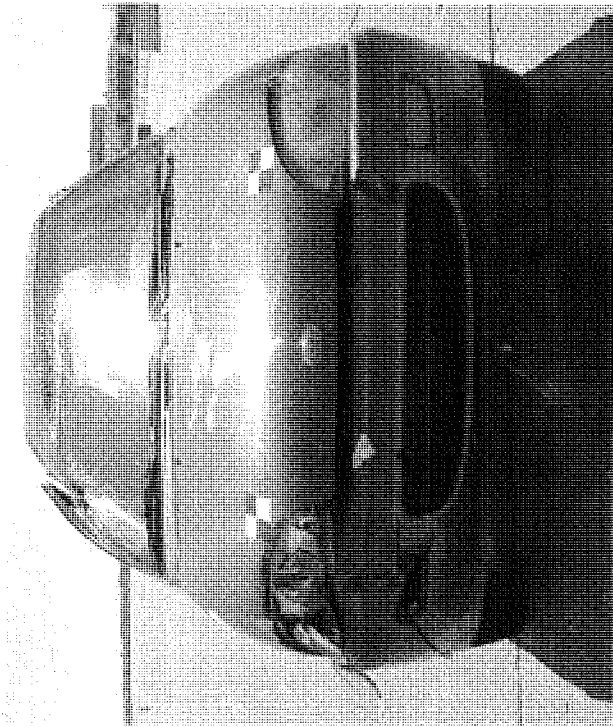
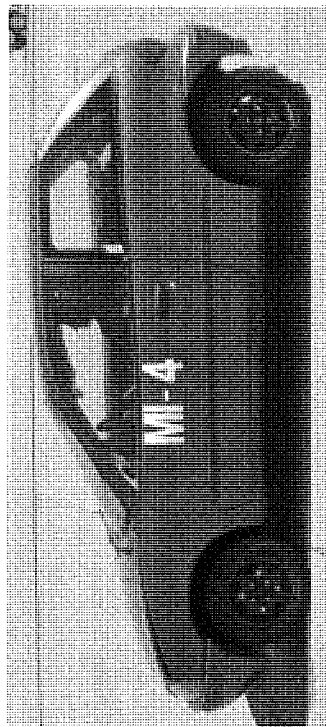
Figure 23. Vehicle Damage, Test MI-4

Exterior vehicle damage is shown in Figures 23 through 25. The front bumper and lower plastic shield encountered minor dents and contact marks. The hood encountered minor scuff and scrape marks. The right side of the roof encountered major indentation (maximum of 133 mm) and subsequent penetration. The right-side A-pillar was crushed extensively in toward the occupant compartment. The roof also sustained scuff and scrape marks. The right-side headlight and park light broke, while the left-side park light was cracked. The right-side door and right-rear windows were shattered. The windshield sustained major “spider web” cracking throughout, with both layers of the right-side and upper-middle regions of the windshield being cracked. Most of the structural

integrity of the windshield on the right side and upper middle was lost and the windshield indented inward toward the occupant compartment. A large hole (slice) through the windshield was located near the center region of the right side. No damage was found to have occurred to the left side, rear end, left-side headlight, nor parking lights.

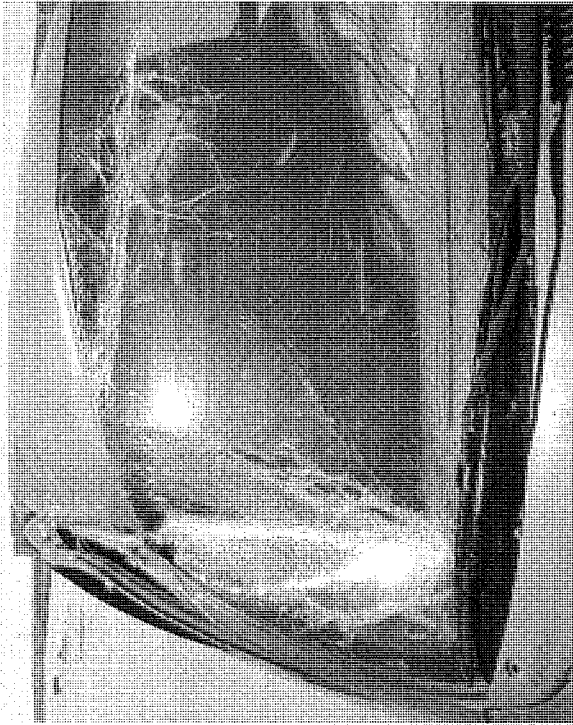
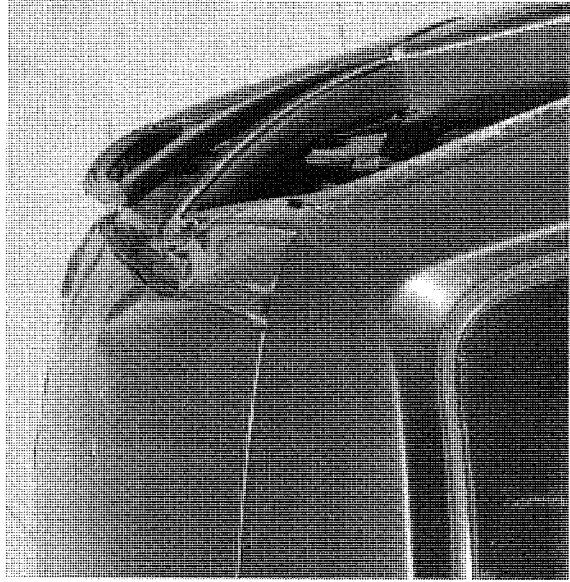
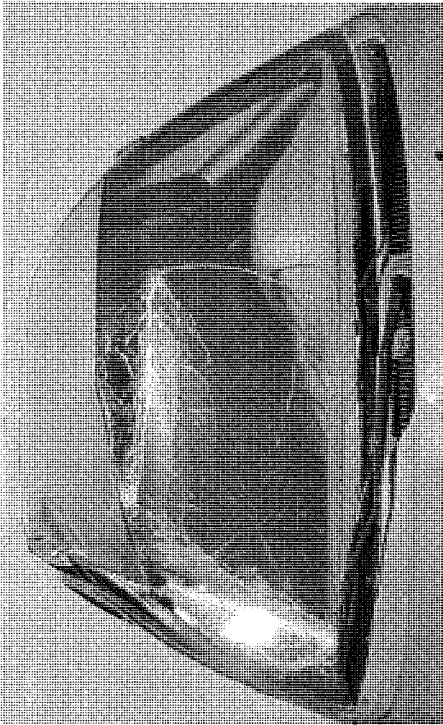
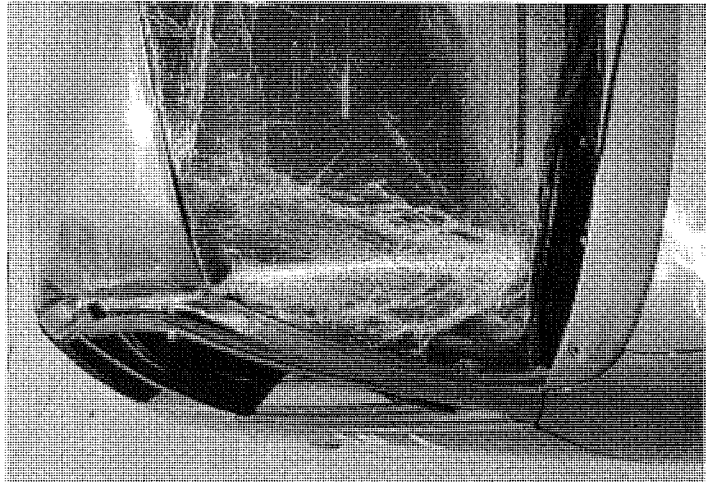
Figure 25. Windshield and Roof Damage, Test MI-4

During the 0-degree impact event, the vehicle struck the masts, causing the right mast to separate from the sign panel. Furthermore, the panel was supported in the air by the top of the left mast. Subsequently, the mast rotated about the front of the vehicle causing the panel to contact the roof and windshield. As a result of the panel contact, the vehicle's right-side door window was shattered and the windshield encountered major "spider web" cracking with a concentrated impact area.

The work-zone traffic control device performed unsatisfactorily according to the test evaluation criteria set forth in NCHRP Report No. 350 and is not recommended for field applications. This work-zone traffic control device includes:
