Appendix A: Portfolios for Each Bridge Site

Bridge S041-63174

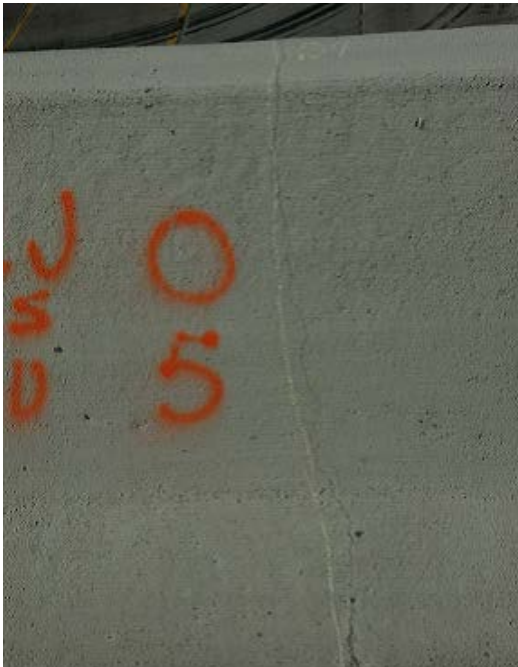
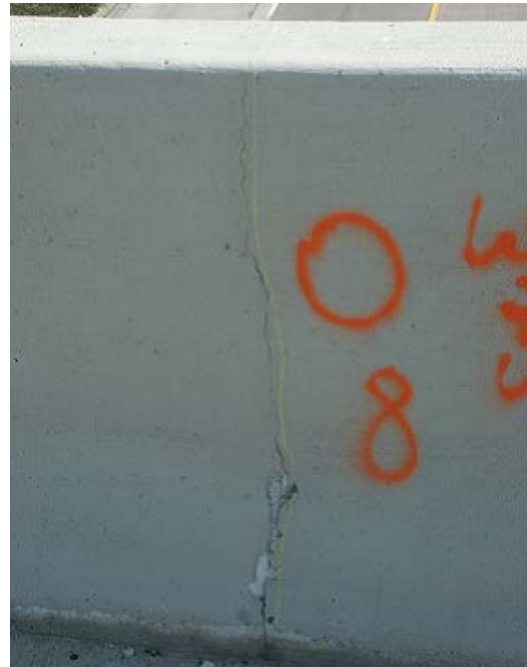
Figure A-1. Core specimen locations for S041-63174.

(a) Core A1- north bound, east exposure

(b) Core A2 –south bound, east exposure

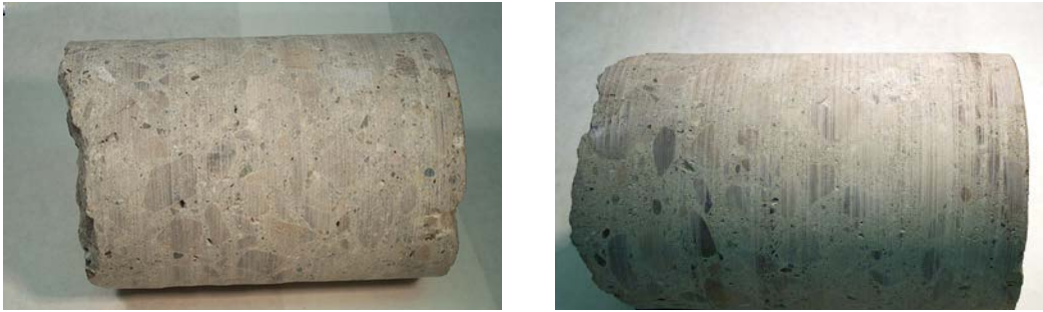
Upon arrival at MTU, the cores from the barriers of the northbound and southbound were identified as A1 and A2 respectively. Photos of the 4-in diameter cores are shown in figure A-2. No steel reinforcement was present in the cores, however there was an imprint of existing rebar at the bottom of core A2 (figure A-3) with no sign of rust. The coarse aggregates were characterized as crushed tan carbonate rocks with a maximum size of 0.75 in. However, a visual inspection of polished slabs cut from the cores (figure A-4) revealed that some larger aggregates (up to 1 in) were present in A2 and also that the gradation of the aggregates in A2 was not as uniform as in A1.

Figure A-2. Cores evaluated for S041-63174, core A1 (left) and A2 (right).

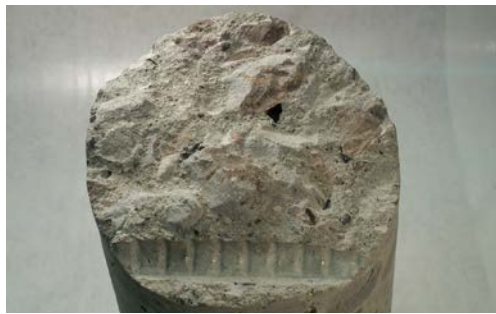
Figure A-3. Imprint of rebar in core A2.

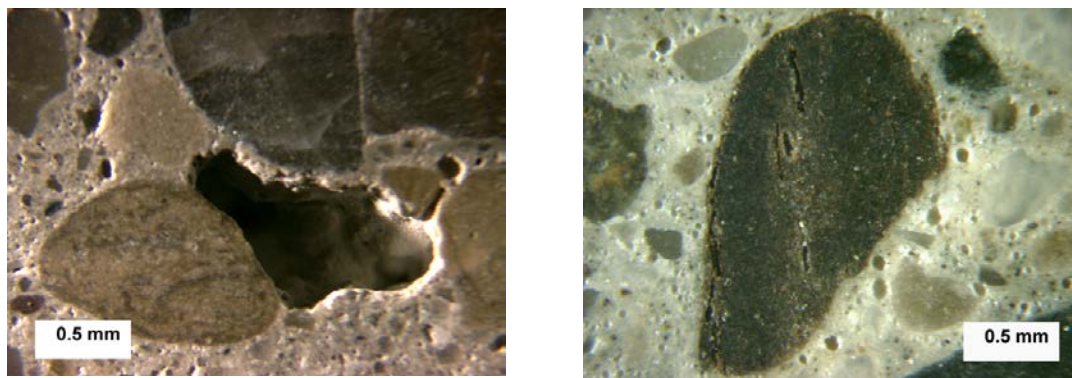
The stereo optical microscope was used to examine polished slabs (figure A-4) cut from each core to assess general conditions of the concrete. Darker rims were visible on several siliceous fine aggregates (figure A-7); however, it was concluded that these were simply the result of weathering since no cracks or reaction products of ASR were apparent. As can be seen from figure A-5, a network of very small well-distributed unfilled air voids were present in each core. Also, some small entrapped air voids and cracked porous siltstones were observed here and there in the paste (figure A-6).

Figure A-6. Stereo optical micrograph of entrapped air void (left) and cracked fine siltstone (right) in core A1.

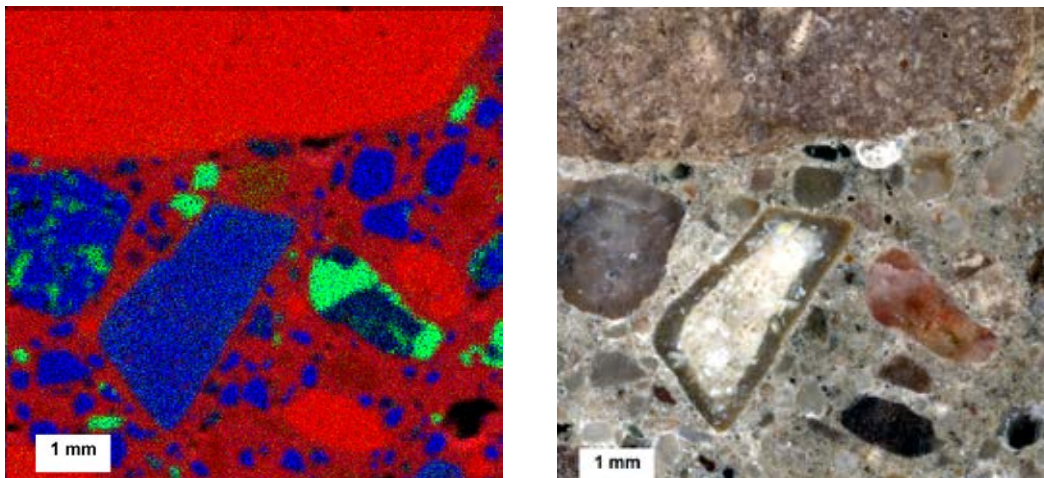
X-ray maps were recorded of the fine aggregates with darker rims. One of these maps is shown in figure A-7 together with a picture of the corresponding area on the slab. The map is presented as an RGB picture, where the red channel is used for the calcium, the green channel for the potassium and the blue channel for the silicon. The map shows that the fine aggregate is indeed a siliceous rock, but that the rim is simply due to weathering since neither micro-cracking, nor ASR reaction products (potassium), are present in the aggregate.

Figure A-7. X-ray map and picture of siliceous aggregate in core A1 (S041-63174). Red: Ca, green: K, blue: Si.

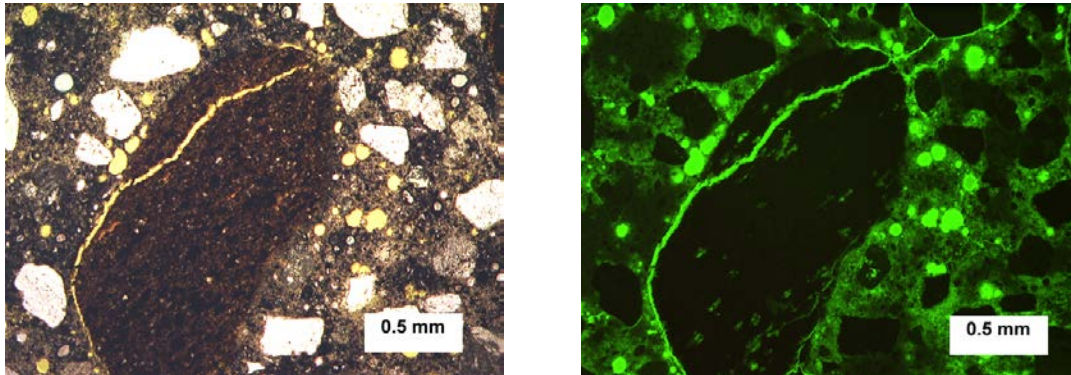
As can be seen from figure A-8, the analysis of a thin section made from concrete of S041-63174 indicates that the cracks present in the fine siltstones extend slightly through the paste. In some cases, the cracks were present only around the aggregate, as an aggregate-paste bond failure through the interfacial zone. Seen the high porosity of the siltstones, that feature might indicate the expulsion of water from the aggregate during freezing and thawing.

Figure A-8. Petrographic micrograph of typical cracked fine siltstone in concrete from S041-63174, plane polarized light and epifluorescent mode.

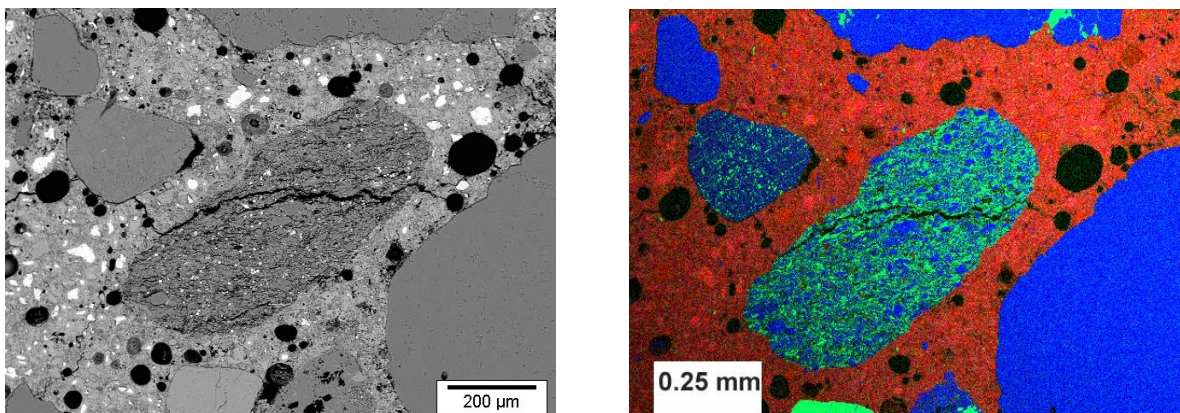
Figure A-9. SEM image (left) and x-ray map (right) of typical cracked siltstone in A1.
Red: Ca, green: K, blue: Si.

Figure A-9, which represents an SEM image and a corresponding x-ray map (with the same color convention as the previous x-ray map) of a cracked siltstone, shows that no alkali-silica gel is present in, or in the vicinity of the aggregate. The cracks are thus more likely due to freeze-thaw deterioration rather than to ASR. Figure A-10 is an SEM image of an aggregate-paste bond failure through the interfacial zone of a siltstone. Figures A-9 and A-10 also show the high porosity of the fine siltstones.

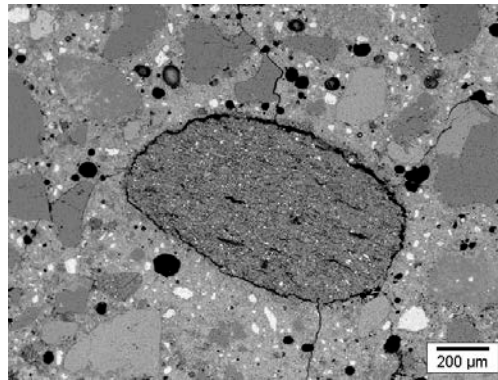
Figure A-10. SEM image of a typical siltstone in A1, aggregate-paste bond failure through the interfacial zone.

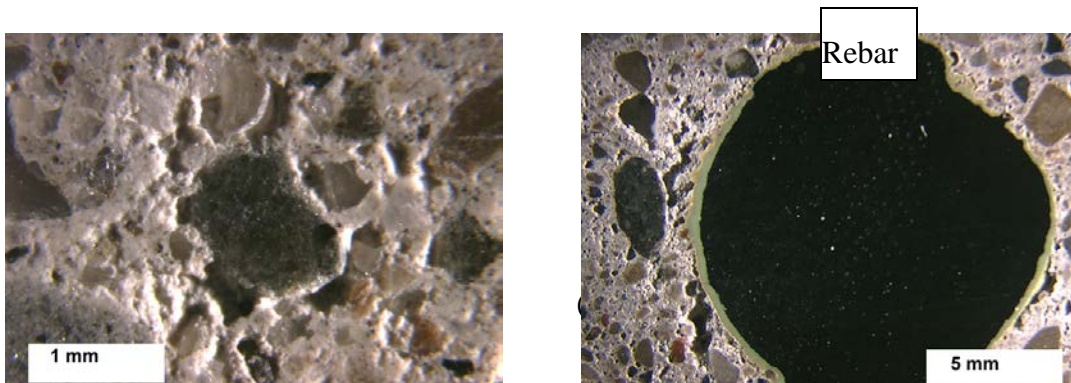
The stereo optical microscope was used to first examine polished slabs cut from each core to assess general conditions of the concrete (figure A-13). A photo of the air-void system of those slabs is shown in figure A-14. In general, the air voids are well distributed throughout the paste and only a few are filled; however, as can be seen from figure A-15, a significant amount of irregularly shaped voids are present around the aggregates and rebar.

Figure A-15. Stereo optical micrograph of irregularly shaped voids around fine aggregates and rebar (S15-63172).

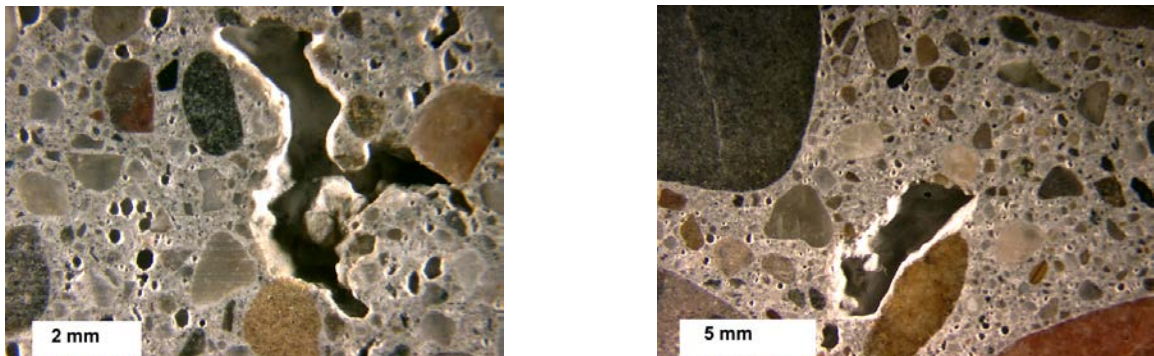
Entrapped air voids were present in slab C2 and in lesser extent in C1 (figure A-19). In both samples, the entrained air-voids were unevenly distributed, but only few were filled. Figure A-20 shows photos of locations where little air voids are present.

Figure A-19. Stereo optical micrograph of entrapped air in core C2.

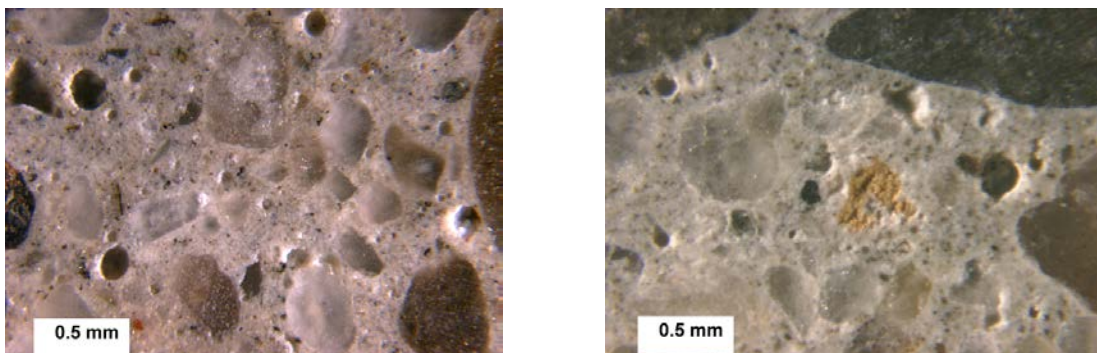
Figure A-20. Stereo optical micrograph of air void structures in C1 (right) and C2 (left).

Sample C1 has an adequate spacing factor ($< 0.2\text{mm}$), specific surface ($> 25\text{mm}^{-1}$) and air (> 6 percent) content, but the spacing factor for sample C2 was a little too high, and the specific surface and air content too low. Consequently, the air-void system of C2 might not be efficient in protecting the concrete against freeze-thaw deterioration.

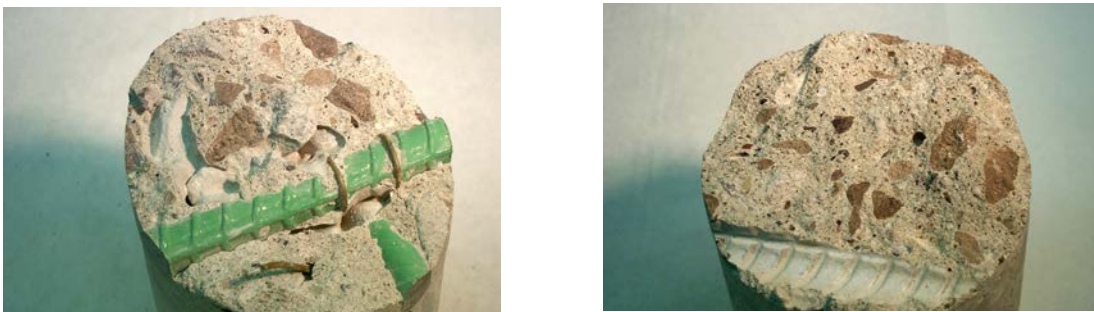
The cores received from WSU were logged into MTU as D1 and D2. Photos of the obtained cores are shown in figure D-22. The coarse aggregates were characterized as crushed tan carbonate rocks with a maximum size of 0.75 mm. Steel reinforcement was present at the bottom of core D1 (11 cm from the surface), and an imprint of rebar was present at the bottom of D2 (12cm from the surface). No rust was observed; however, large gaps were present under and around the rebar in D1 (figure A-23). The imprint in D2 seems to indicate that the consolidation around the rebar was better at that location (figure A-23).

Figure A-23. Steel reinforcement in cores D1 (left) and D2 (right). Poor consolidation around the rebar in D1.

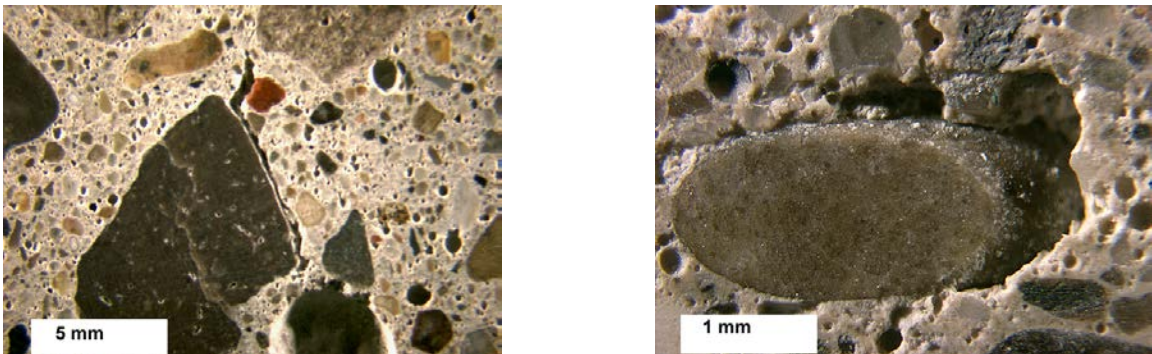
The stereo optical microscope was used to examine polished slabs cut from each core in order to assess the general condition of the concrete. The polished slabs are presented in figure A-24. The inspection revealed poor consolidation around some of the aggregates in D1 (figure A-25); however, the air-void system seemed to be adequate. A lot of entrained air-voids are well distributed in both samples (figure A-26).

Figure A-25. Stereo optical micrograph of entrapped air around coarse and fine aggregates in D1.

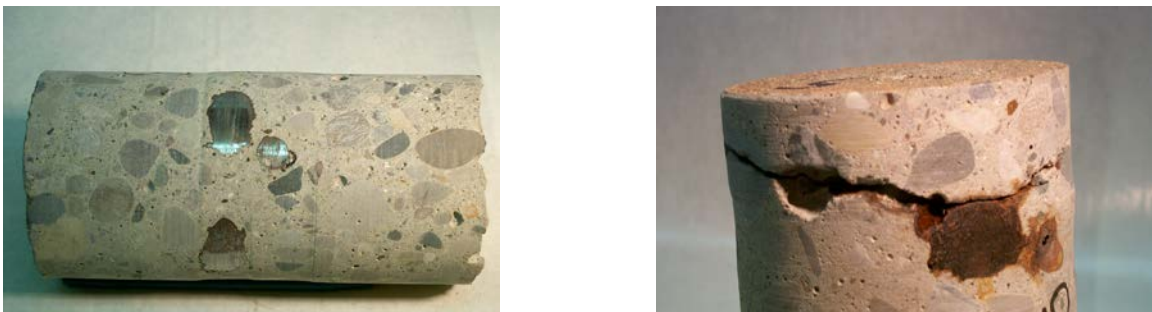
The cores were logged into MTU as E1 and E2 respectively. Photos of the obtained cores are shown in figure A-28. Note that the top of core E2 broke off right above the rebar (1.25 in from the surface) as a result of the corrosion and subsequent expansion of the corrosion product on the surface of the reinforcing steel. Rust was noted on rebar in both samples independently of the depth of embedment (up to 3 in from the surface for E1). Moreover, the paste did not adhere very well to the rebar. The coarse aggregates were characterized as natural gravel with a maximum size of 0.75 in.

Figure A-28. Cores evaluated for S02-23152, E1 (left) and top of E2 (right).

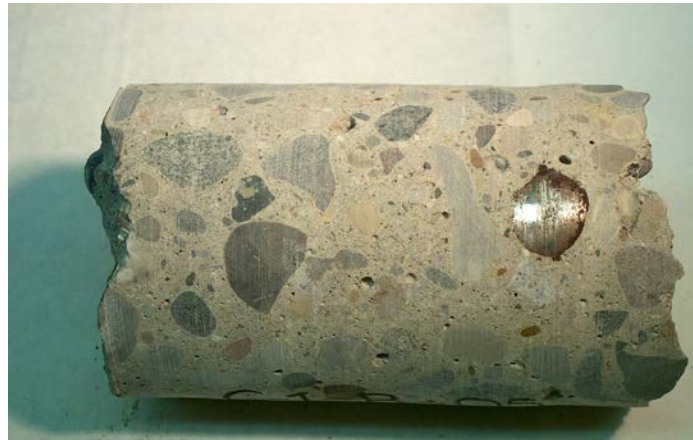
Figure A-29. Core E2 (bottom part), corrosion of reinforcing steel.

The bridge barriers on the north and south bound of I96 over M43 (bridge S02-23152) were constructed in 1980. The major cause of distress observed in those barriers is the corrosion and subsequent expansion of the reinforcing steel leading to delamination of the outer layer of concrete. Also, the recorded depth of carbonation was higher than normal. This indicates that the outer layer of concrete is more permeable to aggressive

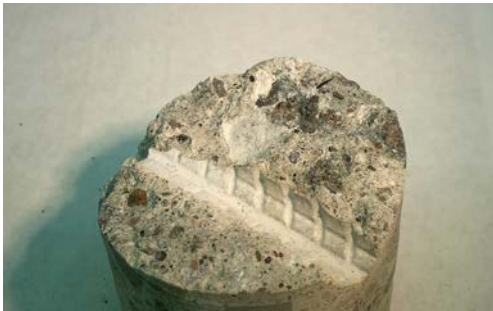
Figure A-34. Imprint of rebar in core F2.

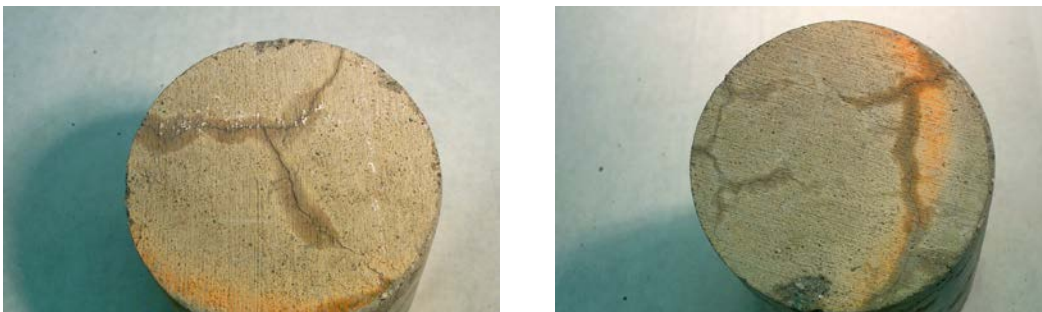
Figure A-35. Map cracking at the top surface of cores F1 (left) and F2 (right).

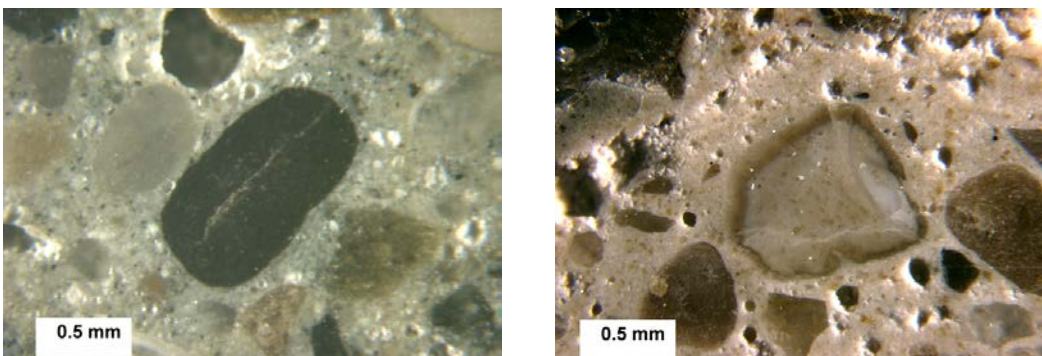
The stereo optical microscope was used to examine polished slabs cut from each core to assess general conditions of the concrete. As can be seen from the polished slabs in figure A-36, some entrapped air voids were present around one of the rebars in F2. Similar but smaller entrapped air-voids were also present here and there in the paste. The most striking feature of the concrete was the abundance of relatively porous cracked siltstones and fine chert aggregates with reaction rims and cracks extending through the paste, a typical sign of alkali-silica reactivity (ASR), (figure A-37).

Figure A-37. Stereo optical micrographs of reacted fine chert and siltstone in F2.

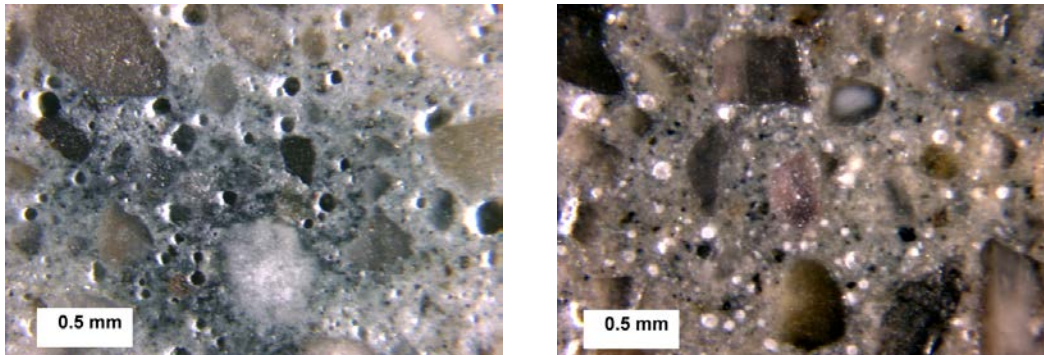
A lot of well-distributed entrained air voids were present in the concrete; however, at some locations those were extensively filled with secondary deposits. Figure A-38 shows stereo optical micrographs of parts of the air-void system of slab F2 with and without serious infilling; the same phenomenon was observed in slab F1.

(a) No infilling

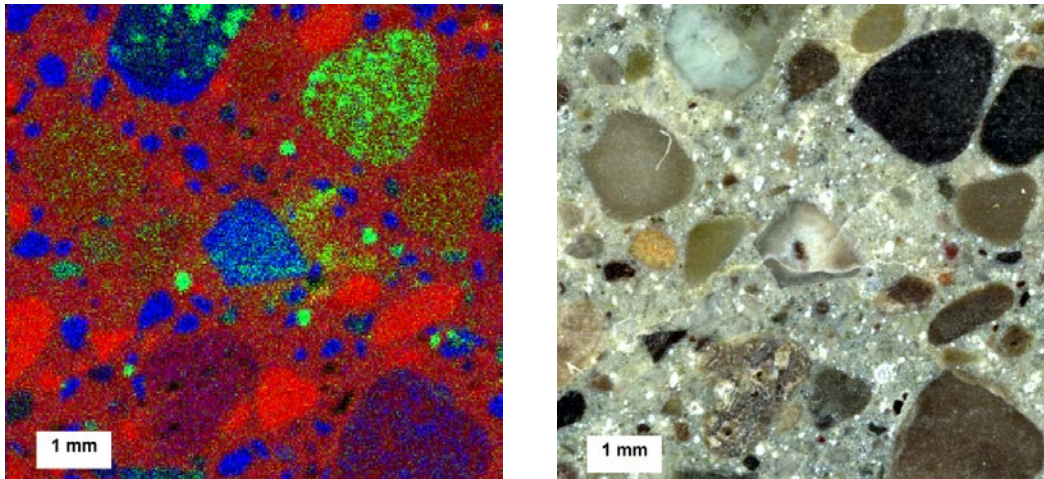
Some x-ray maps of aggregates showing signs of ASR were recorded with the x-ray analytical microscope. One of these maps is shown in figure A-39 together with a picture of the corresponding area on the slab. The map is presented as an RGB picture, where the red channel is used for the calcium, the green channel for the potassium and the blue channel for the silicon. Note the presence of potassium (alkali-silica gel) in the cracks. The maps confirm the reactivity of the fine chert aggregates but not of the cracked black siltstones (absent in figure A-39), because in that case the potassium is evenly distributed over the entire surface of the aggregate, so it is difficult to see from those maps if the potassium is there only as a natural constituent of the aggregate or also as a result of ASR.

Figure A-39. X-ray map (left) and picture (right) of alkali silica reacted chert in F1. Red: Ca, green: K, blue: Si.

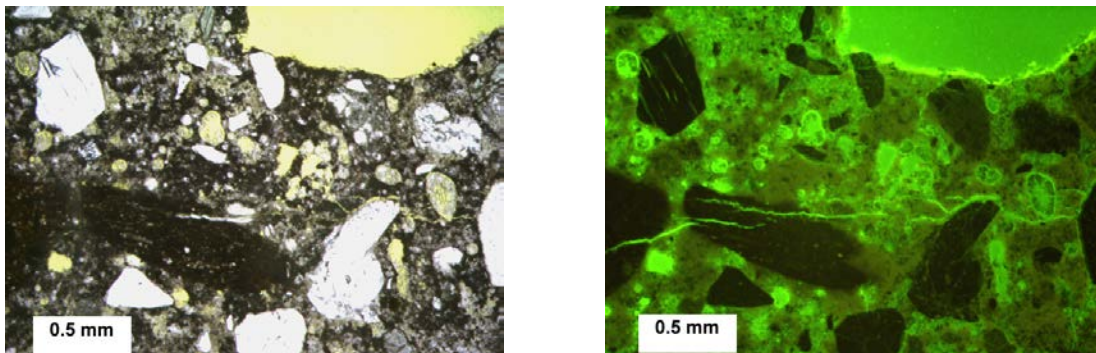
Thin sections viewed under the petrographic microscope confirmed the reactivity of the fine cherts, but also showed that the cracks initiating in the fine siltstones extend through the paste (figure A-40) and that in some cases those cracks are filled with some deposits, possibly alkali-silica gel. In addition, the deposits in the air-voids were recognized as needle-like ettringite crystals.

Petrographic micrograph of reactive fine siltstone and ettringite filled air voids in F1, plane polarized light (left) and epifluorescent mode (right).

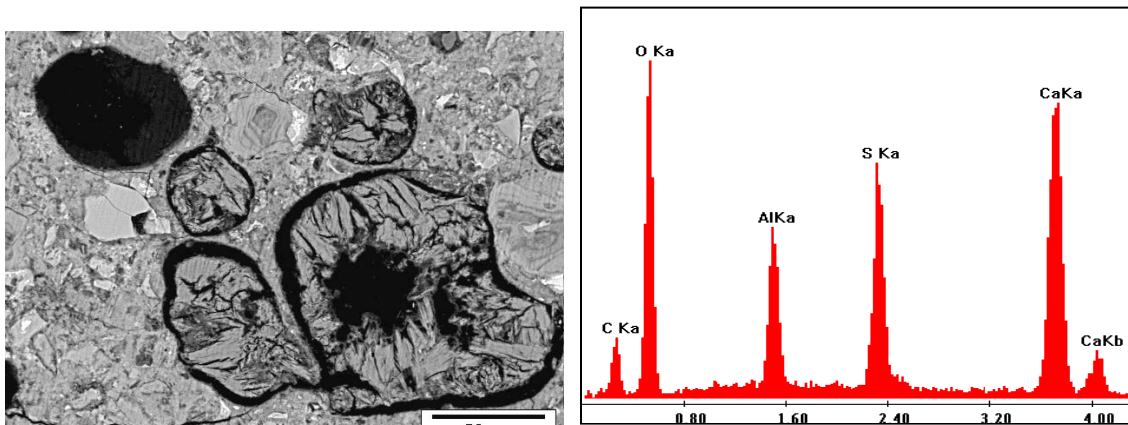
The SEM was used to make qualitative measurements of the composition of the infilling present in the air-voids and in the cracked siltstones and cherts. The results confirm the presence of ettringite (calcium sulfoaluminate gel) in the air voids, and the presence of

Figure A-40. SEM micrograph and x-ray spectrum (keV) for ettringite infilling air-voids in F1.

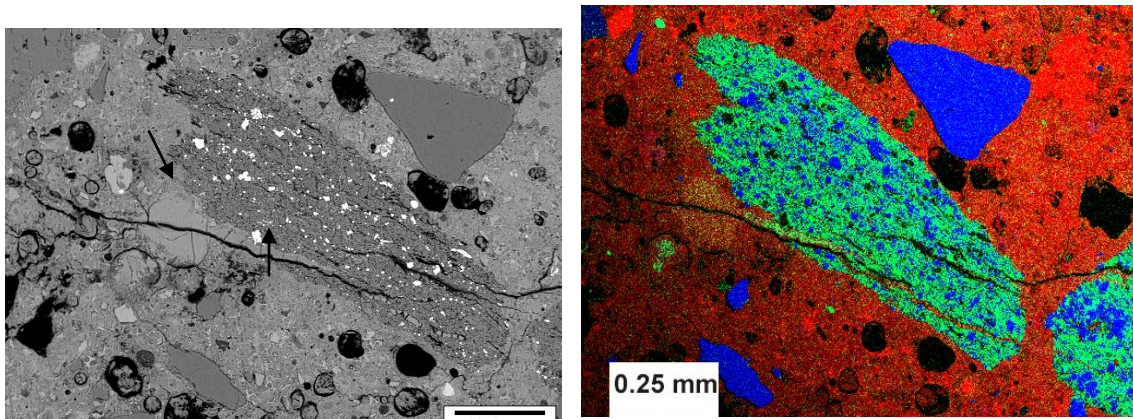
alkali-silica gel in the reacted aggregates and adjacent air voids. Figure A-41 shows a typical SEM micrograph (backscattered electron mode) and x-ray analysis of ettringite infilling air voids, note the needle-like crystals and how the biggest air-void is only partially filled. Figure A-42 shows an x-ray map (represented as an RGB picture with the same color convention as before) and SEM micrograph of an alkali-silica reactive siltstone. Alkali-silica gel (potassium-green) is present in the crack, but also in an air void adjacent to the aggregate (the locations are indicated on the SEM micrograph with black arrows). The concentration of potassium in alkali-silica gel is commonly lower further from the aggregate, which explains the lighter green color in the void.

Figure A-41. SEM micrograph (left) and x-ray map of alkali-silica gel filling air void and crack.

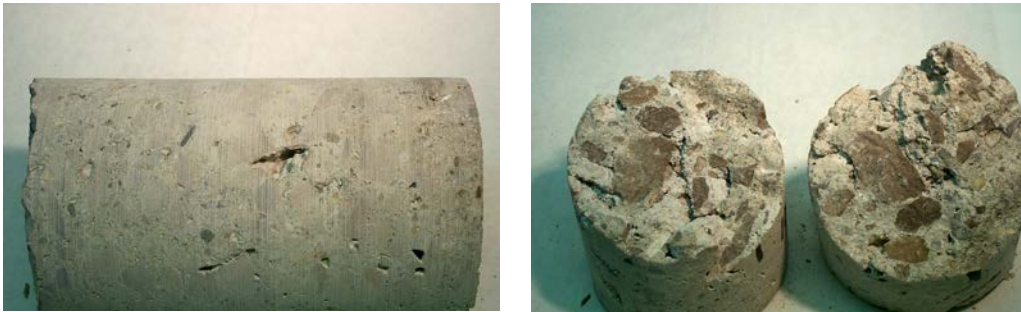
Photos of the obtained cores are shown in figure A-44. As can be seen, the concrete is not well consolidated; the honeycombing in core G2 was even so important that it broke diametrically in two pieces. The coarse aggregates consisted of tan carbonate rocks with a maximum size of 0.75 in. No steel reinforcement was present in the cores.

Figure A-44. Cores evaluated for S01-44044, G1 (left) and G2 (right).

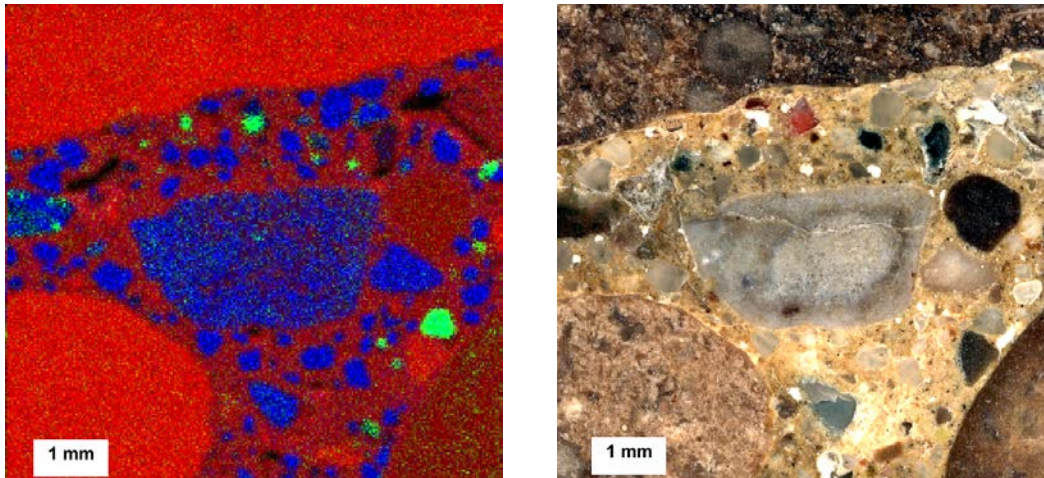
An x-ray analytical microscope was used to record X-ray maps of the fine aggregates showing darker rims. One of these maps is shown in figure A-47 together with a picture of the corresponding area on the slab. The map is presented as an RGB picture, where the red channel is used for the calcium, the green channel for the potassium and the blue channel for the silicon. As can be seen, no potassium is present in the siliceous fine aggregate and the crack does not extend through the paste; therefore, the reaction rim and the crack are probably simply due to weathering and not to ASR.

Figure A-47. X-ray map and picture of fine aggregate in G2. Red: Ca, green: K, blue: Si.

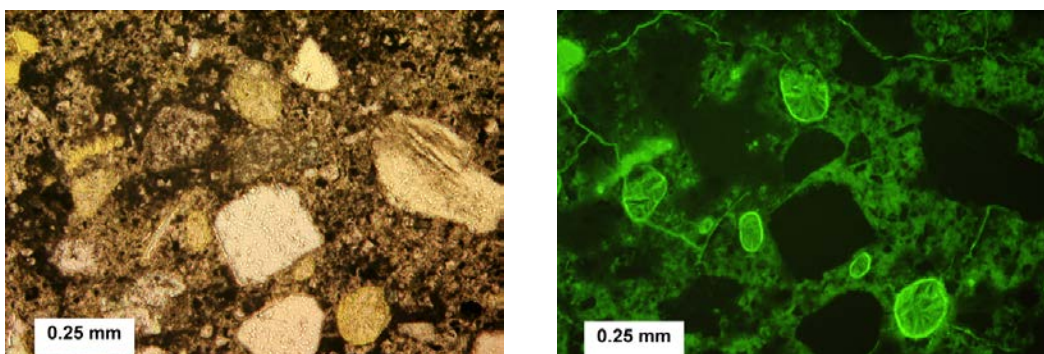
Figure A-48. Petrographic micrographs of ettringite infilling entrained air voids in G2, plane polarized light (left) and epifluorescent mode (right).

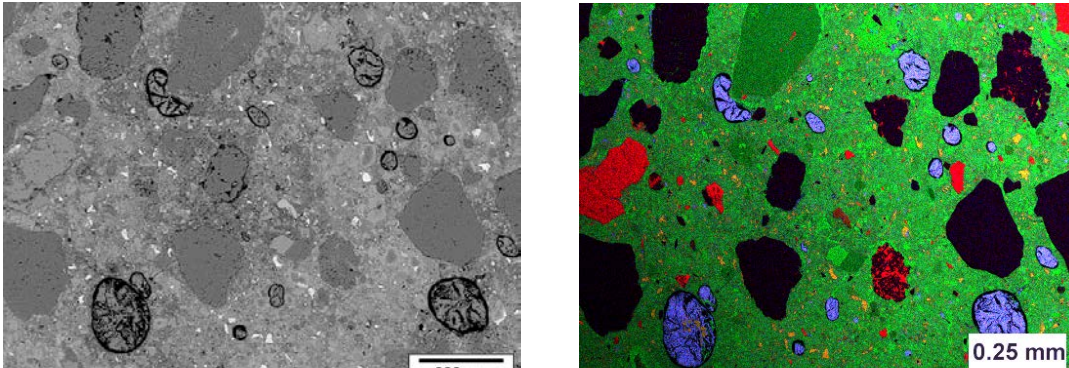
Figure A-49. SEM image and x-ray map of ettringite filled voids in G2.

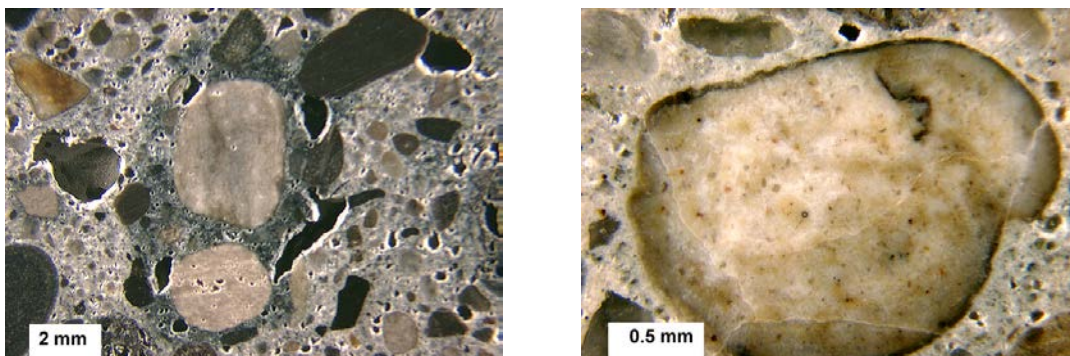
Figure A-54. Stereo optical micrograph of entrapped air and cracked aggregate in H2 (left) and H1 (right).

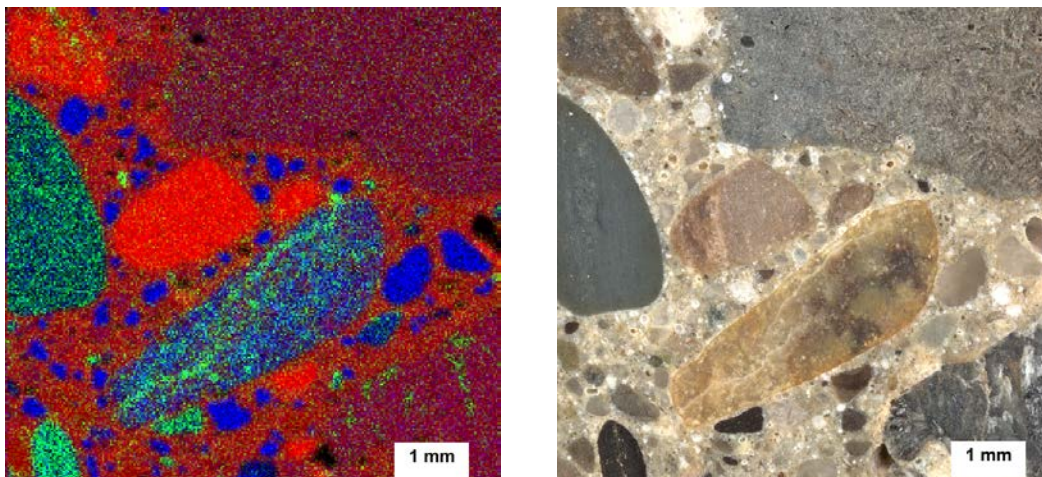
X-ray maps were recorded of the fine siliceous aggregates showing darker rims and of the cracked siltstones. One of these maps is shown in figure A-55 together with a picture of the corresponding area on the slab. The map is presented as an RGB picture, where the red channel is used for the calcium, the green channel for the potassium and the blue channel for the silicon. The maps confirm that the fine siliceous aggregates are undergoing ASR; indeed they show the presence of alkali-silica gel (potassium) in the cracks. On the other hand, potassium is present everywhere in the black siltstones (in the bottom left corner of figure A-55), so it not obvious from those maps if the potassium is there as a result of ASR or naturally occurring in that type of aggregate.

Figure A-55. X-ray map (left) and picture of reacted aggregate (right) in H1. Red: Ca, green: K, blue: Si.

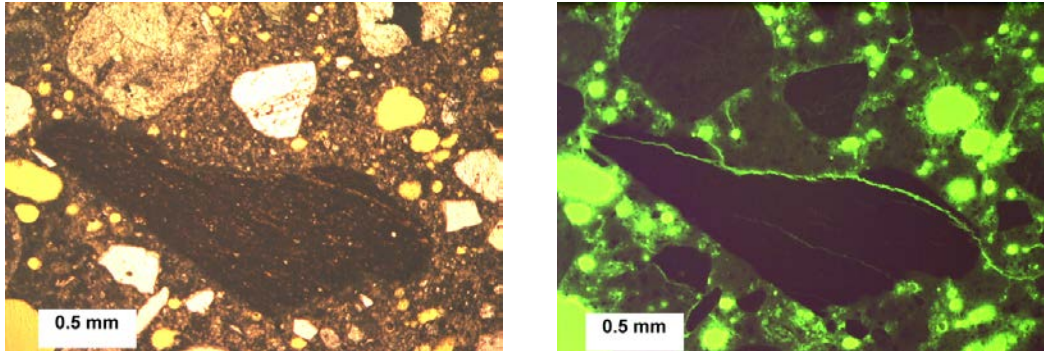
The petrographic microscope confirmed the alkali-silica reactivity of the cherts, but also showed that the cracks present in the siltstones were extending through the paste. Although alkali-silica gel was not extensively observed in the siltstones, the crack pattern and the fact that the same stones were found reactive in other samples indicate that they are probably also alkali-silica reactive. Seen the high porosity of the siltstones, freeze-

thaw damage might also play a role in the deterioration. Figure A-56 shows petrographic micrographs of a reacted siltstone with cracks extending through the paste, and figure A-57 shows a reactive chert.

Figure A-56. Petrographic micrograph of reactive siltstone in H1, transmitted plane polarized light (left) and epifluorescent mode (right).

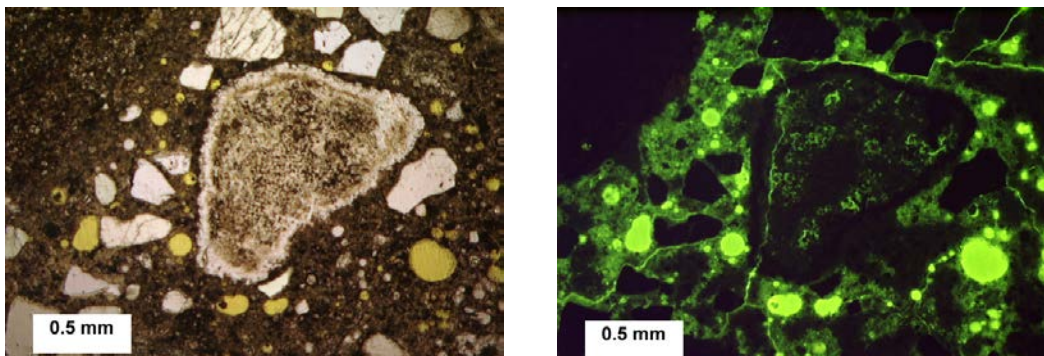
Figure A-57. Petrographic micrograph of reactive siltstone in H1, plane polarized light (left) and epifluorescent mode (right).

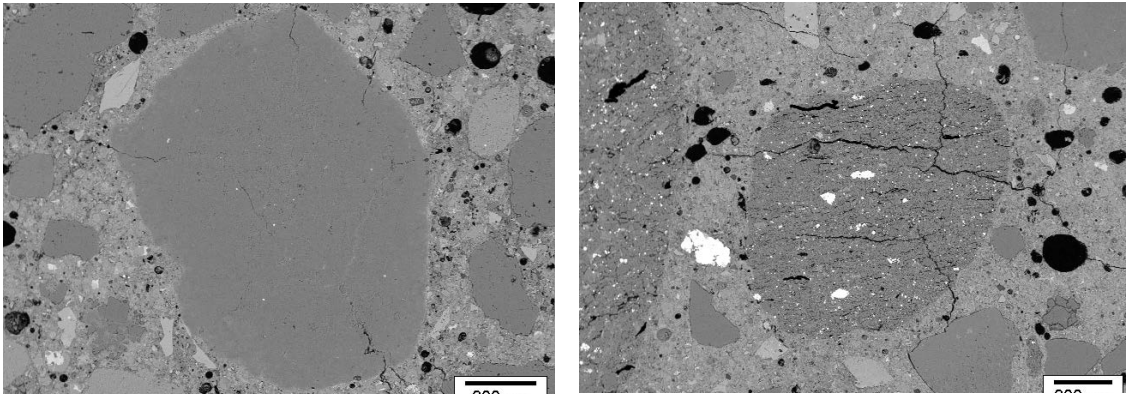
Figure A-58. SEM image of reacted chert (left) and siltstone (right) in H1.
