MICHIGAN
STATE HIGHWAY DEPARTMENT

Subject: Polymer Plastic Marker Posts (Handley Industries, Inc.).
Research Project R-63 NM-87. Research Report R-445.

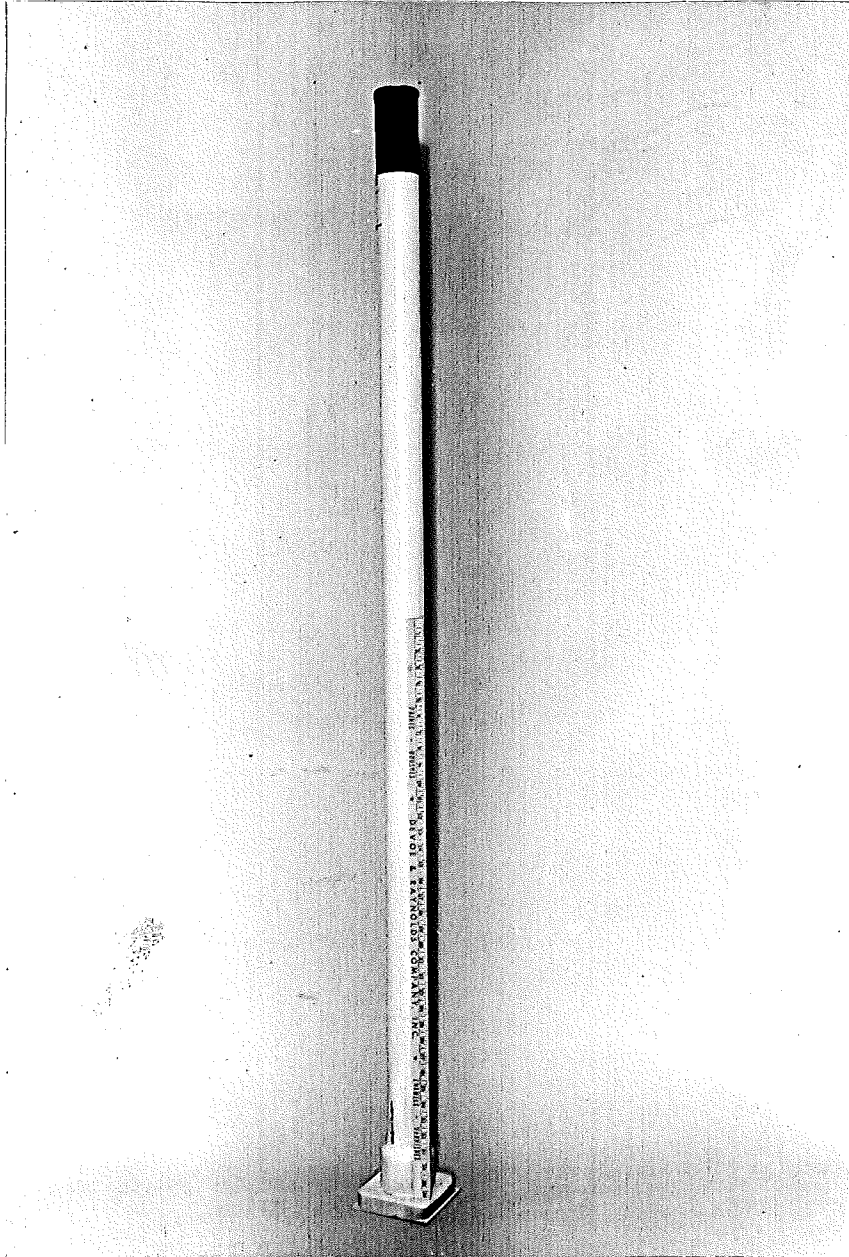
3. Materials: The black plastic used in molding of the post was painted white, with a cap overcoated with black, as shown in Fig. 1.
 - a. After 300 hr of weatherometer exposure and 100 hr in the humidity cabinet, the paints showed considerable loss of gloss and chalking, which was significantly greater than that of license plate finishes run at the same time.

- b. For outdoor exposure, the white paint thickness of about 1 mil is considered inadequate for the chalking and eroding type of paint used on this post as evidenced in the laboratory tests by the appearance of thin spots in the coating.

5. Low-Temperature Brittleness: at -15 F, the material had good resistance to fracture, as tested by a hammer blow.
6. Rot Resistance: ABS plastics are used in sewer pipes because of their good resistance to rot and microorganism attack.
7. Other Remarks: the thin plastic cap closure was bonded to the post by solvent softening and was found to be inadequate for outdoor exposure.

Figure 1. Appearance of polymer plastic post received for evaluation.

Considering the problem the Department has had with repainting of treated cedar posts, because of bleeding and paint peeling, we feel that these plastic posts merit consideration for field trial. Should these posts be recommended for such trial, on the basis of these test results we recommend that the posts be coated with paints of better chalk resistance having a thickness of about 2 mils, and that the cap closure be improved. For field trial, the Committee also may wish to choose dimensions more nearly approximating the cedar post which they would replace.
