MICHIGAN
STATE HIGHWAY DEPARTMENT
Charles M. Ziegler
State Highway Commissioner

EXPERIMENTAL INSTALLATION OF HYDRON FORM LINING
ON BRIDGE WEST OF OVID - B2 of 19-12-4, C2

Research Laboratory
Testing and Research Division
Report No. 148
March 27, 1950

EXPERIMENTAL INSTALLATION OF HYDRON FORM LINING
ON BRIDGE WEST OF OVID

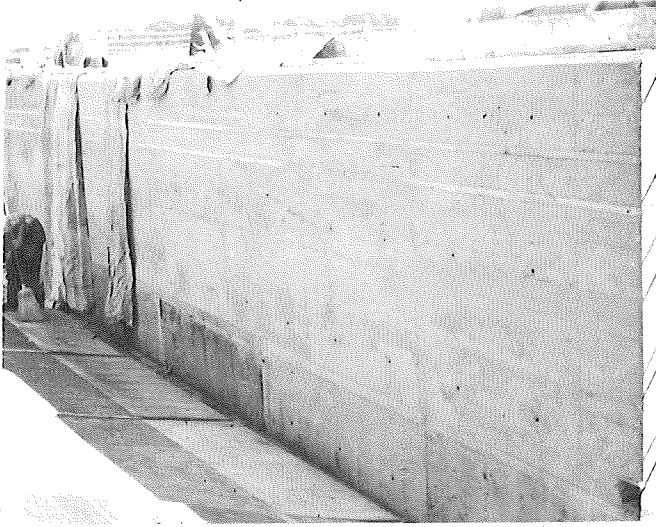
FIGURE 5. SECOND POUR, EAST ABUTMENT.
MIX ADJUSTED TO NEW WEIGHT OF COARSE AGGREGATE.
SURFACE BETTER, BUT STILL UNSATISFACTORY.

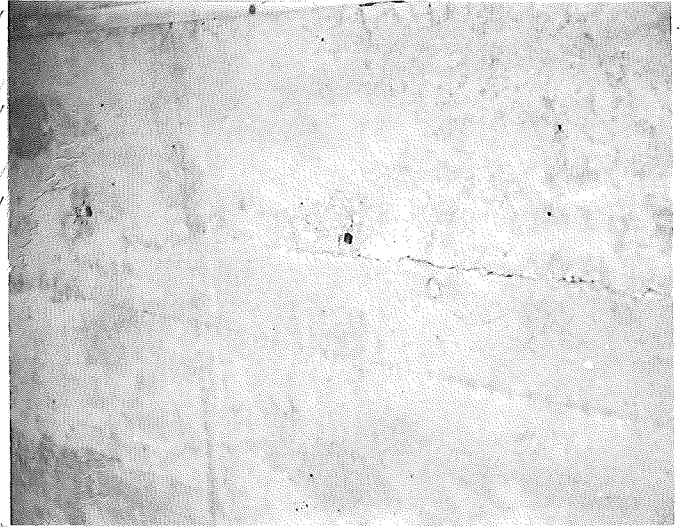
FIGURE 6. CLOSEUP OF WALL IN FOREGROUND
OF FIGURE 5 SHOWING HORIZONTAL POUR LINE.

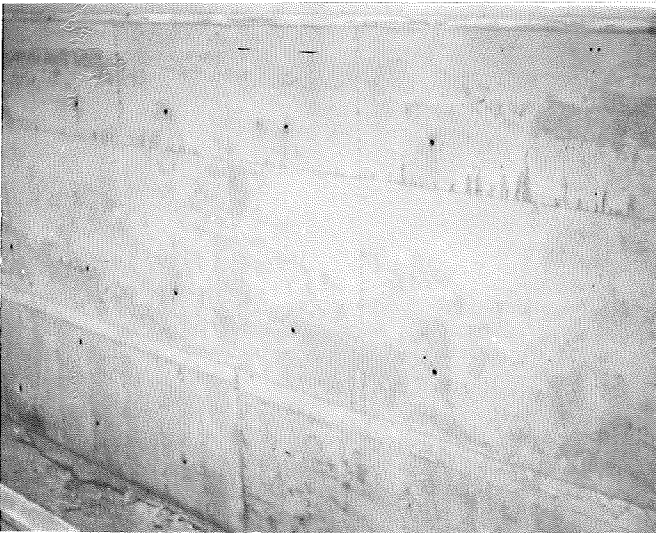
FIGURE 7. SURFACE OF THIRD POUR, BOTTOM 4 FT.,
DRY CONSISTENCY, SLUMP 3-1/2 IN., TOP,
MEDIUM CONSISTENCY WITH SLUMP OF ABOUT 6 TO 7 IN.
SAND STREAKING AT FORM TIES AND LINER JOINTS.

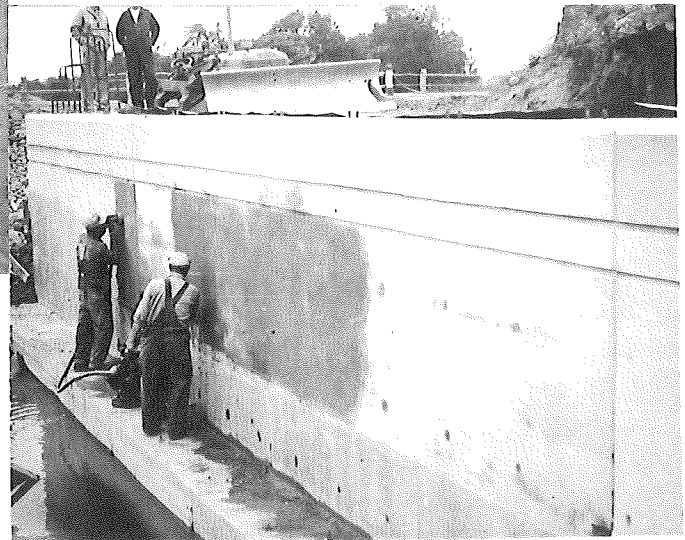
FIGURE 8. RUBBING EAST ABUTMENT.

Rubbing of the Hydron-formed surfaces cannot be eliminated entirely because of the necessity of pointing up tie rod holes and removing joint and staple marks left by the liner. There are also a certain amount of surface voids that must be filled and rubbed to meet present Department standards. This bridge had to be rubbed in the usual way as shown in Figure 8, although the work was made easier by the use of the liner.
