EXPERIMENTAL INSTALLATION OF STYROFOAM AND CORRUGATED PAPER
BOARD TO FORM A CONTRACTION JOINT GROOVE

Construction Project 38-7, C5

Highway Research Project 51 F-21(1)
Sawed Joints on Concrete Pavement

Research Laboratory
Testing and Research Division
Report No. 238
September 19, 1955

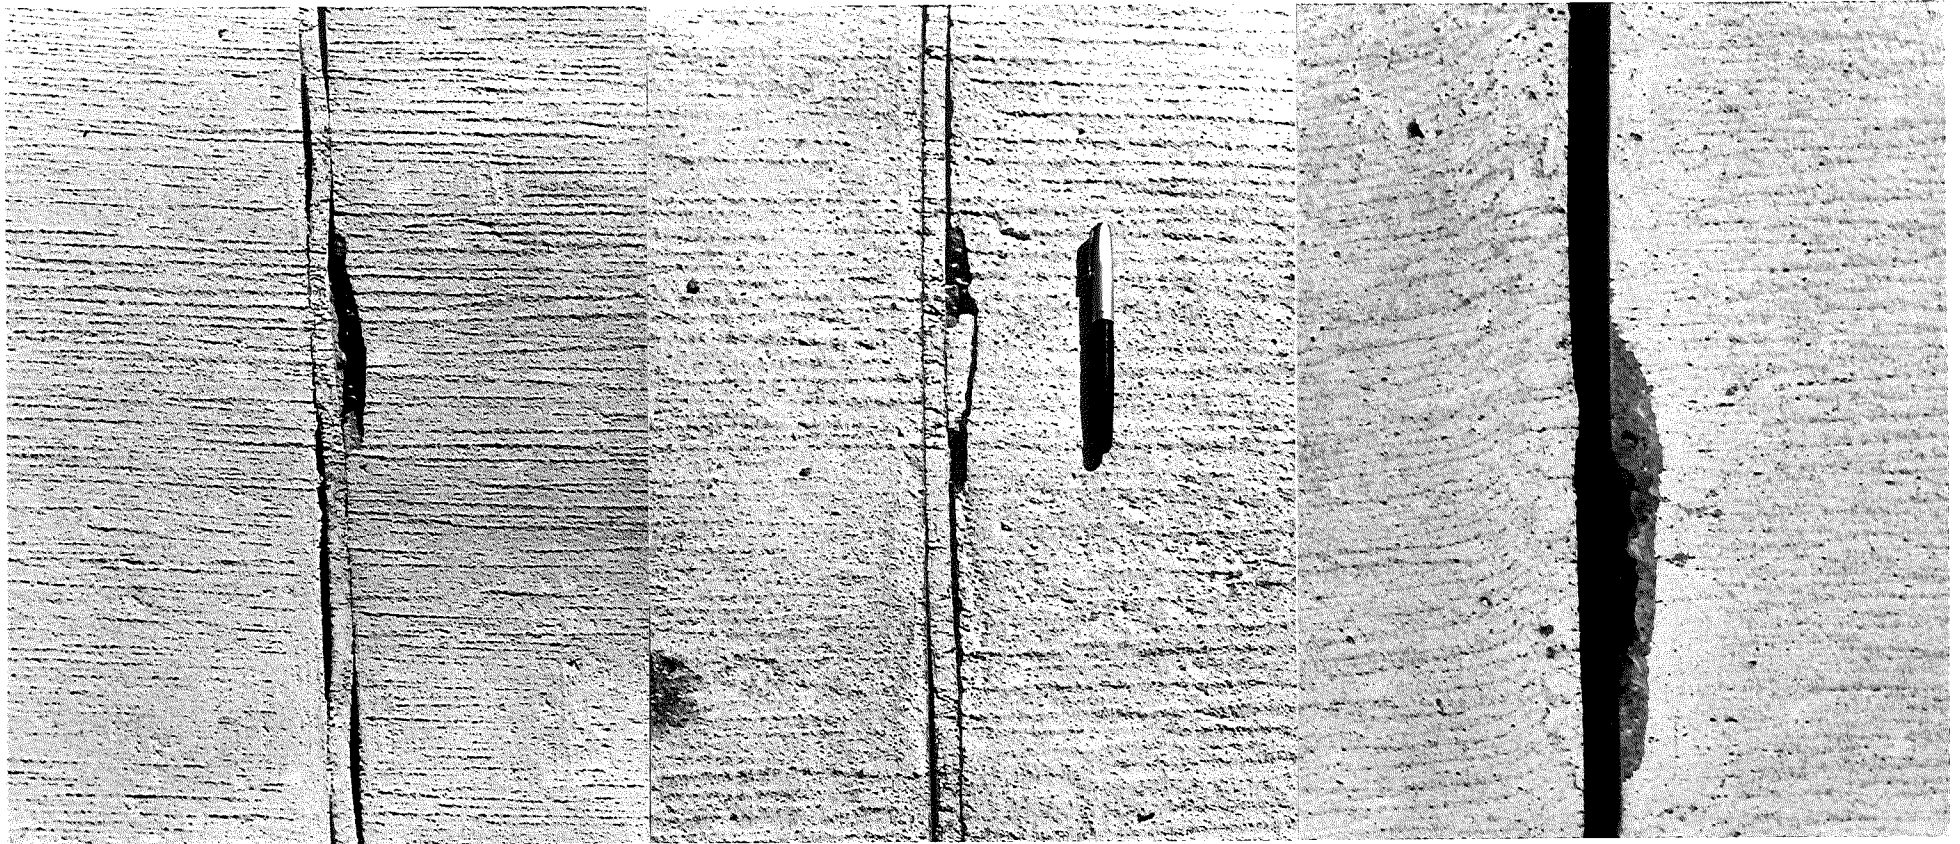
FIGURE II. TYPICAL SPALLS IN STYROFOAM AND PAPER JOINTS

spall averaging about six inches in length and one inch in width. Typical spalls are shown in Figure 11 and a joint with no spalls in Figure 12. The condition of each joint is listed in Table 1 (page 7). It can be seen that spalling was more frequent in the paper joints than in the Styrofoam joints.

(A) STATION 547+45 STYROFOAM.

(B) STATION 551+40 STYROFOAM.

(C) STATION 555+07 PAPER.
THIS SPALL GOES TO BOTTOM
OF JOINT GROOVE

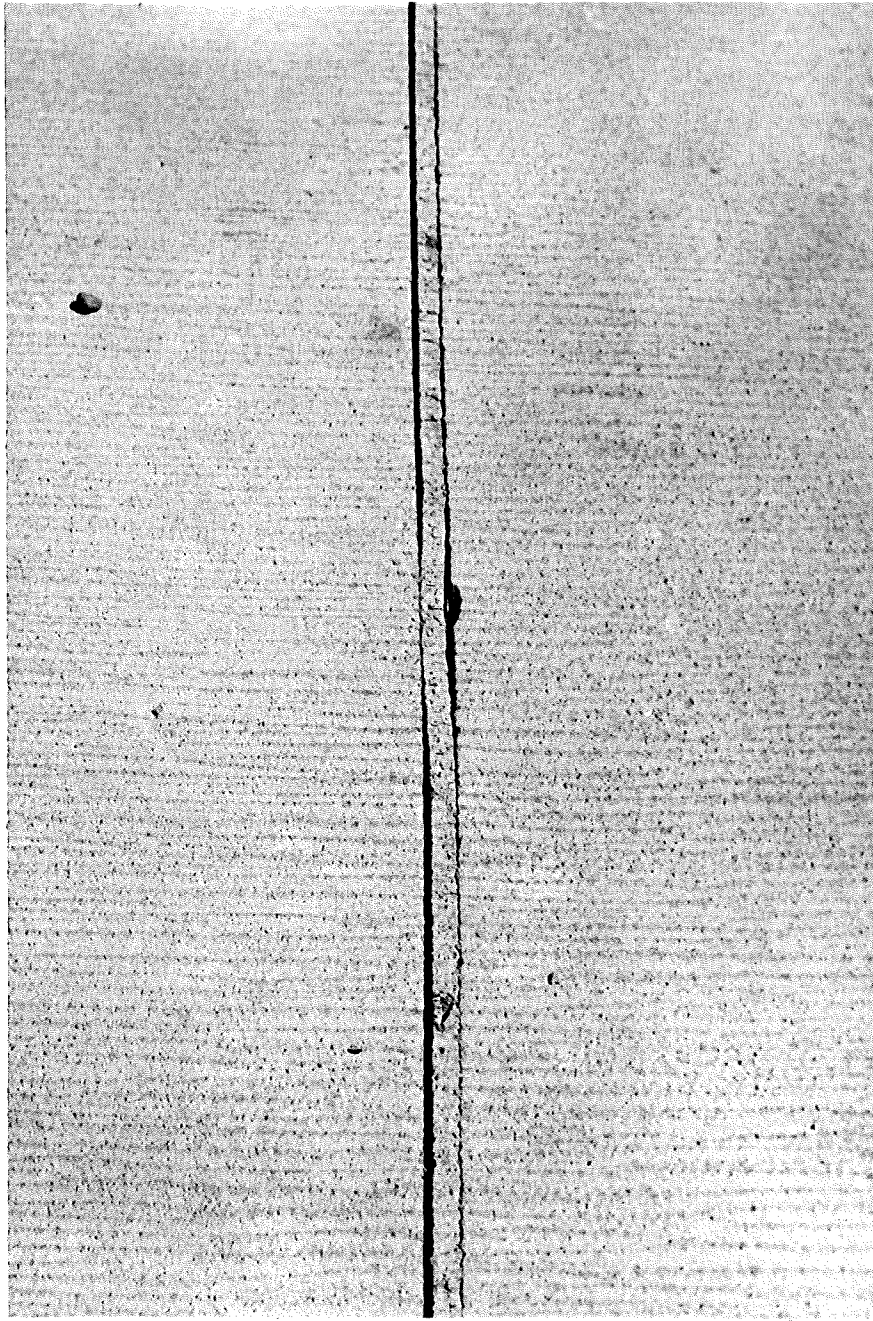
▲ FIGURE 12. STATION 556 + 07 - TYPICAL STYROFOAM
JOINT CONTAINING NO SPALLS.

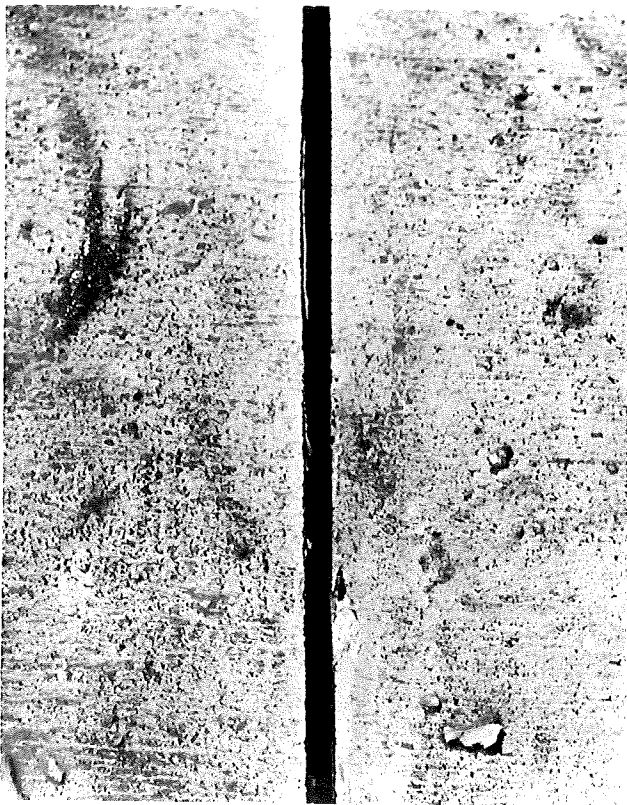
(A) STATION 547+45 STYROFOAM

Attempts to remove both Styrofoam and paper by means of a mechanical saw equipped with carborundum blades were not successful. The saw not only left a considerable amount of material in each joint, Figure 13, but was very difficult to guide in the joint groove without binding. From 5 to 15 minutes was consumed in sawing each joint and then the remaining material had to be removed with hand tools. The saw did leave clean joint faces to which joint seal should readily adhere.

FIGURE 13. STYROFOAM AND PAPER REMAINING IN JOINTS AFTER ROUTING WITH CARBORUNDUM.

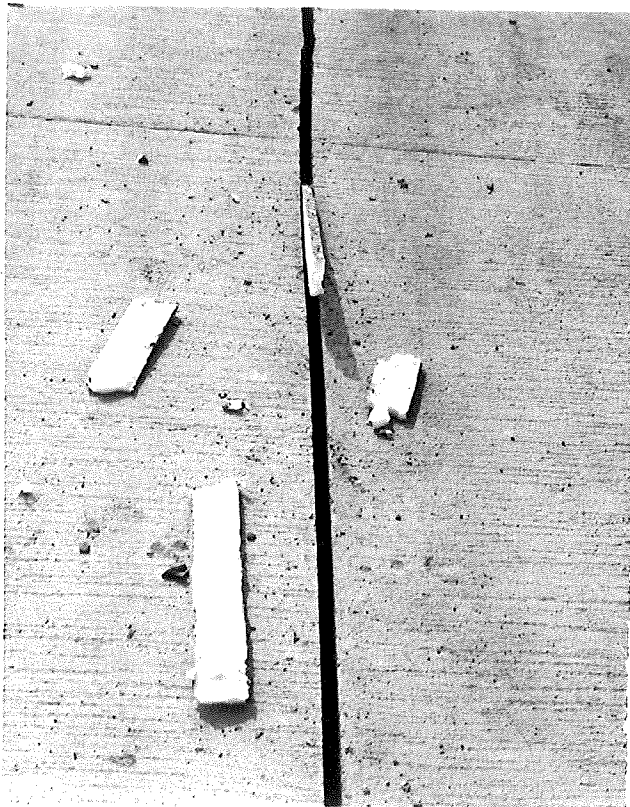
(A) STATION 549+45 STYROFOAM

A few joints were then cleaned of Styrofoam and paper by the use of hand tools alone, Figure 14. The Styrofoam was removed easily and completely in this manner. The paper could be removed completely with hand tools but with much more difficulty.

FIGURE 14. JOINTS FROM WHICH STYROFOAM AND PAPER WERE REMOVED WITH HAND TOOLS.

It was the consensus of those present during these experiments that the use of Styrofoam and its removal with hand tools looked the most promising for this type of joint construction. Sandblasting before sealing would probably then be necessary for good adhesion of joint seal.
