Research Laboratory  
Testing and Research Division  
Report P - 82  
April 18, 1948

REPORT ON CONDITION SURVEY OF GRAYLING CEMENT AND BITUMINOUS SOIL STABILIZATION  
EXPERIMENTAL PROJECT

RESEARCH PROJECT 36 E-5 (1)

By S. M. Cardone

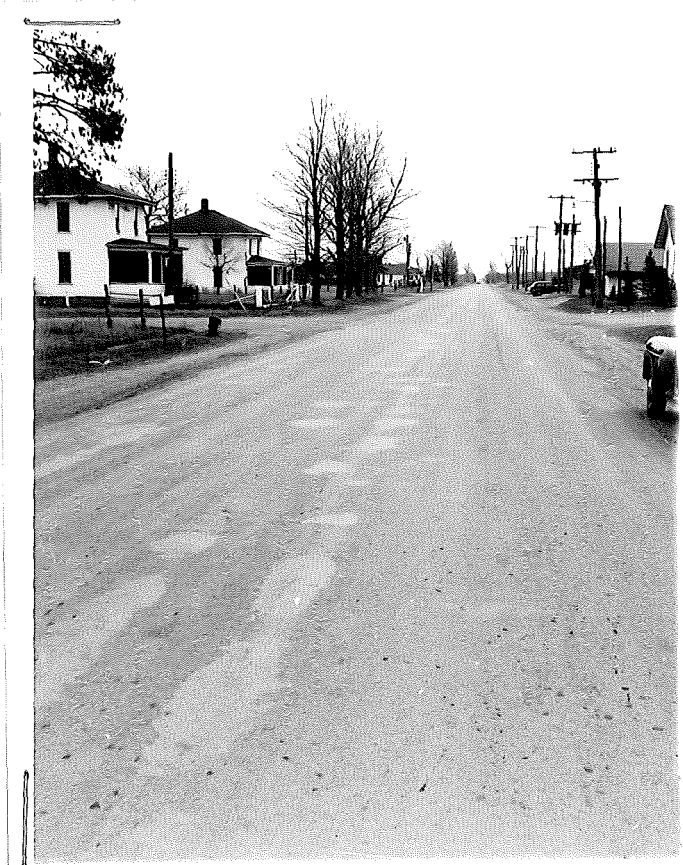
The road surface between Station 0+00 to Station 12+00 appeared to be in excellent condition as may be observed in figure 1. The light areas in figure 1 indicate patched areas in the original seal coat laid in 1942 and not patching of the base course. The base course is apparently sound in this area. This particular section of the project had been an old gravel road prior to bituminous stabilization.

Figure 1. Looking East from beginning of project.

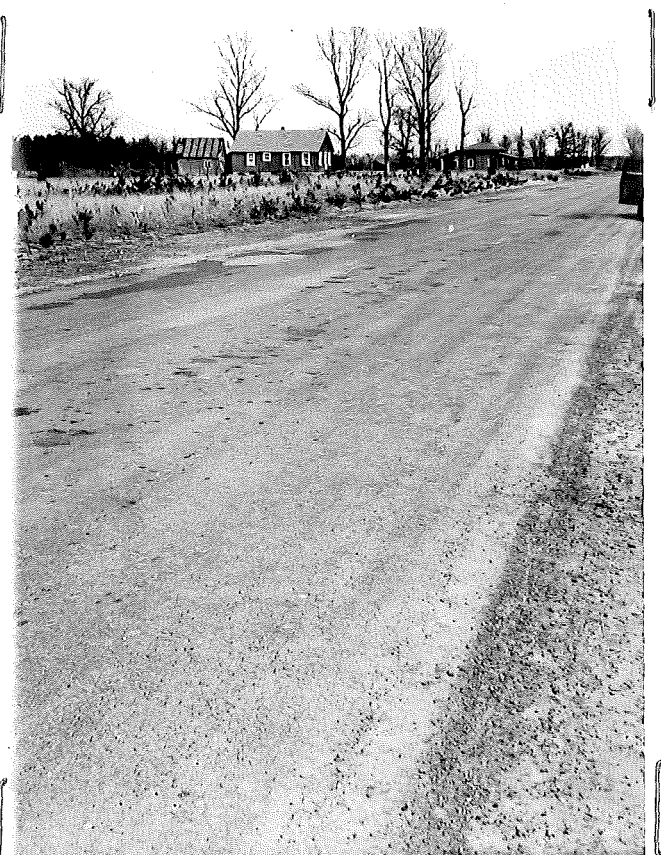
Noticeable breaks in the seal coat started from Station 17+00. See figure 2. From this point to the east end of the emulsion section existing conditions indicate that abnormal deterioration of the road surface is taking place in localized areas. Incipient failure in bond of the seal coat is general in this portion of the bituminous section. When the base course is deprived of the protection of the seal coat, it tends to abrade rapidly under traffic to the extent that considerable patching operations are necessary to preserve the road surface.

Figure 2. Series of small breaks in seal coat starting from Station 17+00. This is the point where deterioration of the surface has started.

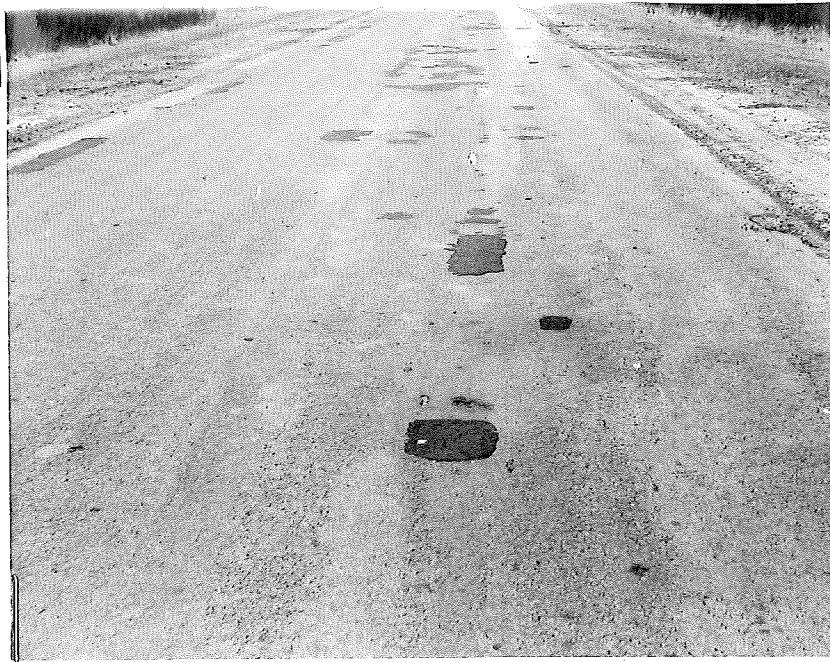
Figure 3. View looking east from Station 30+00 showing recent patching where seal coat has failed.

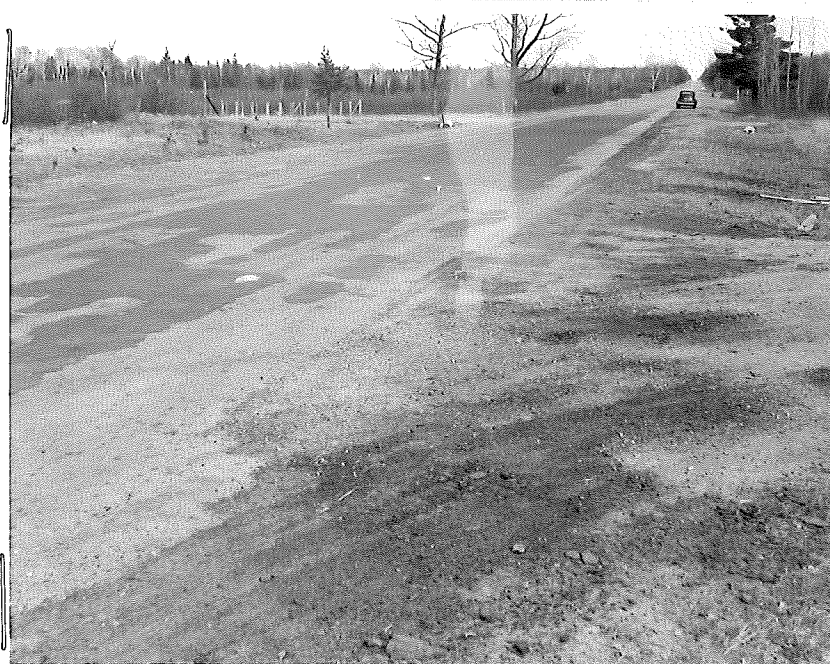
Figure 4. View looking east from Station 34+50 showing area of maximum deterioration which had been patched one week before the picture was taken.

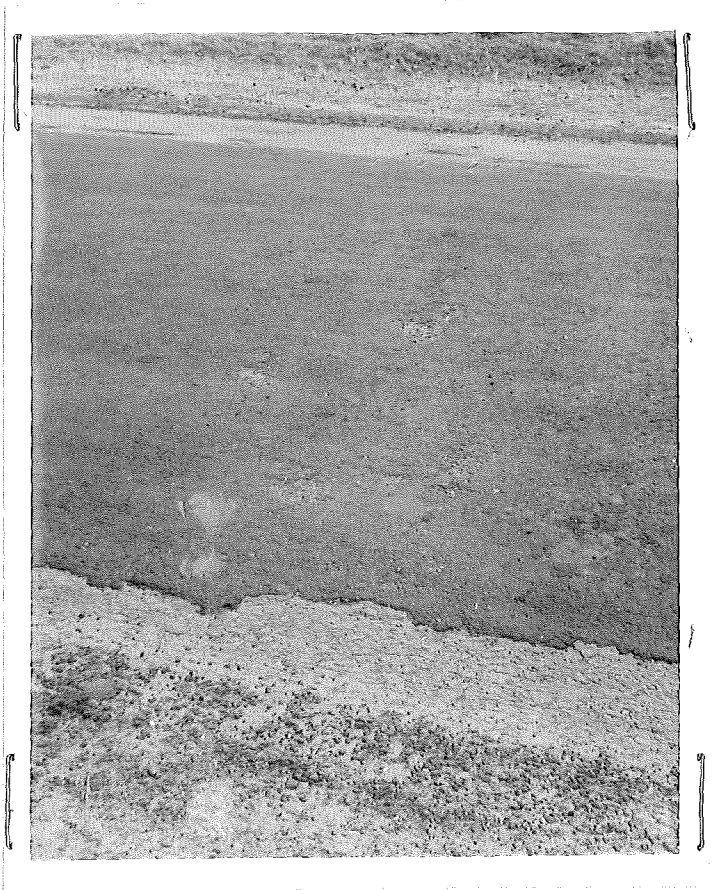
Figure 5. Close-up of large patch in figure 4 showing new patch beginning to peel off of old surface due to improper bond and insufficient thickness of patch. Station 42+00.

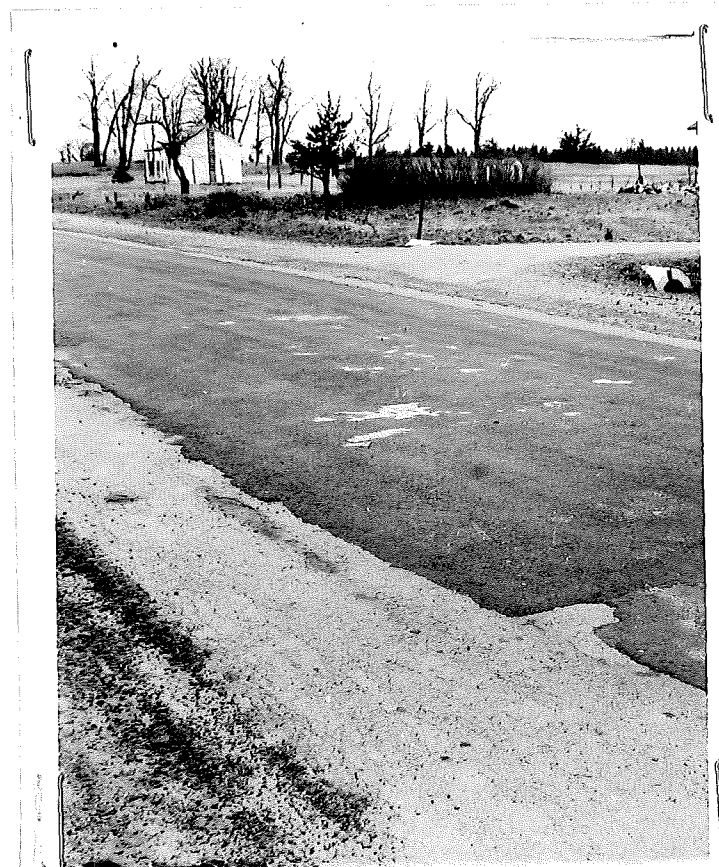
Figure 6. Close-up of large patch in figure 4 showing bleeding (light areas) on new patch.

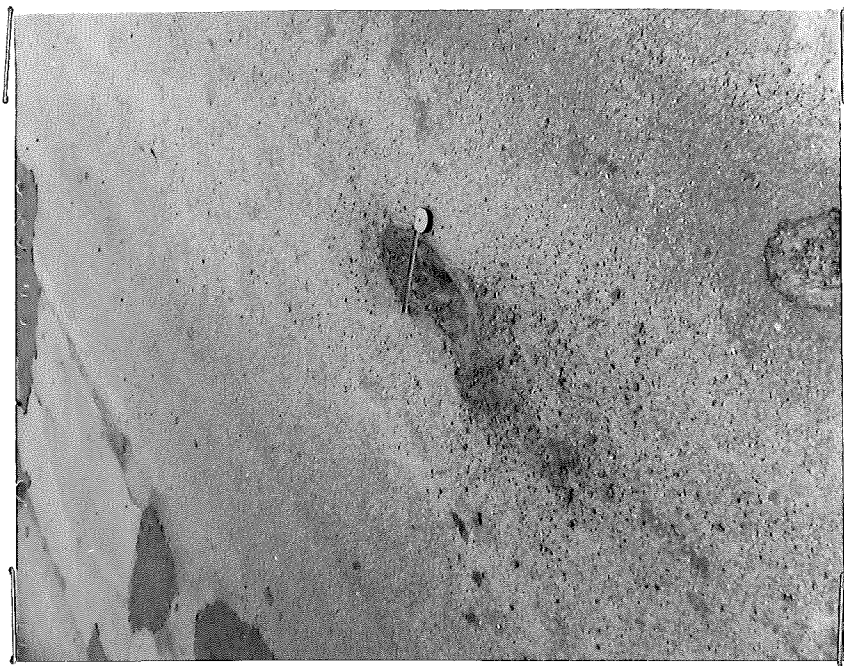
Figure 7. Chuck-hole showing deficiency in bituminous binder. The material could be picked out as easily as the unstabilized soil on the shoulder. Station 45+00.

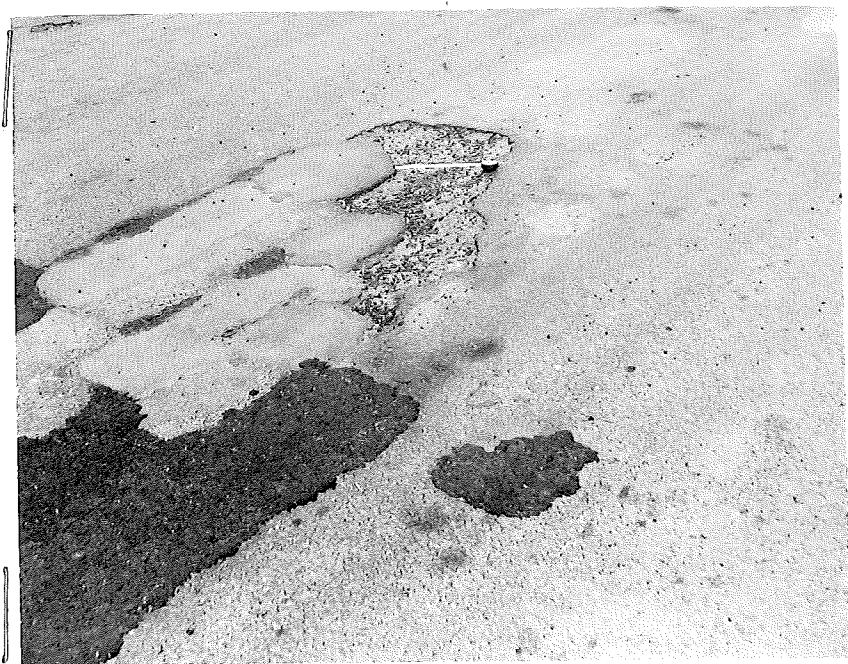
Figure 8. Break in seal coat at Station 45+00 showing progressive breaking of the seal coat and subsequent deterioration of base course.

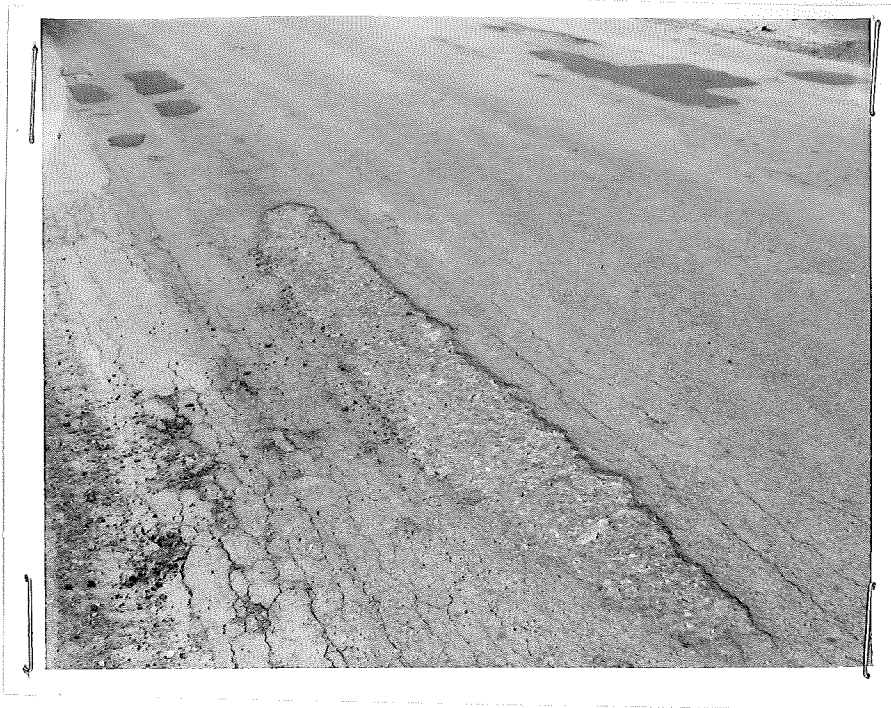
Examination of the stabilized base revealed that neither the mineral filler nor the bituminous binder were intimately mixed during construction. At one point the depth of treatment of the base course was only 3 inches.

Figure 9. Break in seal coat at Station 45+00 showing condition of stabilized base. The light spots are pieces of mineral filler not thoroughly mixed with the soil. The bituminous binder, not evident in picture, also was not intimately mixed with the sand. At this point the stabilized base showed a small amount of cohesiveness, but was also comparatively soft.

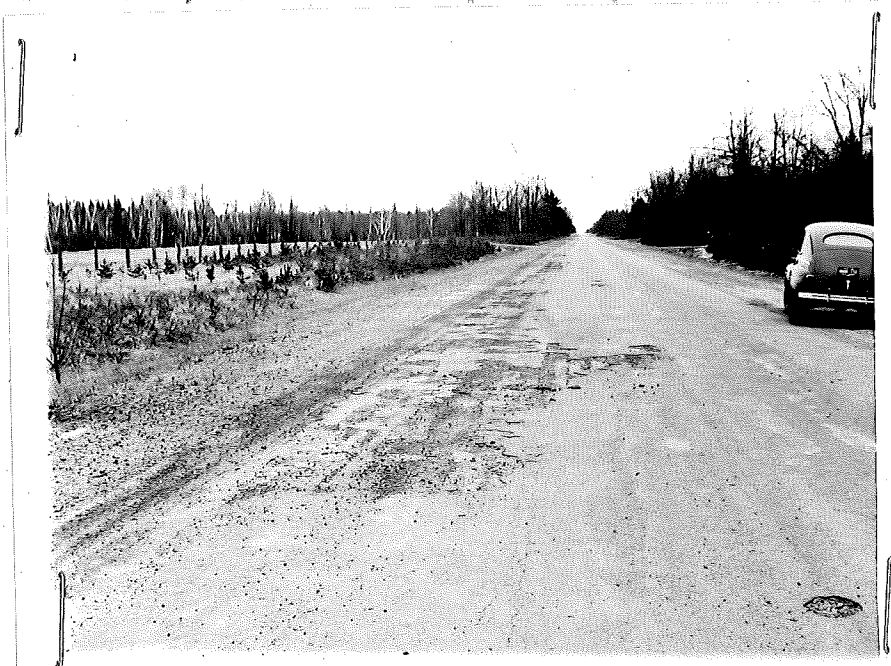
Figure 10. View of large break in seal coat along north lane between Station 57+90 and Station 68+00. Stabilized base possessed very little cohesiveness. Picture taken from Station 68+00. This type of break extended to approximately Station 79+00 which is near the end of the AE-7 bituminous mix section. The AE-7 section ends at Station 80+00.

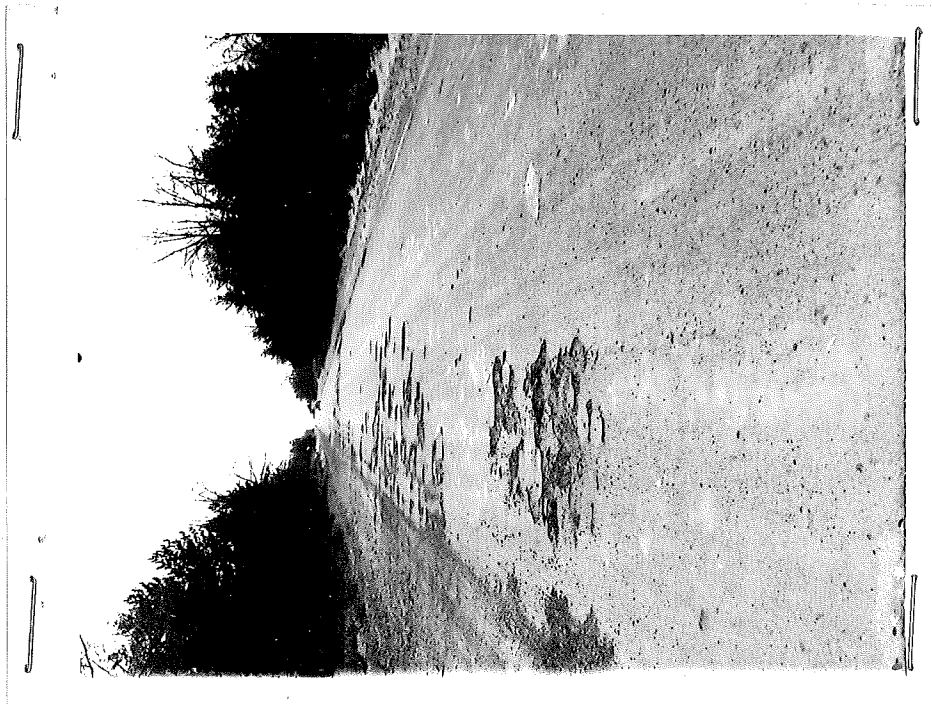
Figure 11. Same type of break in seal coat and rutting of base as shown in Figure 10, also along north lane. Stabilized base material is soft and evidently was poorly mixed. Station 76+50 to Station 79+60.

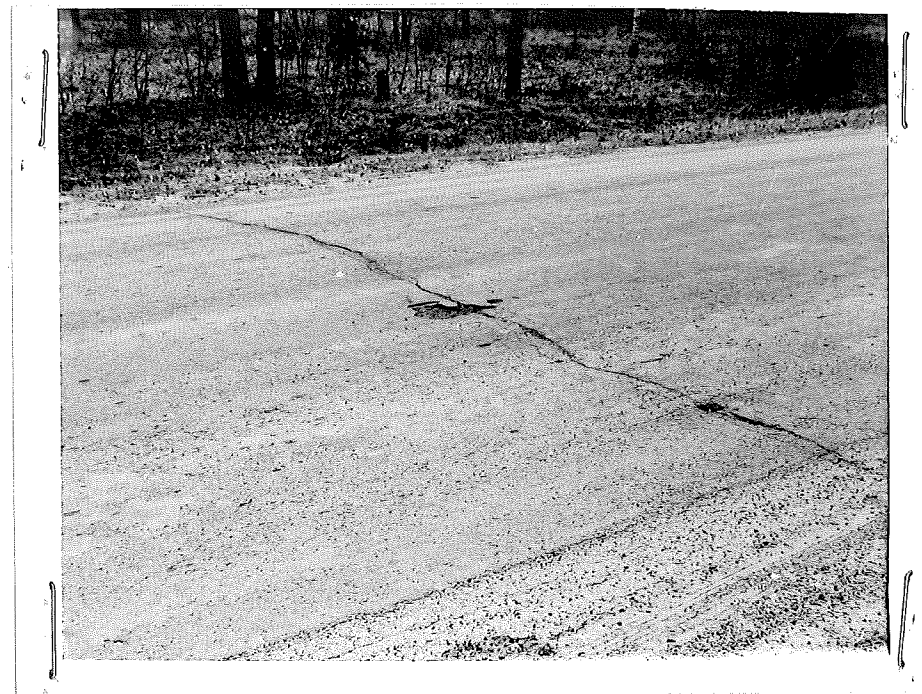
Figure 12. Transverse crack between the AE-7 and the T-3 sections. Note the seal coat beginning to peel off at the crack in center of roadway. Station 80+00.

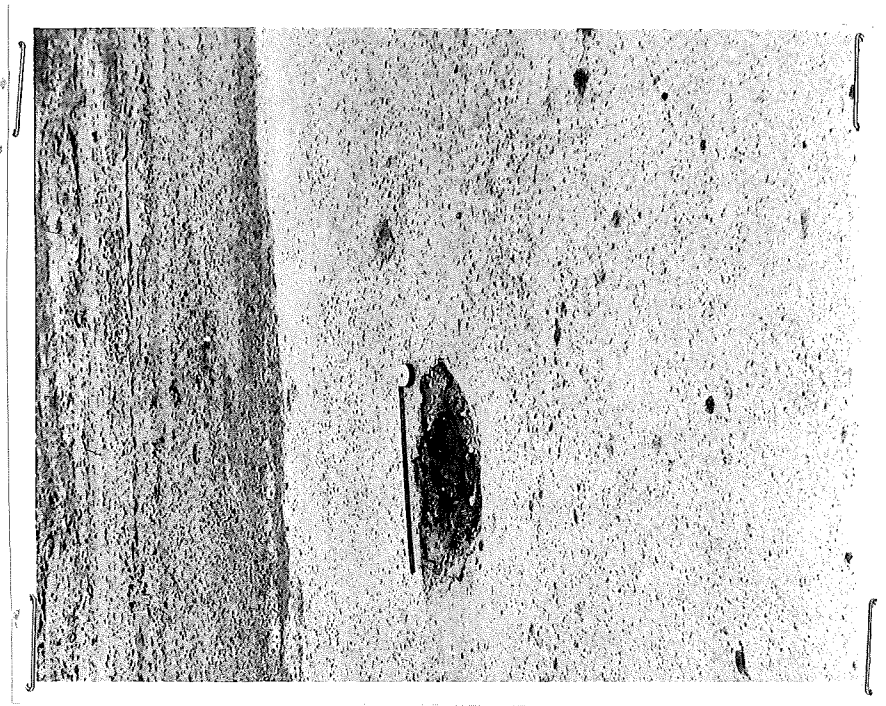
Figure 13. Break in seal coat at Station 215+25 shows chunk-hole 2" deep consisting of 1" of seal coat and 1" of loose soil over hard material below. This hole is in the soil cement section, and indicates that probably the loose soil over the stabilized base was not brushed off prior to the application of the seal coat. Or it could be the result of improper mixing of the cement with the soil.

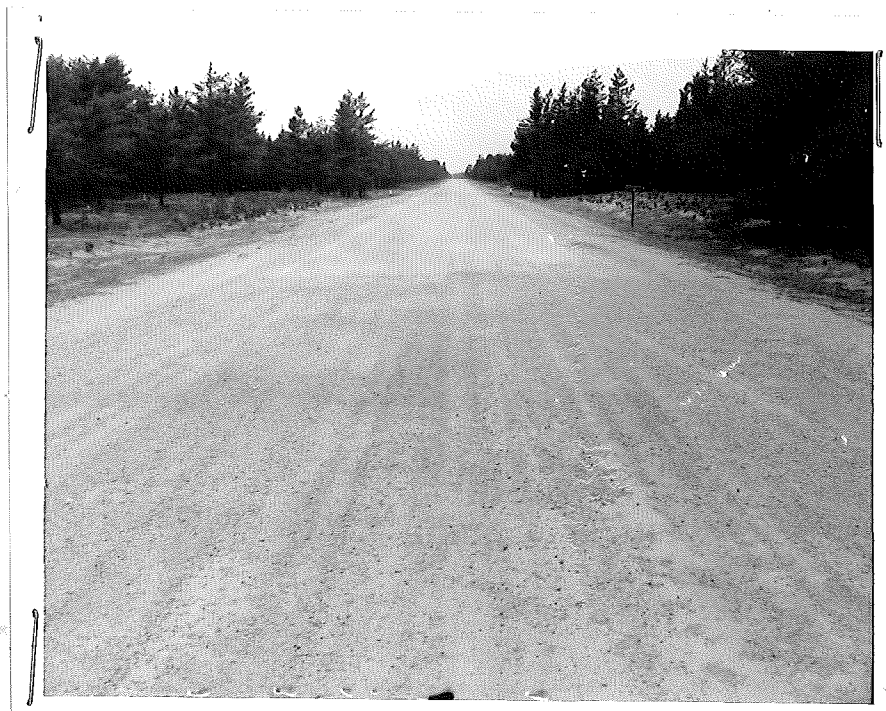
resurfaced during the Summer of 1945. Re-sealing became necessary on the soil cement section when the old seal coat became brittle and started to peel off. The soil cement section is at present in excellent condition. Pictures pertaining to the soil cement section are shown in figures 13 and 14.

Figure 14. View from the east end of the project looking west. Surface is in excellent condition.
