*C-2* FINAL REPORT  
EXPERIMENTAL PROJECT  
ORTHOTROPIC BRIDGE

EXPERIMENTAL ORTHOTROPIC BRIDGE  
S05 of 23081 A  
Crietz Road crossing over I-496  
three miles west of the city limits  
of Lansing

FEDERAL PROJECT 1 496 - 7(21) 138

STATE RESEARCH PROJECT 67 G - 157

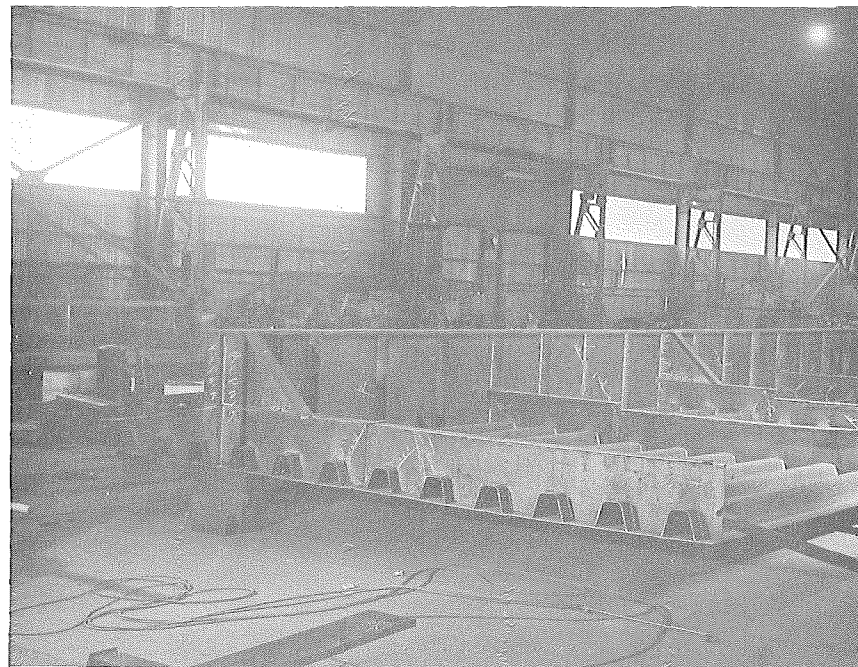
Outer and center deck section being matched for repair and later joining in the field.

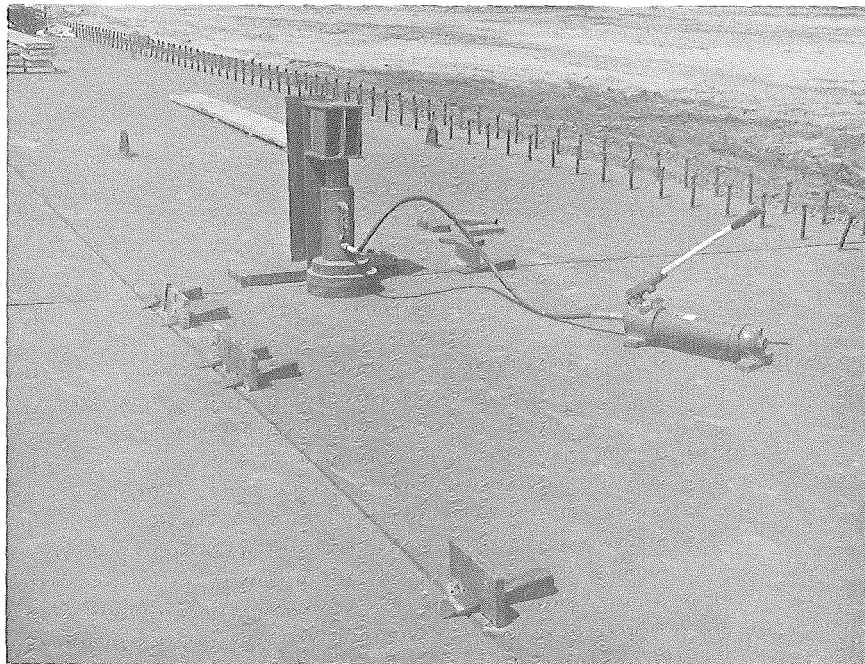
View of hydraulic jack and slot-widge assemblies used to hold down high spots in the deck plate prior to welding.

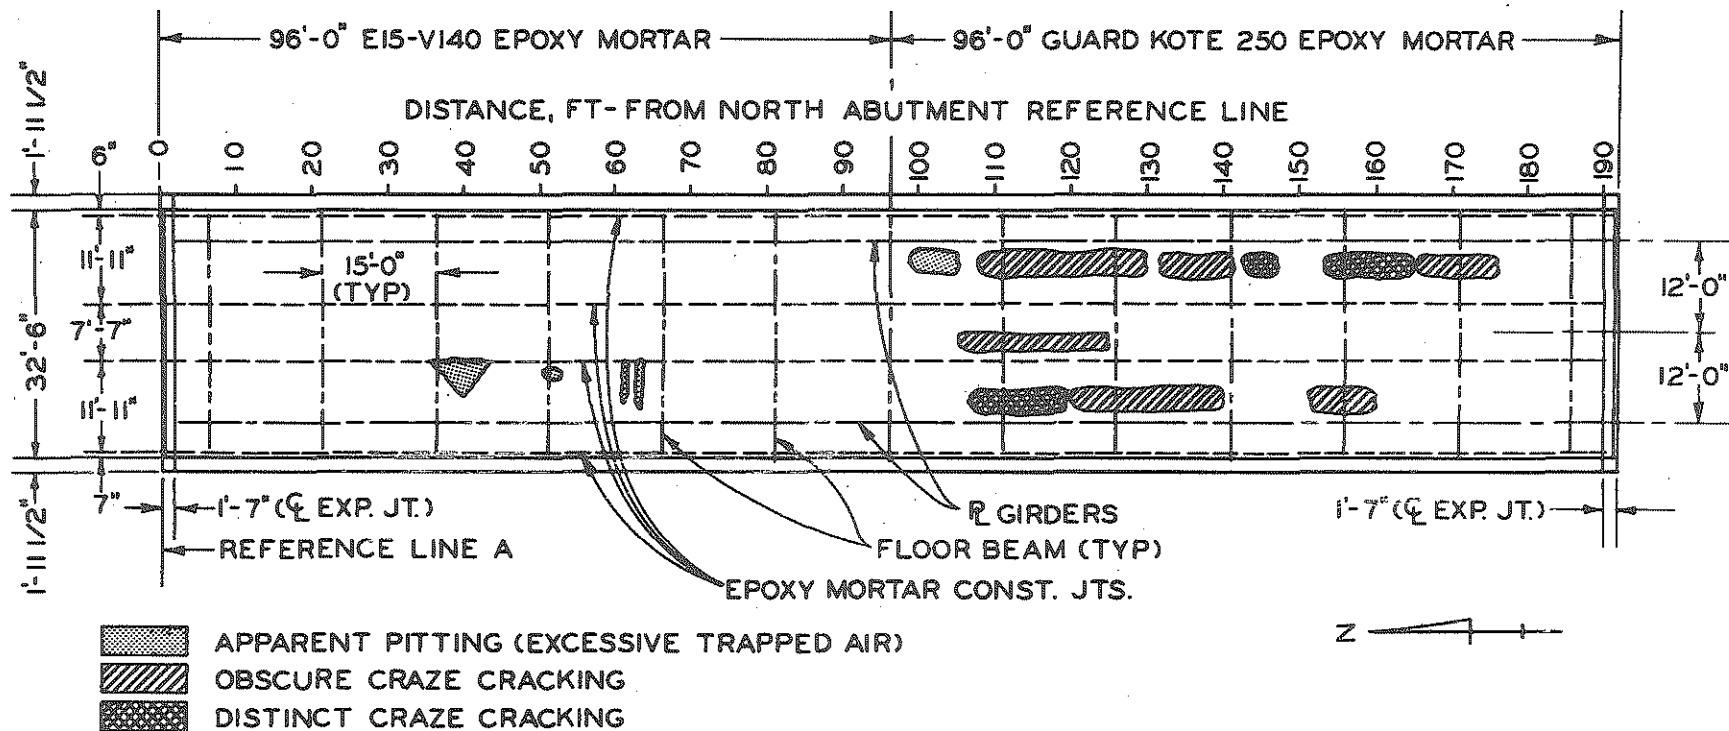
Figure 2. Deterioration features in the epoxy mortar wearing surface as observed on April 29, 1970.

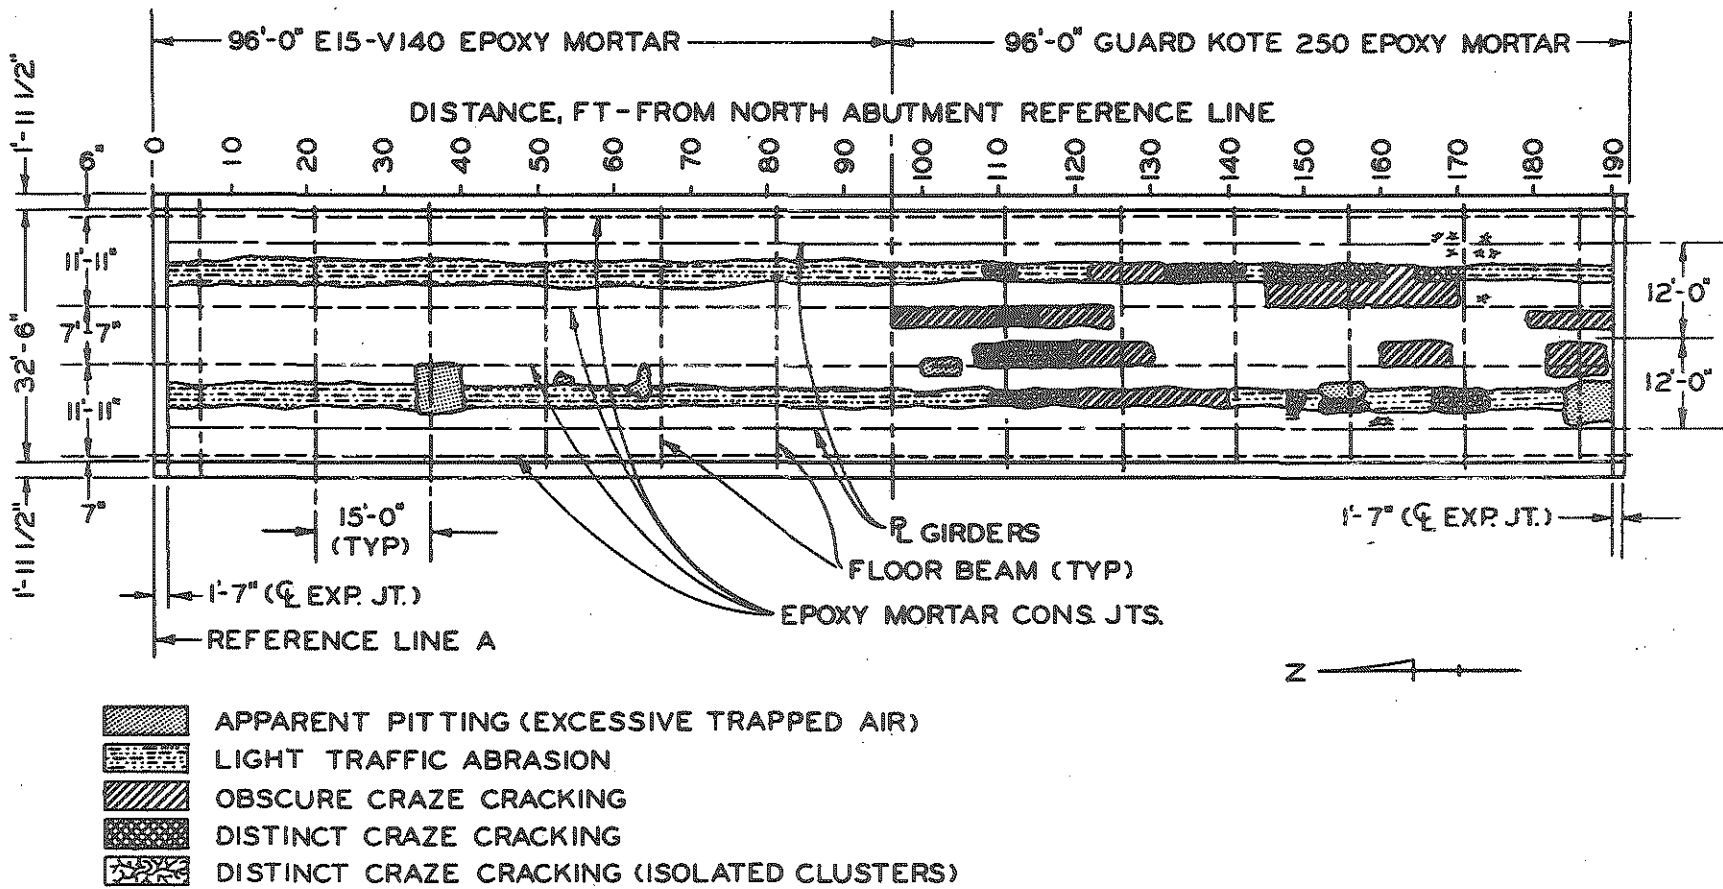
Figure 3. Deterioration features in the epoxy mortar wearing surface as observed on May 6, 1971.

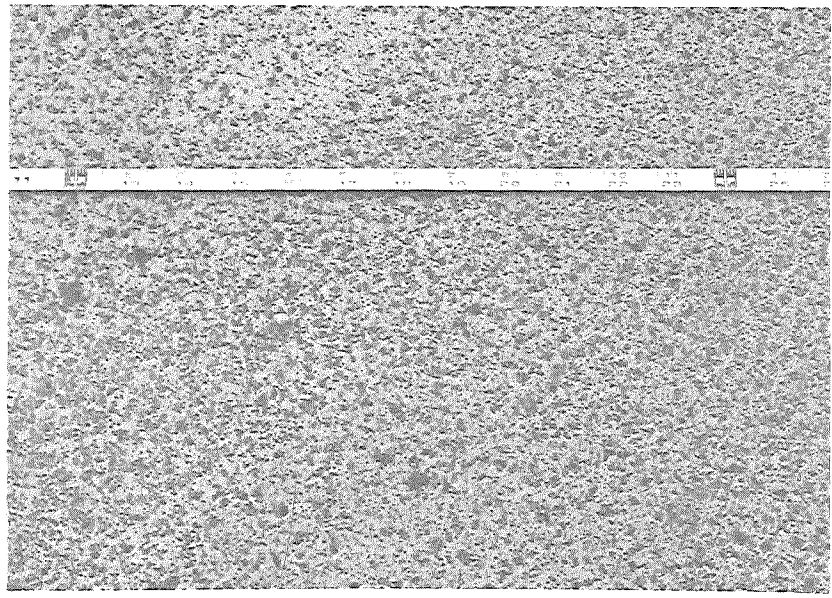
Figure 4. General area and close-up view of apparent pitting in E15-V140 epoxy mortar about 6 ft from the west curb line and at the 40-ft mark from the north abutment reference line.

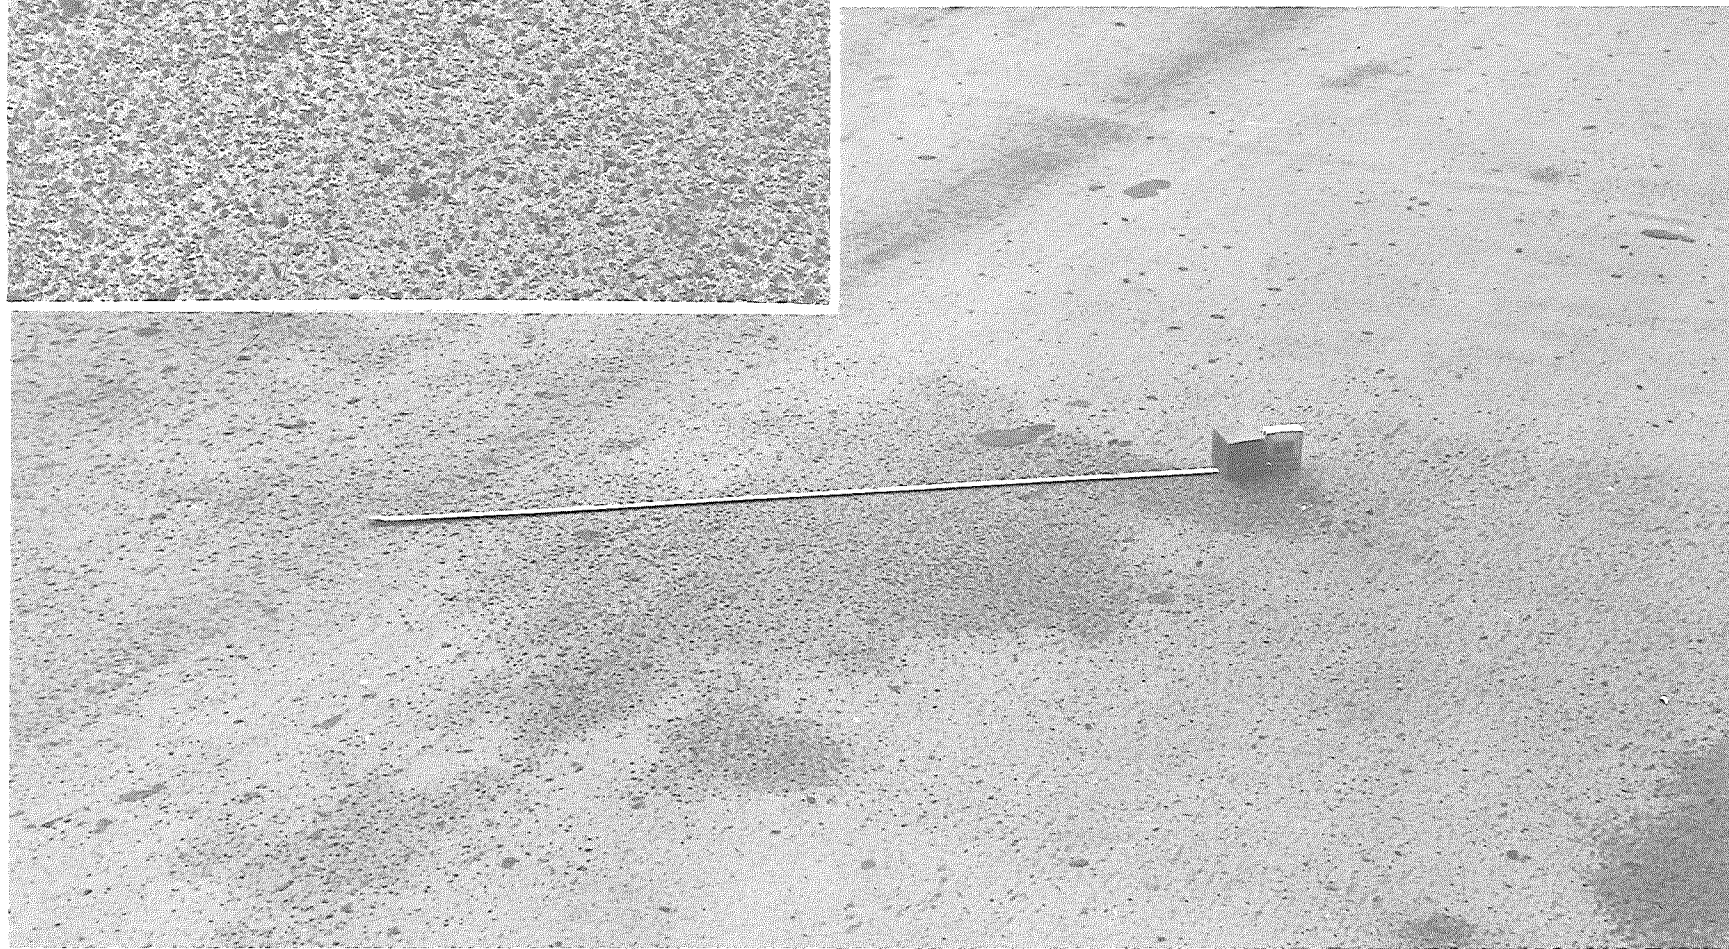
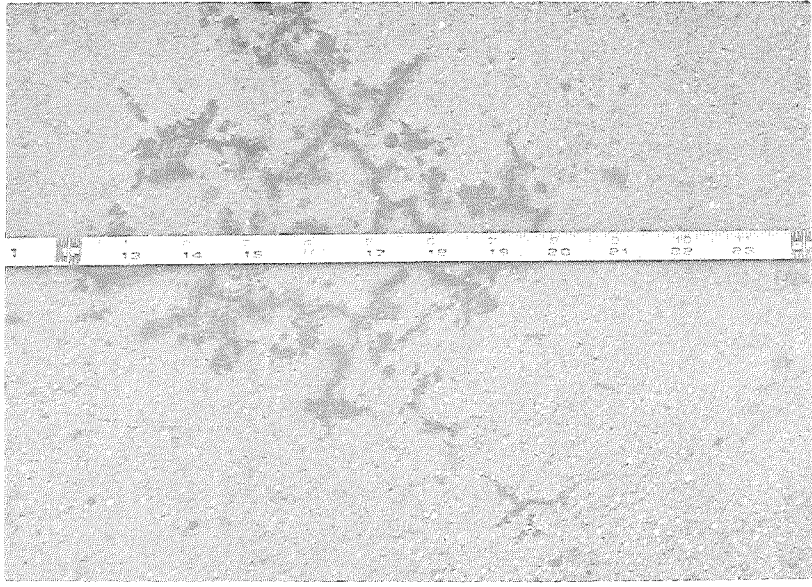
Figure 5. General area and close-up view of isolated distinct craze cracking in the Guardkote 250 epoxy mortar surfacing located 5 ft from the east curb line and at 172 ft from the north abutment reference line. The black streaks originally thought to be rust are actually embedded asphalt probably from approach paving operations.

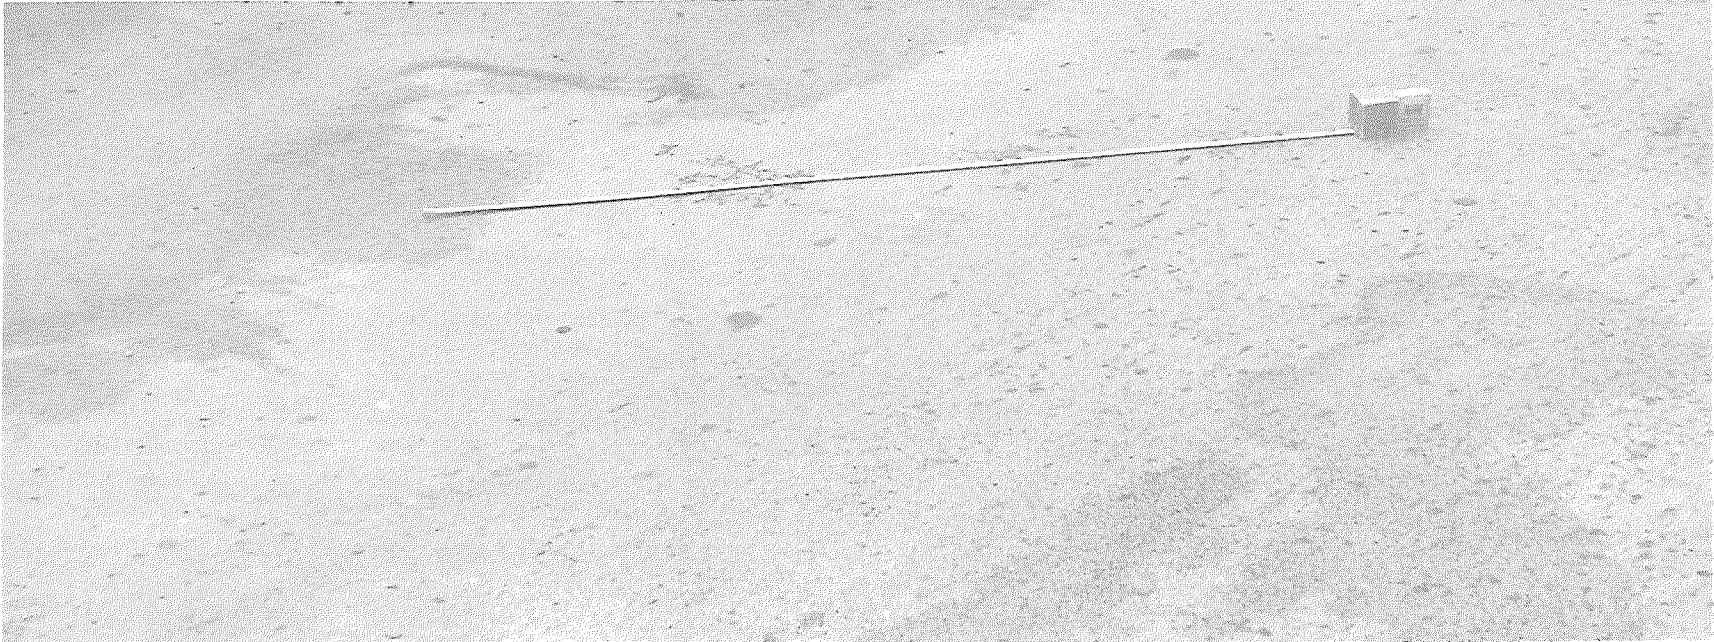
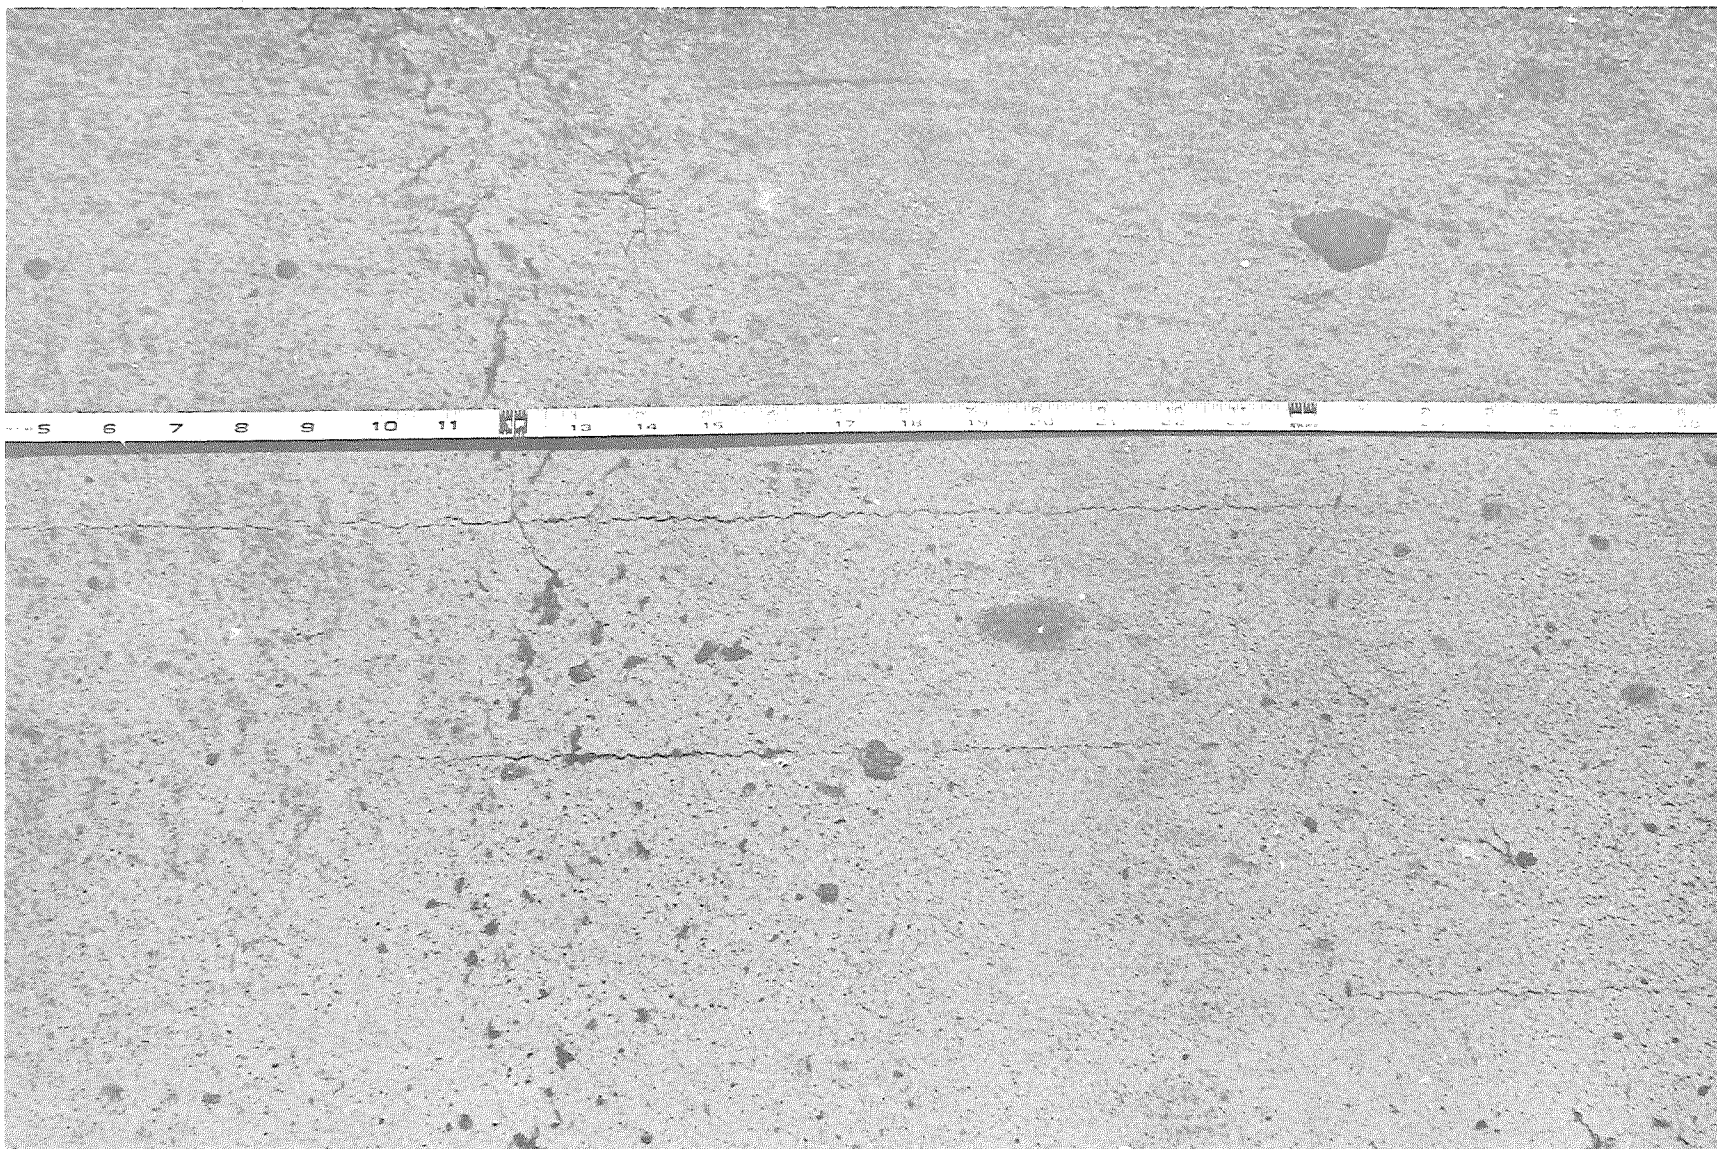
Figure 6. Close-up view of parallel longitudinal cracks which are developing along with a distinct craze crack pattern in the Guardkote 250 epoxy mortar surfacing about 7 ft from the west curb line and at the 150-ft mark from the north abutment reference line.
