MICHIGAN
DEPARTMENT OF STATE HIGHWAYS

Subject: Aluminum-Coated Chain Link Fence
Research Project 61 NM-33 (60 G-102(1)). Research Report No.
R-891.

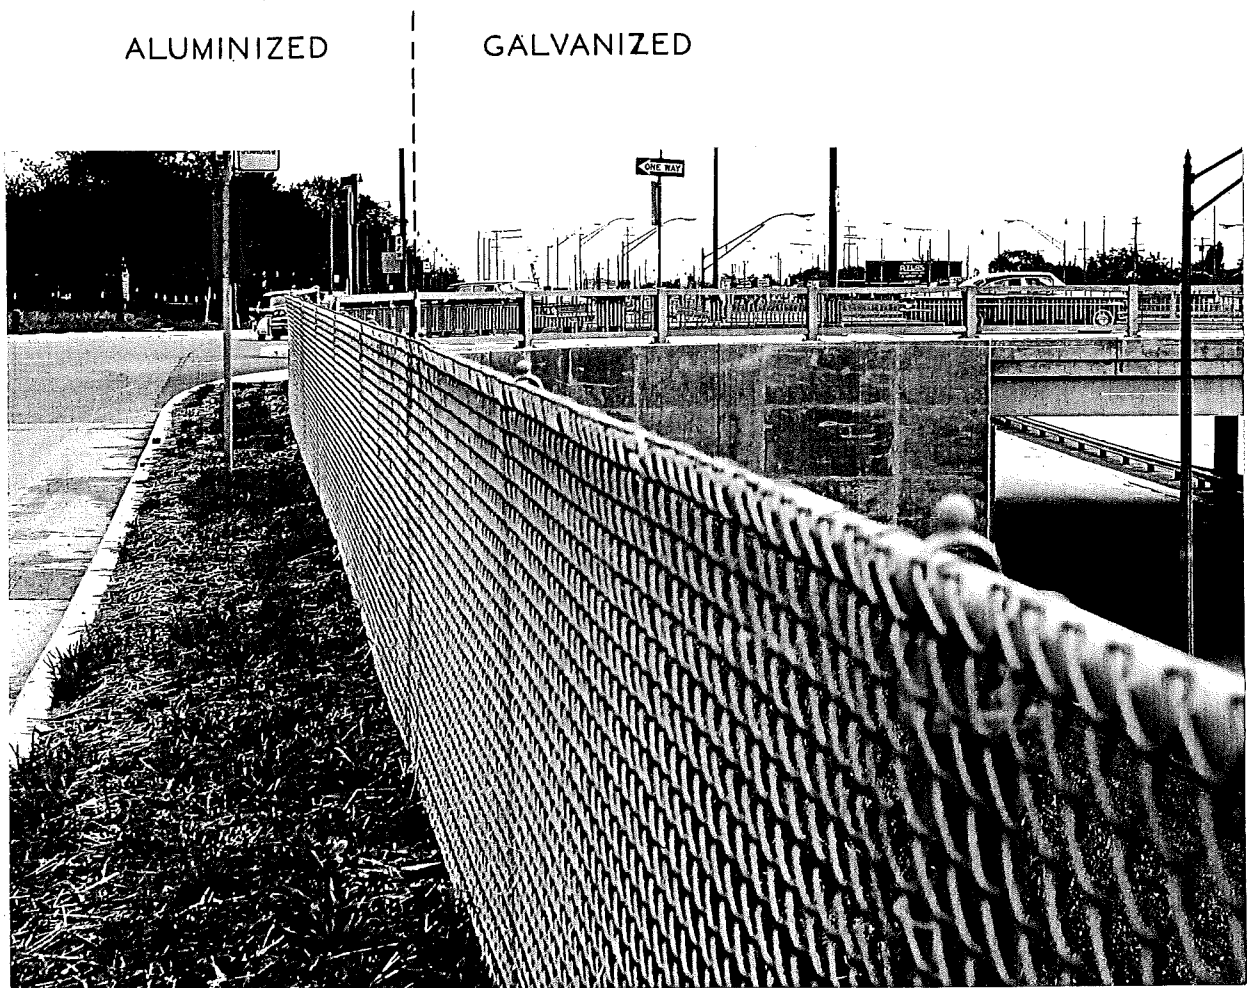
The United States Steel Corporation arranged with the contractor to have 100 ft of its Cyclone brand aluminum-coated fencing installed on a construction project in the Detroit area. This replaced a part of the specified zinc coated material. The installation was made the week of December 3, 1961 on the northeast corner of the intersection of the Southfield Freeway and Plymouth Rd (Fig. 1).

Figure 1. Field installation at Southfield Freeway and Plymouth Rd six months after installation. Aluminum coated fencing in background and zinc-coated in foreground.

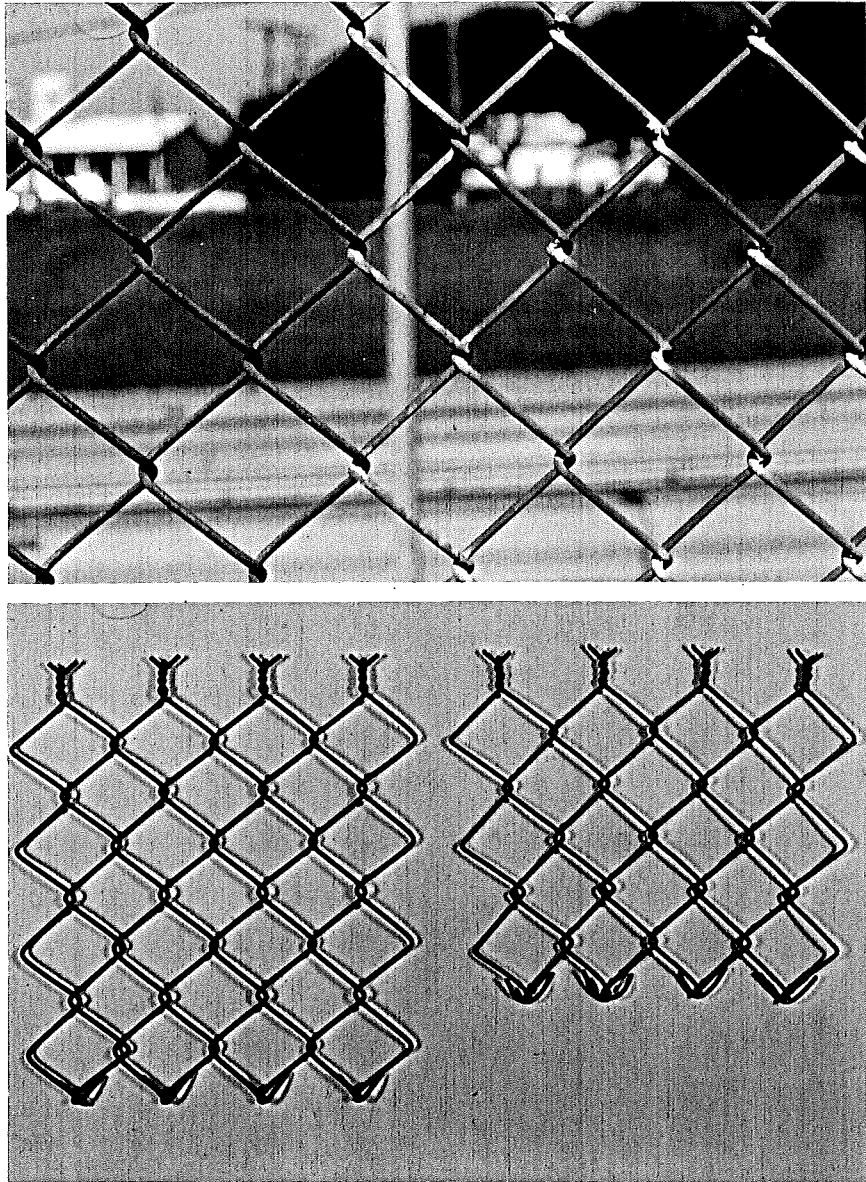
It was claimed by U. S. Steel that for equivalent coating thicknesses, aluminum would outlast zinc 3 to 5 times. It was pointed out that the corrosion products of zinc are watersoluble while aluminum forms a tightly adhering oxide film. Our subsequent observations of both the field installation and the samples exposed to weathering on the roof of the Laboratory confirmed these claims qualitatively. After approximately 12 years exposure to weathering, the zinc coating has eroded from about 90 percent of the area, while there is no apparent rusting of the aluminum coated material. This is true for both exposures (Fig. 2).

Our observations show that the zinc coating quickly changes from a bright silver color to a duller but smooth light blue gray, and retains this appearance throughout its service life with little dirt pick up. This is no doubt due to the smooth surface combined with the water solubility of the corrosion products. Between seven and eight years, very slight rusting began to appear. This progressed to 50 percent rust after 10 years and to 90 percent rust after 12 years.

Figure 2. Field service exposed (top) and roof exposed (bottom) aluminum and zinc-coated chain link fencing after 12 years weathering. The aluminum coated material is on the left in each photo. (Regrettably the bottom color photo does not duplicate the rusting shown in the slide from which it was made.)
