MICHIGAN STATE HIGHWAY DEPARTMENT

ANTI-GLARE SCREEN STUDY

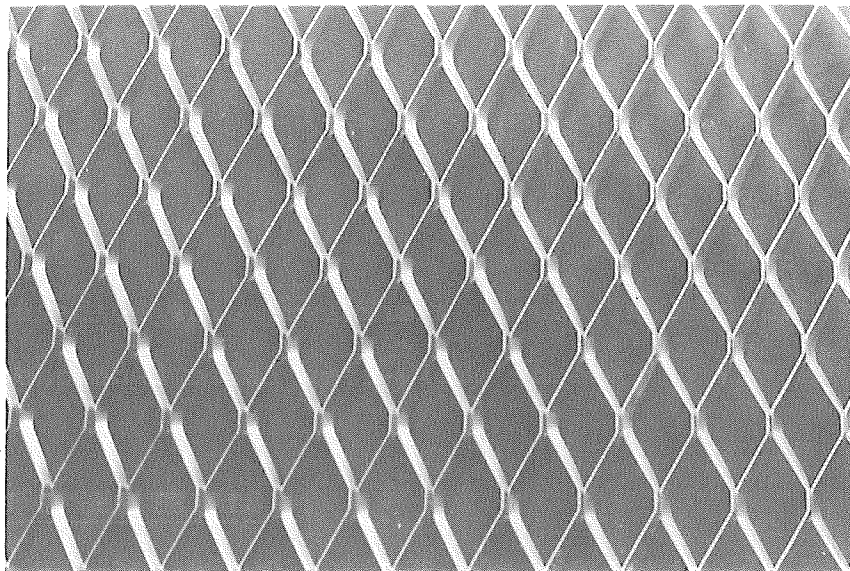
Approximately 1/3 Actual Mesh Size

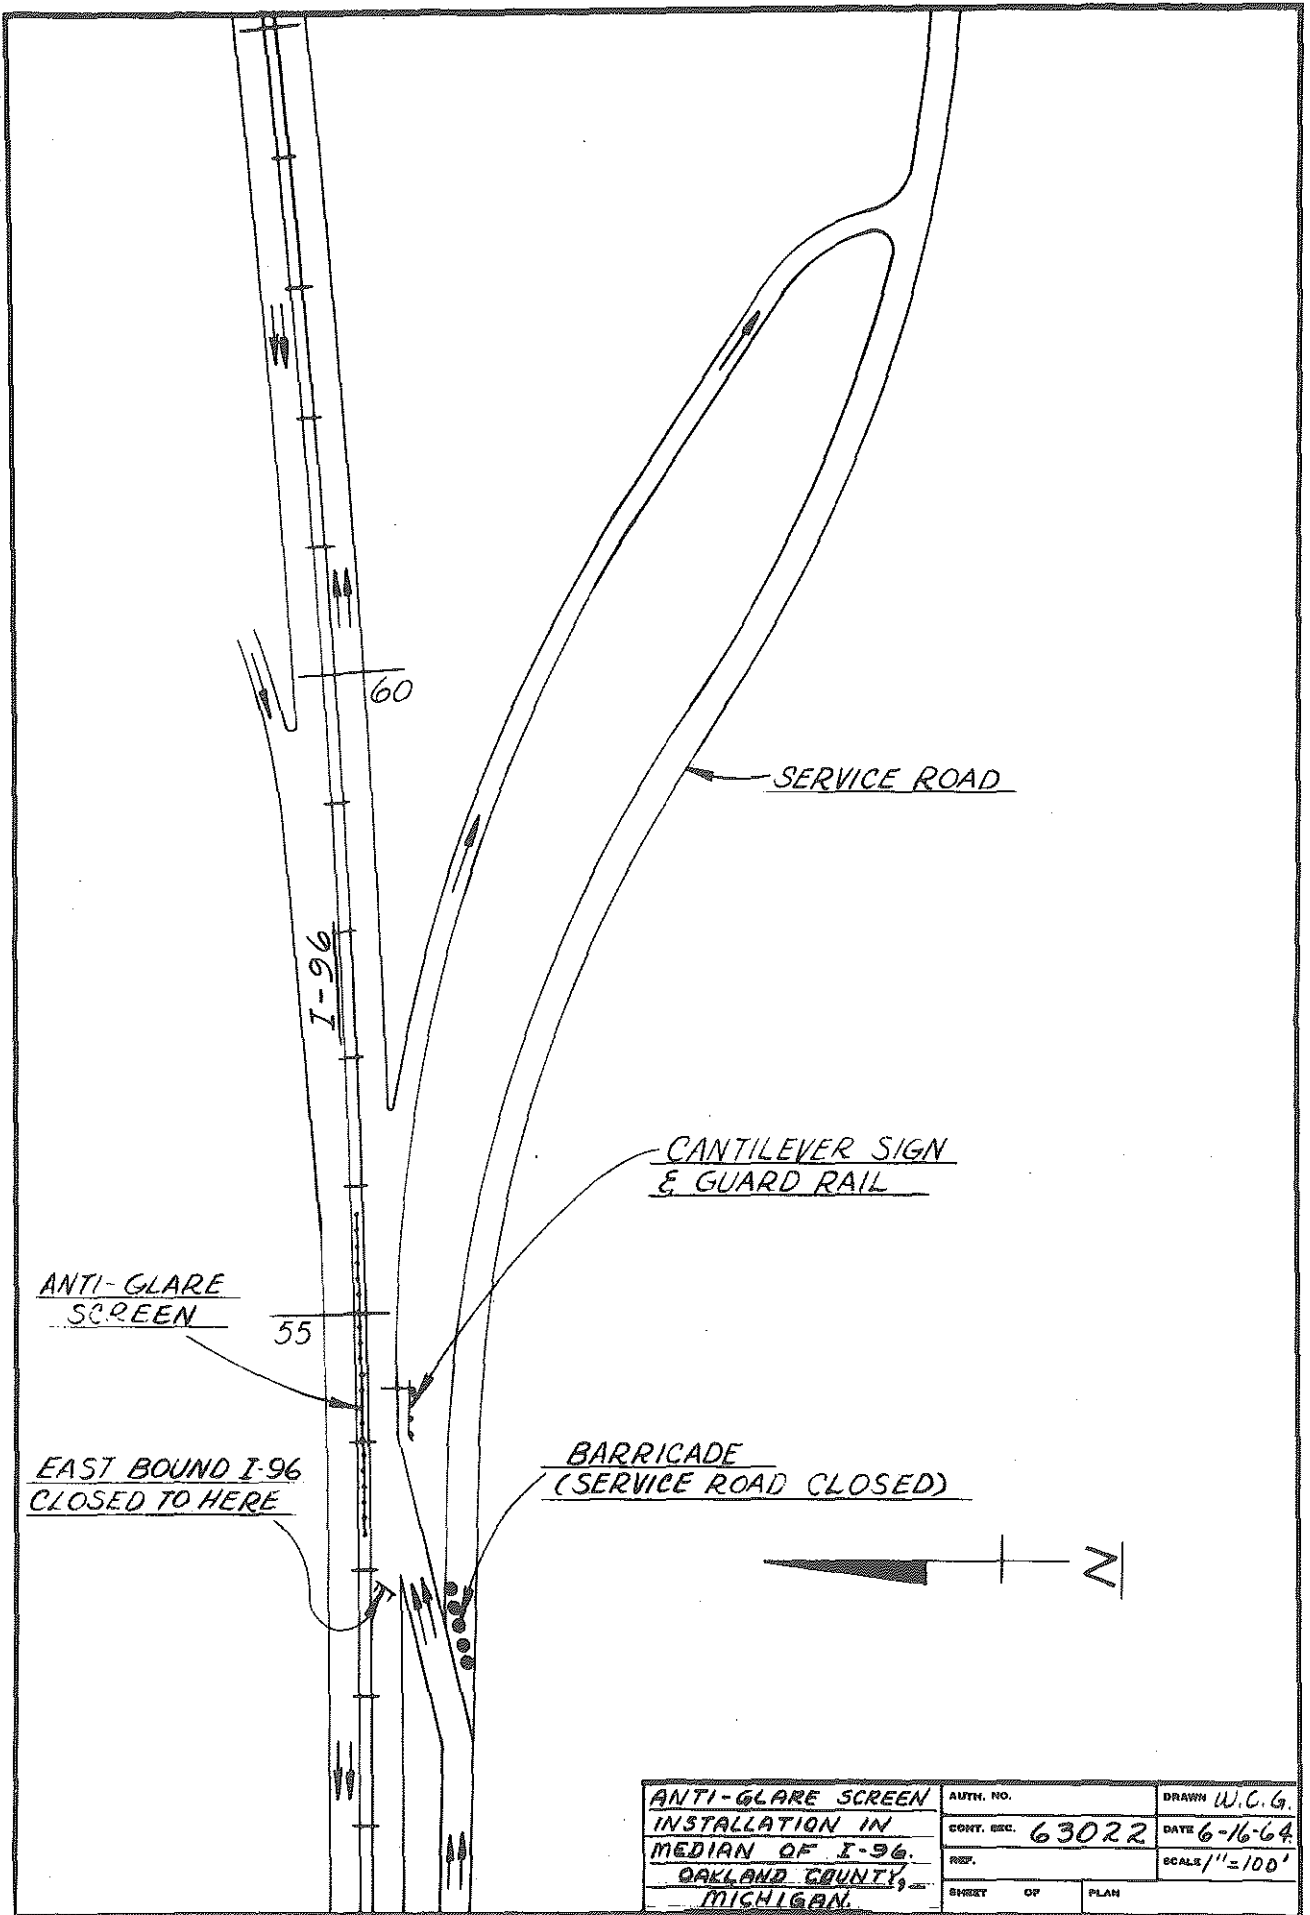
FIGURE 1

The first situation involved a detour during the construction of the Interstate 96 freeway. The eastbound traffic, which was being detoured, entered the freeway at a point on the outside of a 30 minute curve (see Figure 1). The curve, plus the entrance angle of the detour, caused the headlights of the eastbound vehicles to be aimed across the westbound roadway (see Figures 1 & 3). A 250 foot section of anti-glare screen was installed in the freeway median to alleviate this condition.

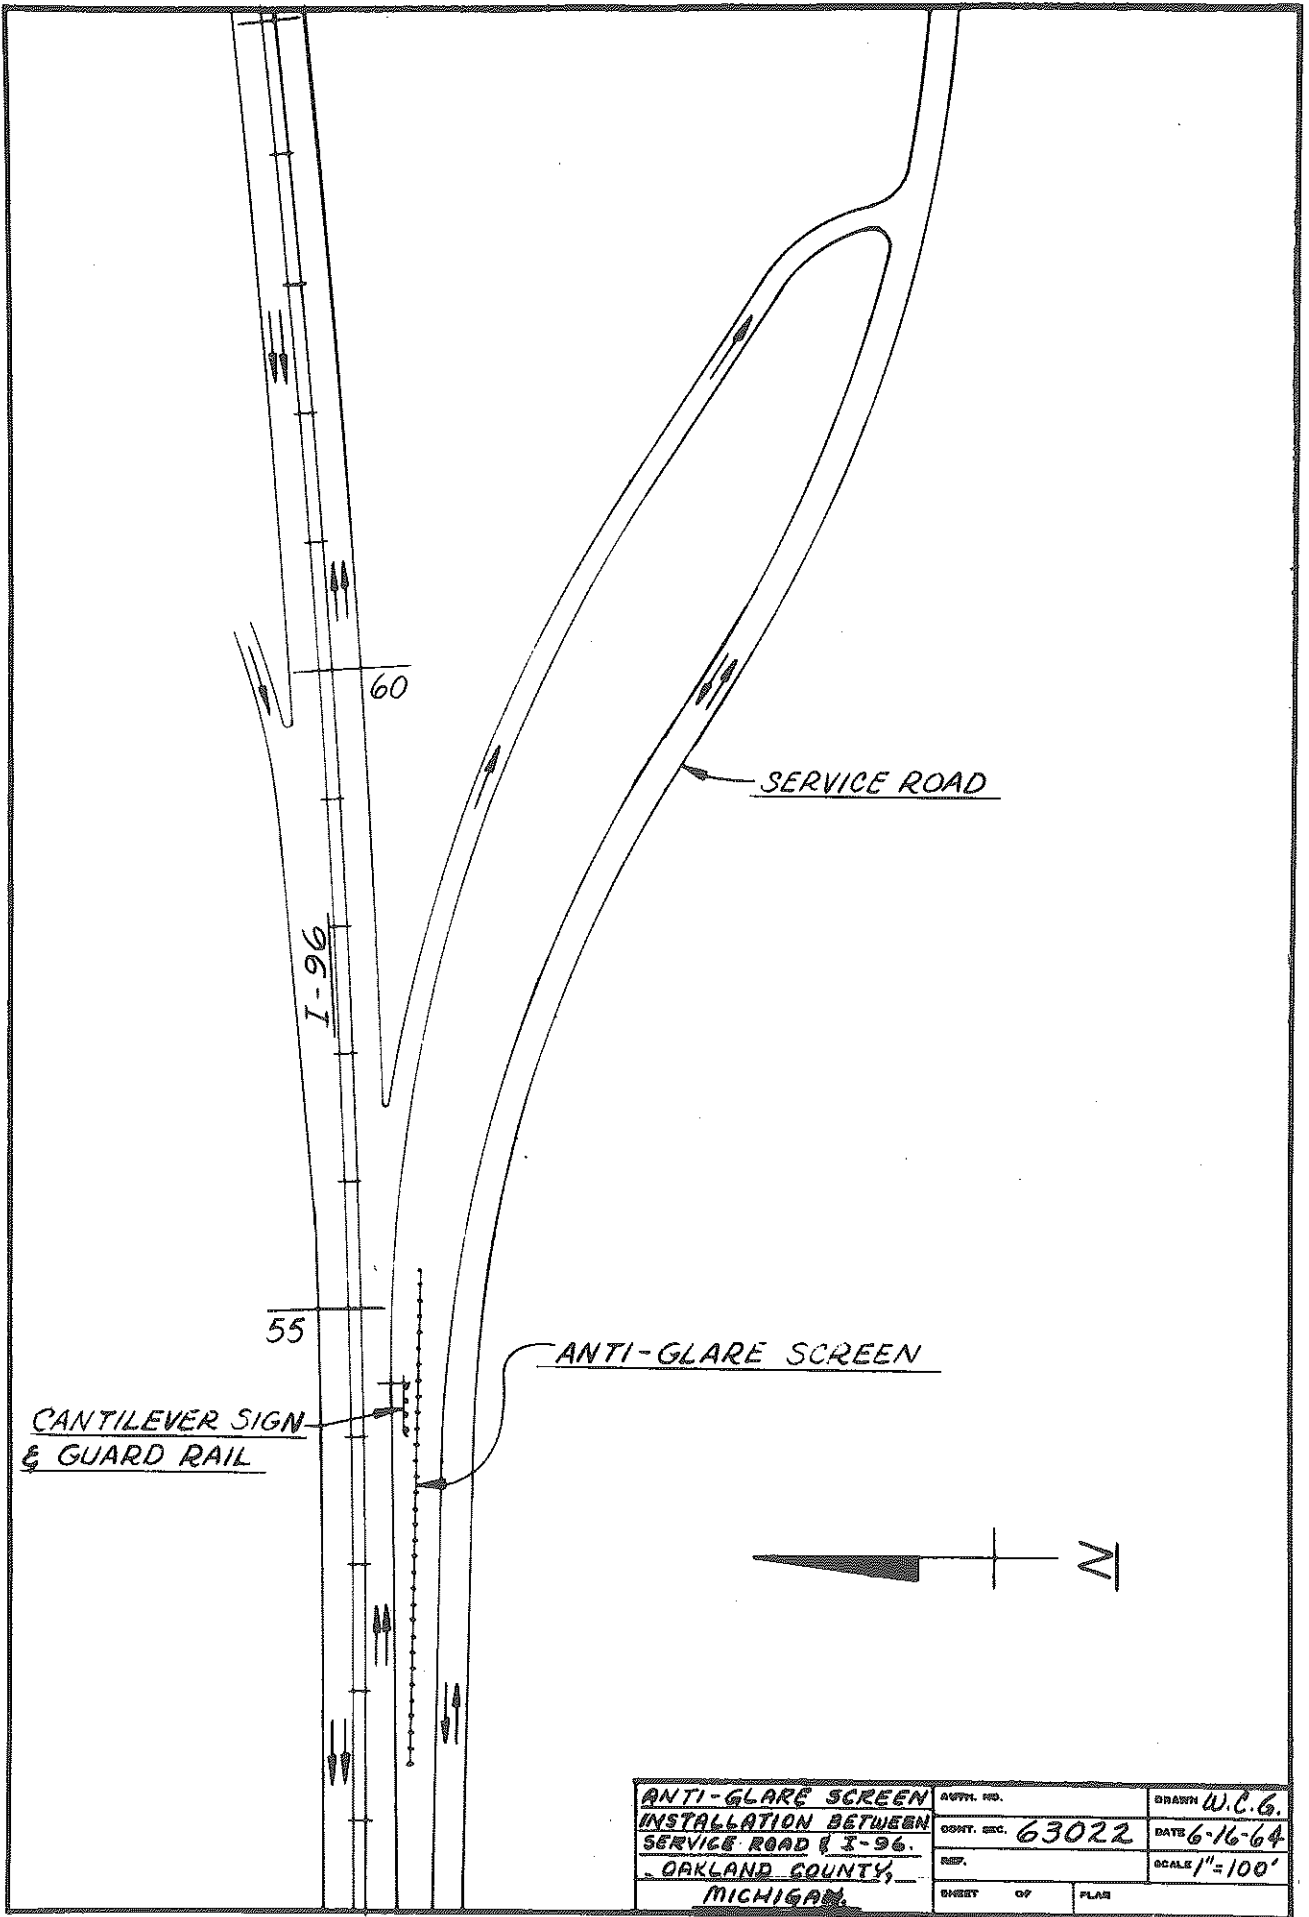
FIGURE 2

In the second situation, headlight glare from westbound vehicles on the service road lessened visibility for eastbound freeway traffic (see Figure 2). A 400 foot section of anti-glare screen was installed between the freeway and the service road in this critical area of headlight glare.

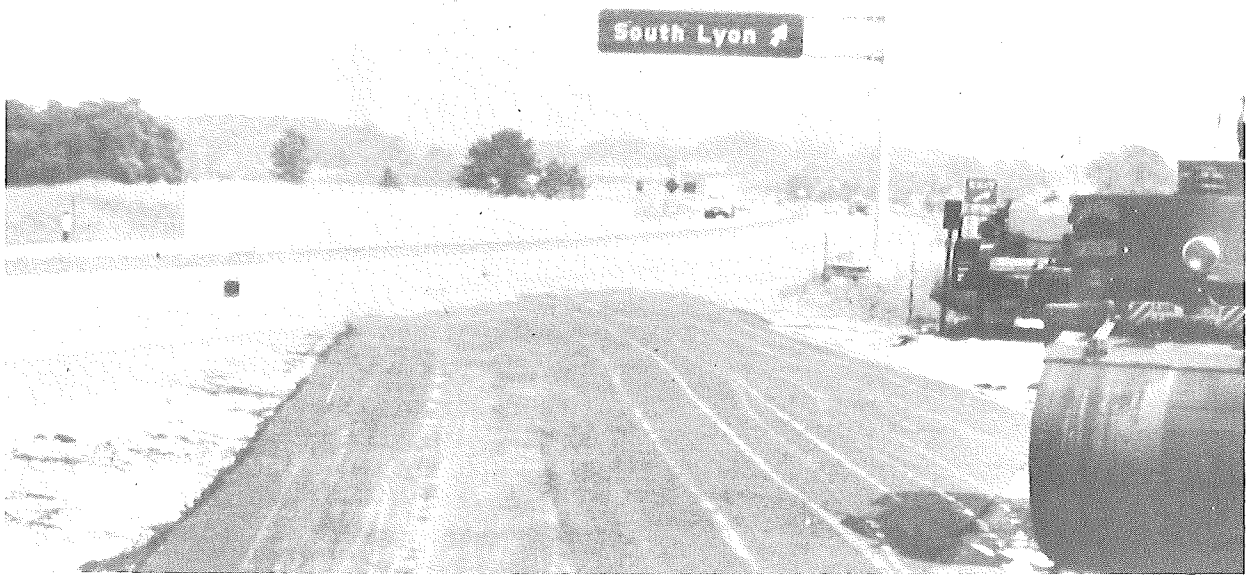
Fig. 4

Various photographs were taken to show the screen's effectiveness. Figure 4 shows the first anti-glare screen installation shortly after it was erected. In the area of the second post from the left, note that the lower part of the vehicle is visible under the screen while the top is concealed by the screen.

Eastbound approach to Anti-Glare Screen in Median
of I-96 at Kent Lake Road.

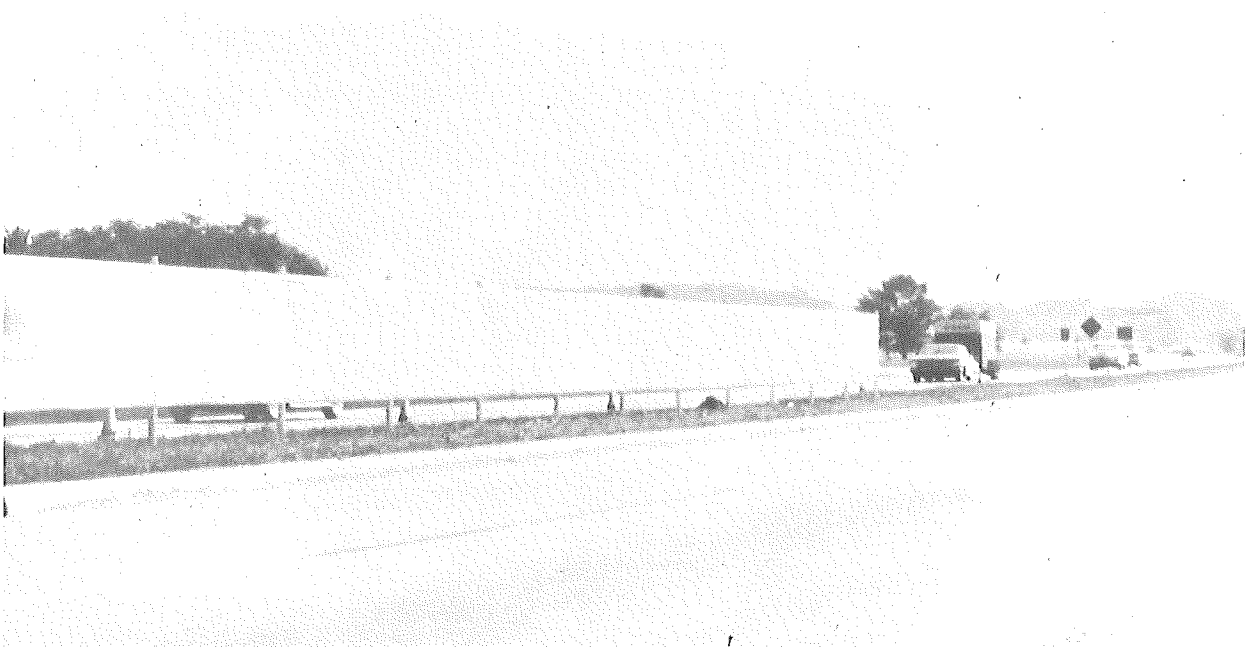
Fig. 5

Close up view of Anti-Glare Screen in Median of
I-96 at Kent Lake Road.

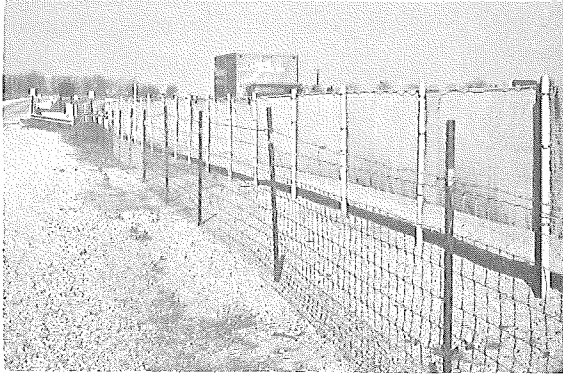
Fig. 6

Figures 5 through 8 show the screen as seen from angles of 10, 15, 25, and 40 degrees, respectively. From 10°, the lower portion of the truck is completely concealed; from 15°, it is faintly visible; from 25°, the entire truck is visible but the portion behind the screen is little more than a silhouette; and from 40°, the entire truck can be observed in some detail.

Anti-Glare Screen viewed at 10° angle from Service Road.

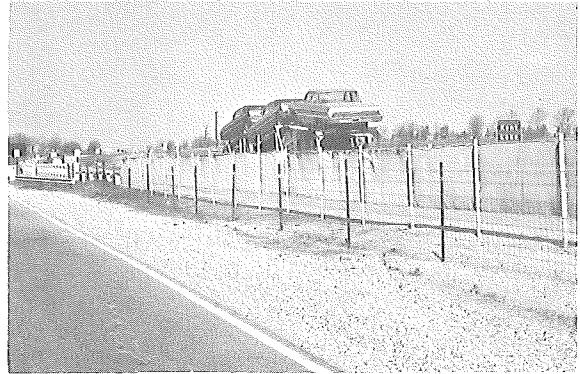
Fig. 7

The cost of purchasing and installing this glare screen at the time of installation in 1961 was approximately \$3.25 per foot. Maintenance cost would vary depending upon the type of location. Actual maintenance costs for this installation were not available. They were included in general roadside maintenance by the county doing the maintenance and could not be determined. During the time the screening was located in the median and since it has been moved to its present location, damage to the screen has been extensive. Several sections of the screening have been ruined by vehicles crashing into it. Snow plowing has caused some damage; however, this was not extensive enough to remove the screen's effectiveness. Observations in this study showed that during the winter the screen developed bowing and some sags from being struck by snow which was thrown from plows (this shows somewhat in Figure 6). This detracts appearance-wise, but the screen is still effective as a glare shield.

Anti-Glare Screen viewed at 15° angle from Service Road.

To date, most maintenance had involved repairing sections damaged by vehicles. It appears that in the near future the entire installation will require tightening to correct the sagging and bowing that was becoming quite apparent. However, the screen is still in effective condition to block headlight glare.

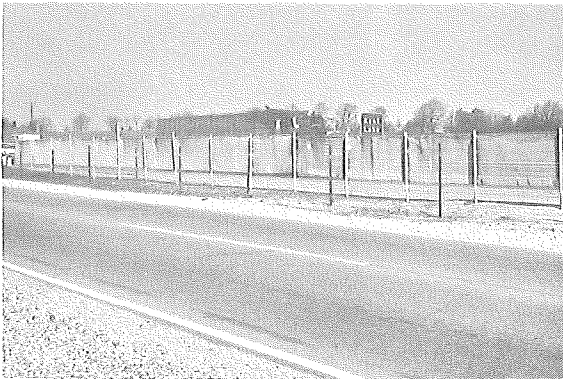
Fig. 8

Anti-Glare Screen viewed at 25° angle from Service Road, westbound.

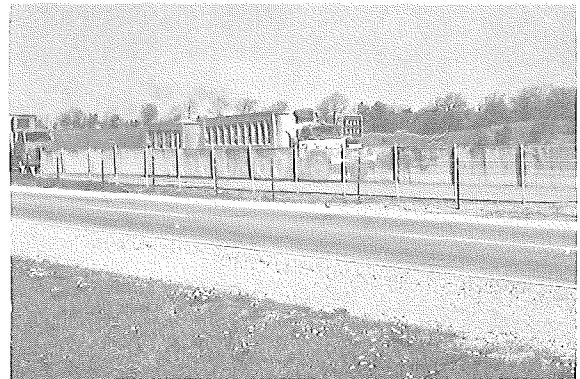
Fig. 9

Anti-Glare Screen viewed at 40° angle from Service Road, westbound.

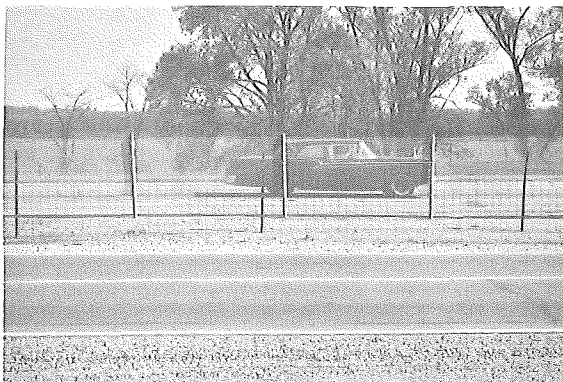
Fig. 10

In Figure 9, the screen is viewed from the perpendicular. The car and trees can be observed in detail through the screen, and the screen itself is faintly visible.

Anti-Glare Screen viewed at 90° angle

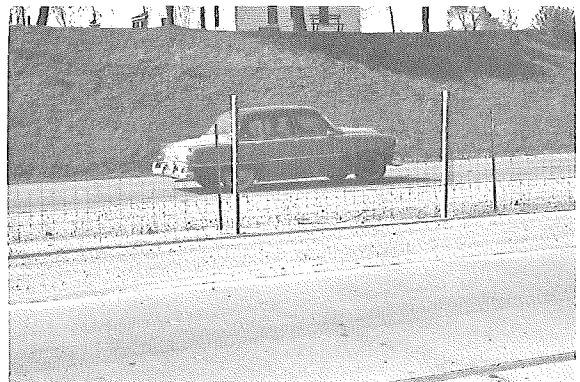
Fig. 11

In Figure 10, the screen is being observed from the angle of minimum restriction of view, about 135°, as measured from the center line of eastbound roadway. Objects behind the screen can be observed in detail and the screen is barely visible.

Anti-Glare Screen viewed from 135° angle from east-bound roadway.

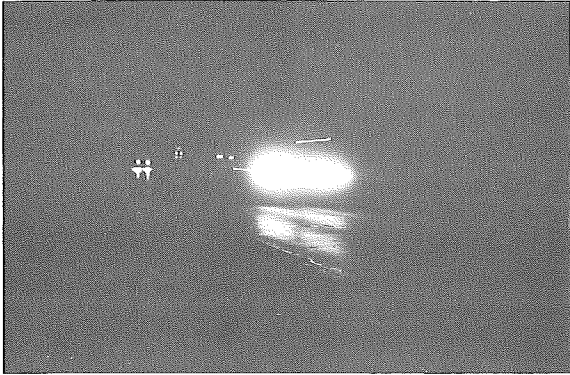
Fig. 12

Figure 11 is an unobstructed view of an approaching vehicle.

Unobstructed view of approaching vehicle.

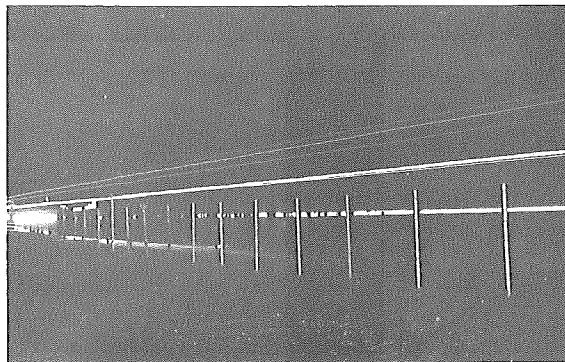
Figures 14 and 15 are time exposures showing trucks passing the glare screen on eastbound I-96. The photograph in Figure 14 was taken at approximately 10° and the one in Figure 15 at 15° . Light streaks above the screen are the truck's running lights shown in time lapse. The cutoff of glare is quite similar to that shown in Figure 13. The end of the screening is about $3/4$ of an inch from the left edge of the photo.

Truck passing Anti-Glare Screen on eastbound I-96 as viewed from Service Road at approximately 15° angle.
