OFFICE MEMORANDUM

R-684

MICHIGAN
DEPARTMENT OF STATE HIGHWAYS

Subject: Feasibility of Portland Cement Concrete Shoulder Construction.
Research Project 68 F-101. Research Report No. R-684.

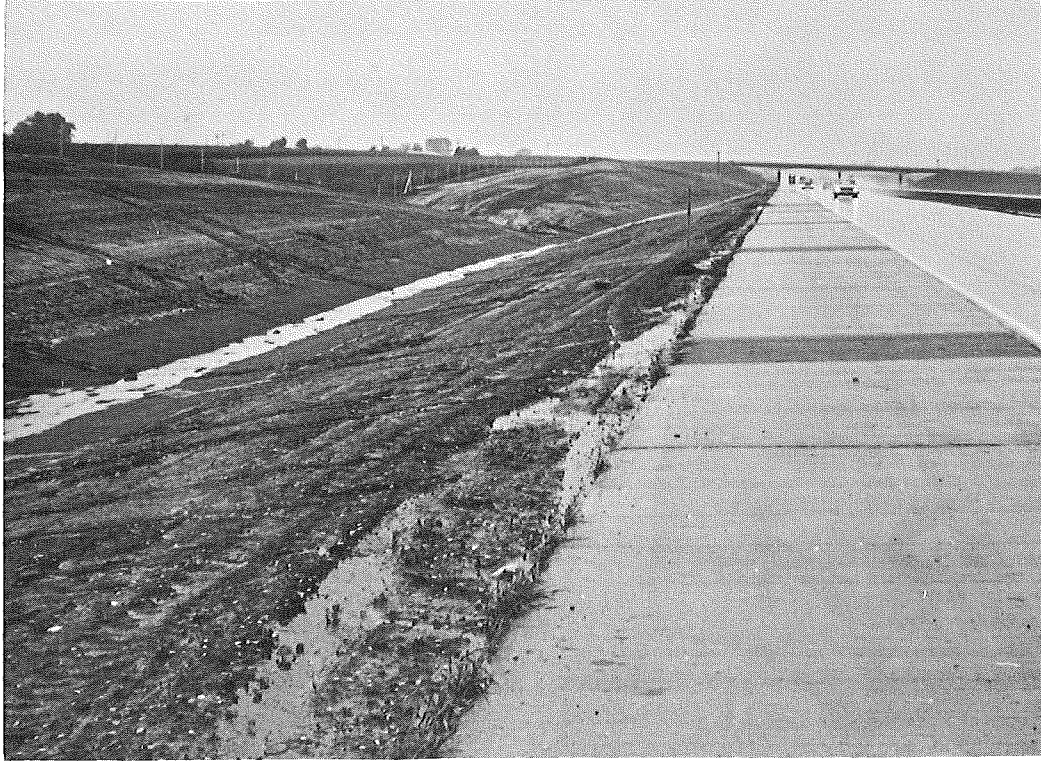
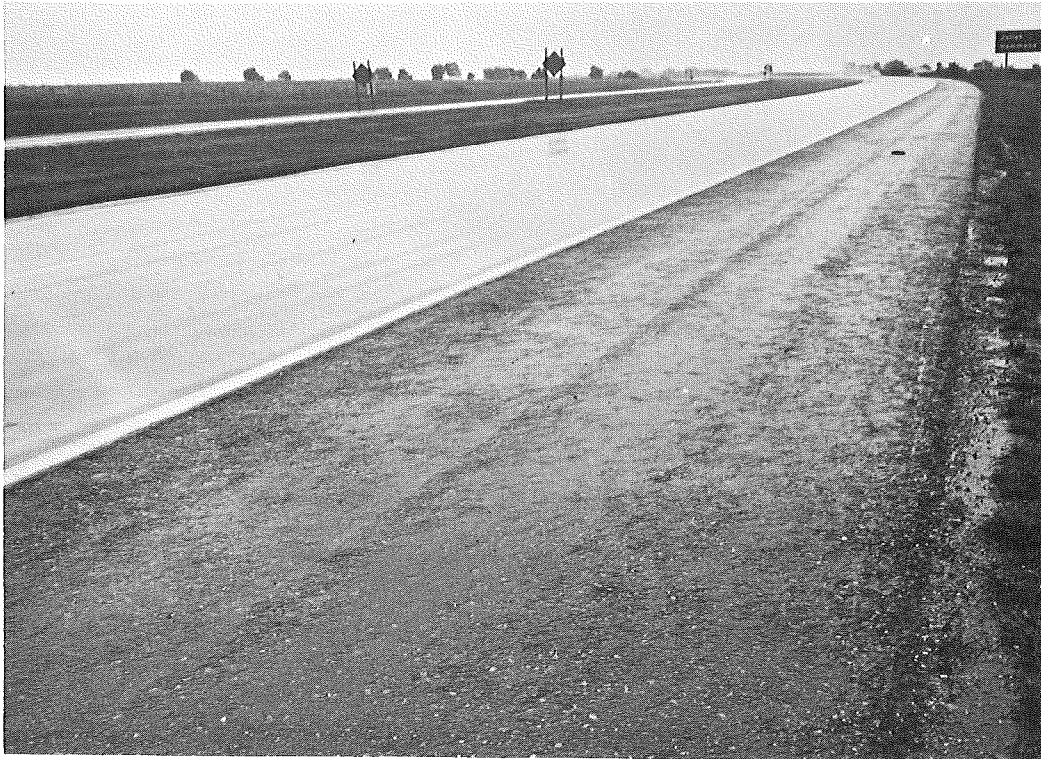
Research Laboratory personnel, visiting the site on September 19, 1968, found both the bituminous and concrete shoulders to be in excellent condition (Fig. 1). Figure 2 shows the narrow concrete shoulder on the median side of the roadway. Rumble strips can be seen on both the outside and median side concrete shoulders.

Figure 1. Illinois experimental shoulder installation: non-reinforced portland cement concrete (above) and bituminous aggregate (below).

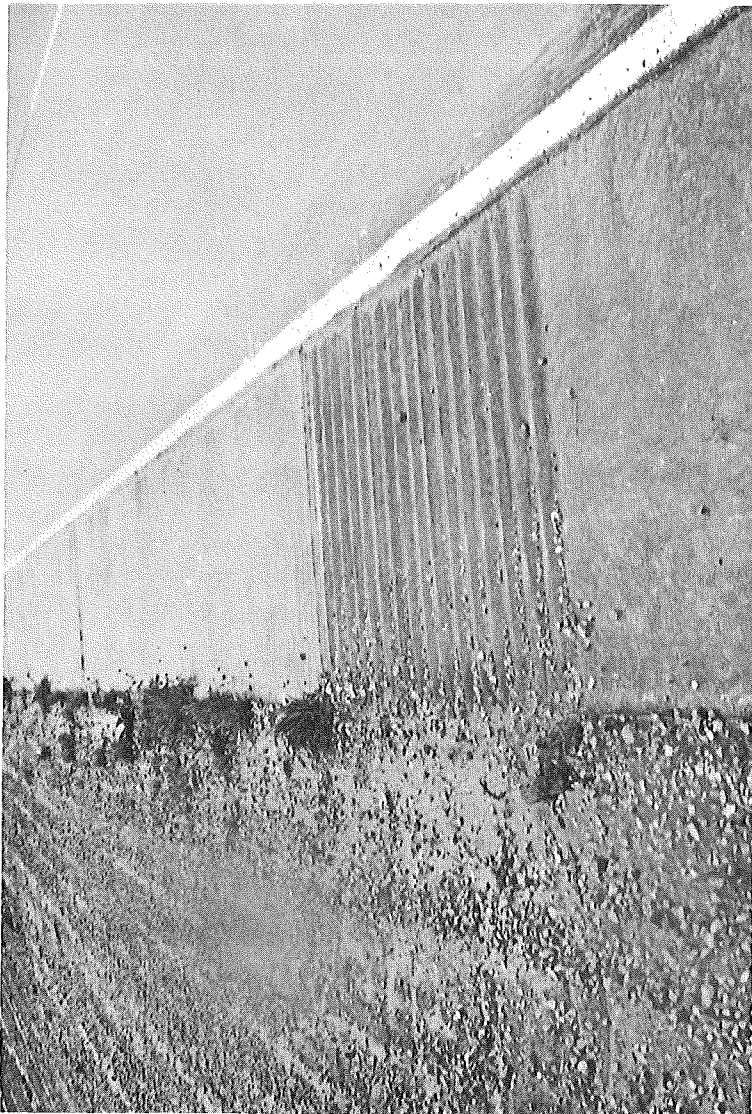
Figure 2 (above). Portland cement concrete shoulder on median side of roadway. Note edge line and rumble strip.

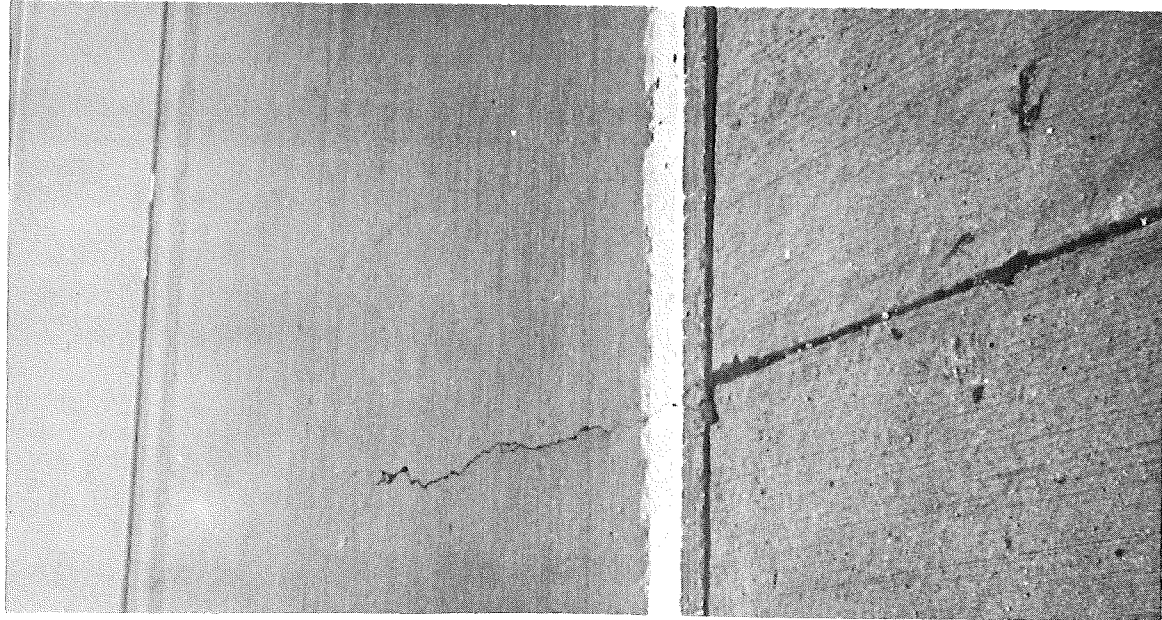
A design incompatibility between the continuously reinforced concrete pavement and the non-reinforced shoulder has caused rather open cracks in the continuously reinforced pavement at approximately every other shoulder joint. A typical example is shown in Figure 3. The continuously reinforced pavement expands and contracts, with this movement being absorbed in fine, transverse cracks, varying in spacing from one to perhaps 10 or 12 feet apart. The concrete shoulder absorbs contraction and expansion at joints spaced at 20-ft intervals, and yet the pavement and shoulder are tied together with 1/2-in. diam tie bars. As a result, the continuously reinforced pavement develops a larger crack adjacent to every joint (20 ft) or every other joint (40 ft) in the concrete

shoulder. This crack is open much wider than it normally would have been, and is a source for infiltration of water, maintenance chemicals and dirt. If not sealed, the cracks will result in corrosion of the continuous reinforcement.

Figure 3 (right). Commutative cracking in continuously reinforced concrete pavement at shoulder joint.

In Michigan design practice, where a continuously reinforced and a jointed pavement are adjacent and tied together, we have recommended (and installation has been made) a circular compressible doughnut around the tie bar to permit some absorbing of the small relative longitudinal displacement of these two pavements.
