PROGRESS REPORT ON
EVALUATION OF A RUBBER PAD RAILROAD CROSSING

Research Laboratory Section
Testing and Research Division
Research Project 64 G-134
Research Report No. R-698

State of Michigan
Department of State Highways
Lansing, April 1969

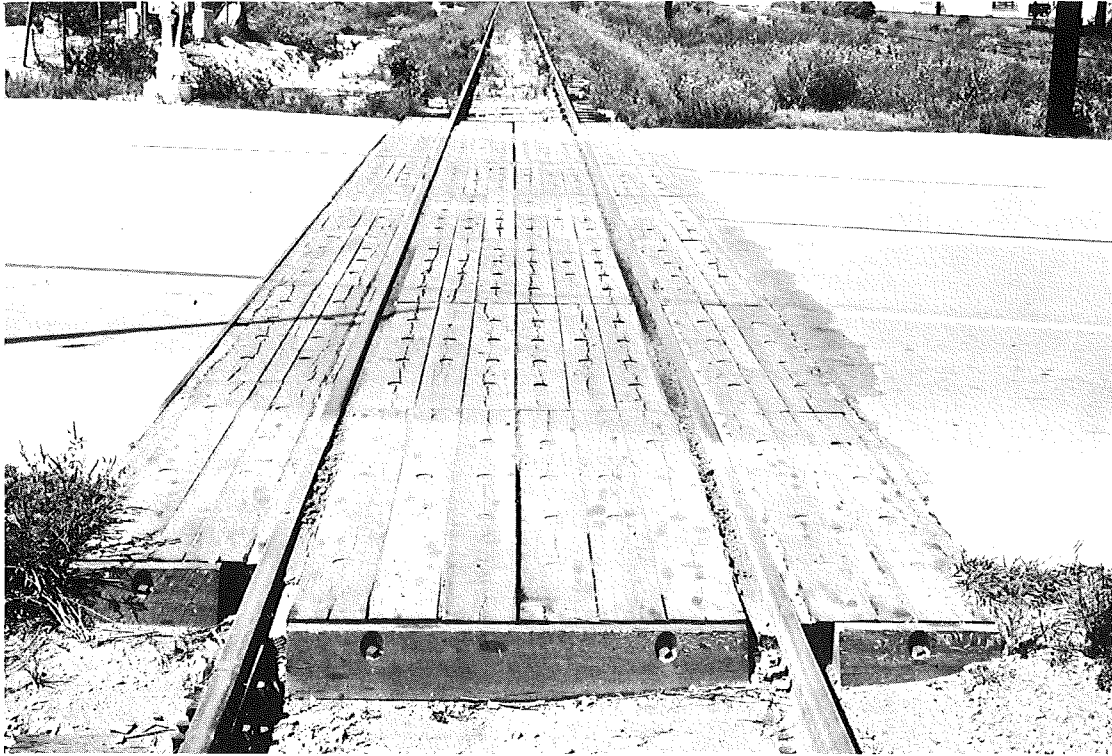
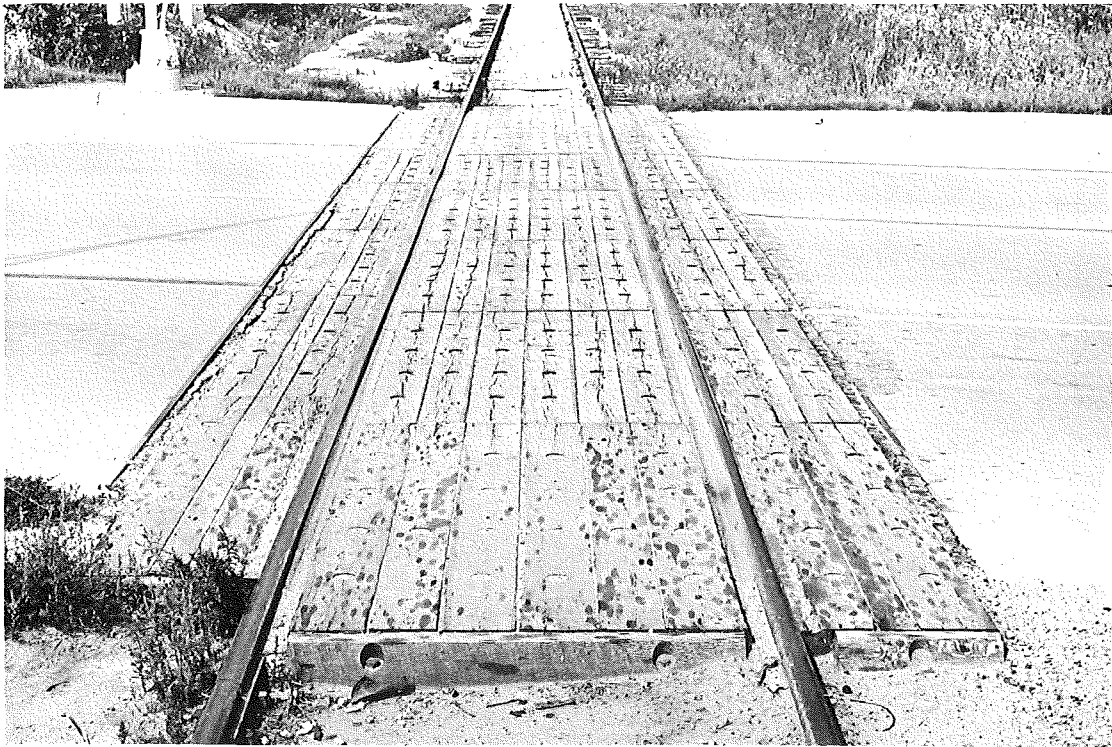
The first inspection of the timber crossing was made in August 1964. It was noted that the south side of the crossing was from 1/2 to 1 in. low with respect to the pavement and that the north side was high by about the same amount. A 6- to 12-in. wide bituminous transition strip had been laid at the north side to provide a smoother crossing. The timbers were in good condition and neither they nor the rails were loose. The 1965, 66, and 67 inspections revealed no noticeable changes. During the March 1968 inspection it was noted that the crossing had settled. The south side was found to be about 2 in. lower than the pavement and the north side was nearly at the same elevation as the concrete slab. The 1968 summer inspection disclosed no further settlement. During the final inspection all crossing elements appeared to be securely fastened and no significant surface wear of the timbers was evident. Figure 2 shows the condition of the crossing after one and five years.

Figure 2. Views of timber crossing one year after installation (top), and five years after installation (bottom).

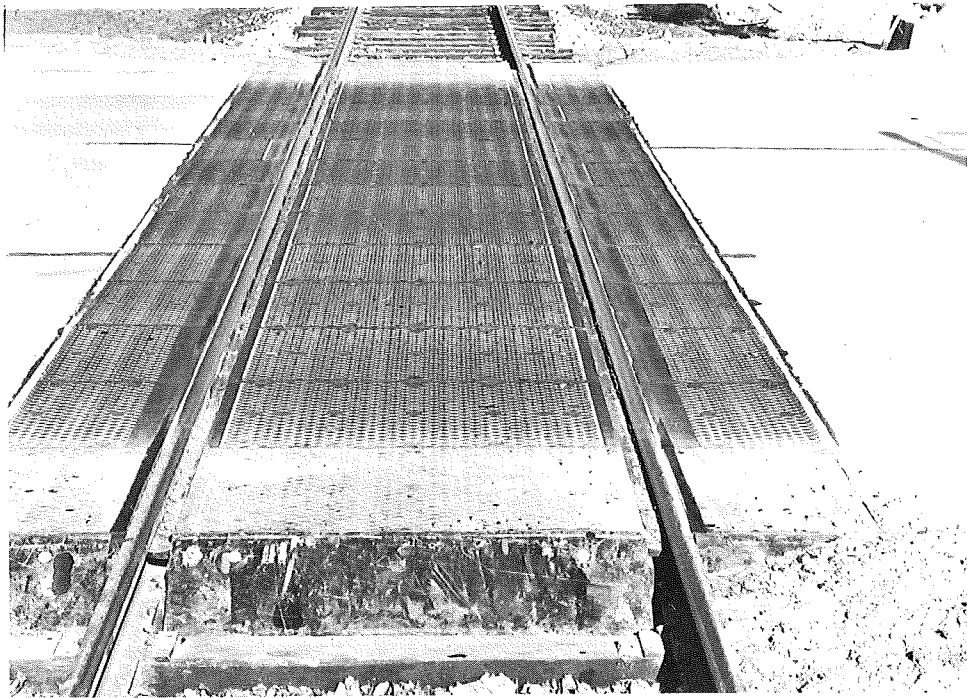
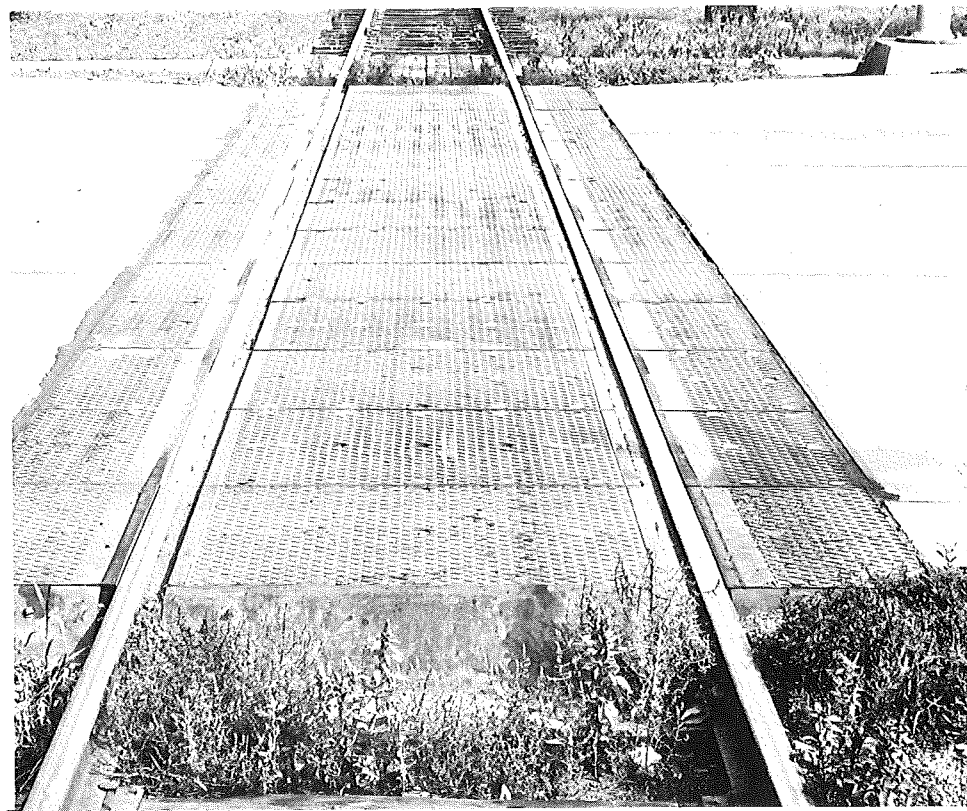
The rubber crossing was inspected for the first time in the winter of 1966 and was found to be in excellent condition. The 1966 summer inspection revealed that seven bolt-hole rubber caps had been lost, presumably due to snow removal operations. These caps have never been replaced. No change in condition was noted at the 1967 winter inspection, but a slight deflection of the approach side of the crossing in the right hand lane was noted during the summer inspection when vehicles passed over the crossing. This deflection was also noted at the winter inspection of 1968. In addition the sealer at the approach edge showed the beginning of adhesion failure. At the 1968 summer inspection the approach side of the crossing in all three lanes deflected slightly under load, and the seal at this edge had failed completely in the right hand and center lanes. The pads and rails appeared to be securely fastened to the ties. The slight deflection of the approach side is probably the result of a loss of support under the ties at this edge. However, this deflection does not adversely affect the excellent rideability of the crossing. To date there is no visible wear of the pads. Figure 3 shows the condition of the crossing as constructed and three years later.

Figure 3. Views of rubber pad crossing. As constructed (top), and three years after construction (bottom).
