Research Record

Issue Number 90

An Enlightening Experience

MDOT's Investigation of Tower Lighting Units Yields New Inspection Procedures

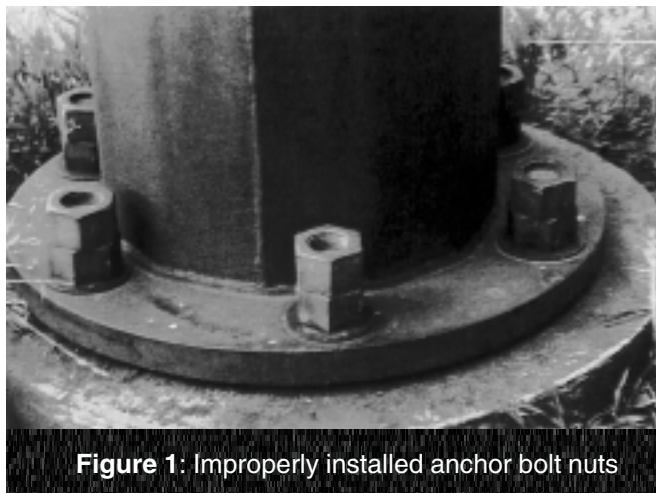
At the eighth interchange, which accounted for four HML, the leveling nuts were improperly installed. Rather than having a set of leveling nuts located below the base plate of the structures, and a set of anchoring nuts located above the base plate to secure the structure, both groups of nuts were located above the base plate (see Figure 1). This placed the base plate flush with the foundation of the structure, and created the same ventilation and drainage problems noted above. This problem was more difficult to resolve, as the HML had to be removed and reinstalled with the leveling nuts relocated to the proper location below the base plate.

Figure 1: Improperly installed anchor bolt nuts

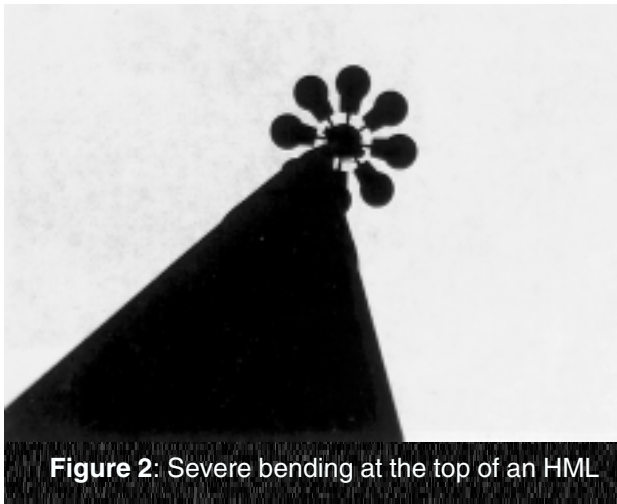
Nearly all of the HML that were inspected exhibited some minor bending near the top of the pole. However, four HML were found to have bending at the top that was in excess of 1.22 meters (see Figure 2). These structures were the first HML installed by MDOT, and have a significantly smaller cross-section at the top of the structure than the rest of the HML located around the state. This bending is not critical at the moment; however, these HML will be closely monitored as they are more susceptible to weld cracks due to the increased tensile stress in the slip joint areas.

Figure 2: Severe bending at the top of an HML

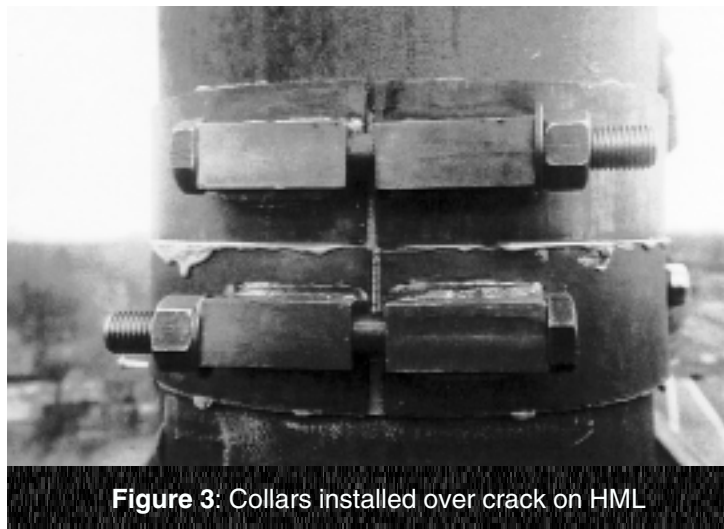
It was found that 19 of the A-588 weathering steel HML had cracks in the longitudinal weld. Eighteen of the cracks were located in the weld at the slip joint. Each slip joint ranges between 600 mm and 900 mm, depending on the height of the structure. Cracks were typically found at the first and/or second slip joint, and were between 24 mm and 432 mm in length. The nineteenth crack was 430 mm long, and found in the longitudinal weld away from the slip joint.

longitudinal joint areas, the researchers needed to understand the cause of the cracking. It appears that the cracking is the result of defects in the longitudinal welds, combined with high residual stress fields that allows stress corrosion cracking (SCC) to occur. This type of cracking is generally associated with weathering steels, as the stress normally needed for initiation do not normally occur. However, stress studies performed by the Illinois Department of Transportation indicated that the material used in the manufacture of some of the poles was cold worked to the point that higher than normal residual stresses existed adjacent to the weld areas. This in turn allowed smaller defects to create the greater stress intensity factors necessary for SCC.

Figure 3: Collars installed over crack on HML

The Structural Research Unit designed a 100 mm wide by 6 mm thick collar that wrapped around the area of the crack to replace any lost material, and to reduce the stress intensity in the area of the blunted crack tip. The collars were constructed with A-588 weathering steel to ensure compatibility, and to help eliminate the need for future maintenance. The collars were constructed with 25 mm diameter A325 Type 3 bolts and high strength connection lugs (see Figure 3). The bolts were tightened to 133 kN, which applied a circumferential stress of 207 Mpa into the pole. This load was chosen because it provides the desired amount of compressive force across the crack, minimizes the chance of future corrosion between the collar and the HML, and allows reserve capacity in the event of high-wind situations. The bolts are positioned perpendicular to the crack surface.

All of the defective A-588 weathering steel HML were repaired in this fashion by the Structural Research Unit. Subsequent inspections of the collars have shown through the tension in the bolts that they are sustaining the desired load. One minor problem with the collar design is that the collar can interfere with the lowering of the fixture ring during maintenance.
