MICHIGAN  
STATE HIGHWAY DEPARTMENT

August 5, 1957

SUBJECT: Rusting of Steel Beam Guard Rail on Ford  
and Lodge Expressways  
Research Project 49 G-50(4) Report No. 280

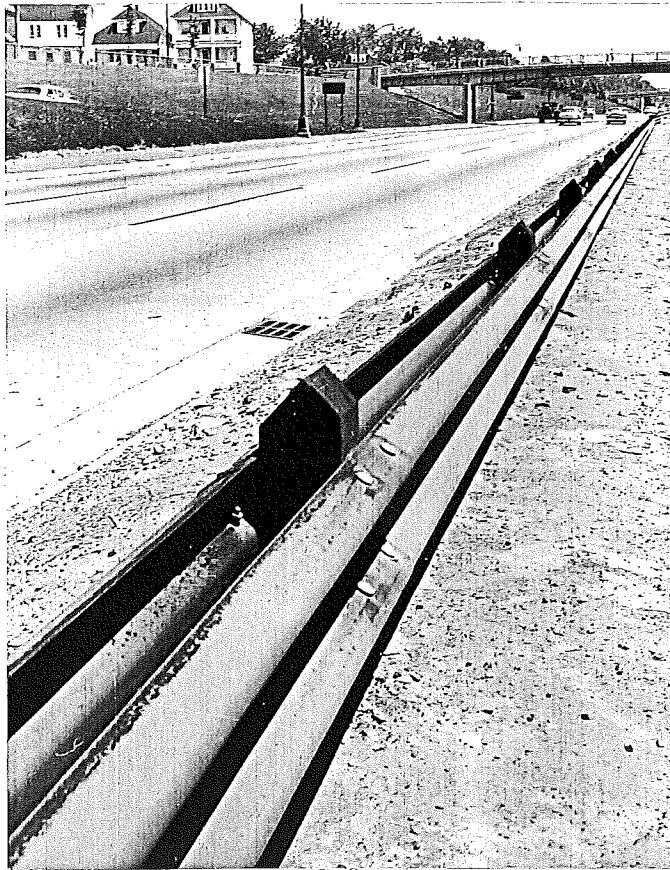
At the time of inspection we found that the double beam railings were installed at only certain areas along the two Expressways. A small portion of the installed railing was not top coated in the field over the factory applied primer paint and was rusted quite badly as shown in Figure 1.

Figure 1 shows that both the exterior and interior faces of the beam railing were rusted which signifies that the primer paint was poor in rust inhibition and was also applied in too thin a film: Actual measurement confirmed the latter conclusion by showing a primer film thickness of only 0.5 to 1.0 mils.

Figure 1. Primed but not field coated railing on West Ford Expressway; installation about 1/2-year old. Dark areas denote rusting.

It is recommended that a closer control be exercised over the quality and thickness of primers that are applied over beam railings. Use of a chemical surface treatment or phosphatizing treatment on the steel beam railings prior to priming should be studied for primer improvement. It is recommended that more rust inhibiting ability be included in the beam paint system by substituting MSHD No. 1-A paint, or faster drying modification, for the first field coat of the specified No. 6B-4 white paint. The possibility of providing more space between double beam railings should be studied to facilitate necessary maintenance painting.

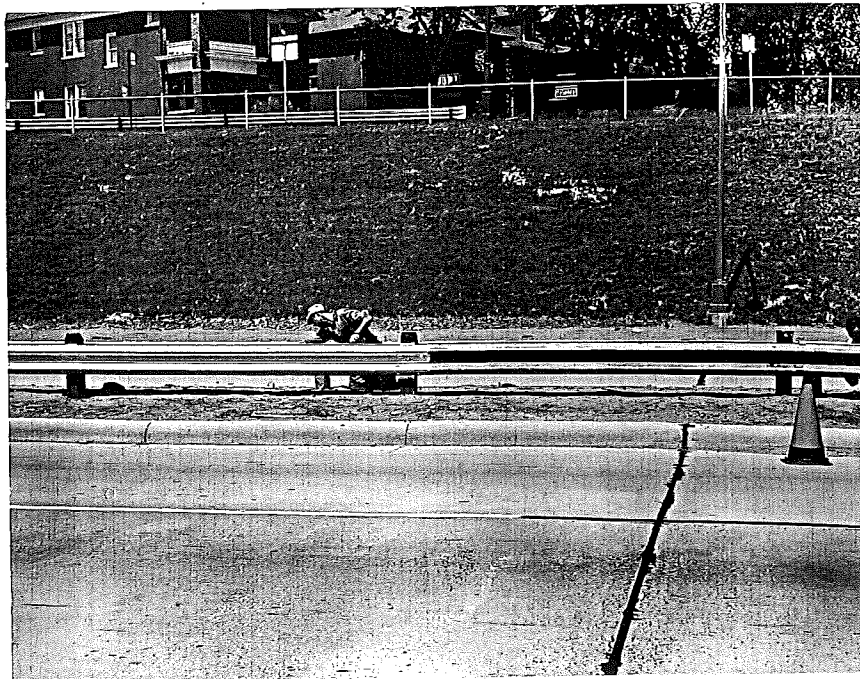
The greater part of the installed beam railing had been field coated with one coat of apparently a white paint which at the time of inspection looked a dirty gray because of the large amount of road dirt that was stuck on it. A paint maintenance crew on the Lodge Expressway stated that the field coated portions were painted with an MSHD specified white paint of the No. 6B-4 type. Because of the prevailing cold weather during field coating the slow drying character of this white paint was accentuated to produce a tacky surface for a period long enough to accumulate large amounts of divider-strip and road dirt blown on it by winds and traffic. Excessive rusting was present on these field coated railings also. This rusting was believed to be caused by the poorly primed surface and perhaps to poor preparation of the railing surface prior to field thickness amounted to about 3 mils. Figure 2 shows the maintenance crew painting field coated railing with a second coat of a fast drying aluminum paint on the Lodge Expressway on July 2, 1957. This operation took place several months after application of the first field coat.

Figure 2. Top coating of beam railing with second field coat on Lodge Expressway. Rust has penetrated first field coat.

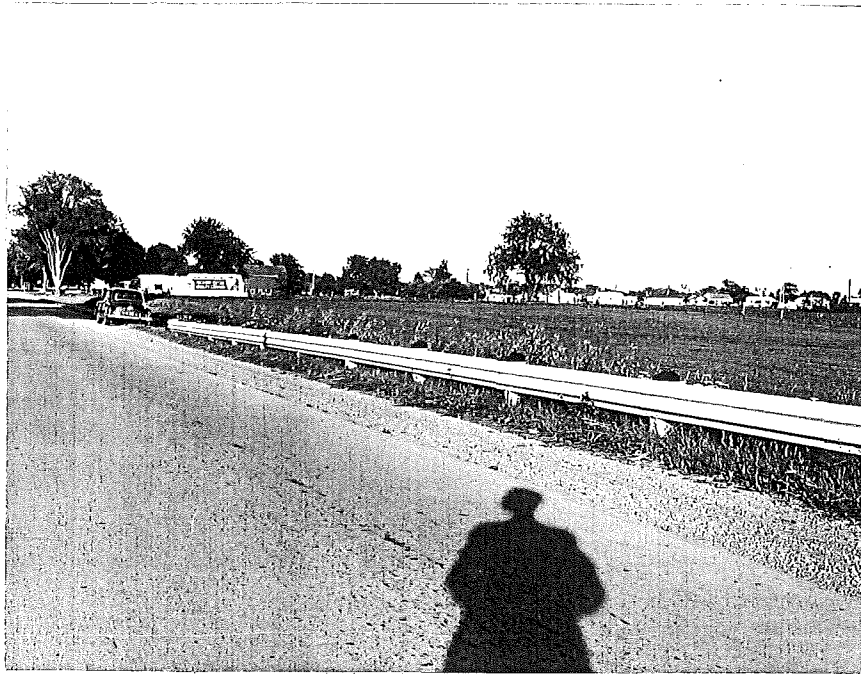
While discussing this problem after the inspection, Messrs. Finney and Shaefer advised examination of the coatings on some of the oldest installations of beam railings on our trunklines for comparison purposes. Accordingly the beam railings on M-50, M-52 west of Tecumseh were inspected on July 10, 1957. These painted beam railings, about four years old, were found to be in very good con-

dition as shown in Figure 3. By field measurement the front or roadside faces had an average total thickness of paint of 5 to 8 mils while the backs had a topcoat of black paint and had a total thickness of 2 to 3 mils, which was also in very good condition. A steel beam railing approach to Bridge XI and B1 of 38-1-14 (1949) north of Jackson on US-12 was also found to be in comparatively good condition and had a total paint thickness of about 10 mils: This beam railing was offset from the posts by steel brackets.

Figure 3. Condition of beam railing on M-50, M-52, west of Tecumseh; installation about four years old. Coating in good condition.

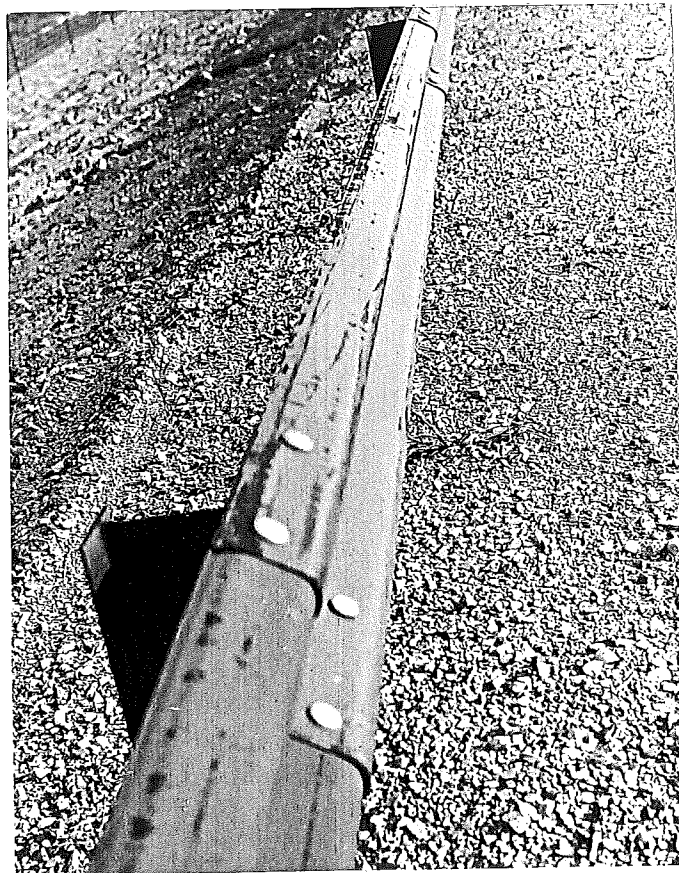
Newly installed beam railing on US-127 south of Mason was also examined. It was observed on one 500 foot section between stations 106+00 and 1055+00, which was factory primed but not field coated, that there were at least two different batches of primer paint. The coating condition of the poorer of the two batches is shown in Figure 4, which shows fairly large amounts of rusting that would be difficult to allay by subsequent top coating in the field with the presently specified MSHD No. 6B-4 white paint.

Figure 4. Newly installed factory primed, but not field coated railing on US-127; Station 1056/60. Dark areas denote rusting.
