Subject: Application and First Inspection of Epoxy Sealers Between Concrete and Bituminous Wearing Surface of Approach Deck Spans on International Bridge at Sault Ste. Marie (B01 of 17034, C3). Research Project R-59 F-53(2). Research Report No. 446.

APPLICATION OF EPOXY SEALERS
ON INTERNATIONAL BRIDGE APPROACH SPANS

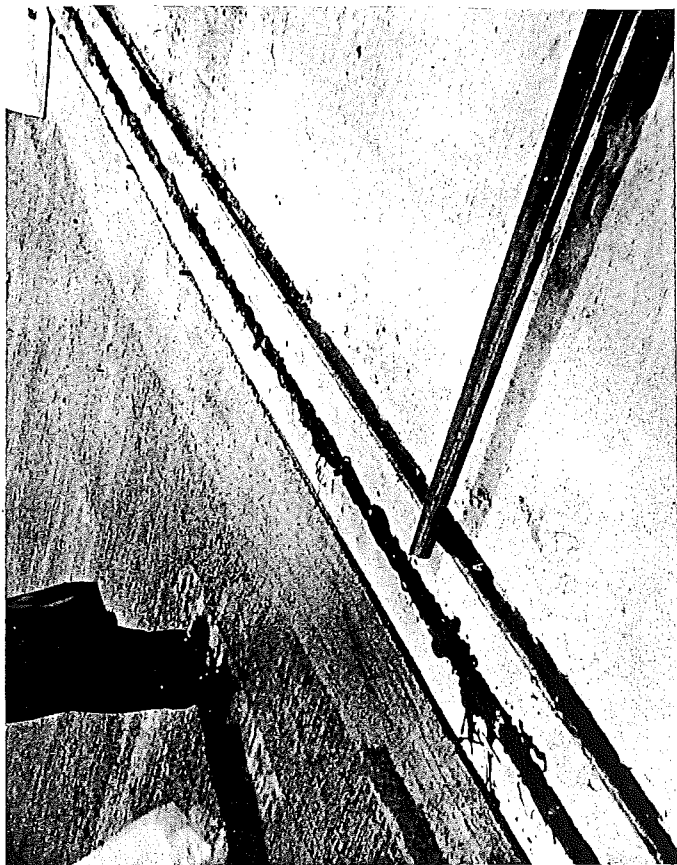
Deck concrete on the Michigan approach spans was of 7-in. uniform thickness and was laid over stay-in-place forms, as shown in Fig. 1. The bituminous wearing surface was 1-1/2-in. thick. The deck had a 1-3/4-in. crown and a 3.75-percent grade.

Figure 1 (upper left). Stay-in-place forms on bridge approach looking north toward spans over locks.

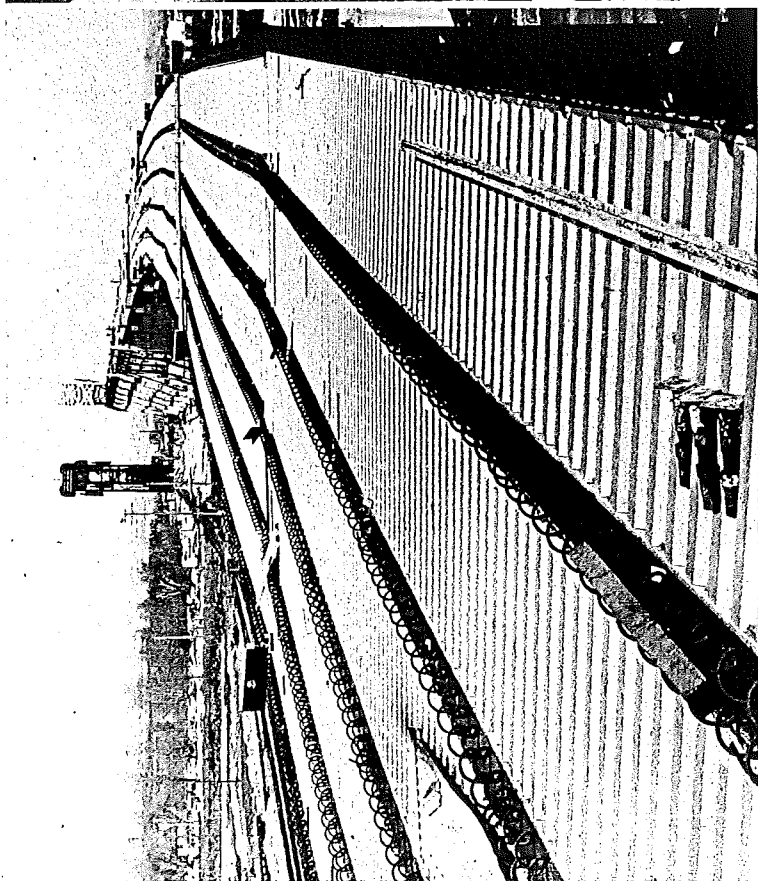
- (a) Completed acid etching to pier 2 (Fig. 2).
- (b) Swept northern portion of deck to remove powderiness.
- (c) Began applying polysulfide epoxy (Desco PE 150) at pier 18R.

Figure 2 (upper right). Acid-etched deck above joint, ready for sealer application. Raised concrete at joint will abut bituminous wearing course to be placed in foreground.

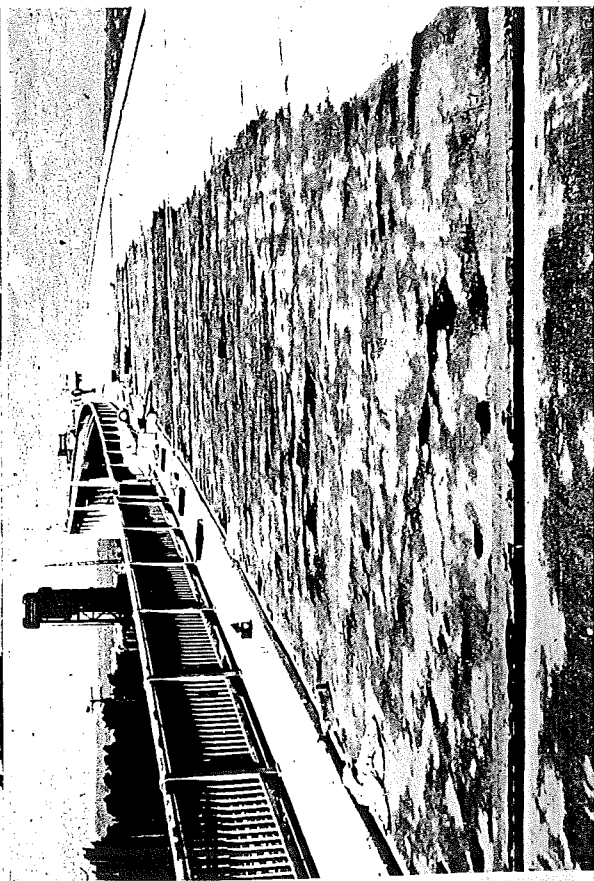
Coverage = 1.5 lb per sq yd, which met specification requirement of 1-1/2 lb per sq yd (about 60 sq ft per gallon). Applied sealer is shown in Fig. 3.

Figure 3 (lower left). Coal-tar modified epoxy sealer application on left portion of approach deck. Excess sand on sealer was subsequently broomed off, prior to tack coat and overlay application.
