MICHIGAN  
STATE HIGHWAY DEPARTMENT  
Charles M. Ziegler  
State Highway Commissioner

THE MUSKEGON EXPERIMENTAL PROJECT  
AFTER SEVEN YEARS IN SERVICE

Construction Project M-61-27, C5

Research Laboratory  
Testing and Research Division  
Report No. 78  
December 10, 1945

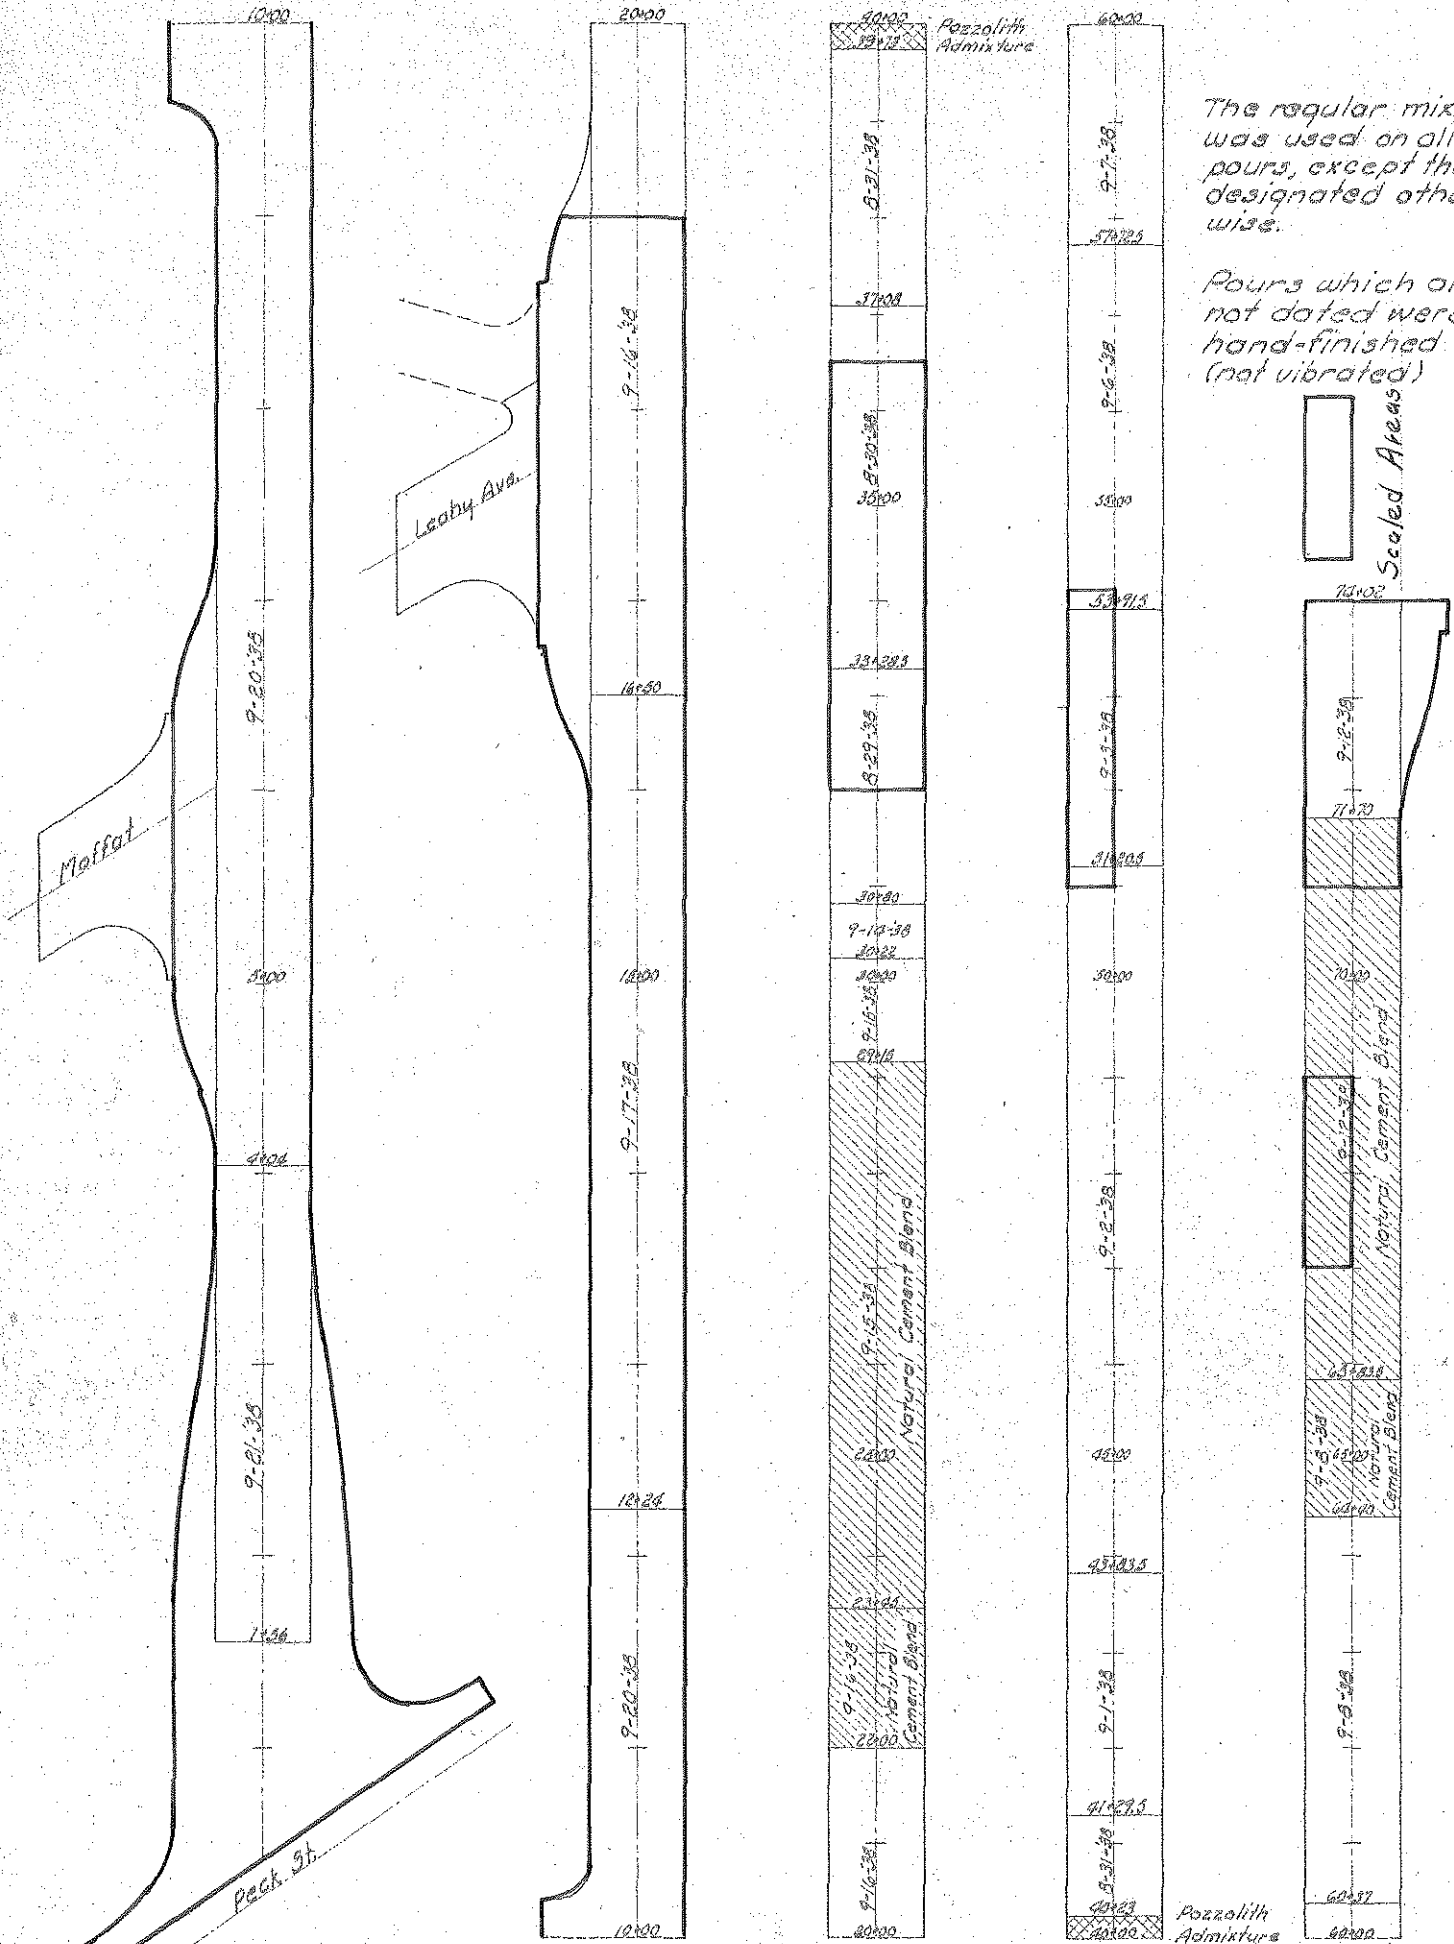
Figure 2

The results from the recent condition survey of the Muskegon project, as shown in Figures 2 and 3, as well as the results from other subsequent experiment work conducted by the Department and embodying the same features, clearly indicate that none of the methods outlined above will prevent scaling of concrete pavements.

In Figures 2 and 3, it may be observed that considerable scaling has occurred on both lanes between Stations 0+00 and 19+00, and from 31+00 to 36+50; on the east lane only between Stations 51+00 and 54+00 and from 66+00 to 68+00; and again over both lanes from Station 71+00 to the end of the project at Getty Avenue. The worst scaling has occurred between Peck Street and Leahy Avenue, Stations 0+00 to 19+00. This is probably due to the fact that frequent and heavy chloride-sand applications are necessary because of the many intersections in that particular area. The same condition prevails at the Getty Avenue end of the project. Scaling in the other areas was observed to be sporadic and of no serious consequence at the present time. No scaling was noted on the area containing Pozzolite, but that test section is so short that it is of no value in establishing a criterion in this respect and, therefore, must be discounted. The use of bituminous membranes, as well as the brooming process did not prevent scaling of concrete pavement surfaces. Views illustrating character of scaling are shown in Figure 4.

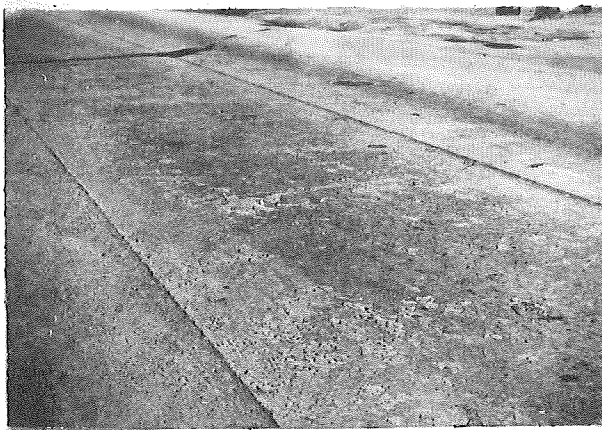
Scaling Between Stations  
0+00 to 19+00

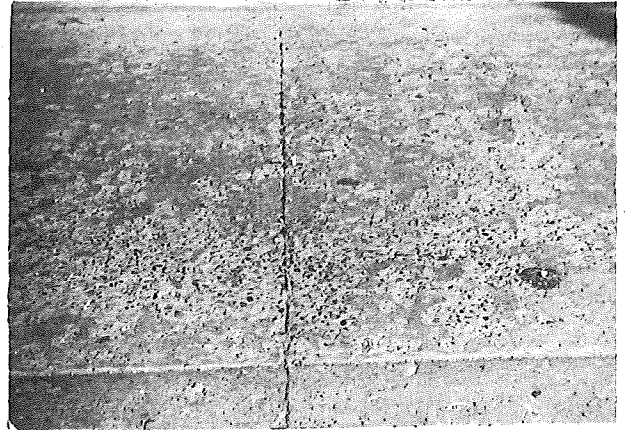
Scaling Between Stations  
0+00 to 19+00

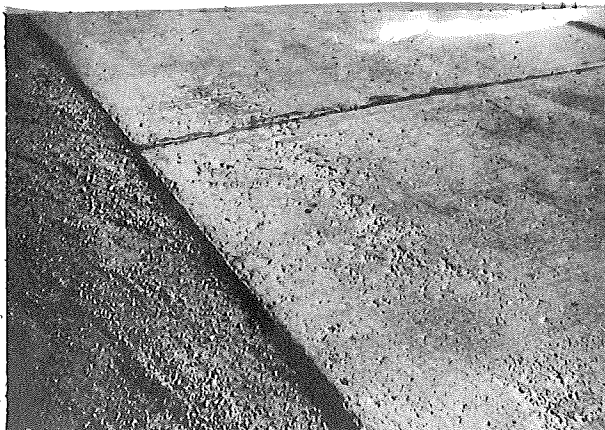
Typical Edge Scaling Stations  
51+00 to 54+00 and 66+00 to 68+00

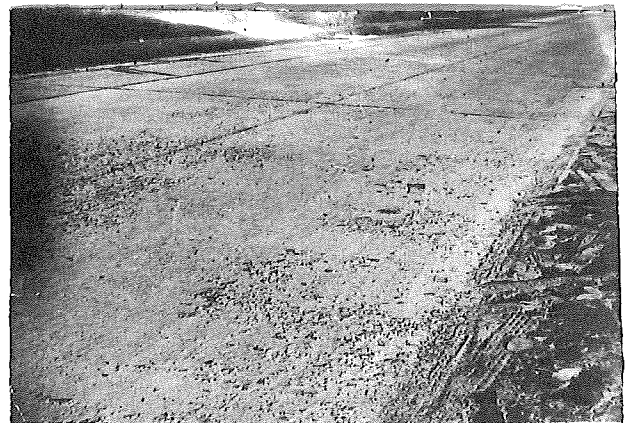
Typical Scaling at Getty Avenue

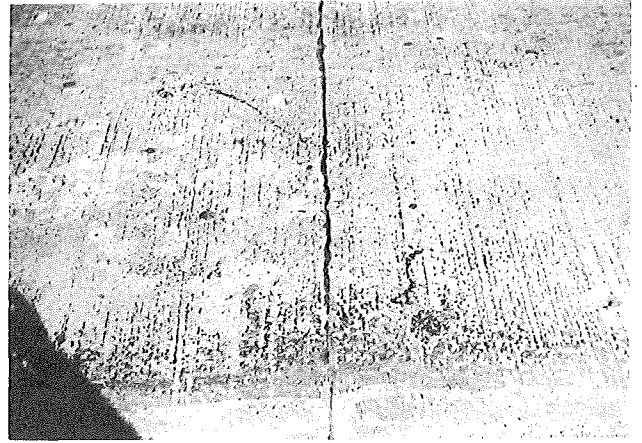
Since no method for determining the true joint width movement was provided on the project for this study, the data in Table II is based on what would be apparent to the eye and, therefore, must be considered in that light. However, it was readily discernible that many of the joints were locked because, in a great many cases where the dowels in the joints midway between the expansion joints were coated with grease or asphalt, there appeared unusually wide openings, as much as 1/2 inch and even 3/4 inches in certain instances. See Figure 6. On the other hand, joints with uncoated dowels, especially those located adjacent to the expansion joints, have apparently not been opening and closing in a normal manner. Obviously many of the plane of weakness joints which seem to be locked are operating in a manner similar to that of dummy joints in which the mesh is continuous through the joints, as in the case of current construction practice.

The locking of the joints may be caused, in some cases, by the misalignment of the dowel bars during the pouring operation.

Typical Condition of Closed Transverse Plane of Weakness Joints. Station 14+92. Dowels Uncoated.

3. Results in connection with the load transfer study indicate that dowel bars, if not properly coated or aligned, will tend to lock the abutting slabs at the joint thus causing the joint width movement to be much greater at some joints than at others instead of being properly distributed equally among all the joints as intended for this type of construction. Dowel bars must be adequately coated with a suitable material and properly aligned when installed to insure normal functioning of each joint.

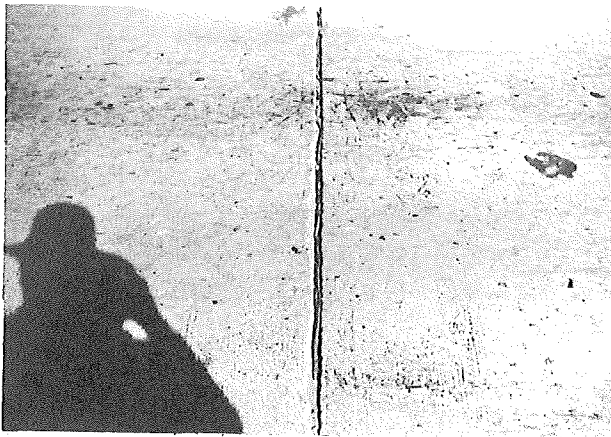
Typical Condition of Open Transverse Plane of Weakness Joints, Opening 3/4 inch. Station 31+08. Dowels Greased.

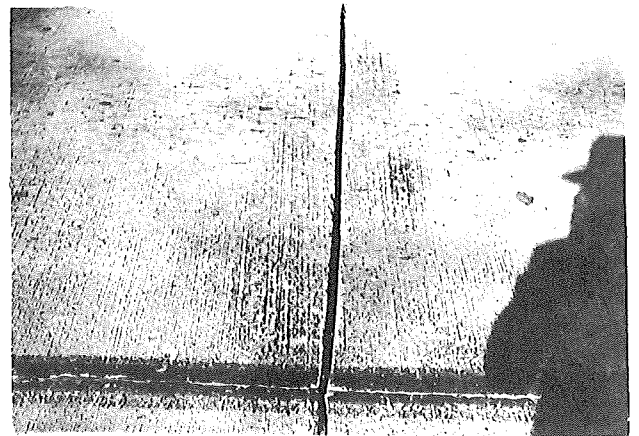
Open Transverse Plane of Weakness Joint at Station 55+12, Opening 3/4 inch. Dowels Coated with AE-1 Bituminous Emulsion.

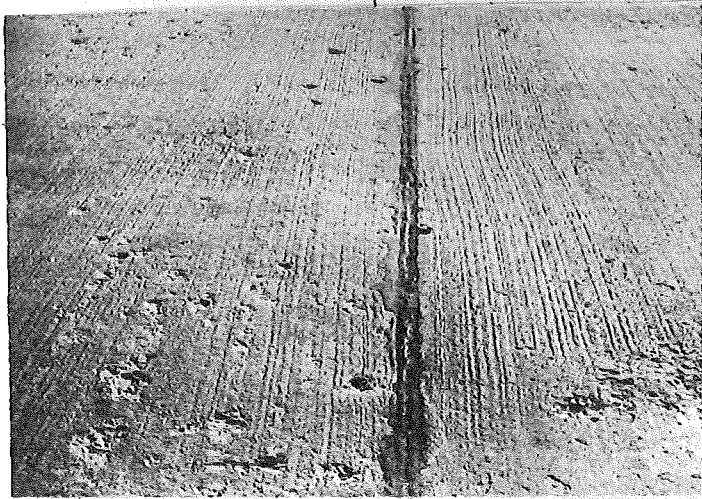
The survey revealed that the expansion joints at Stations 68+80 and 69+80 have been functioning in a normal manner. The present condition of the two joints is illustrated in Figure 9. A blow up has occurred at the third special joint located at Station 71+00. The slab edges at the joint have heaved approximately two inches causing the slabs to crack several feet back from the joint. The present condition of the joint is shown in Figure 9.

The asphalt-latex joint seal compound used in the three poured type expansion joints was still in place at the time of condition survey and the material possessed a considerable amount of plasticity and adhesion. The condition of the material may be observed in Figure 9. The material had a brownish granular appearance, the typical effect of weathering. The asphalt-latex material and method of application have been considerably improved since this experiment. It has not been necessary to service these joints during their seven years in service.

Typical Condition of Special Asphalt Latex Expansion Joints at Station 68+80. Age 7 years.

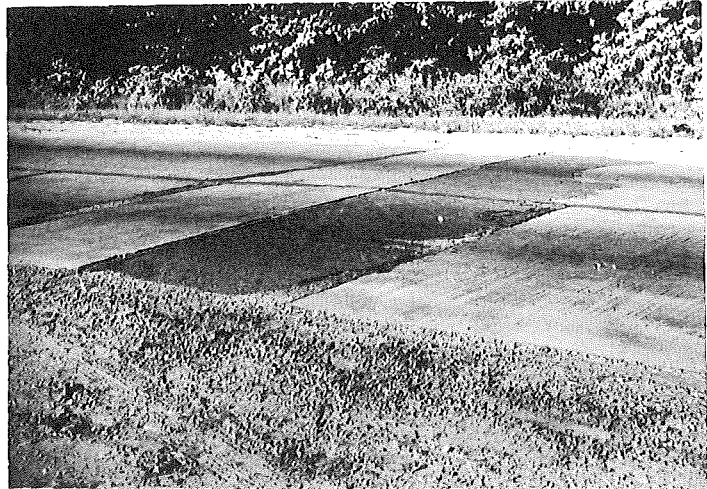
Blowup Has Occurred at Third Special Asphalt Latex Expansion Joint at Station 71+00.

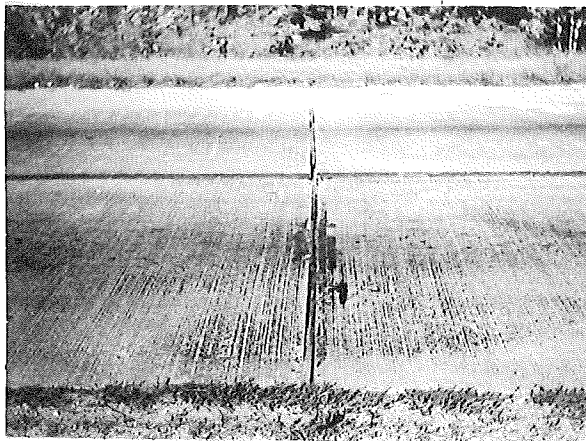
At Stations 67+70, 72+21 and 73+10, white pine boards specially prepared were installed in the expansion joints as a substitute for the common bituminous fiber board type of filler. The boards were cut in sections 10 feet long and installed with the grain horizontally. The physical condition of the joints at the present time are illustrated in Figure 10. Certain sections of the wood board in joints at Stations 67+70 and 72+21 have been displaced by traffic. This condition would not occur if the grain of the wood ran vertically. With the exception of this one incident both joints are apparently in good condition. The joints should be sealed, however.

Condition of Expansion Joint with Wood Filler at Station 67+70

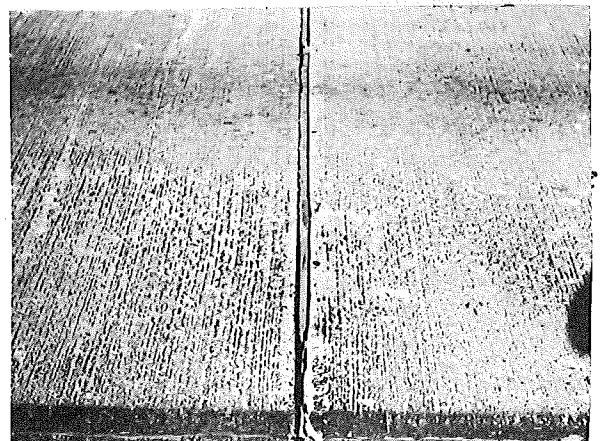
Close View of Joint at 67+70 Showing Failure of Wood Installed with Grain Horizontal.

5. Wood filler material in order to give satisfactory service should be placed in the joint with the grain vertical. This is now recognized as the proper procedure for wood filler material.
6. The asphaltic-oil latex joint seal still possessed remarkable life and tenacity after seven years. These results further substantiate the fact that asphalt-rubber joint seal compounds are the best materials which have been developed for this purpose up to the present time.

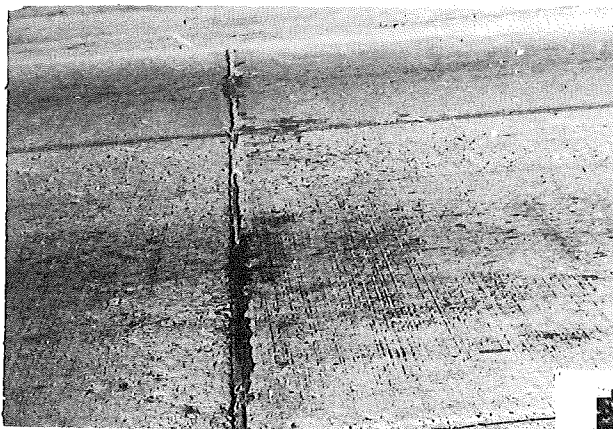
View of Expansion Joint with Wood Filler at Station 72+21

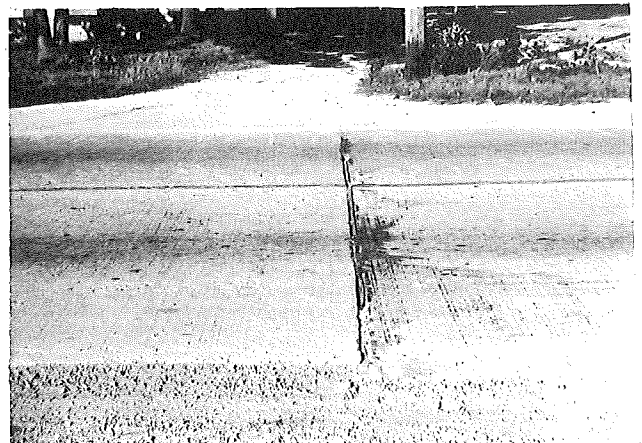
View of Expansion Joint with Wood Filler at Station 73+10
