EVALUATION OF TIMBER PILES
FROM FORT STREET BRIDGE

Research Laboratory Section
Testing and Research Division
Research Project 80 TI-722
Research Report No. R-1164

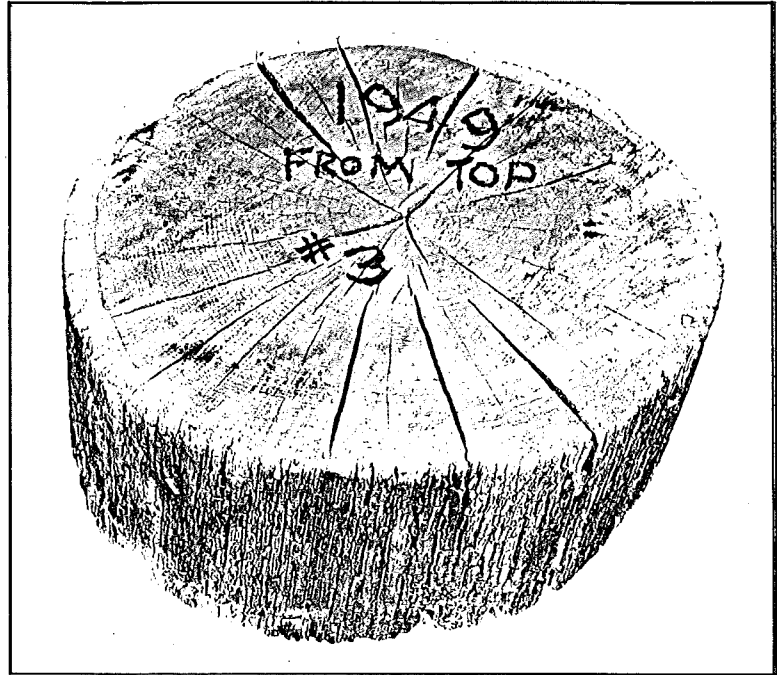
Figure 1. Typical pile section.

Samples of timber piling removed from the protective fender system at the Fort St bascule bridge, which was struck by the S. S. Silverdale, have been evaluated. This evaluation was requested by R. J. Eisenberg, of the State Attorney General's Office in order to obtain another opinion of the condition of the pile sections. Previously, portions of the same piles had been examined by S. B. Preston at the University of Michigan. The samples of timber piling were received at the Research Laboratory on December 4, 1980, from the Project Engineer's Office where they had been stored. The delivery of the piles to our laboratory was requested by the District Maintenance Office. The received short sections of piling were reported to have been removed from the remaining portions of four piles at approximately 12 ft below the waterline. Two of the samples were labeled as having been removed from piles installed in 1921 and the other two came from piles installed in 1949. The samples were reported to have been taken from the same piles, and adjacent to the samples evaluated by Mr. Preston at the University of Michigan. It had been previously determined by the examination performed at the University of Michigan that the section of piling installed in 1921 is red oak; whereas that identified as having been installed in 1949 is white oak. The length of the pile sections ranged from 5-1/2 to 6-1/2 in. Figure 1 shows a typical pile section.

The portions of piling received contained soft rot in the outside 1/2 to 1 in. The USDA "Wood Handbook" states, "Soft rot typically is relatively shallow; the affected wood is greatly degraded and often soft when wet, but immediately beneath the zone of rot the wood may be firm," (p. 17-4). This was found to be true of the pile sections examined. The average loss of usable cross-sectional area attributed to soft rot was approximately 21 percent.

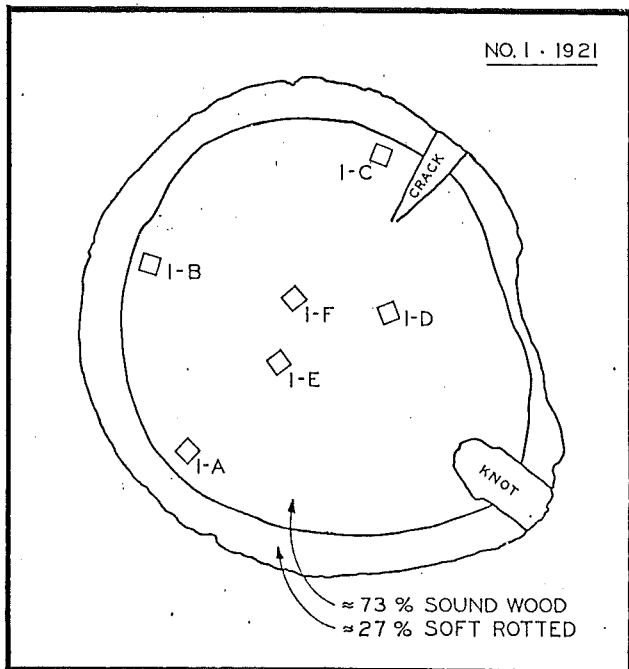
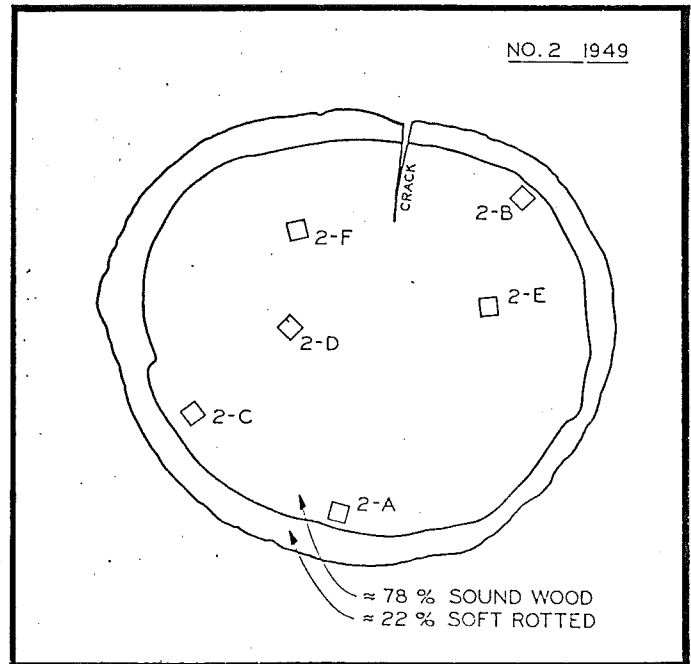
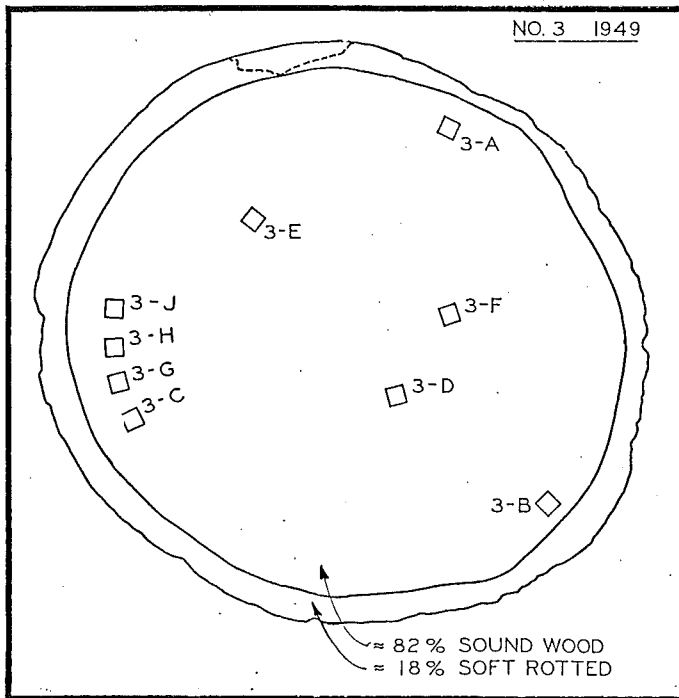
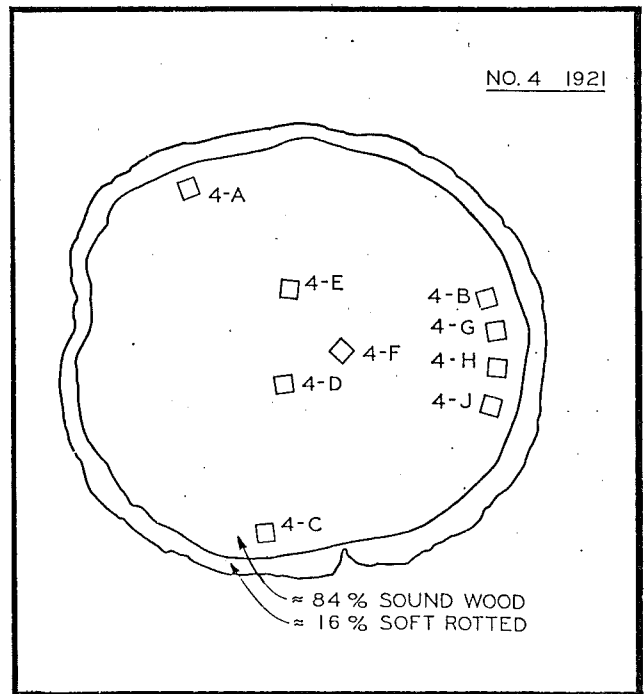
Figure 3. Timber pile cross-section and location of removed static bending specimens.

Results of the evaluations performed are given in Table 1. Figure 3 shows the locations where the modulus of rupture specimens were taken from each pile section.
