CORROSION PERFORMANCE OF ALUMINUM CULVERTS
First Progress Report

Research Laboratory Division
Office of Testing and Research
Research Project 60 NM-26
Research Report No. R-569

State of Michigan
Department of State Highways
Lansing, March 1966

First Progress Report

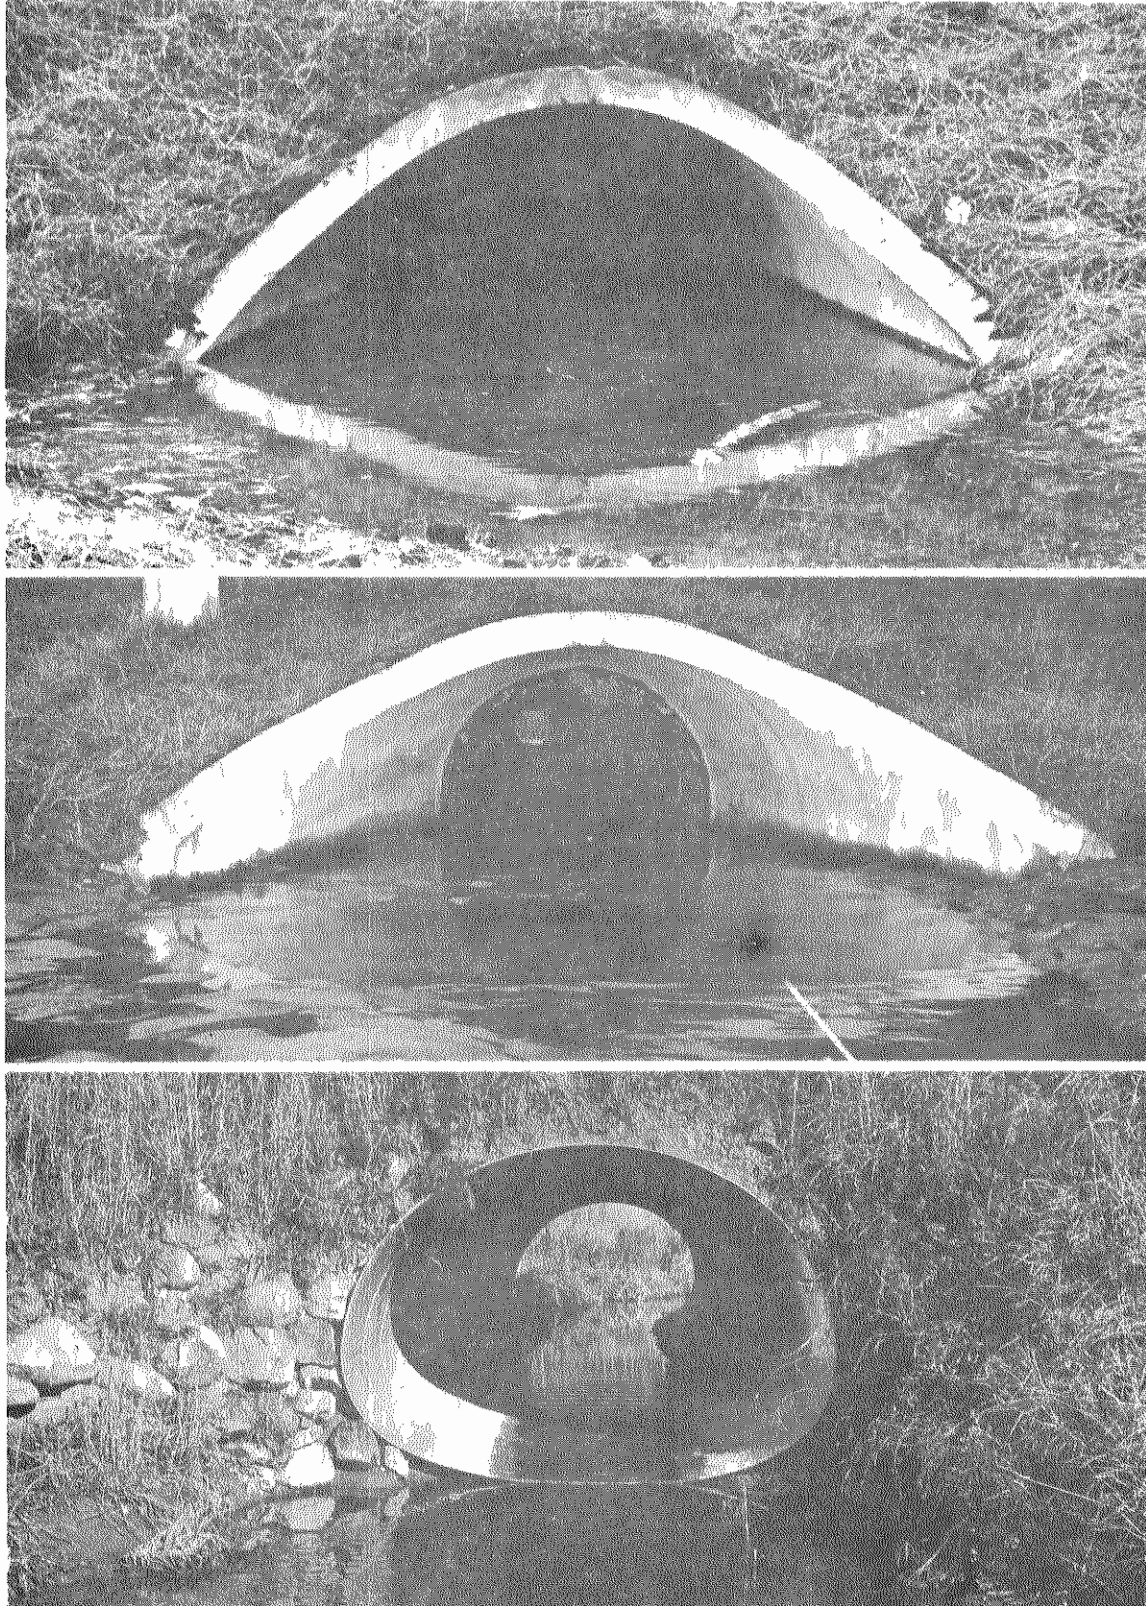
The location, properties, and environmental site conditions of each culvert selected for examination are summarized in Table 1. The natural soil in the area where the US 2 projects are located consists mostly of the Adolph, Skanee, and Wakefield series, with peat and muck areas occurring at frequent intervals throughout the projects. The area generally exhibits poor drainage conditions and at the time of inspection ponded water was noted in many of the culverts. The drainage pattern at the county locations was much better, because the area's natural slope provided a sufficient gradient to prevent water from ponding in the culverts. Figure 1 illustrates drainage conditions at three culvert locations.

Figure 1. Drainage conditions for a US2 galvanized steel culvert (top: Sta. 96+00), a US2 aluminum culvert (center: Sta. 181+10), and the Ewen aluminum culvert (bottom).

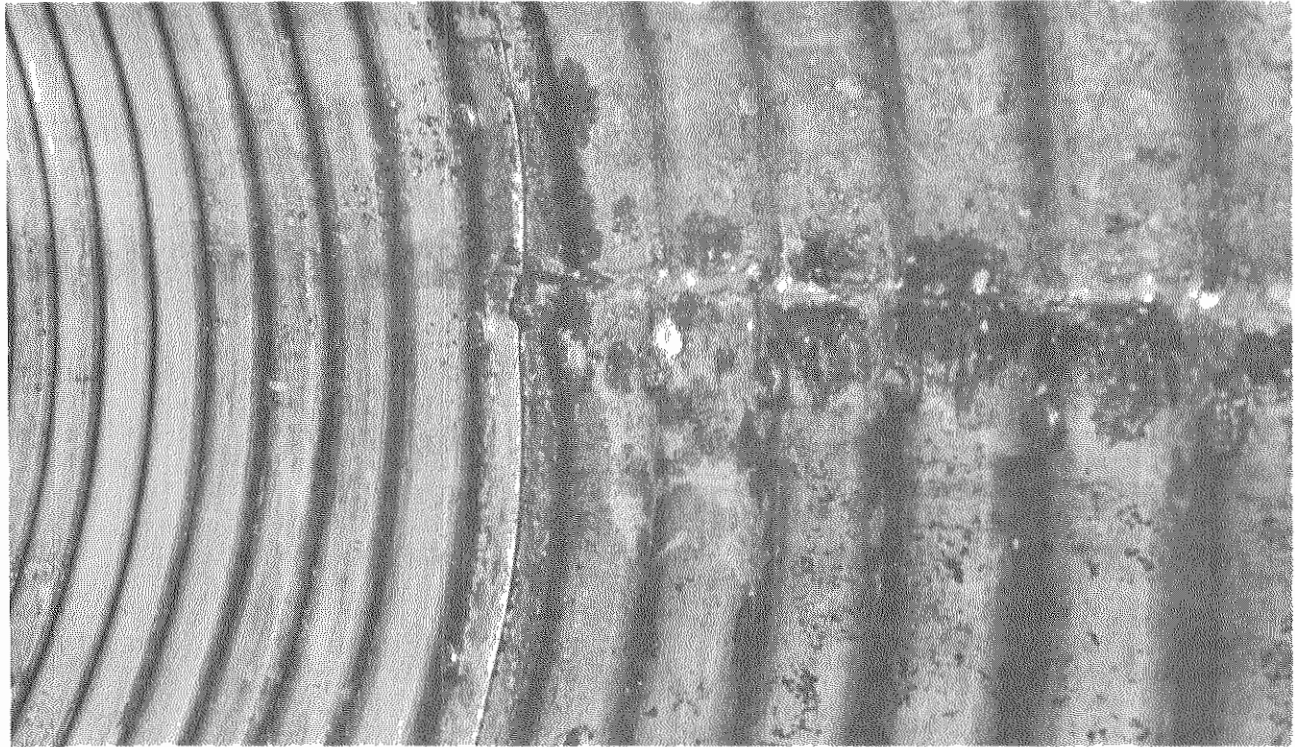
Sta. 549+50. The north end of the culvert was inspected. The soil-side surface was in excellent condition. Several spots of white rust, up to 1/2-in. diam, were noted on the fifth, sixth, seventh, and eighth corrugations from the culvert end on the water-side surface. No serious attack on the galvanizing had occurred.

Figure 2. Lines of "white rust" spots along riveted joint in a US2 galvanized steel culvert (north end, Sta. 549+50).

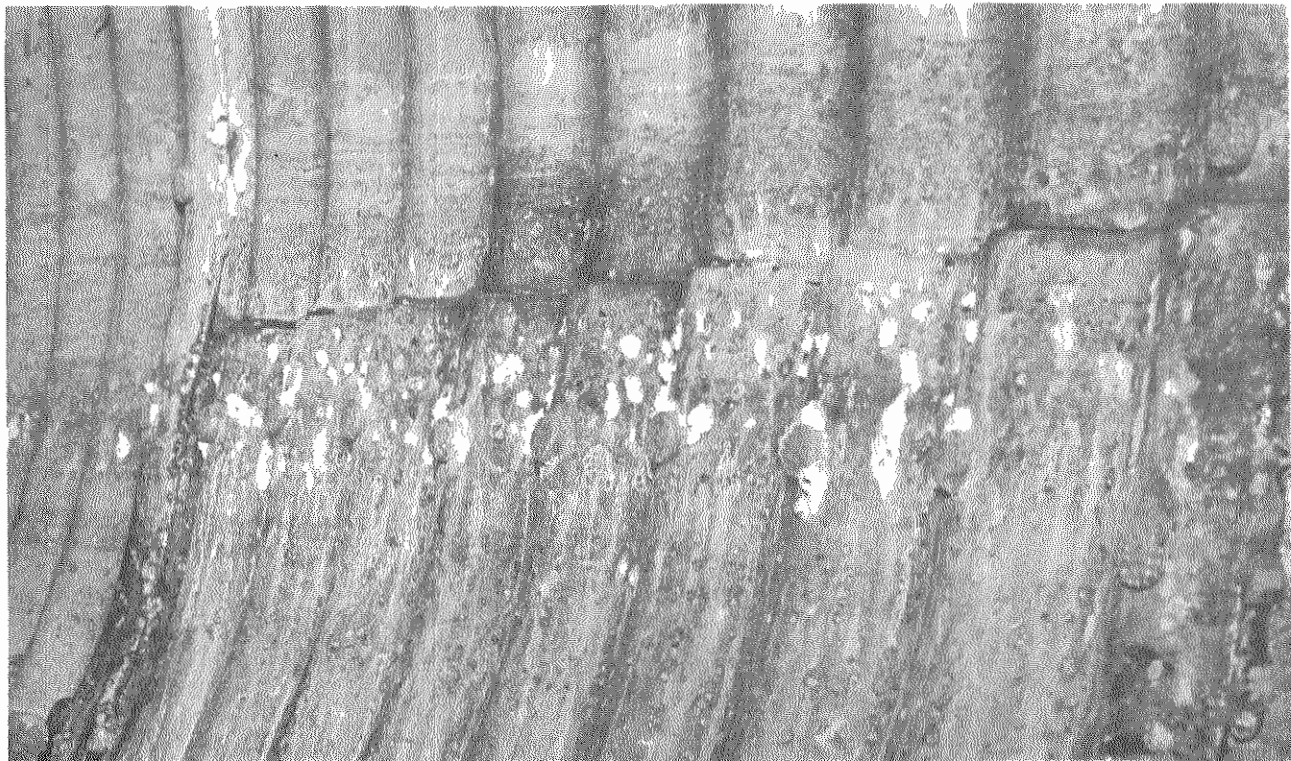
Sta. 121+75. At this location the soil-side surface was not inspected, because of deep embedment at both culvert ends. Both the north and south ends of the water-side surface were in good condition, except for several small spots of white stain along the high waterline mark at the south end.

Figure 3. White spots along a former air-water interface in a US 2 aluminum culvert (north end, Sta. 121+75).

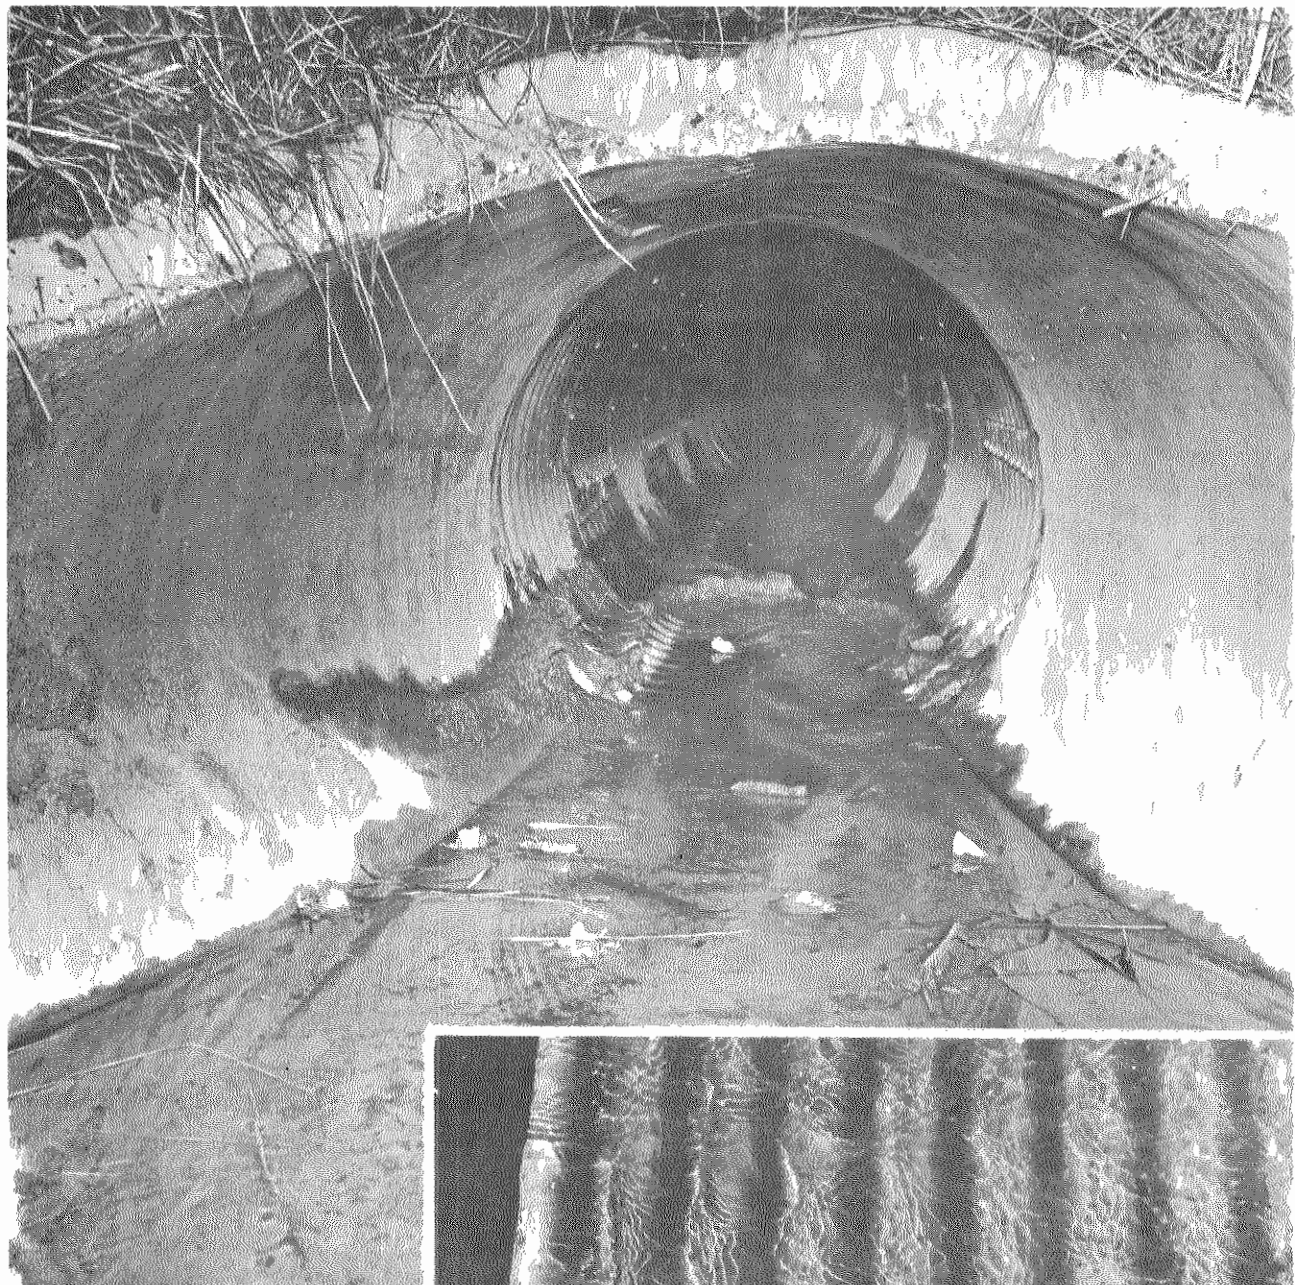
Figure 4 (above). Brown stains below some riveted joints in a US 2 aluminum culvert (south end, Sta. 121+75).

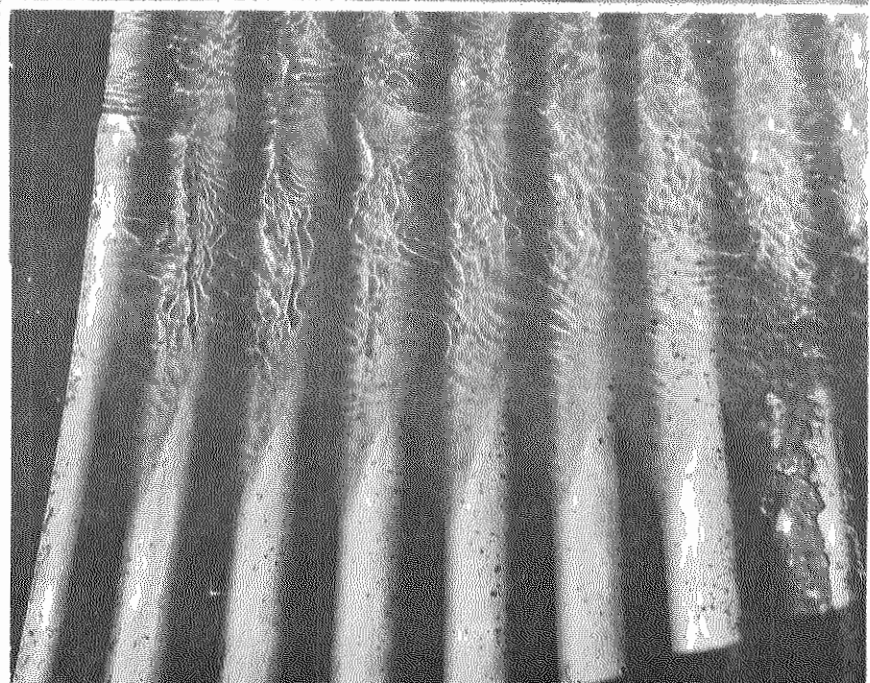
Figure 5 (right). Small dark spots indicate penetration of cladding on the Ewen aluminum culvert.

Ewen. The soil-side surface was not examined because of almost vertical backfill slopes. On the water-side surface, the portion above the present water level showed only a few minor, randomly located white spots. Below the water surface the invert was quite severely pitted. At the outlet end of the culvert, 6 to 8 pits per sq in. were common, with a few pits up to 1/4-in. diam. The pitting became progressively less severe toward the inlet end. Most pits had penetrated the cladding. No significant difference was noted in corrosion attack on the upstream and downstream faces of the corrugations.
